Supplemental Aquatic Resource Report
for the
Pennsylvania Pipeline Project Stations
Washington, Westmoreland, Cambria,
Huntingdon, Perry, Dauphin, Berks, Delaware
Counties,
Pennsylvania

Prepared By:
Tetra Tech, Inc.
For
Sunoco Pipeline, LP
525 Fritztown Road
Sinking Spring, PA

May 2016

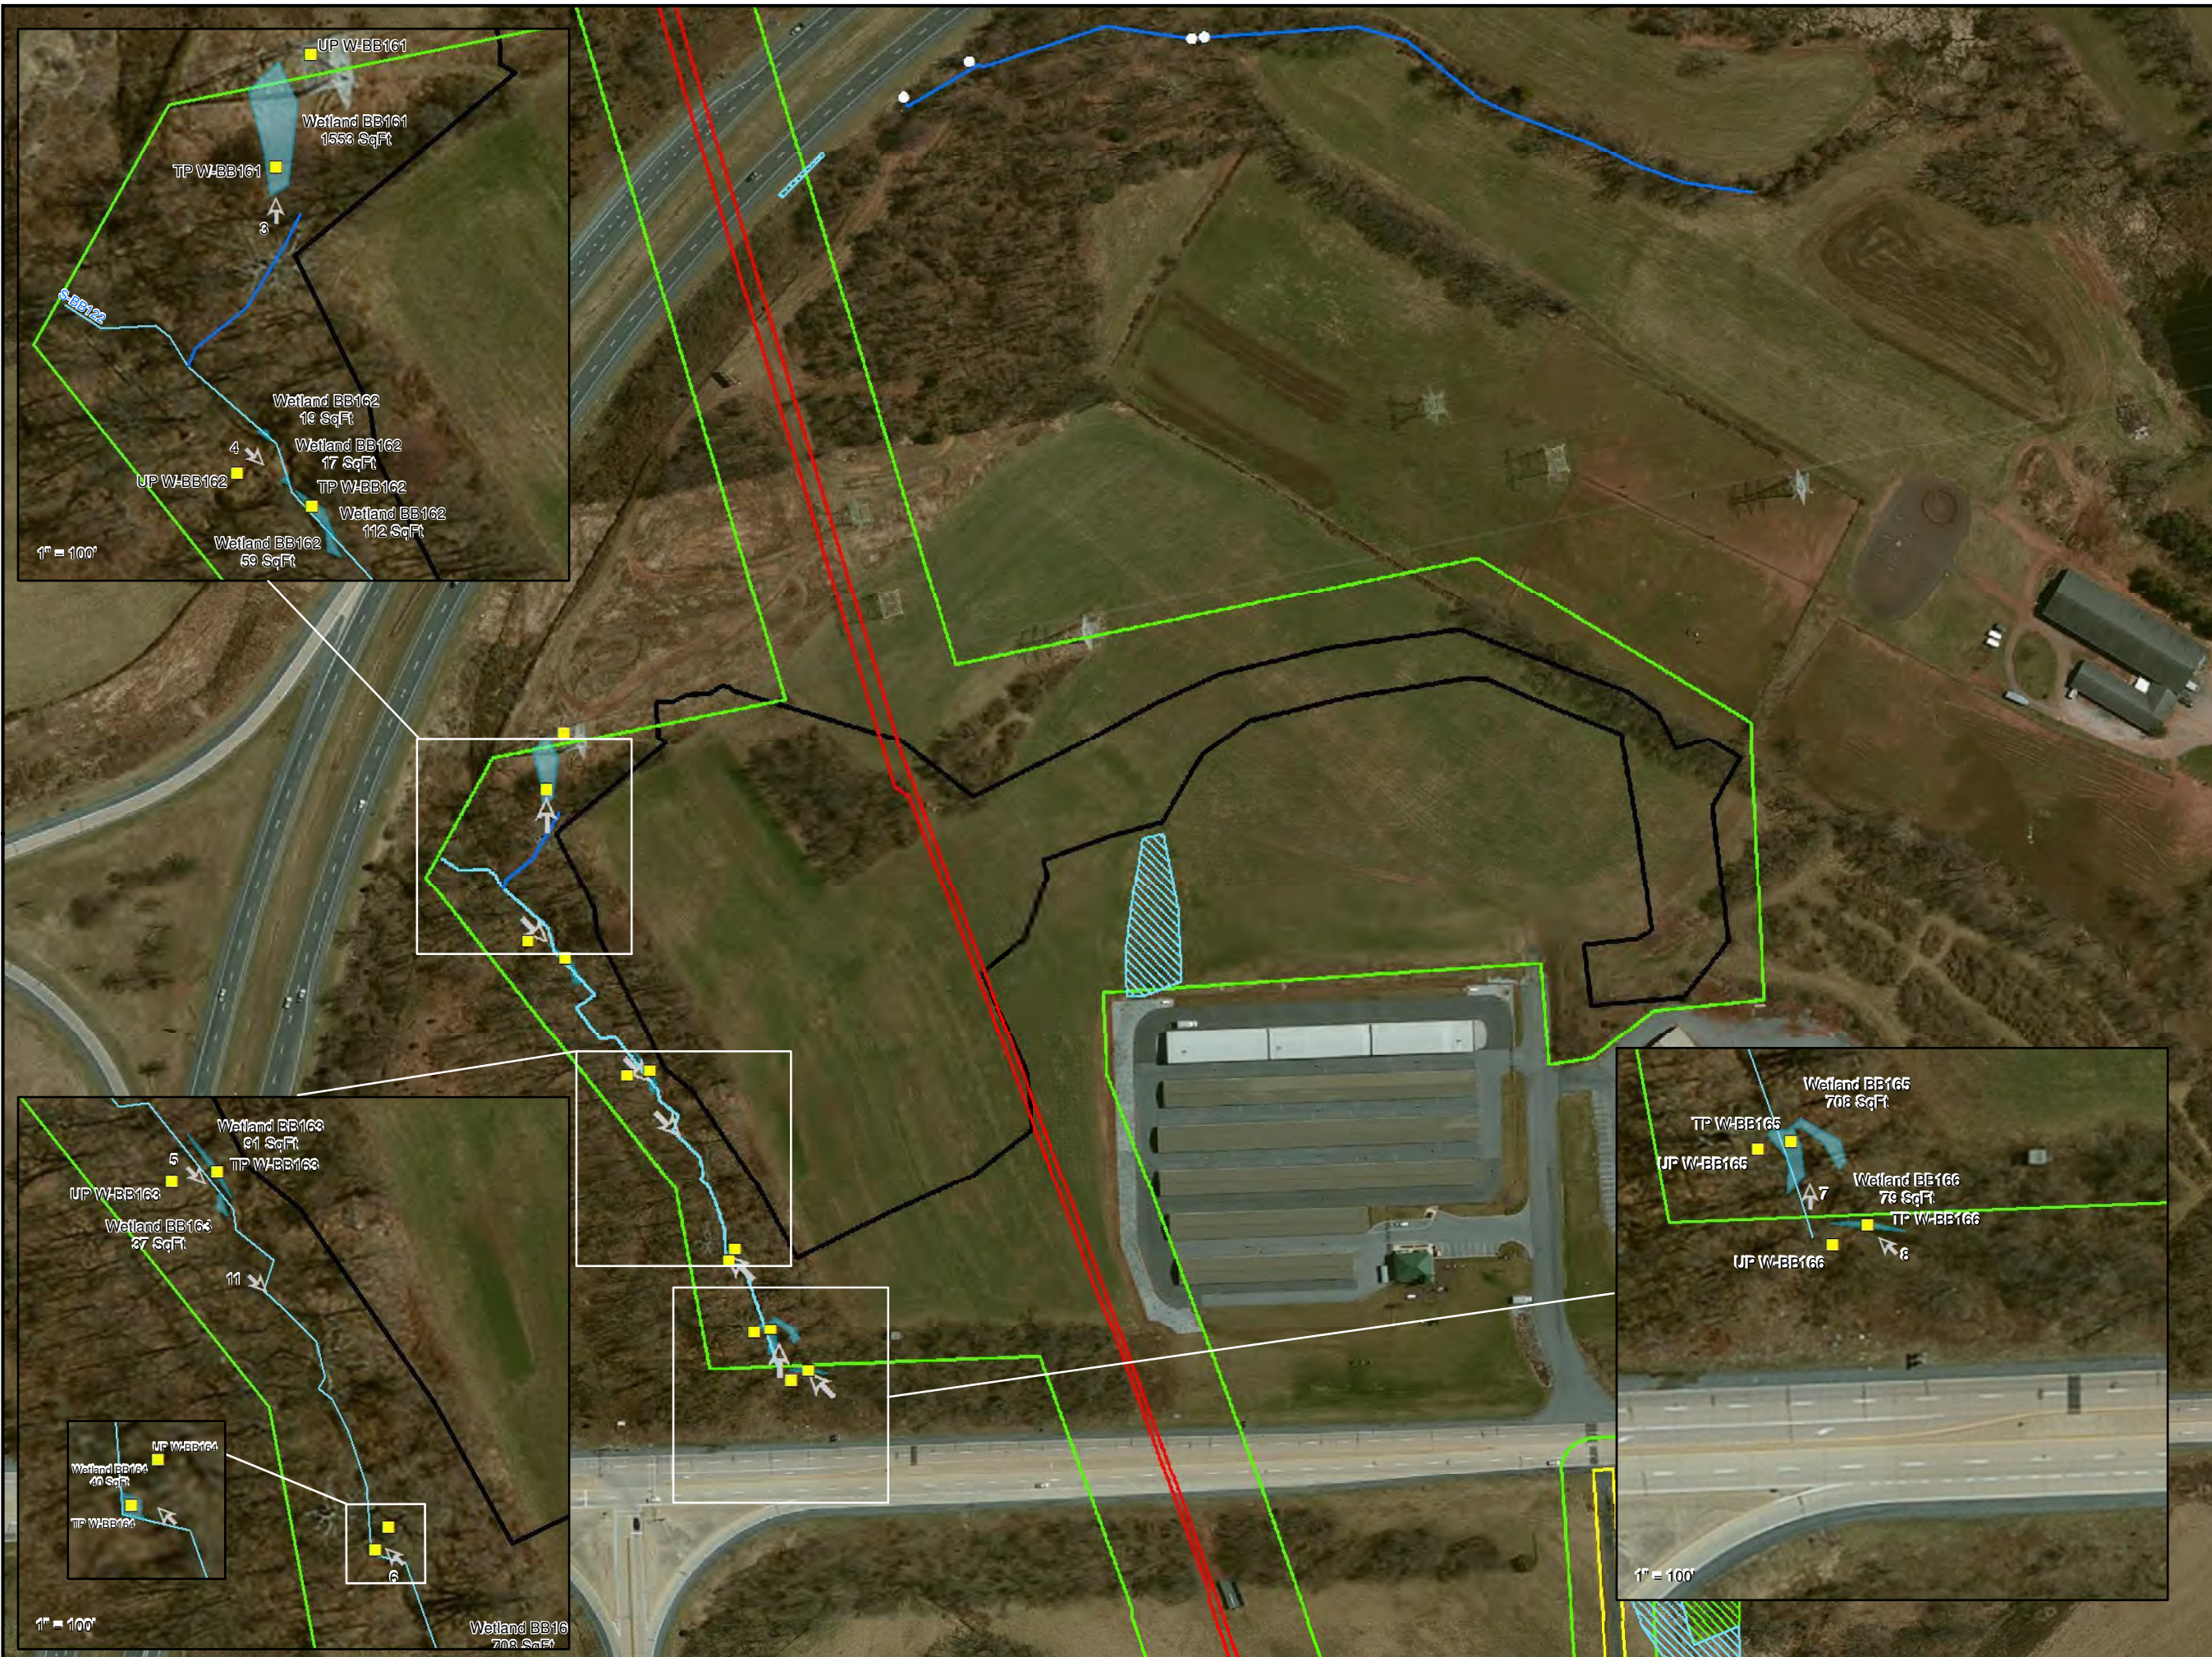
WETLAND DETAIL MAP
FIGURE 4-6
PENNSYLVANIA PIPELINE PROJECT
FEBRUARY 25, 2016 ALIGNMENT
SUNOCO LOGISTICS, L.P.
DAUPHIN COUNTY, PA

Wetland BB161 (W-BB161) is a 1,553-SF PEM wetland (Figure 4-6). Indicators of wetland hydrology include a high water table, saturation within the upper 12 inches of the soil profile, drainage patterns, and a positive FAC-neutral test. Dominant vegetation consists of rambler rose (*Rosa multiflora*), Japanese stilt grass (*Microstegium vimineum*), common boneset (*Eupatorium perfoliatum*), spotted touch-me-not (*Impatiens capensis*), dark green bulrush (*Scirpus atrovirens*), an unidentified sedge (*Carex* sp.), and flat-top goldenrod (*Euthamia graminifolia*). The soil between 0 and 16 inches exhibits a low-chroma matrix (7.5YR 4/2) with a silty clay loam texture that contains redoximorphic features (10YR 4/6 and 7.5YR 4/6).

Wetland BB163 (W-BB163) is a 128-SF PEM wetland (Figure 4-6). Indicators of wetland hydrology include a high water table, saturation within the upper 12 inches of the soil profile, sediment deposits, and a positive FAC-neutral test. Dominant vegetation consists of spotted touch-me-not (*Impatiens capensis*) and Japanese stilt grass (*Microstegium vimineum*). The soil between 0 and 16 inches exhibits a low-chroma matrix (7.5YR 4/2) with a sand loam texture that contains redoximorphic features (10YR 4/3).

Wetland BB164 (W-BB164) is a 40-SF PEM wetland (Figure 4-6). Indicators of wetland hydrology include a high water table, saturation within the upper 12 inches of the soil profile, sediment deposits, drainage patterns, and a positive FAC-neutral test. Dominant vegetation consists of spotted touch-me-not (*Impatiens capensis*) and Japanese stilt grass (*Microstegium vimineum*). The soil between 0 and 12 inches exhibits 7.5YR 4/3 matrix with a sand loam texture. The soil between 12 and 16 inches exhibits a low-chroma matrix (7.5YR 4/2) with a loam texture that contains redoximorphic features (7.5YR 4/3).

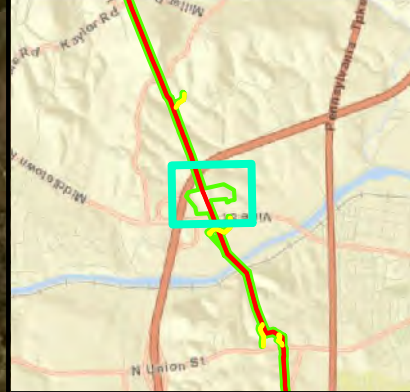
Wetland BB162 (W-BB162) is a 207-SF PEM wetland (Figure 4-6). Indicators of wetland hydrology include a high water table, saturation within the upper 12 inches of the soil profile, sediment deposits, and a positive FAC-neutral test. Dominant vegetation consists of spotted touch-me-not (*Impatiens capensis*), dark green bulrush (*Scirpus atrovirens*), Canadian clearweed (*Pilea pumila*), and halberd-leaf tearthumb (*Persicaria arifolium*). The soil between 0 and 8 inches exhibits a 7.5YR 4/4 matrix with a sandy texture. The soil between 8 and 16 inches exhibits a low-chroma matrix (7.5YR 4/2) with a silty clay loam texture that contains redoximorphic features (10YR 4/3).

Wetland BB165 (W-BB165) is a 708-SF PEM wetland (Figure 4-6). Indicators of wetland hydrology include a high water table, saturation within the upper 12 inches of the soil profile, sediment deposits, drainage patterns, and a positive FAC-neutral test. Dominant vegetation consists of southern arrow-wood (*Viburnum dentatum*), Asiatic tearthumb (*Persicaria perfoliata*), spotted touch-me-not (*Impatiens capensis*), skunk cabbage (*Symplocarpus foetidus*), and an unidentified sedge (*Carex* sp.). The soil between 0 and 6 inches exhibits a low-chroma matrix (7.5YR 4/2) with a silt loam texture that contains redoximorphic features (7.5YR 3/4). The soil between 6 and 16 inches exhibits a 7.5YR 3/4 matrix with a silt loam texture.

Wetland BB166 (W-BB166) is a 79-SF PEM wetland (Figure 4-6). Indicators of wetland hydrology include surface water, a high water table, saturation within the upper 12 inches of the soil profile, iron deposits, and a positive FAC-neutral test. Dominant vegetation consists of spotted touch-me-not (*Impatiens capensis*), Canadian clearweed (*Pilea pumila*), lamp rush (*Juncus effusus*), and Japanese honeysuckle (*Lonicera japonica*). The soil between 0 and 6 inches exhibits a low-chroma matrix (7.5YR 4/2) with a silt loam texture that contains redoximorphic features (7.5YR 3/4). The soil between 6 and 16 inches exhibits a 7.5YR 4/3 matrix with a silt loam texture.

Stream BB122 (S-BB122) is a perennial unnamed tributary (UNT) to Swatara Creek (Figure 4-6). The stream bank is approximately 7 feet in width. The bank height is approximately 27 inches. The stream bed contains a cobble, gravel, sand, silt, and clay substrate. At the time of the field investigation the stream exhibited an average water depth of 3 inches.

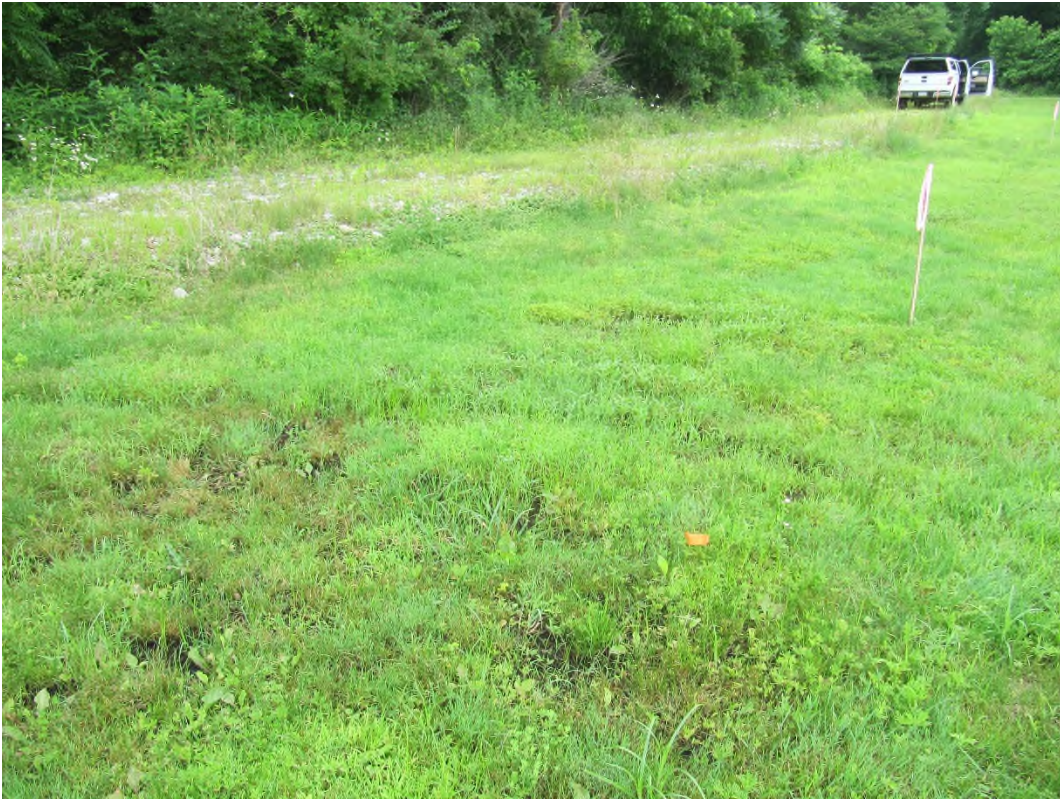
Wetland Q67 (W-Q67) is a 1,449-square foot (SF) PEM wetland (Figure 4-1). Indicators of wetland hydrology include surface soil cracks, saturation visible on aerial imagery, geomorphic position, and a positive FAC-neutral test. Dominant vegetation consists of pinkweed (*Persicaria pennsylvanica*) and spotted lady's-thumb (*Persicaria maculosa*). The soil between 0 and 3 inches exhibits a low-chroma matrix (10YR 5/2) with a silt loam texture that contains redoximorphic features (7.5YR 5/6). The soil between 3 and 12 inches exhibits a 10YR 5/3 matrix with a silt loam texture that contains redoximorphic features (7.5YR 5/6 and 10YR 5/1).

Photograph Number: 1 **Feature Name:** W-Q67 **Date:** 06/25/2015
Direction: SE **Plant Community:** PEM **Remarks:** N/A

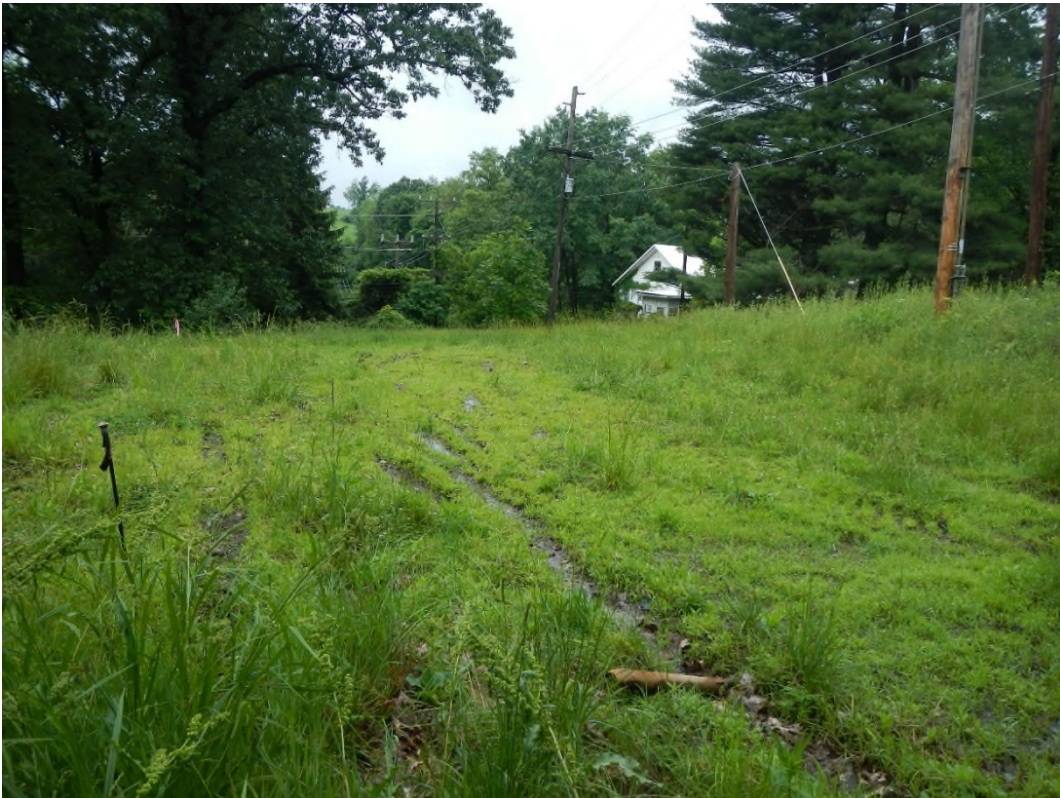
Photograph Number: 2 **Feature Name:** W-DS4 **Date:** 06/15/2015
Direction: S **Plant Community:** PEM **Remarks:** N/A

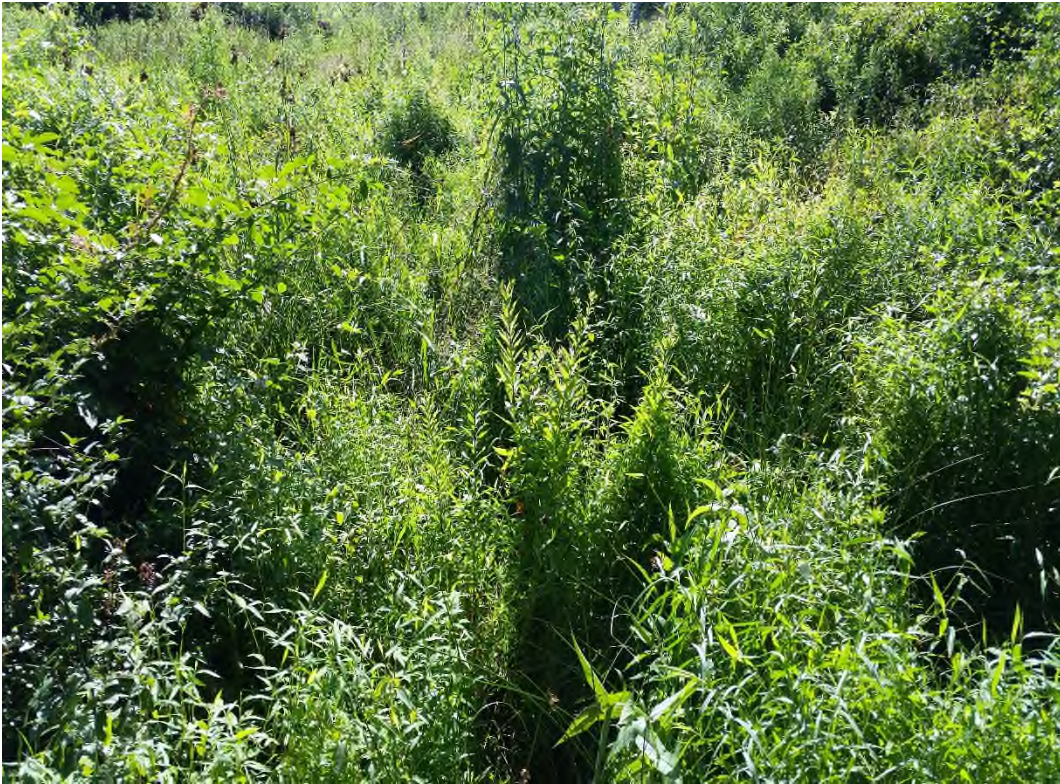
Photograph Number: 3 **Feature Name:** W-BB161 **Date:** 07/23/2015
Direction: E **Plant Community:** PEM **Remarks:** N/A

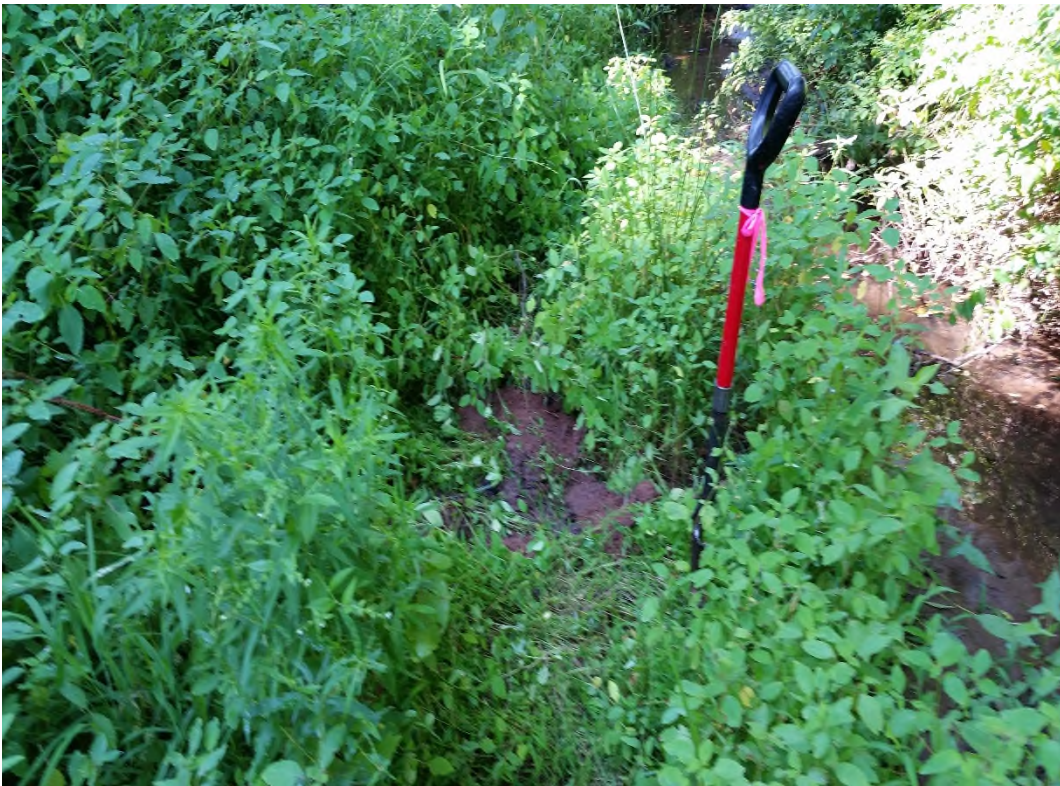
Photograph Number: 4 **Feature Name:** W-BB162 **Date:** 07/23/2015
Direction: SW **Plant Community:** PEM **Remarks:** N/A

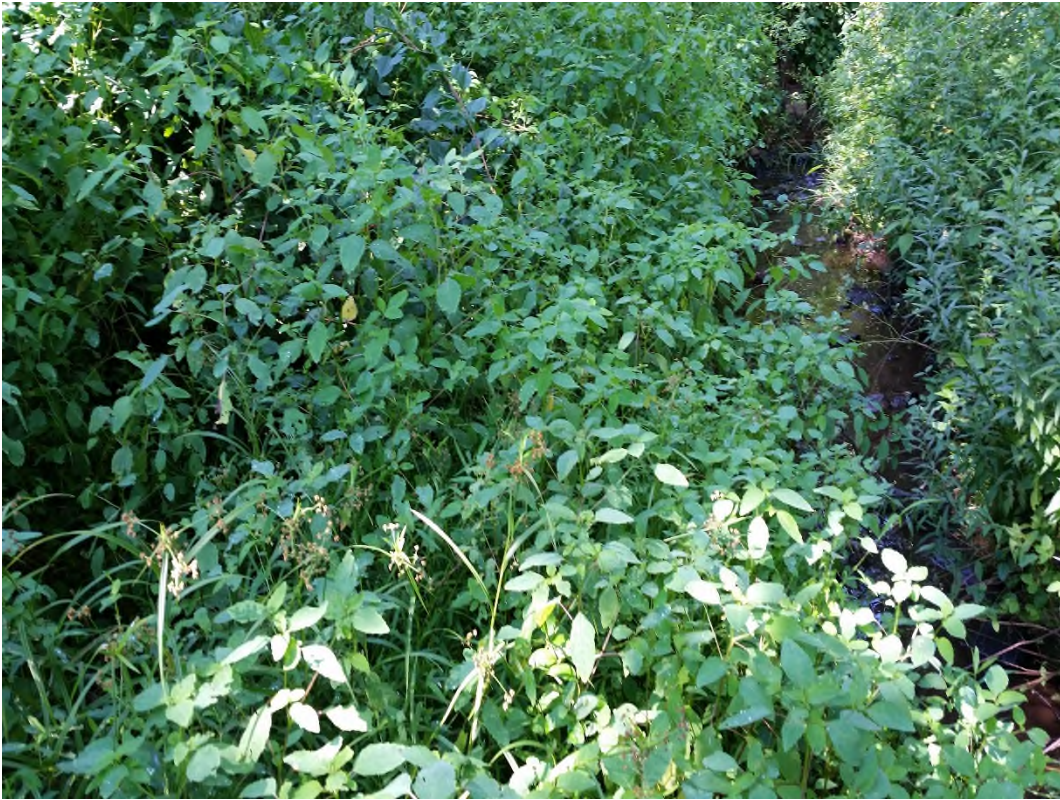
Photograph Number: 5 **Feature Name:** W-BB163 **Date:** 07/23/2015
Direction: SW **Plant Community:** PEM **Remarks:** N/A

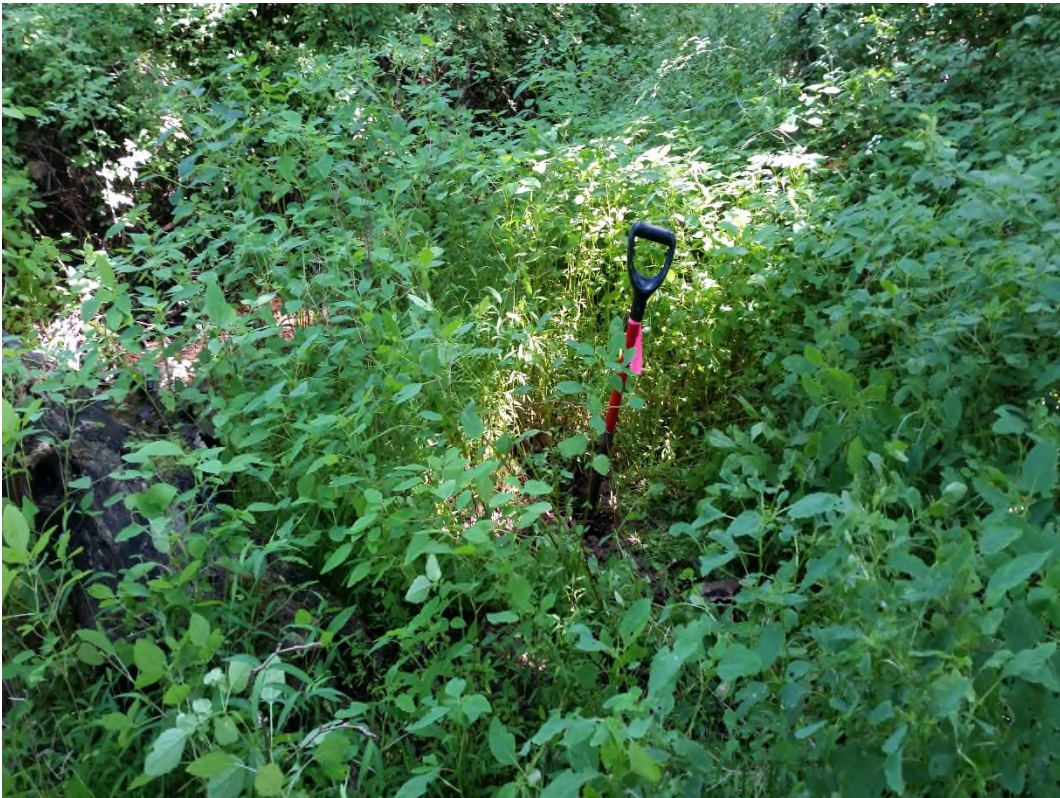
Photograph Number: 6 **Feature Name:** W-BB164 **Date:** 07/23/2015
Direction: NE **Plant Community:** PEM **Remarks:** N/A

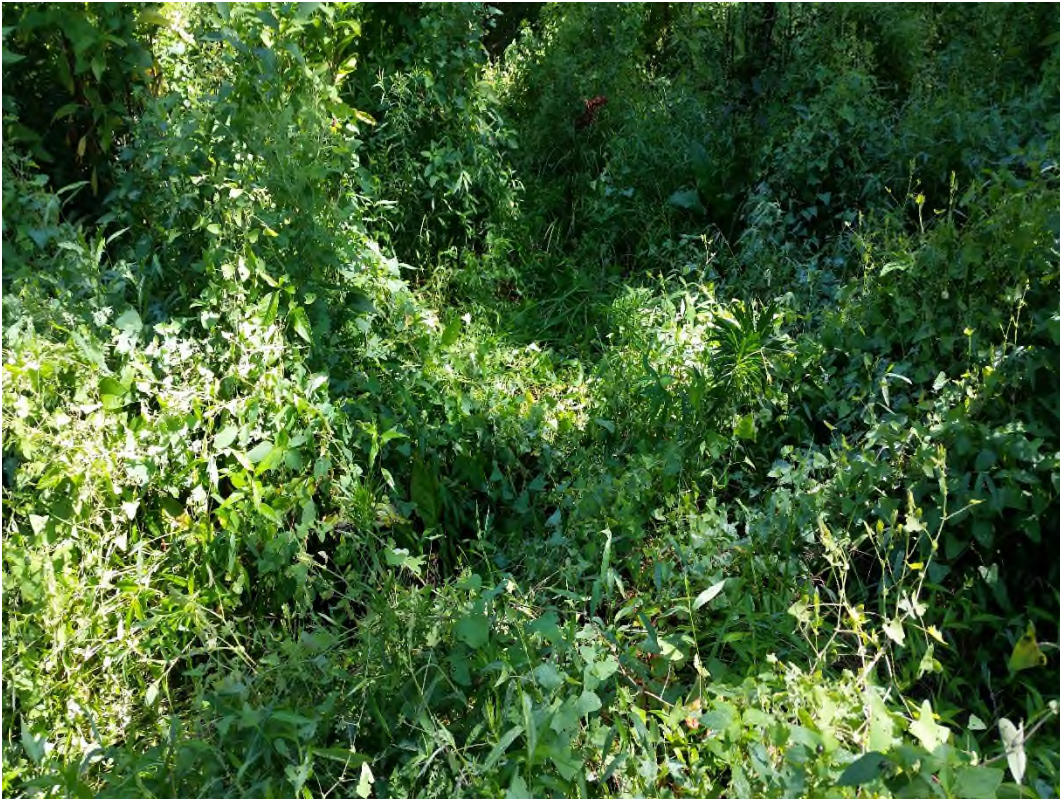
Photograph Number: 7 **Feature Name:** W-BB165 **Date:** 07/23/2015
Direction: E **Plant Community:** PEM **Remarks:** N/A

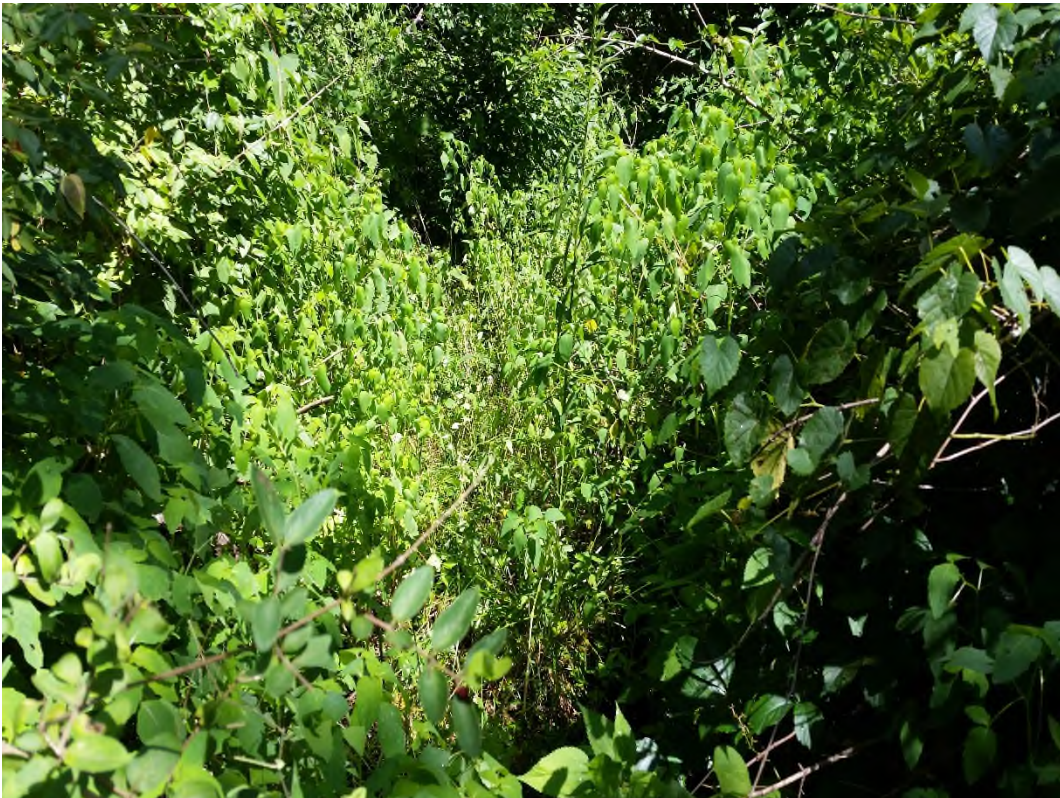
Photograph Number: 8 **Feature Name:** W-BB166 **Date:** 07/23/2015
Direction: NE **Plant Community:** PEM **Remarks:** N/A

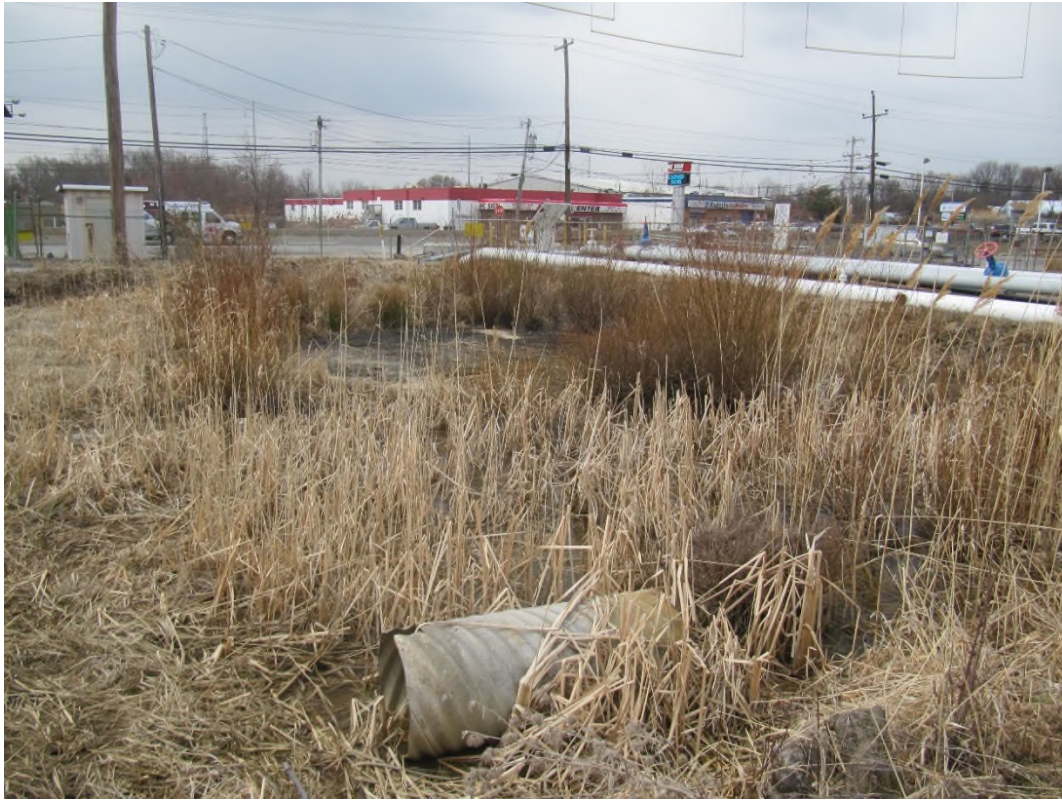
Photograph Number: 9 **Feature Name:** W-13 **Date:** 03/25/2014
Direction: S **Plant Community:** PEM **Remarks:** N/A

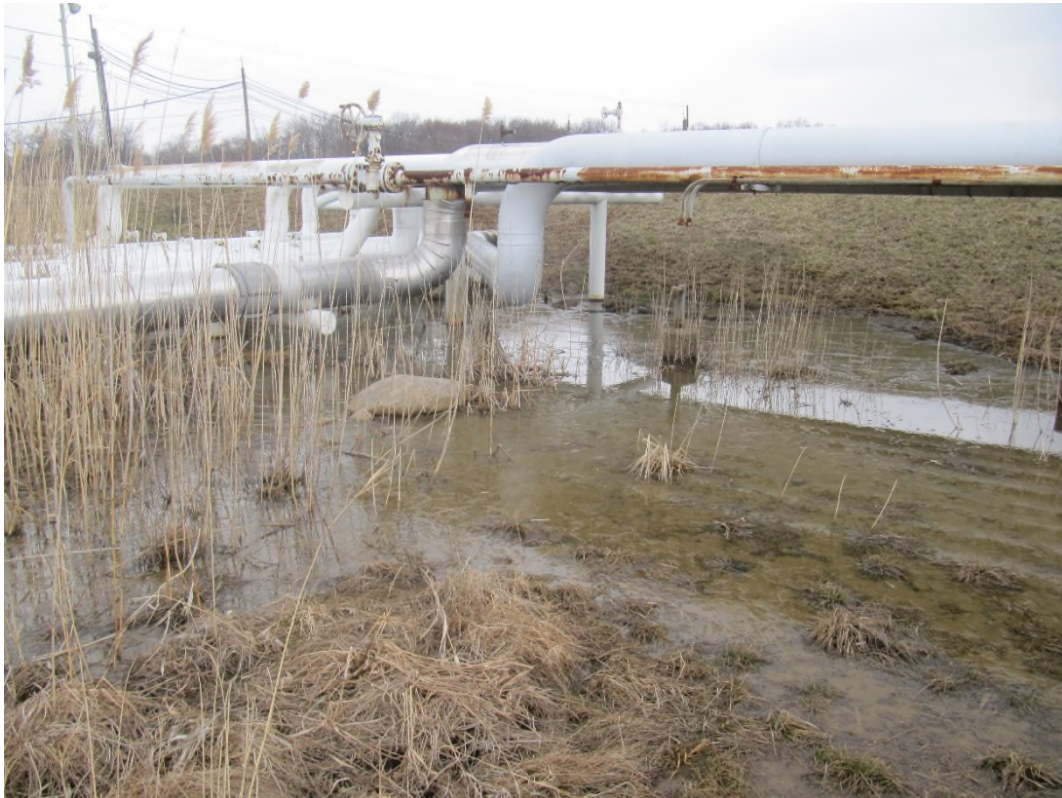
Photograph Number: 10 **Feature Name:** W-14 **Date:** 03/25/2014
Direction: N **Plant Community:** PEM **Remarks:** N/A

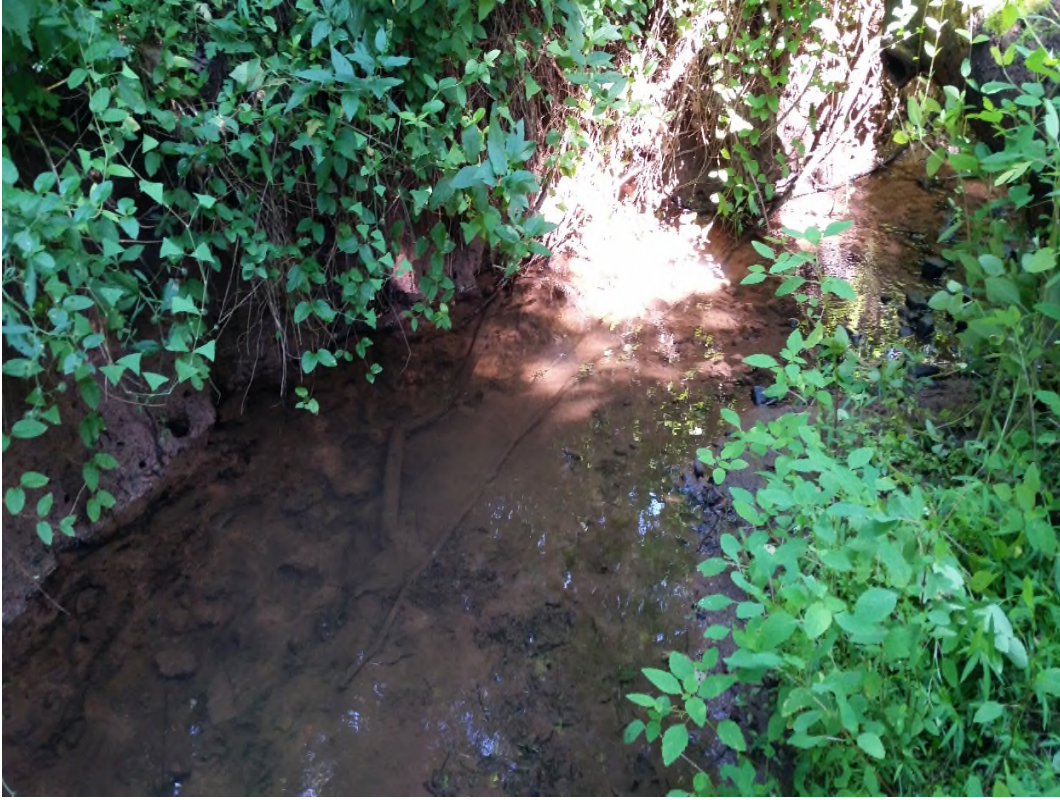
Photograph Number:	11	Feature Name:	S-BB122	Date:	07/22/2015
Direction:	SW, Downstream	Flow Regime:	Perennial	Remarks:	N/A
