# Geological Data Report Interstate 81 and SR315 Crossing

PennEast Pipeline Project

PennEast Pipeline Project  
353754-MM-E-E-099 RevE

## **PennEast Pipeline Project**

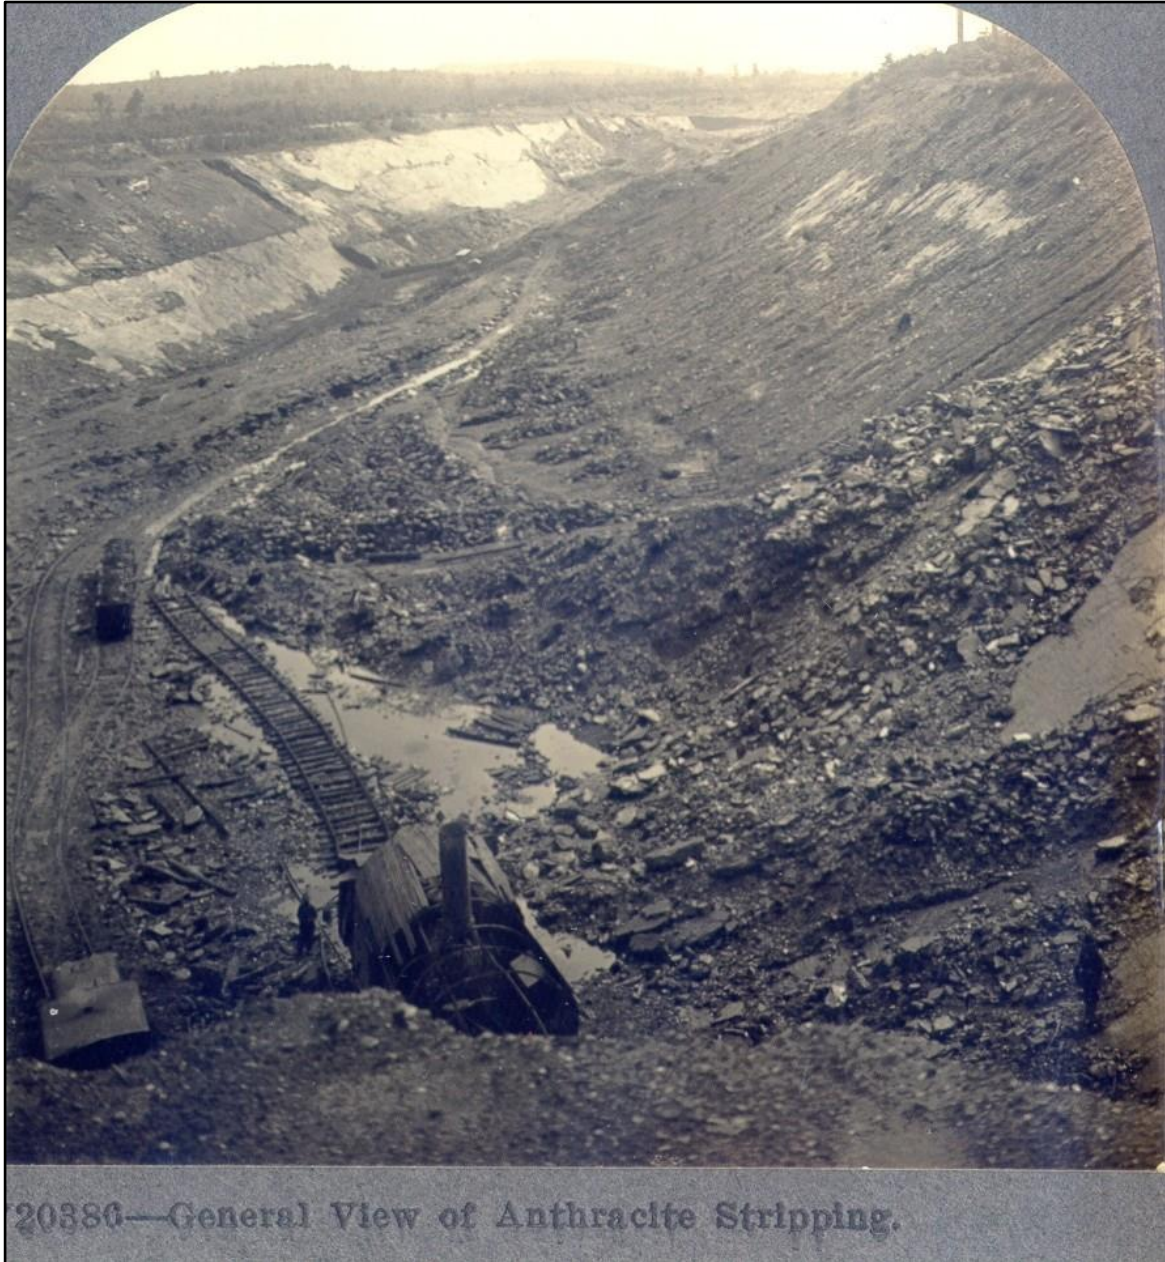
Figures 1 and 2 show historical photographs of typical surface and underground coal workings. These photographs are not from the specific I-81 crossing location, but they are from the Northern Anthracite Coal field during the correct time period, and are believed to represent similar practices which resulted in the ground conditions present beneath I-81. Figure 3 presents a modern photograph from within a coal mining access tunnel in the general vicinity of the I-81 crossing.

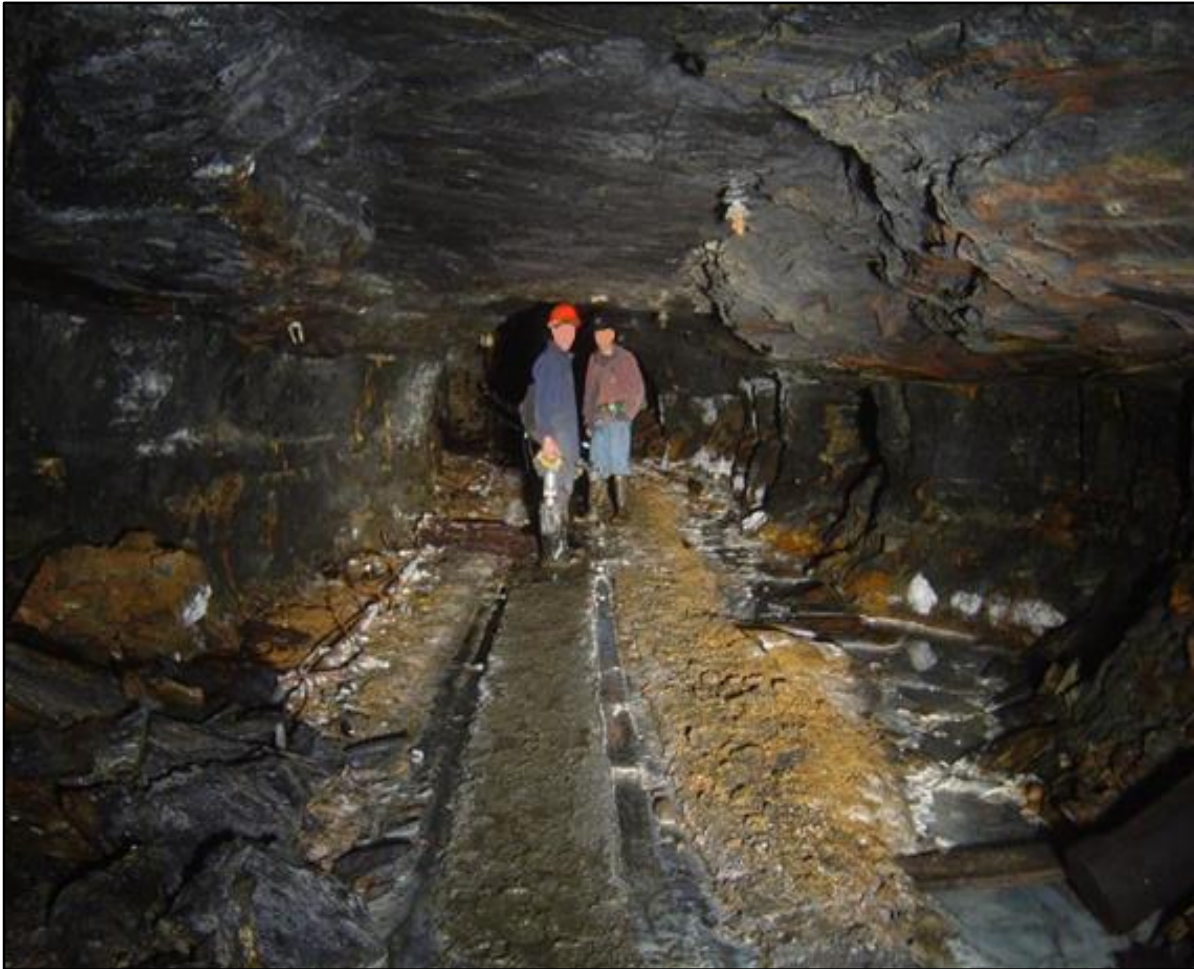
**Figure 3: Modern photograph by members of the “Underground Miners Club” who investigate and document abandoned mine workings.**

This photograph was claimed to have been taken along the Pine Ridge No.34 Colliery. Their photographs and descriptions demonstrate that many of the access tunnels and workings remain open. This photograph was taken during the 2002-2015 time period.
