Environmental Assessment

Texas Eastern Transmission, LP
Schuylkill River HDD Project
June 2023

Figure 4
Delineated Features - Sheet 1 of 5
Texas Eastern Transmission, LP
Schuylkill River HDD Project
Chester and Montgomery Counties, Pennsylvania

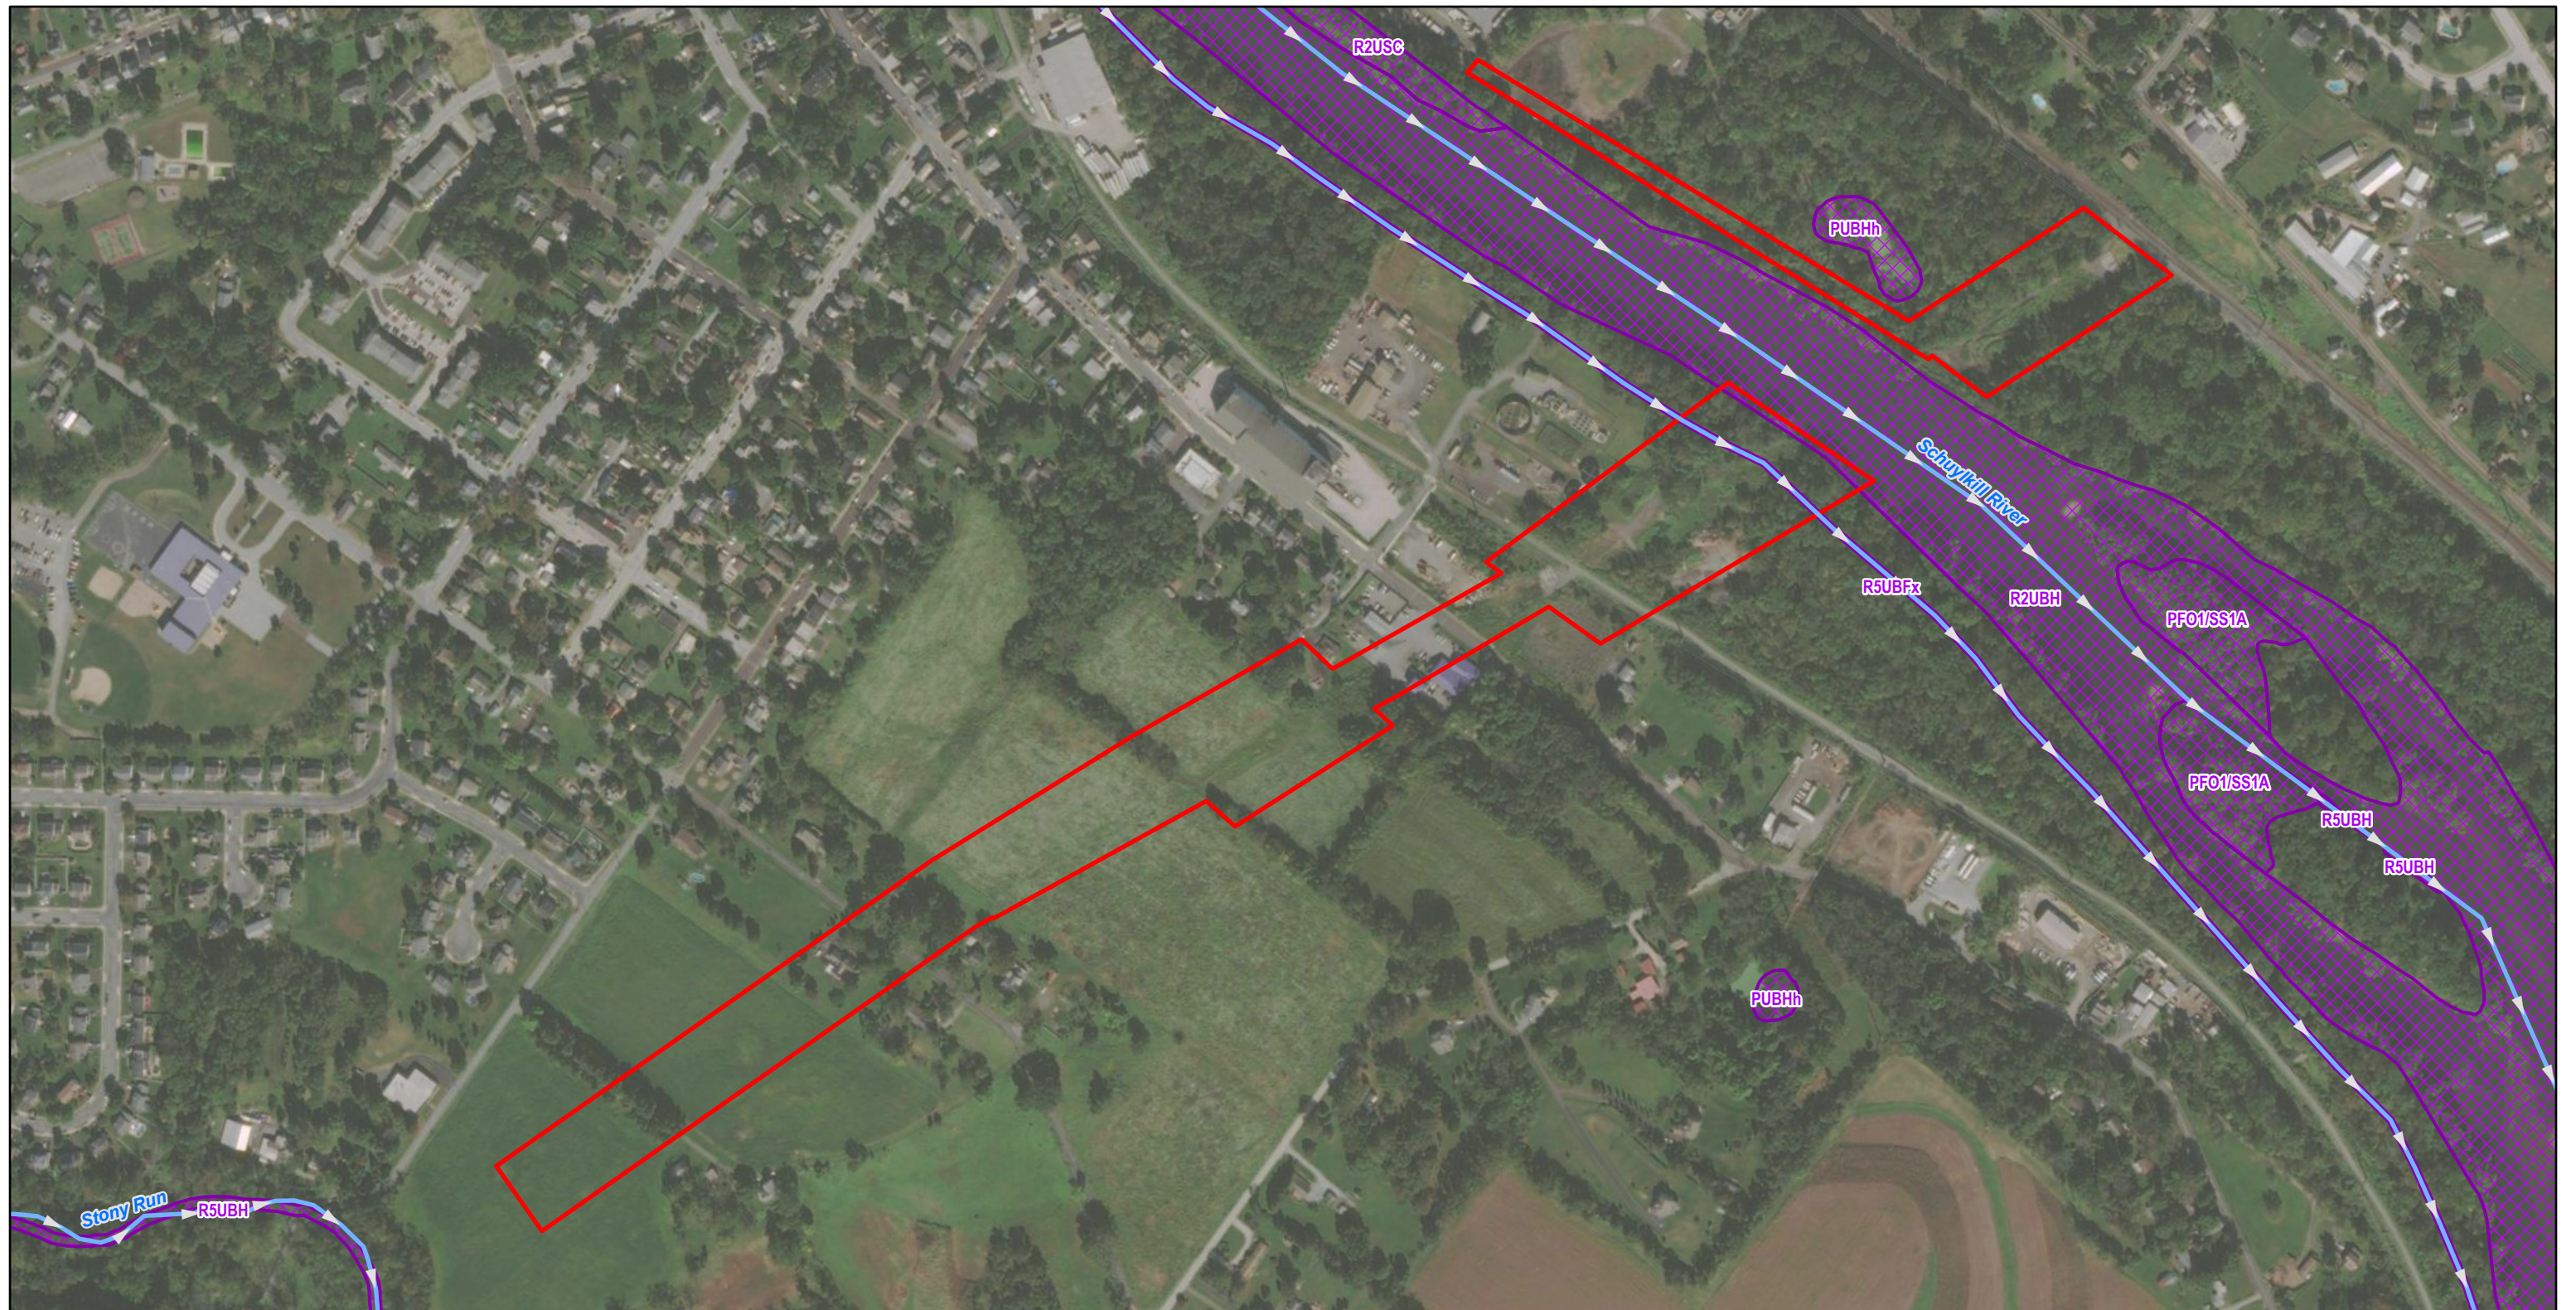
Figure 2
National Wetlands Inventory (NWI) and
National Hydrography Dataset (NHD) Map
Texas Eastern Transmission, LP
Schuylkill River HDD Project
Chester and Montgomery Counties, Pennsylvania

NWI maps are used as a guide to indicate potential presence of wetlands. According to NWI mapping, there are no wetlands present within the ESA. The Schuylkill River is noted as a riverine feature (R2UBH) which crosses perpendicularly the existing pipeline easement (**Attachment A, Figure 2**).

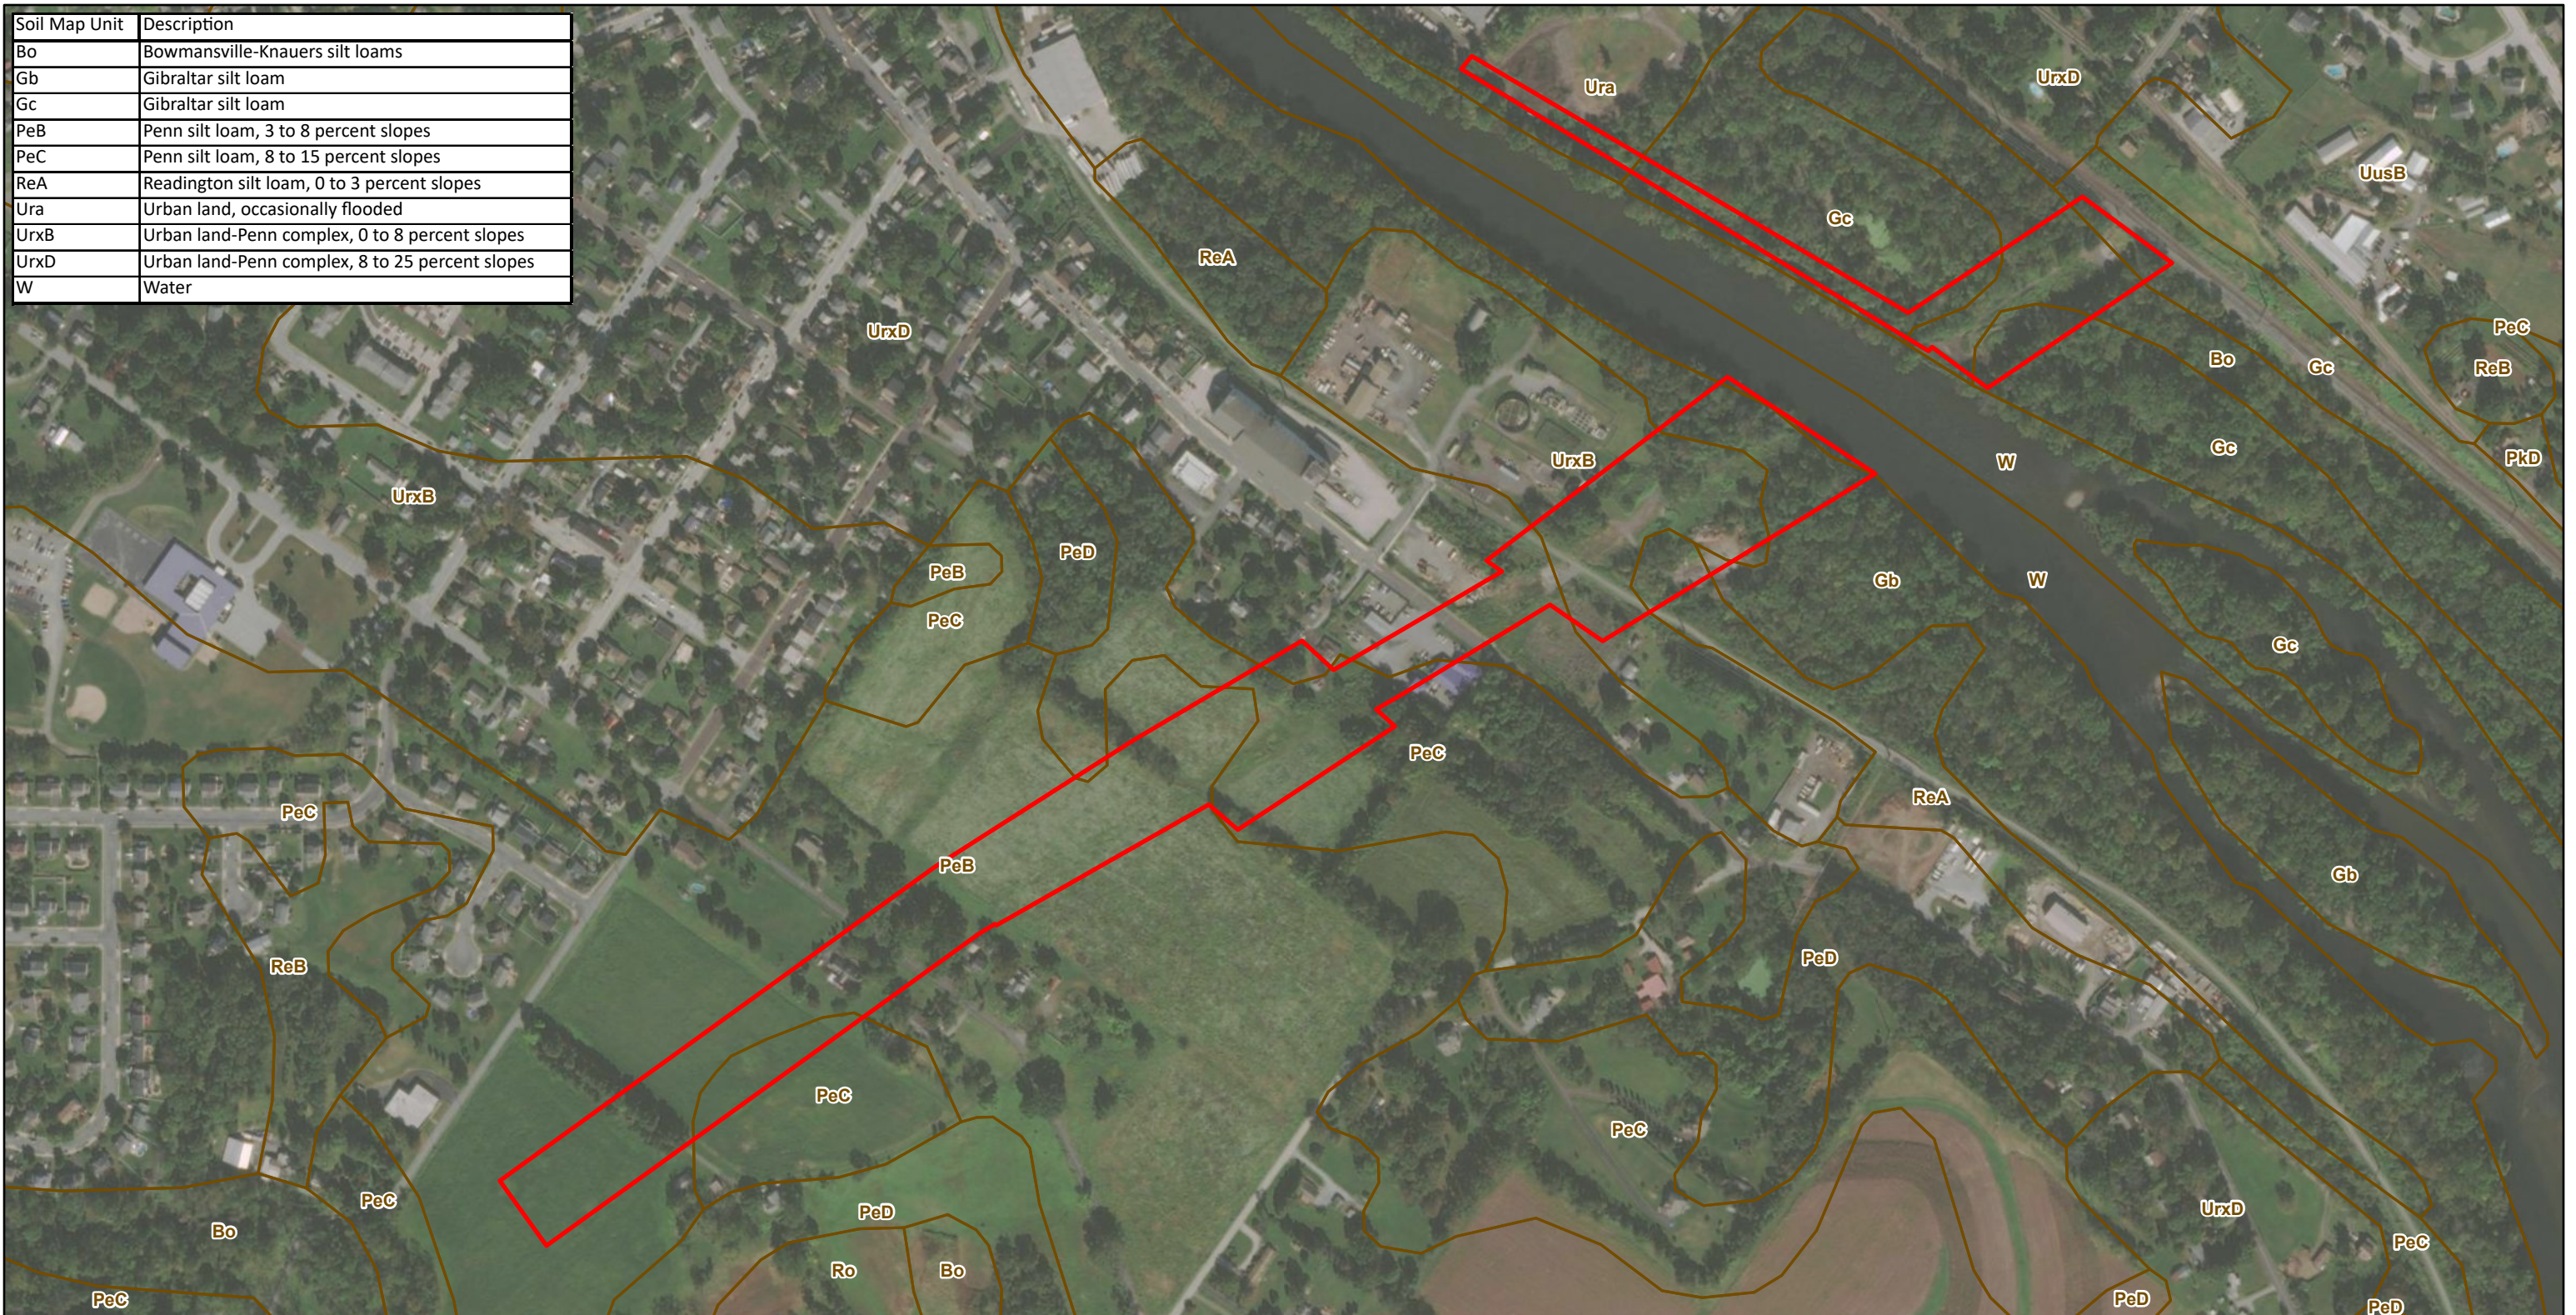
Figure 3
 Natural Resources Conservation Service (NRCS) Soils Map
 Texas Eastern Transmission, LP
 Schuylkill River HDD Project
 Chester and Montgomery Counties, Pennsylvania

The USDA NRCS soil survey indicates the location of soil map units. Drainage classes refer to the frequency and duration of wet periods in conditions in which the soil formed. Hydric soil ratings with a “yes” or “no” indicate whether the map unit component is classified as hydric soils or not. Mapped soil units identified within the ESA are presented in **Table 2** and are also presented in **Attachment 1, Figure 3**.

Soil Map Unit	Description
Bo	Bowmansville-Knauers silt loams
Gb	Gibraltar silt loam
Gc	Gibraltar silt loam
PeB	Penn silt loam, 3 to 8 percent slopes
PeC	Penn silt loam, 8 to 15 percent slopes
ReA	Readington silt loam, 0 to 3 percent slopes
Ura	Urban land, occasionally flooded
UrxB	Urban land-Penn complex, 0 to 8 percent slopes
UrxD	Urban land-Penn complex, 8 to 25 percent slopes
W	Water

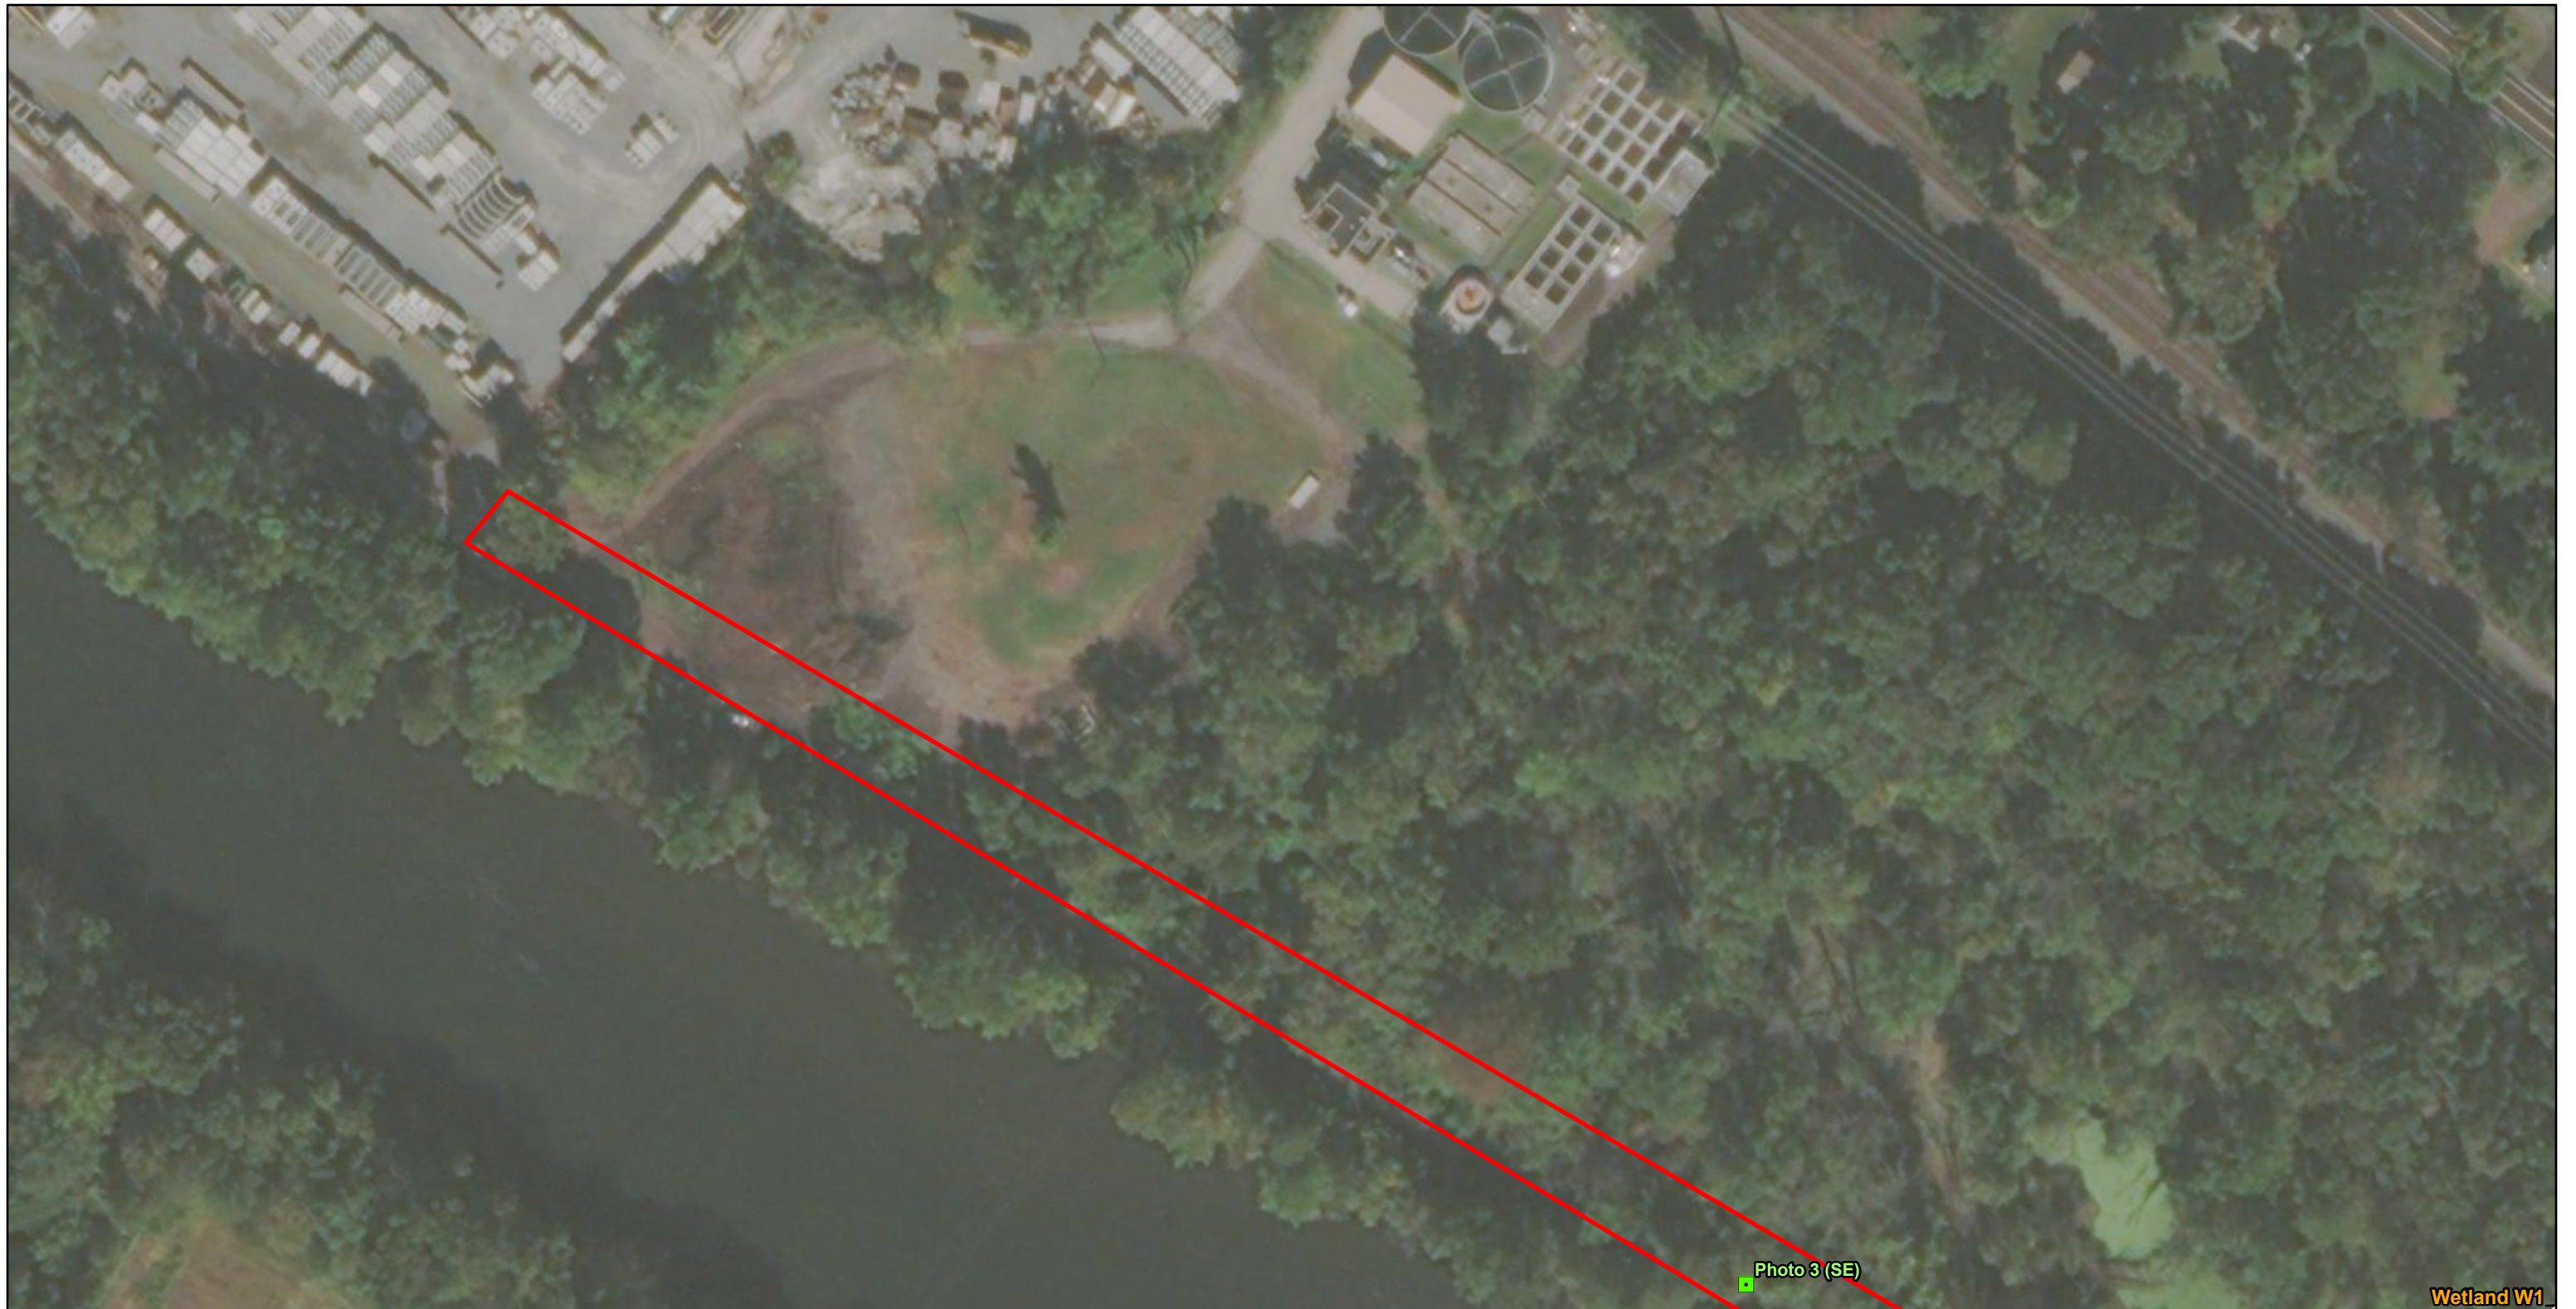
Wetland W1

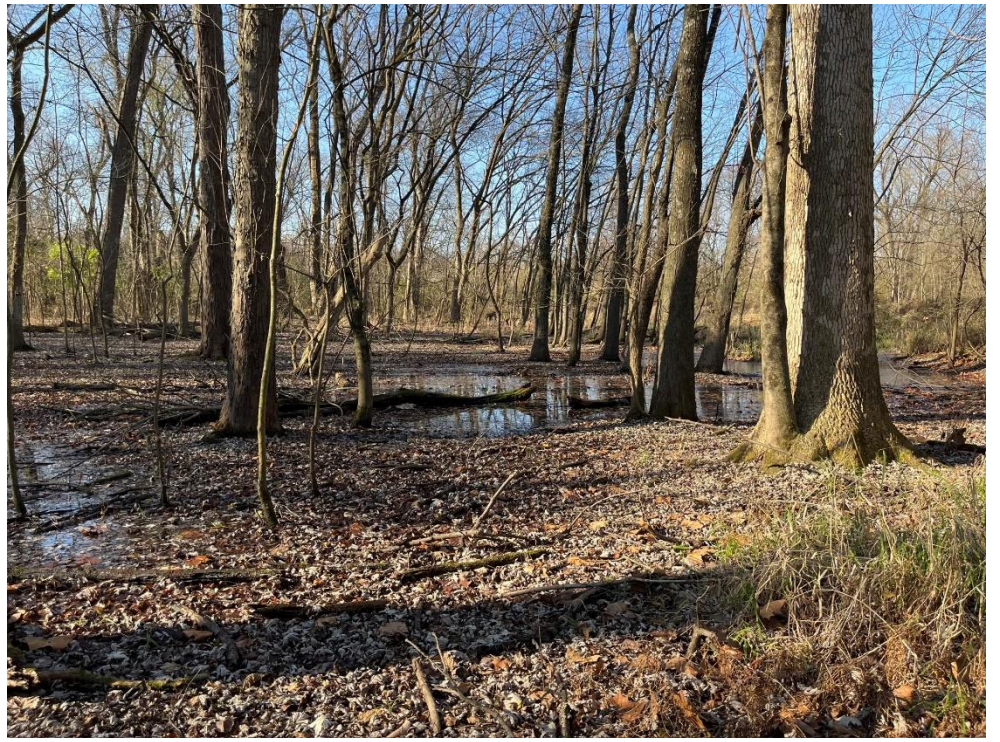
PHOTO NO.	
1	
SITE NAME	
Schuylkill River HDD	
PHOTO LOCATION	
40.173382, -75.532491	
DIRECTION	DATE
SW	Nov. 18, 2022
DESCRIPTION:	
View of PFO Wetland W1 in the northeast extent of the environmental survey area (ESA). Photo is facing west towards the ROW.

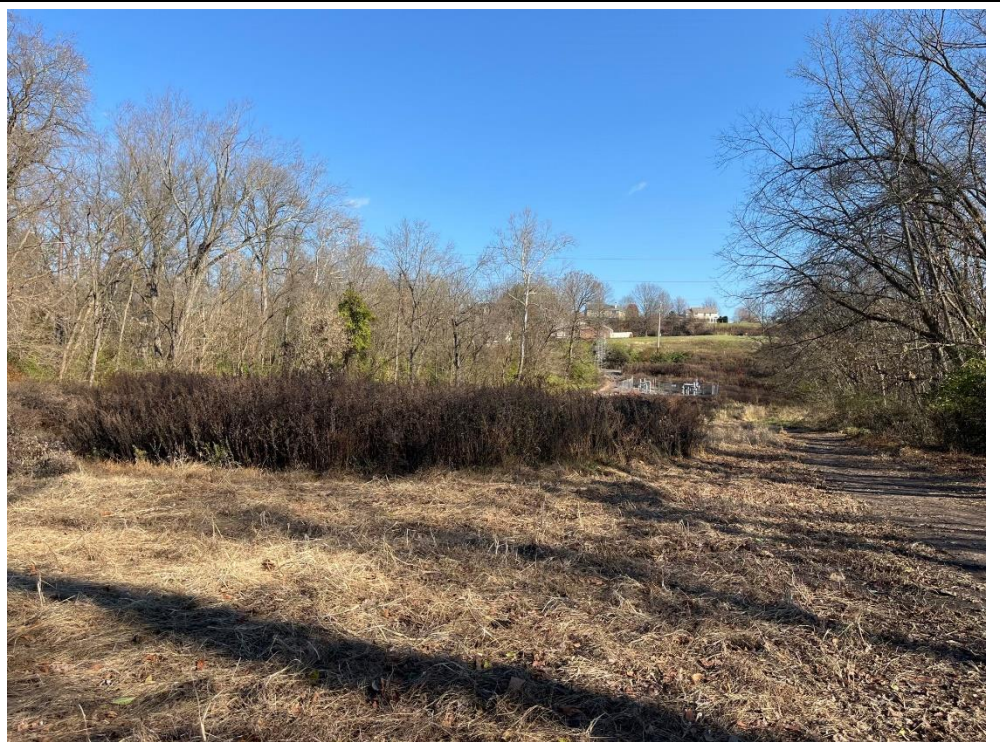
PHOTO NO.	
2	
SITE NAME	
Schuylkill River HDD	
PHOTO LOCATION	
40.172824, -75.533724	
DIRECTION	DATE
NE	Nov. 18, 2022
DESCRIPTION:	
View of PEM Wetland W1 in the northeast extent of the ESA. Photo is taken from the existing ROW and shows the existing Texas Eastern valve site in the distance.

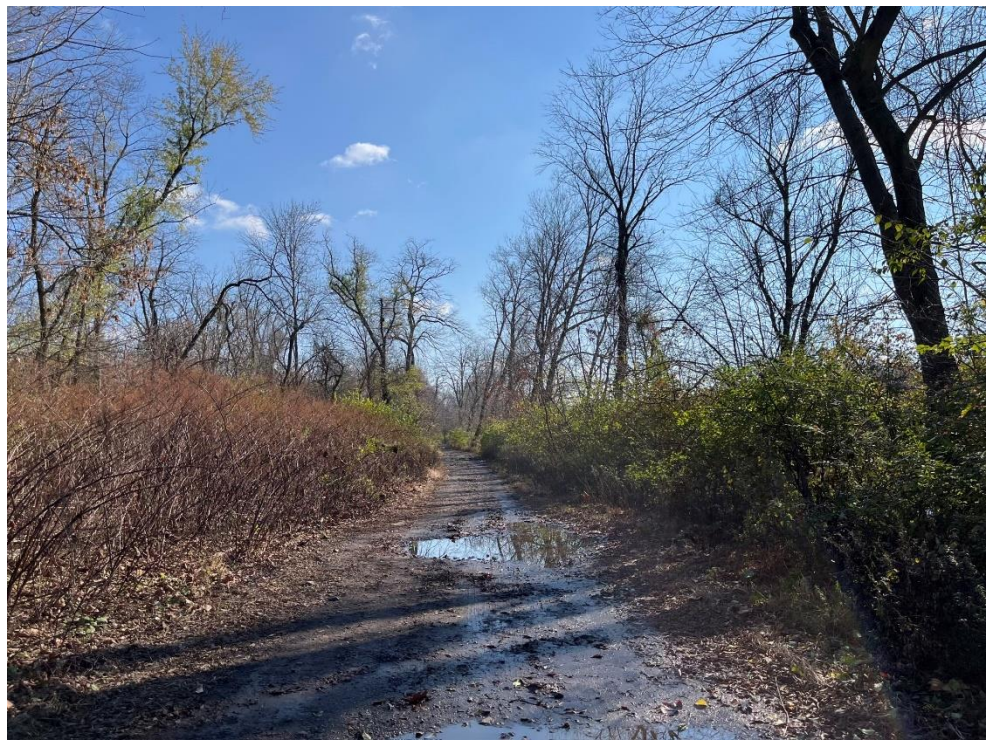
PHOTO NO.	
3	
SITE NAME	
Schuylkill River HDD	
PHOTO LOCATION	
40.173553, -75.535499	
DIRECTION	DATE
SE	Nov. 18, 2022
DESCRIPTION:	
Photo is taken from the access route to the ROW on the northeast side of the Schuylkill River. No wetlands or waterbodies were delineated along the access route.

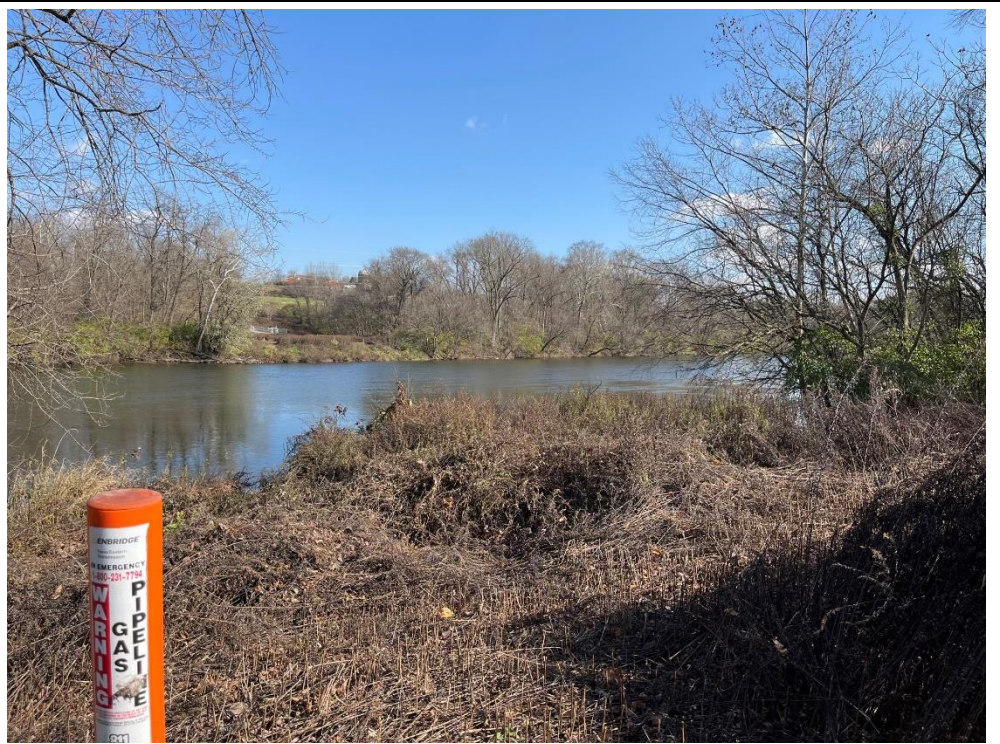
PHOTO NO.	
4	
SITE NAME	
Schuylkill River HDD	
PHOTO LOCATION	
40.172351, -75.535447	
DIRECTION	DATE
NE	Nov. 18, 2022
DESCRIPTION:	
View of the Schuylkill River (Stream S1) from the ROW.

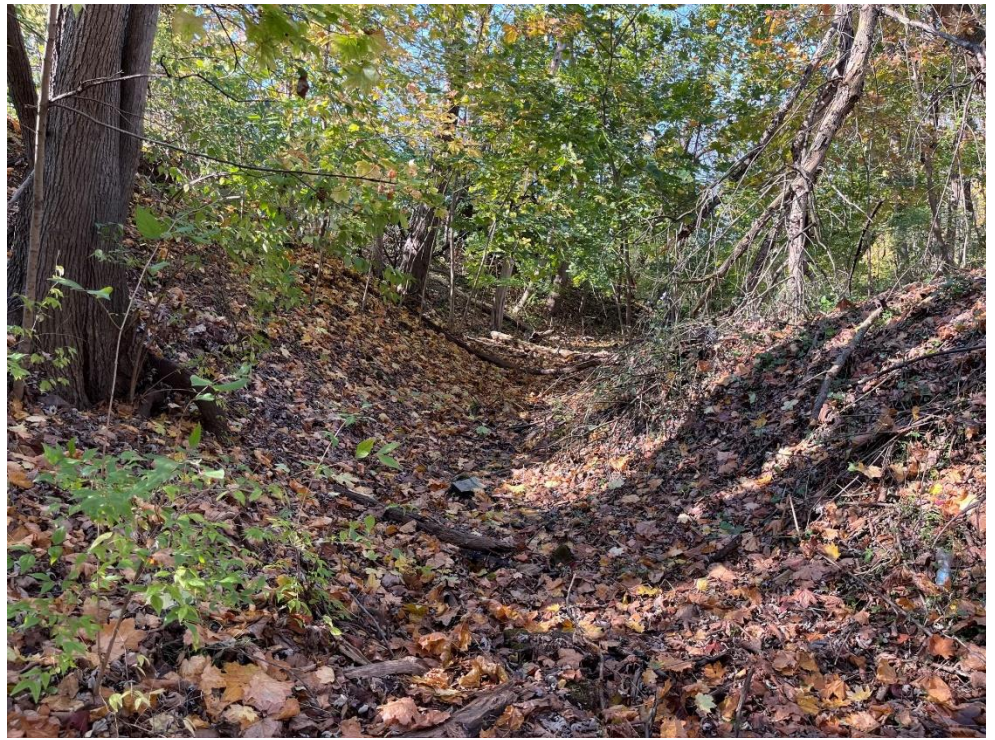
PHOTO NO.	
5	
SITE NAME	
Schuylkill River HDD	
PHOTO LOCATION	
40.172455, -75.535898	
DIRECTION	DATE
W	Nov. 18, 2022
DESCRIPTION:	
View of Stream S2 located north of the ROW. Stream S2 is an ephemeral feature that flows into the Schuylkill River.

Stream S2 is an ephemeral located southwest of the Schuylkill River. The feature originated from a concrete headwall. No outfall was observed; however, due to the deteriorated condition of the headwall, the outfall appears to have been buried and likely originates from the Municipal Public Works building adjacent to the ROW. Stream S2 drains into the Schuylkill River, a TNW, and therefore is likely to be considered jurisdictional by the USACE.

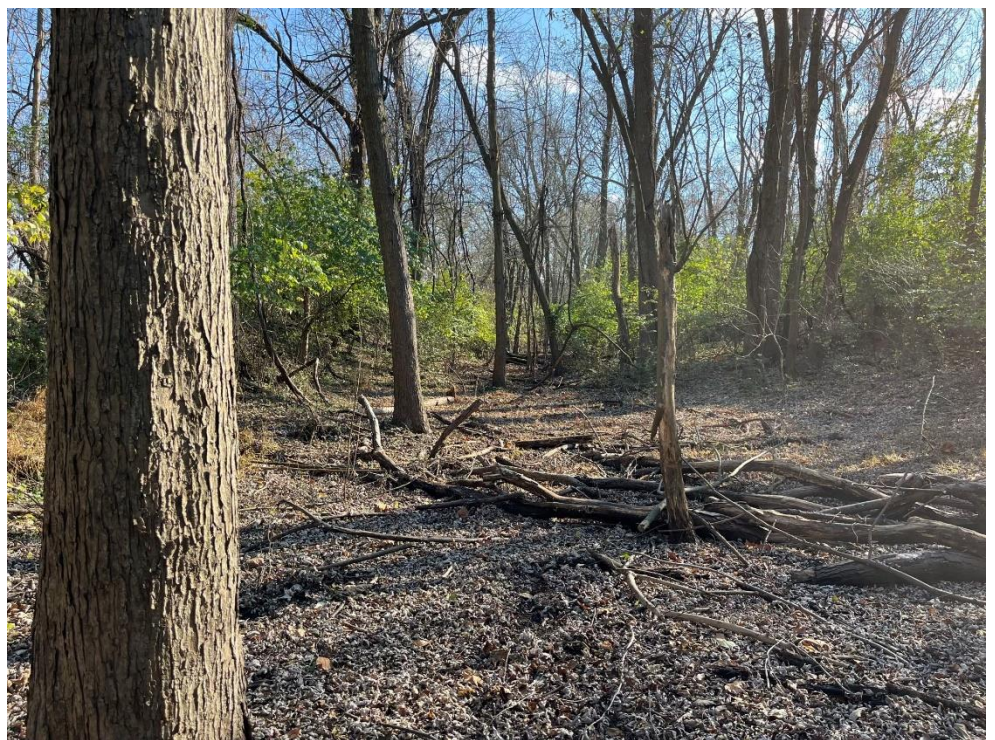
PHOTO NO.	
6	
SITE NAME	
Schuylkill River HDD	
PHOTO LOCATION	
40.172181, -75.535384	
DIRECTION	DATE
SE	Nov. 18, 2022
DESCRIPTION:	
View of PFO Wetland W2. Wetland W2 is a depressional area located south of the ROW.

Wetland W2 is located within the ESA, southwest of the Schuylkill River. As defined by Cowardin et al. 1979, Wetland W2 consists of a PFO wetland cover type. Wetland W2 is open ended and extends outside the ESA to the southeast. The PFO wetland vegetation included silver maple (*Acer saccharinum*, FACW) and red maple (*Acer rubrum*, FAC). Wetland hydrology indicators included water marks, moss trim lines, and sparsely vegetated concave surface. Hydric soil characteristics observed consisted of low chroma soils with redox features.

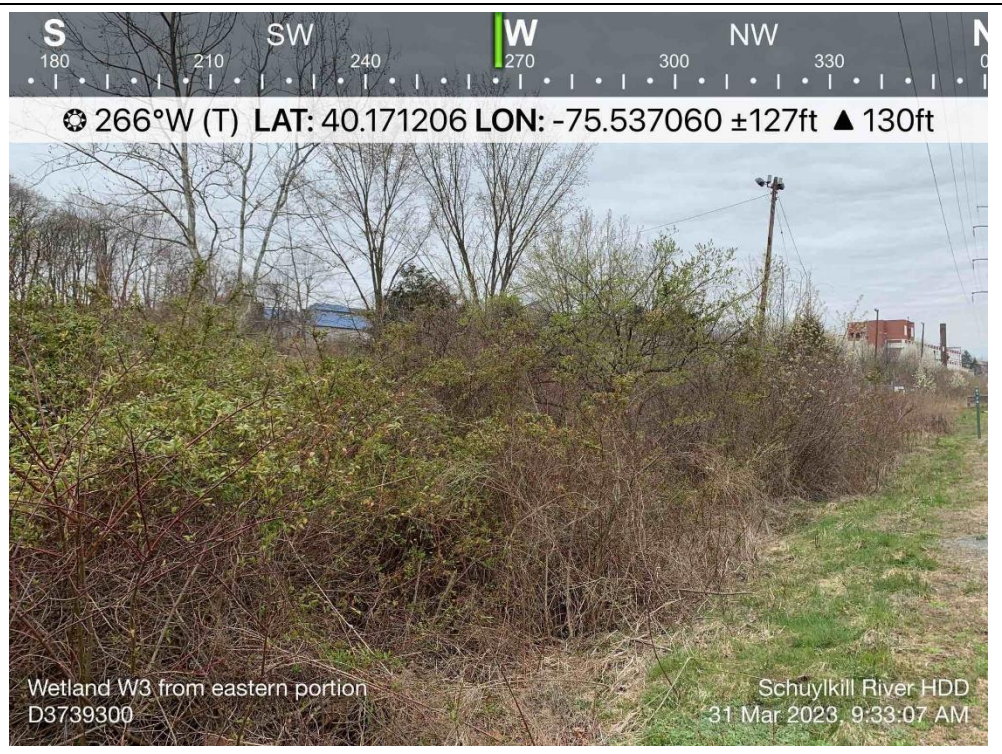
PHOTO NO.	
5	
SITE NAME	
Schuylkill River HDD	
PHOTO LOCATION	
40.171206, -75.537060	
DIRECTION	DATE
W	March 31, 2023
DESCRIPTION:	
Alternate view of PSS Wetland W3, taken from the southeastern extent of the survey area.

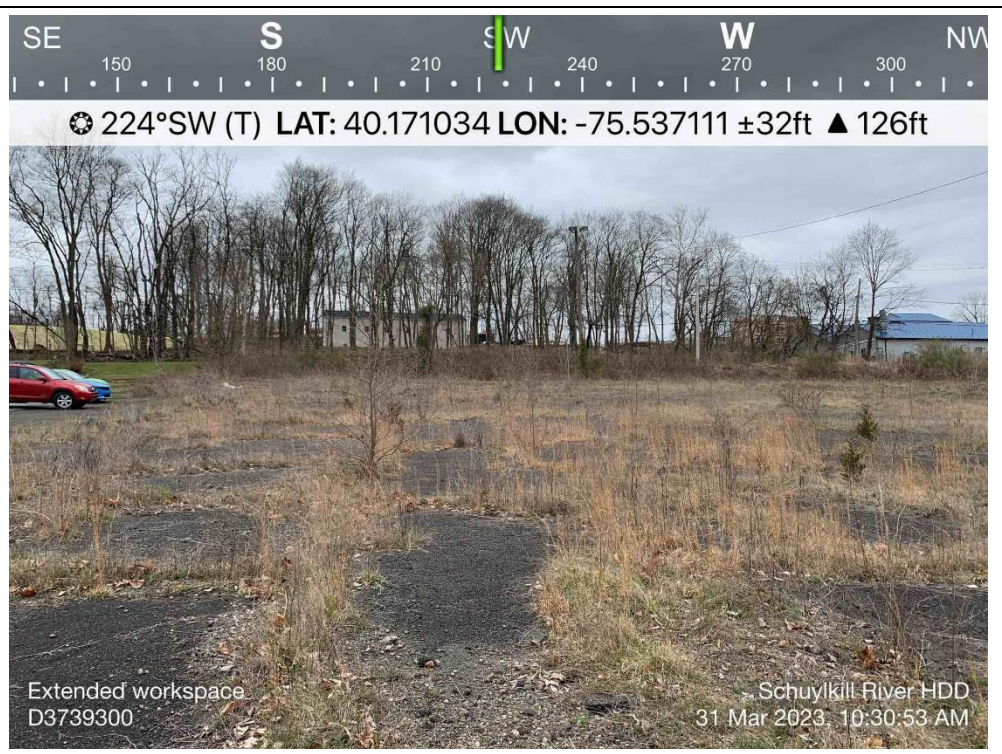
PHOTO NO.	
6	
SITE NAME	
Schuylkill River HDD	
PHOTO LOCATION	
40.171034, -75.537111	
DIRECTION	DATE
SW	March 31, 2023
DESCRIPTION:	
View of the ATWS, southwest of the Schuylkill River Trail. This area consists of an abandoned gravel parking lot.

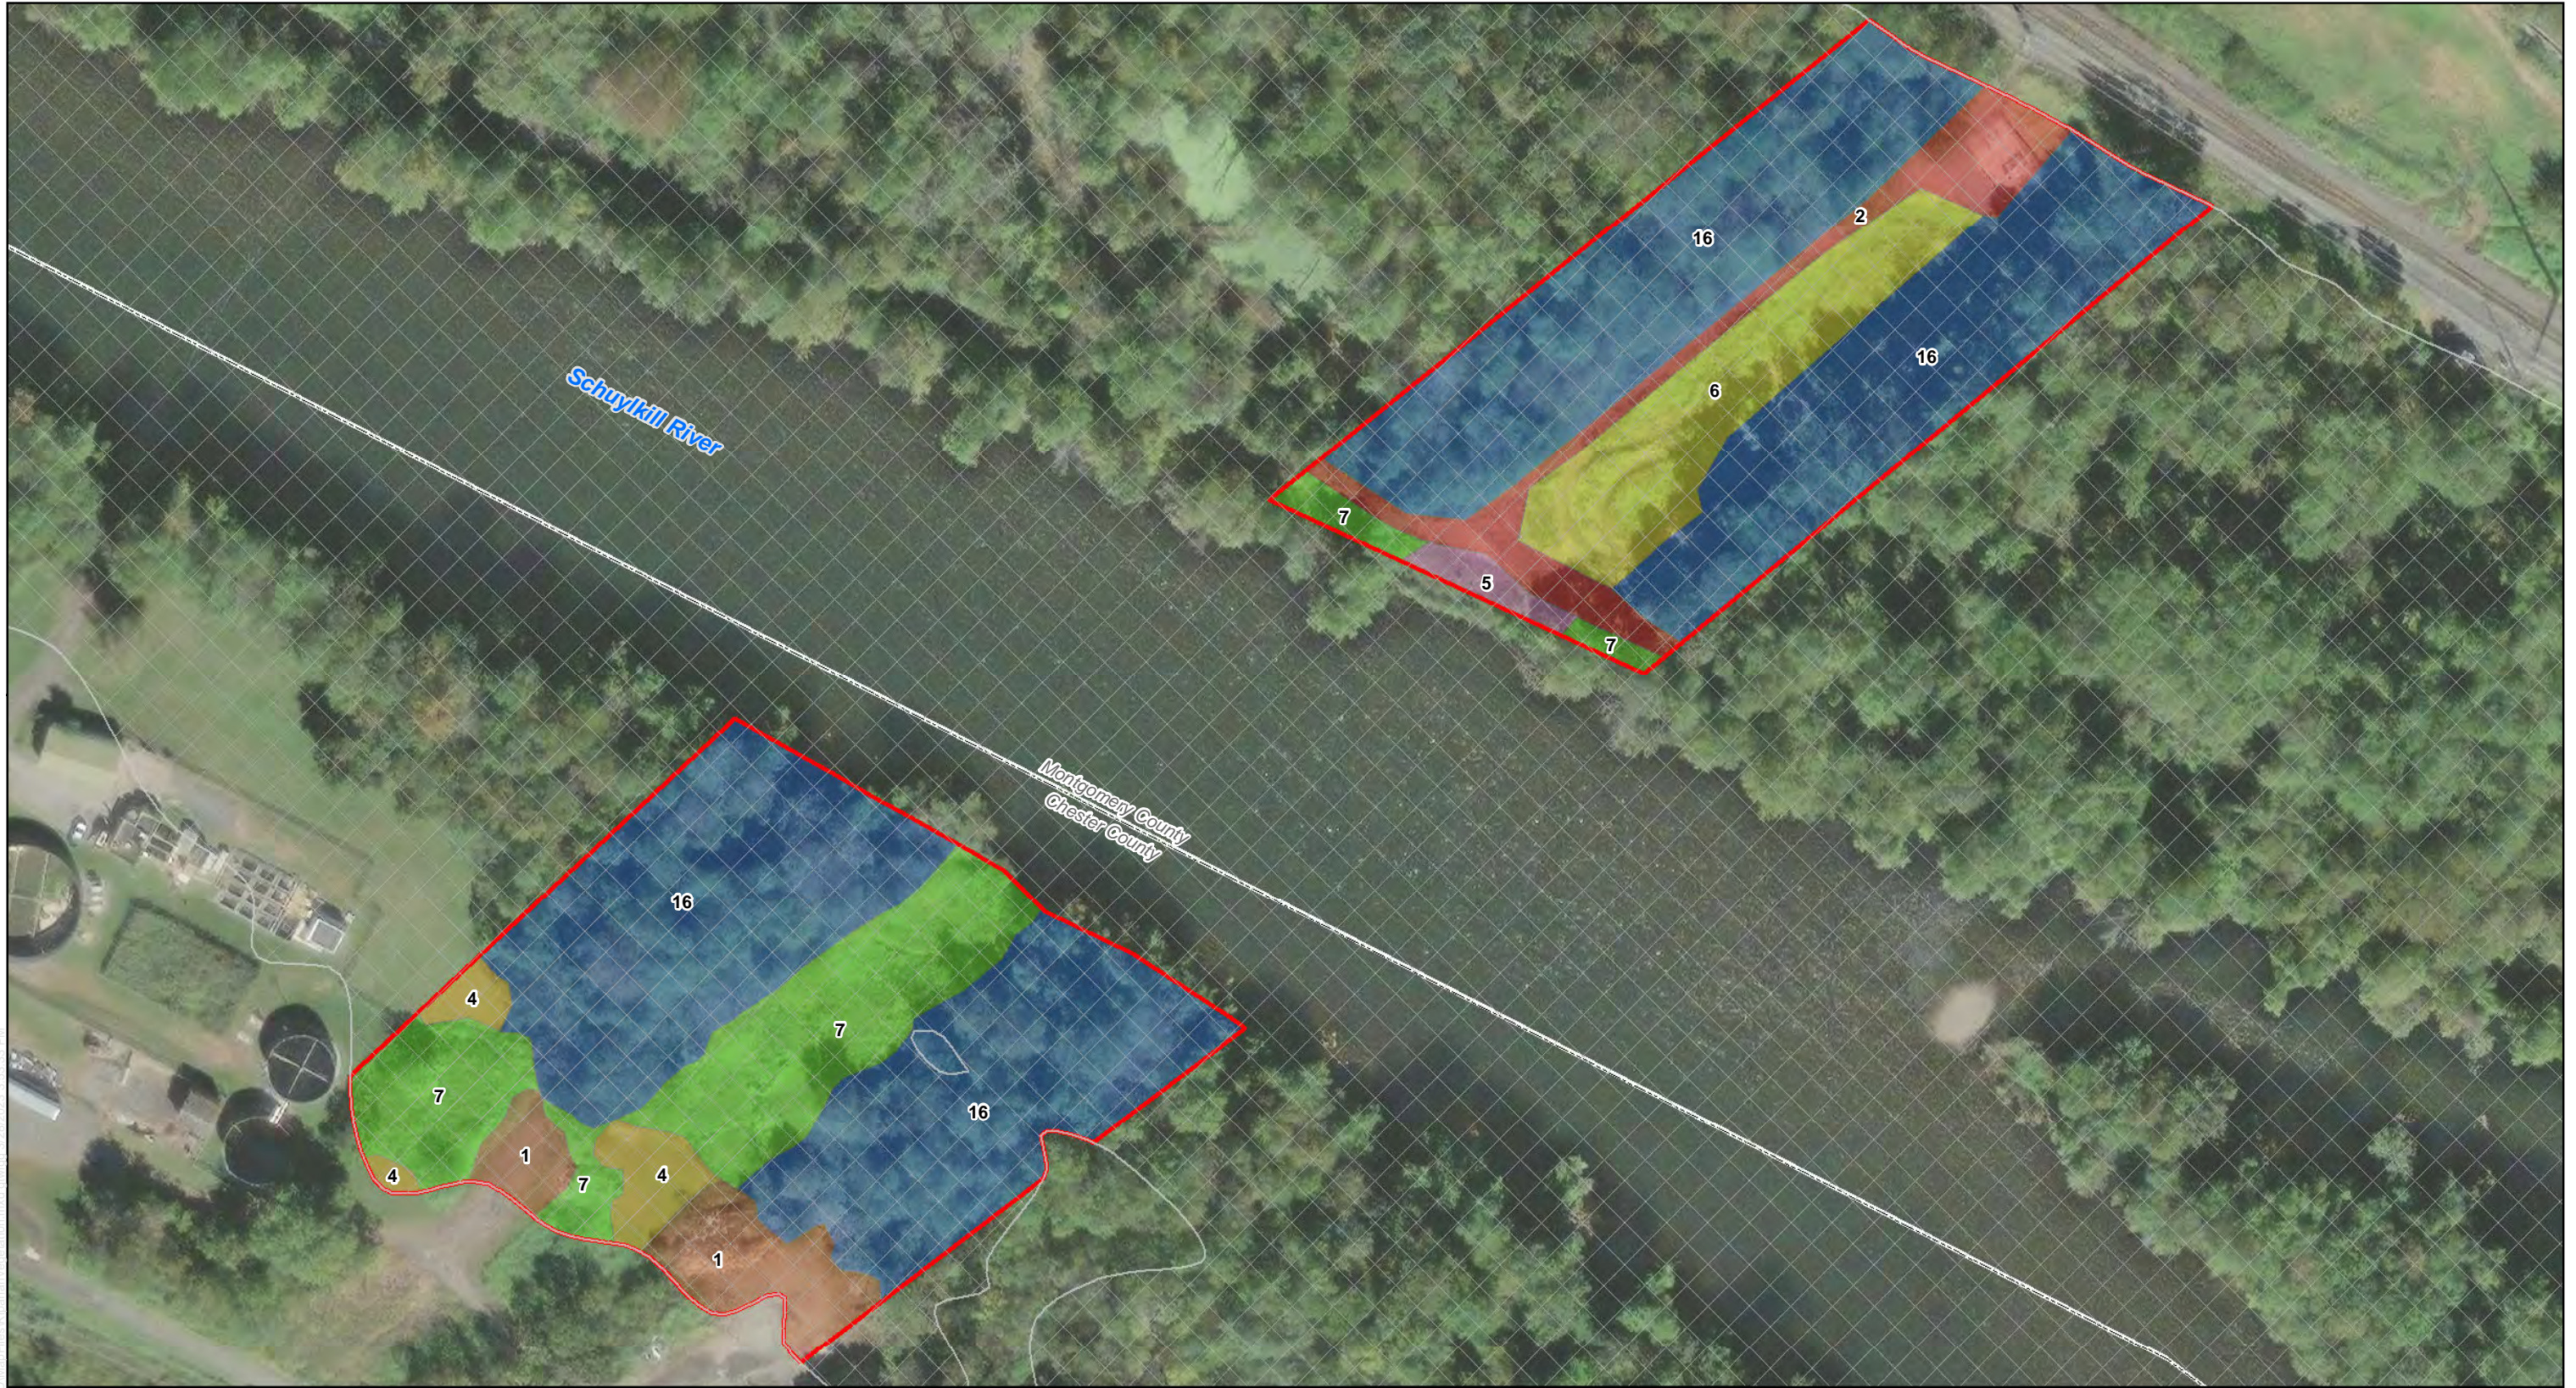
100-Year Floodplain	Condition Categories
Assessment Area (AA)	Low Poor - 1
County Boundary	Low Poor - 2
	High Poor - 4
	Low Poor - 5
	Low Marginal - 6
	Low Marginal - 7
	Optimal - 16
