**COMMONWEALTH OF PENNSYLVANIA
ENVIRONMENTAL QUALITY BOARD**

PETITION FORM

Name: Foundation Mining, LP

Amend a regulation (Citation Citation 25 Pa. Code Section 93.9v
Tributaries to South Fork of Tenmile)

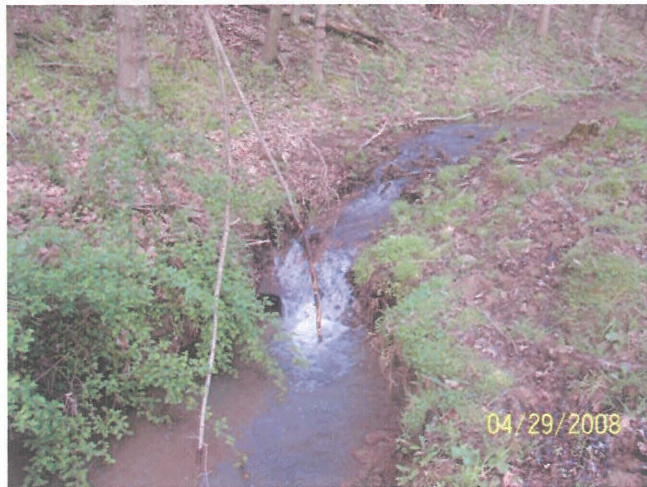
HQ 1 Headcut

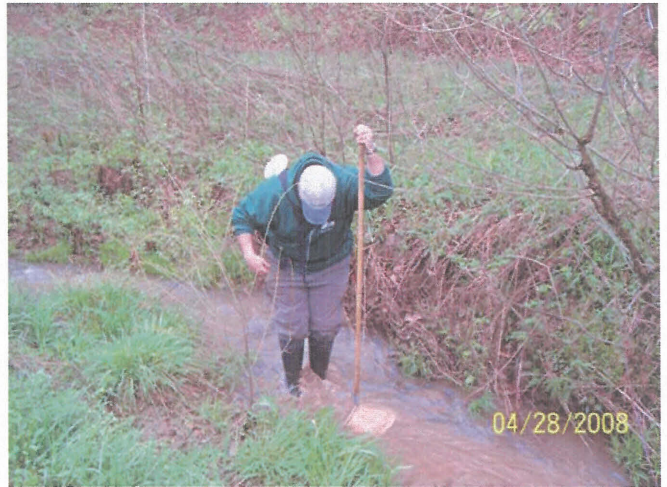
HQ 3 Sample Kick

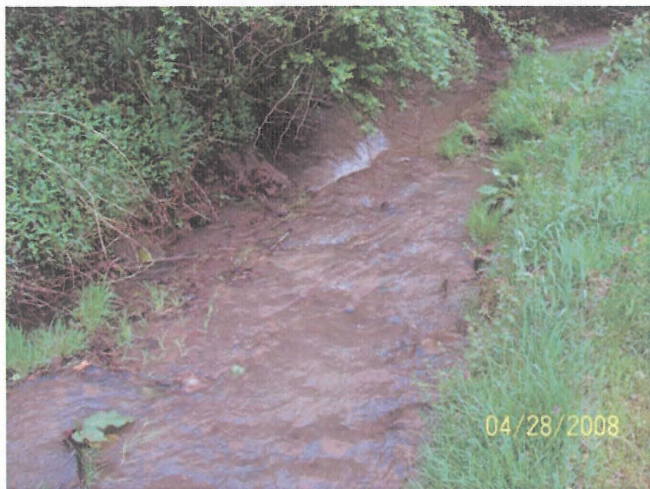
HQ 3 Riffle Habitat

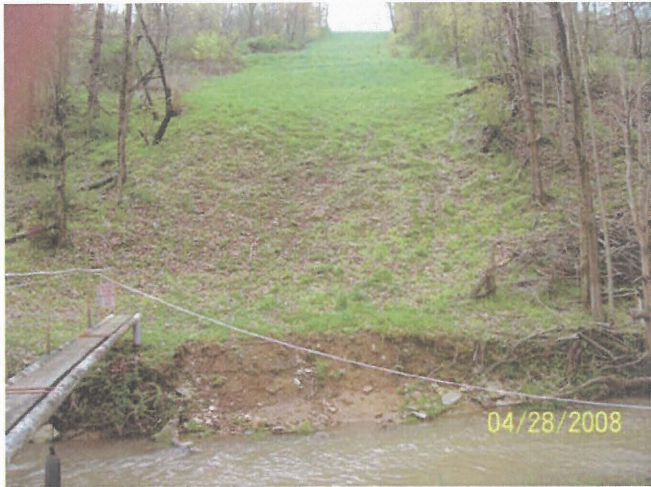
HQ 5 Left bank to right bank at bridge with gas line

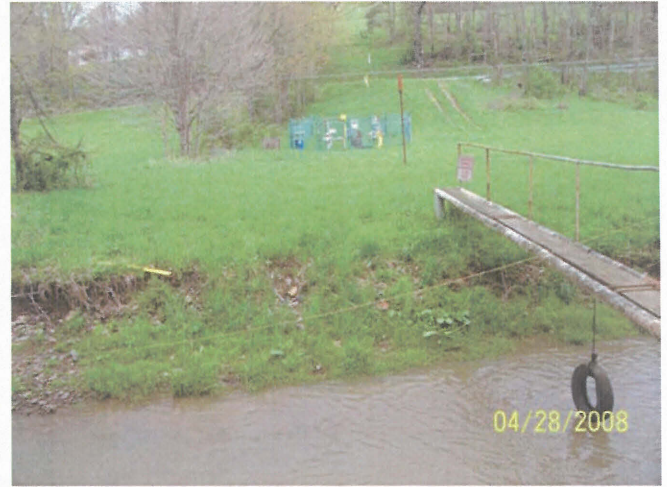
HQ 5 right bank to left bank at bridge with gas line

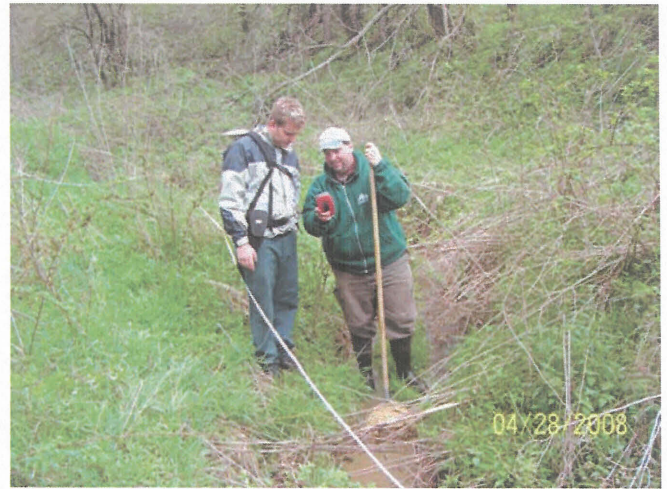
HQ 7 Marking Kick #1 with GPS unit
