Enclosure A: Figures

Figure 1A
Project Location Map
 S.R. 0010 Emberclear Water Main
 City of Reading, Berks County, Pennsylvania

Enclosure B: Photographs

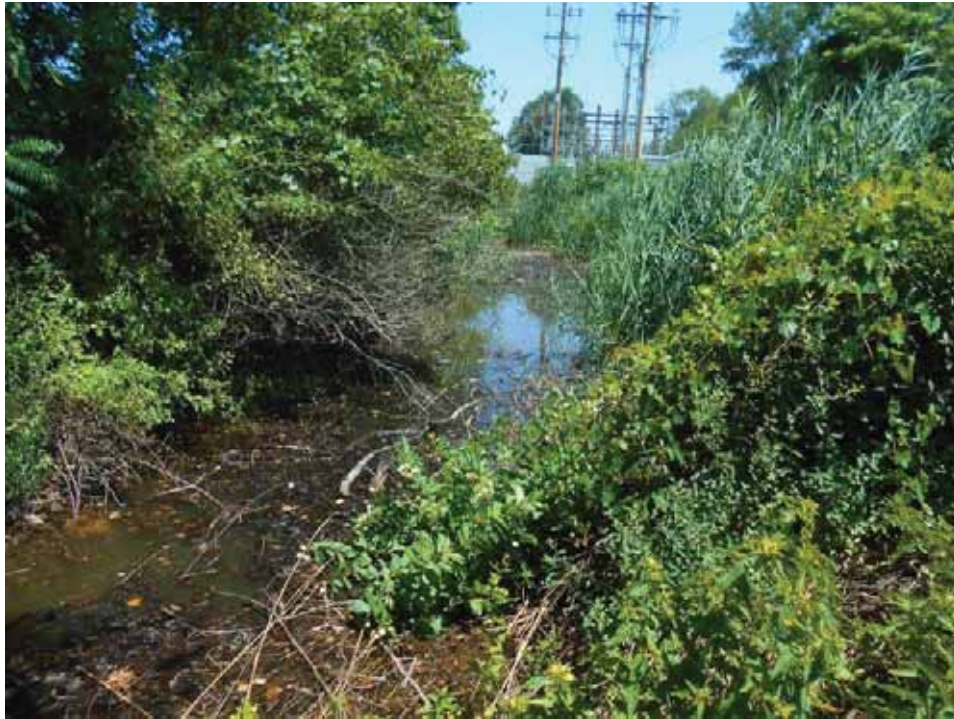
Photograph 9: View of Wetland 1, facing northeast (July 2016).

Wetland 1 was an isolated wetland that contained no inlet or outlet. Vegetation was scarce within the wetland; however, dominant vegetation growing along the edge of the open water included *Phragmites australis* (common reed), *Rosa multiflora* (multiflora rose), *Toxicodendron radicans* (poison ivy), *Muscadine rotundifolia* (grapevine), and *Lythrum salicaria* (purple loosestrife). The vegetation in Wetland 1 passed the dominance and prevalence index tests for hydrophytic vegetation.

Soil test pits were dug to observe soils matrix colors and hydric soil indicators; however, a soil profile was inaccessible due to the loose soil profile within the water column. Because hydrophytic vegetation and hydrological indicators of surface water (A1), high water table (A2), saturation (A3), sparsely vegetated concave surface (B8), and microtopographic relief (D4) were present, it was assumed soils within Wetland 1 were hydric. Surface water within Wetland 1 was at a depth of 14 inches, and saturation was present at the surface.

Remarks: (Explain alternative procedures here or in a separate report.) W1 met three out of three wetland criteria. A soil sample was inaccessible due to a loose soil profile within the water column; however, with hydrophytic vegetation and hydrological indicators present within the sample point, it is assumed that soils at this point are also hydric. W1 was the representative data point for Wetland 1. Wetland 1 is 100% POW wetland.

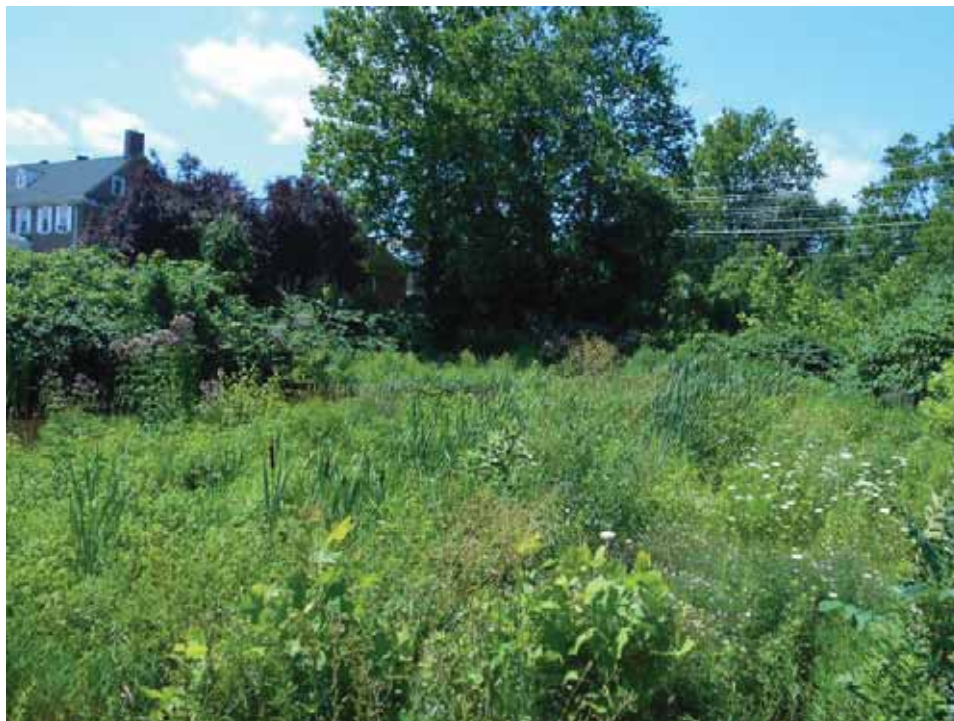
Photograph 10: View of Wetland 2, facing northwest (July 2016).

Soil test pits were dug to observe soil matrix colors and hydric soil indicators. From 0 to 7 inches, the soil was a dark brown (7.5YR 3/2) loam with red (7.5YR 4/4) redoximorphic features. A rock restrictive layer was present at 7 inches. Wetland 2 met the redox dark surface (F6) indicator of hydric soils. Indicators of wetland hydrology observed within Wetland 2 included surface water (A1) at the ground surface, a high water table (A2), saturation (A3), and geomorphic position (D2).

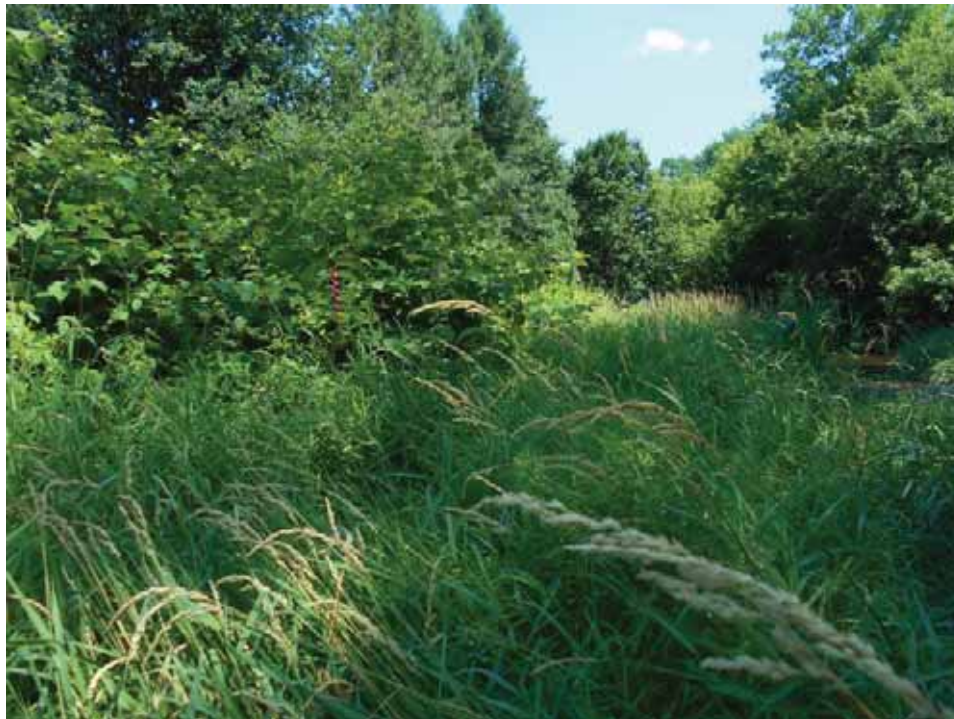
Photograph 12: View of Wetland 3, facing southeast (July 2016).

Soil test pits were dug to observe soil matrix colors and hydric soil indicators. From 0 to 8 inches, the soil was a dark brown (7.5YR 3/2) loam with red (7.5YR 4/4) redoximorphic features. A rock restrictive layer was present at 8 inches. Wetland 3 met the redox dark surface hydric soil indicator. Indicators of wetland hydrology observed within Wetland 3 included a high water table (A2) at 2 inches, saturation (A3) at the surface, and geomorphic position (D2).

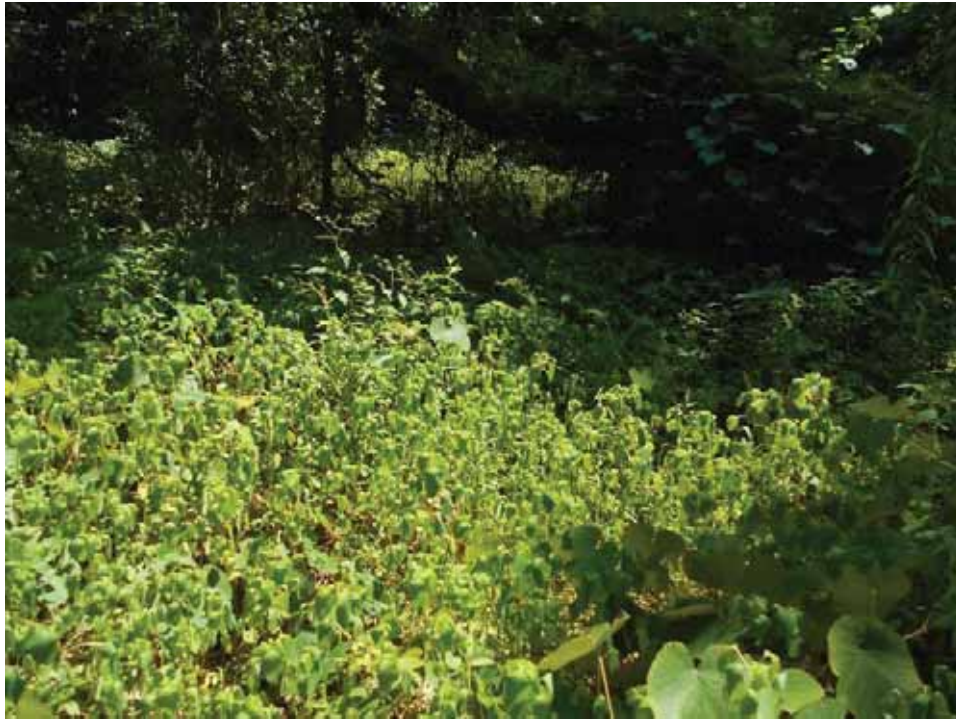
Photograph 13: View of Wetland 4, facing southwest (July 2016).

Soil test pits were dug to observe soil matrix colors and hydric soil indicators. From 0 to 4 inches, the soil was a dark brown (5YR 4/1) loam with reddish-brown (5YR 4/4) redoximorphic features, and contained a co-matrix from 4 to 18 inches of grey (5YR 7/1) and reddish brown (5YR 4/4) loam with dark brown (5YR 3/2 and 2.5YR 4/3) redoximorphic features. The soils in Wetland 4 met the depleted matrix (F3) indicator for hydric soils. Indicators of wetland hydrology observed within Wetland 4 included drainage patterns (B10) and microtopographic relief (D4).

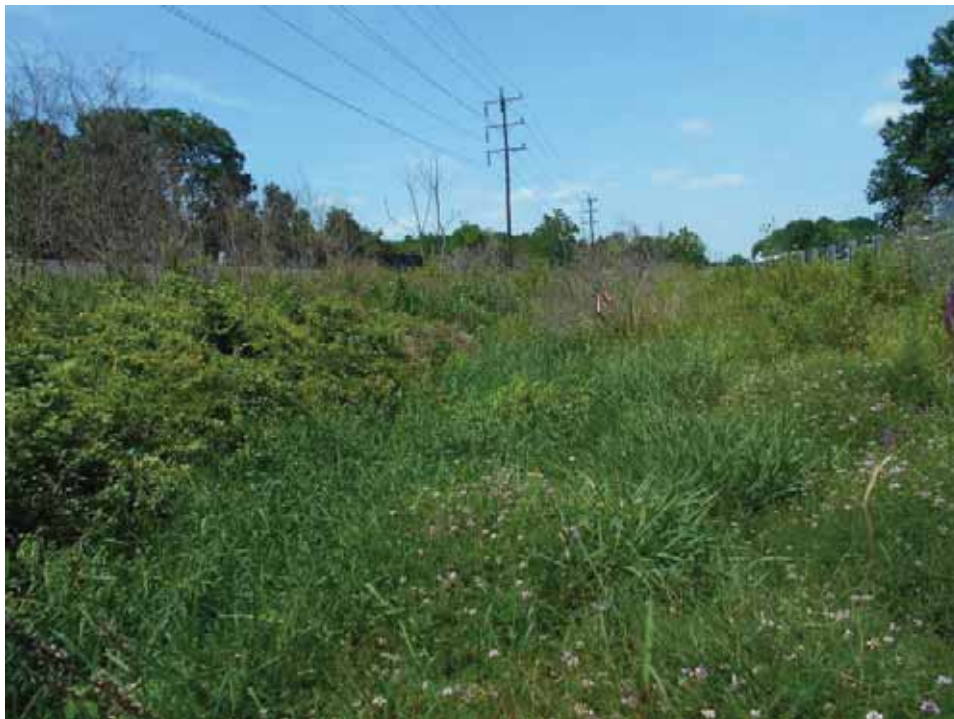
Photograph 14: View of Wetland 5, facing northwest (July 2016).

Wetland 5 is a PEM wetland located south of S.R. 0724 and draining to Waterway 7. The wetland was 0.23 acre in size and within a concave depressed area that contained groundwater seeps and stormwater runoff from S.R. 0724. During stormwater events, it is likely that hydrology from Wetland 5 is conveyed into Waterway 7. Dominant vegetation within the wetland included reed canary, spotted jewelweed, and purple loosestrife. The vegetation in Wetland 4 passed the dominance and prevalence index tests for hydrophytic vegetation.

Soil test pits were dug to observe soil matrix colors and hydric soil indicators. From 0 to 24 inches, the soil was a strong dark brown (7.5YR 2/1) muck. The soils in Wetland 5 met the 2-centimeter muck (A10) indicator for hydric soils. Indicators of wetland hydrology observed within Wetland 5 included surface water (A1) at 4 inches, high water table (A2), saturation (A3), and drainage patterns (B10).
