CHAPTER 102 INSPECTION REPORT

PA Department of Environmental Protection

Report No.: 17

| Project/Site Name: | Alliance 51 st Street, Philadelphia | Permit Issuance Date: | 9/5/2023 |

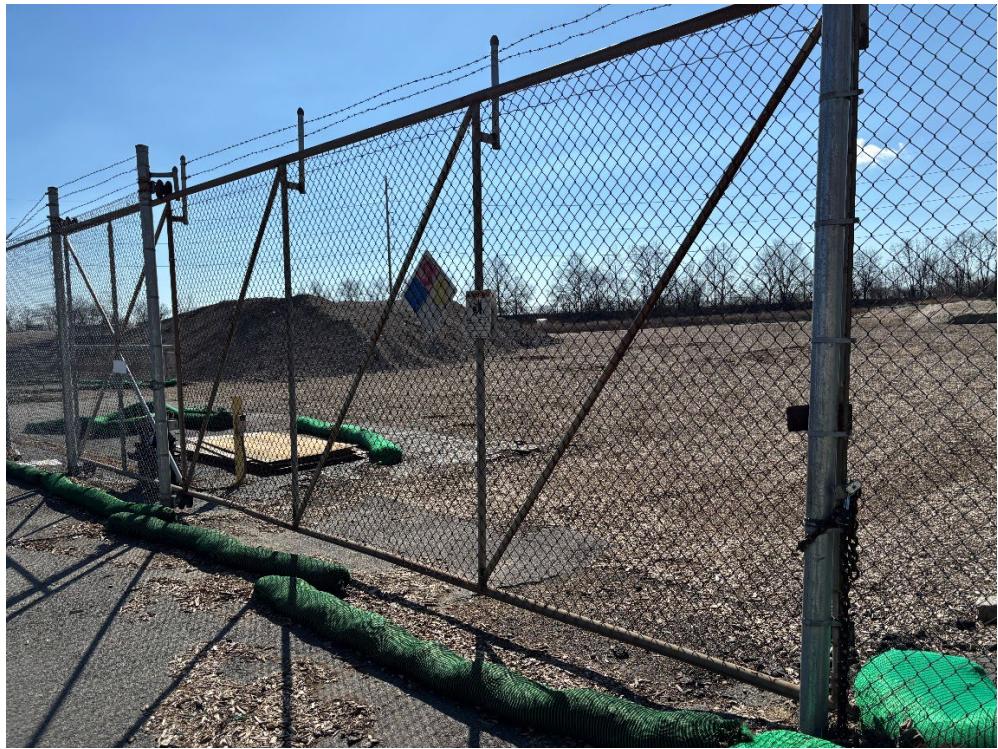
Most upslope gate and filter sock.

I noted that the filter sock along both 51st St. gates to the site were in proper position and in good operating condition. The stone stockpile appeared similar in appearance as with recent past inspections. Mulching on the site appeared to remain generally uniform. Perimeter filter sock around the site was in place and in good functional condition.

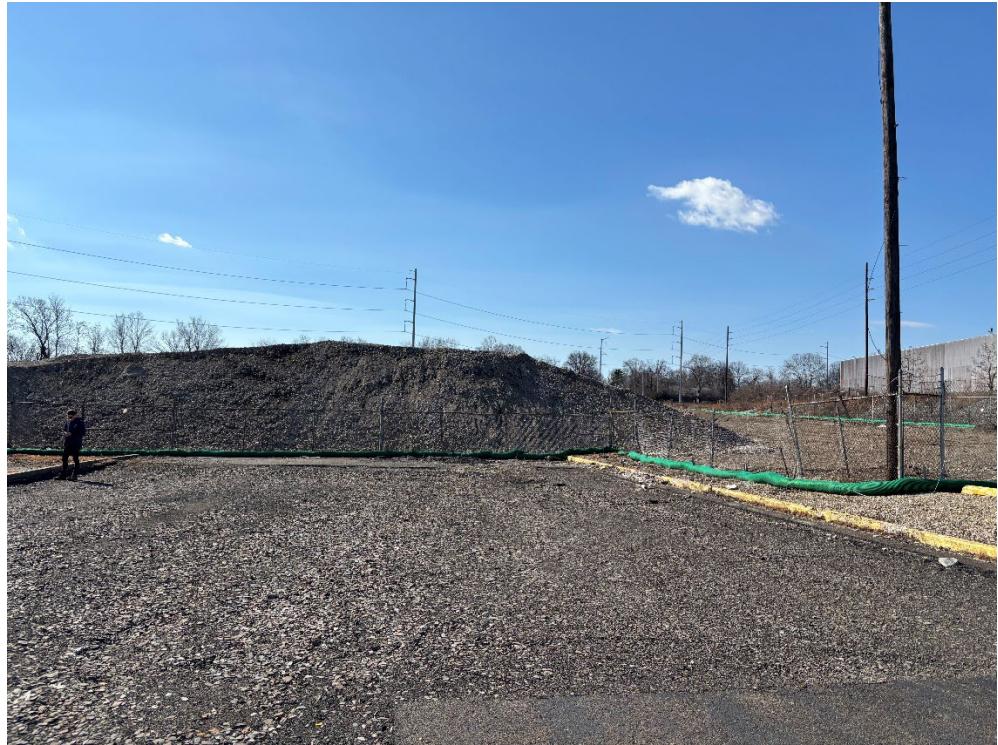
Mid-slope parking lot and stone stockpile.

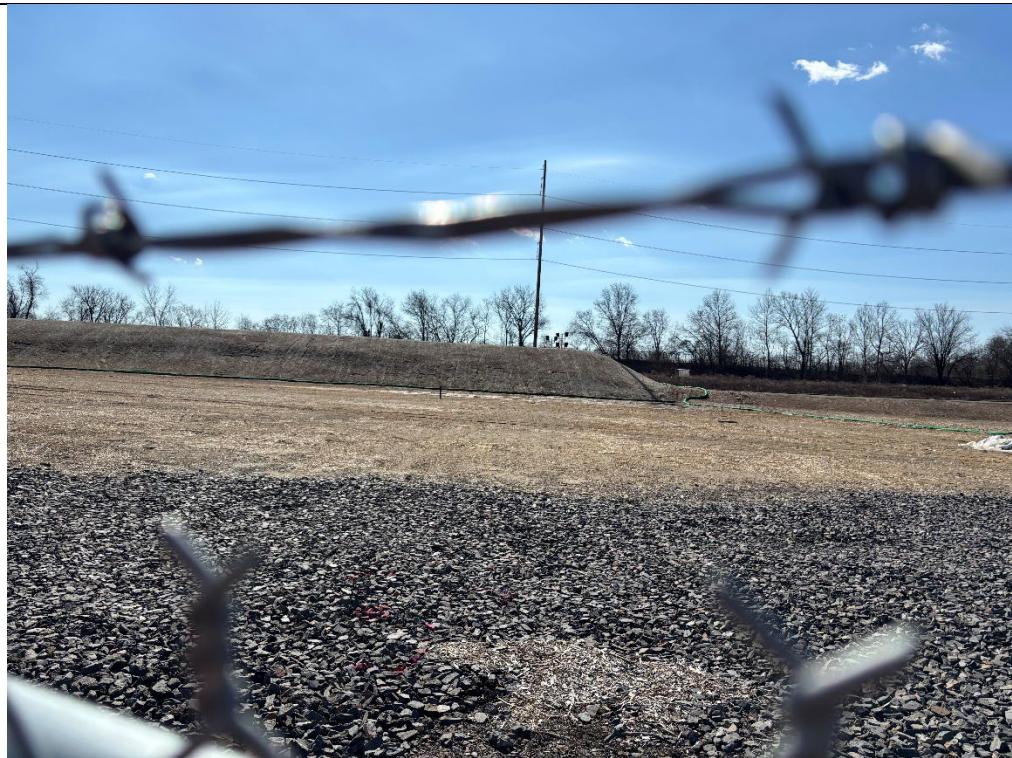
Midslope portion of site with upslope part of large fill dirt stockpile in distance.

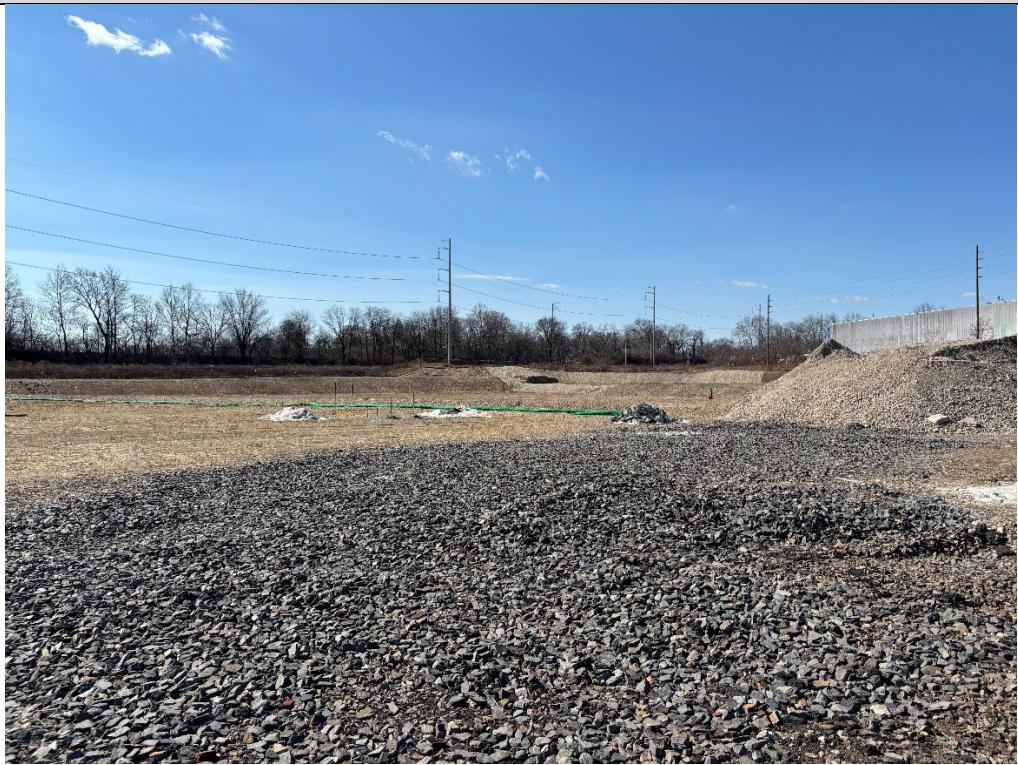
Looking upslope from 51st St.

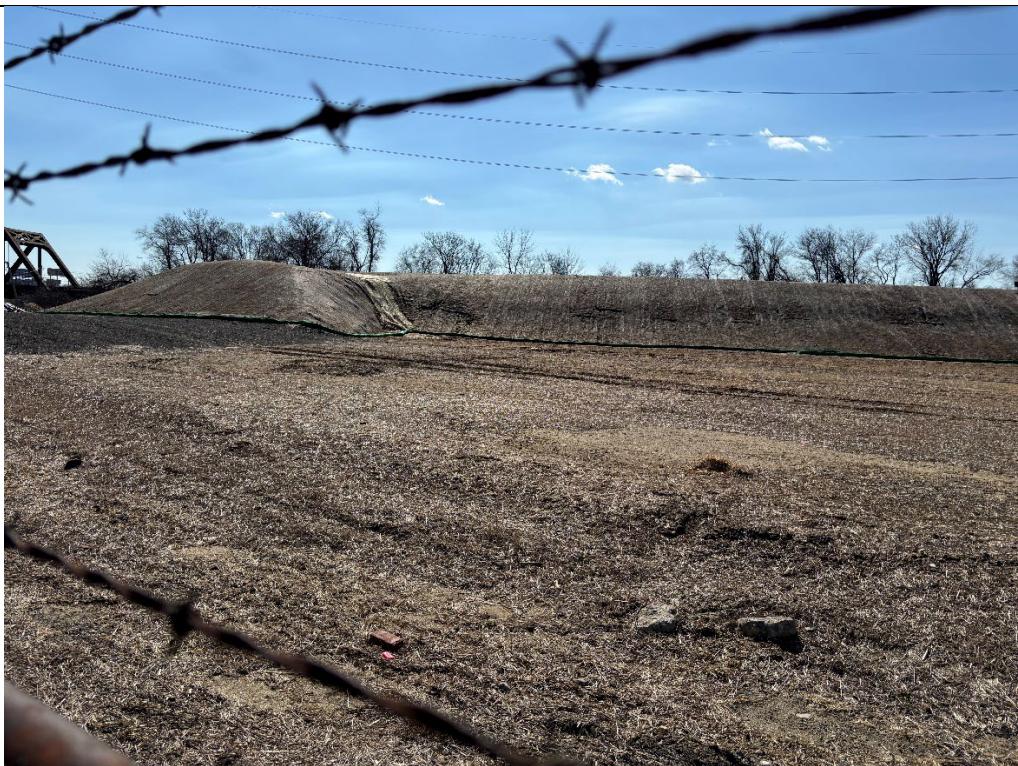
The most severe erosion gullies, located in the bend of the large fill dirt stockpile (as previously noted), was now covered in erosion control blanket. Therefore, the associated violation (DEP violation no. 8207051, first noted 10/22/24), has been closed out by DEP.

Downslope portion of site and of large fill dirt stockpile, with erosion blanket present in bend of stockpile.

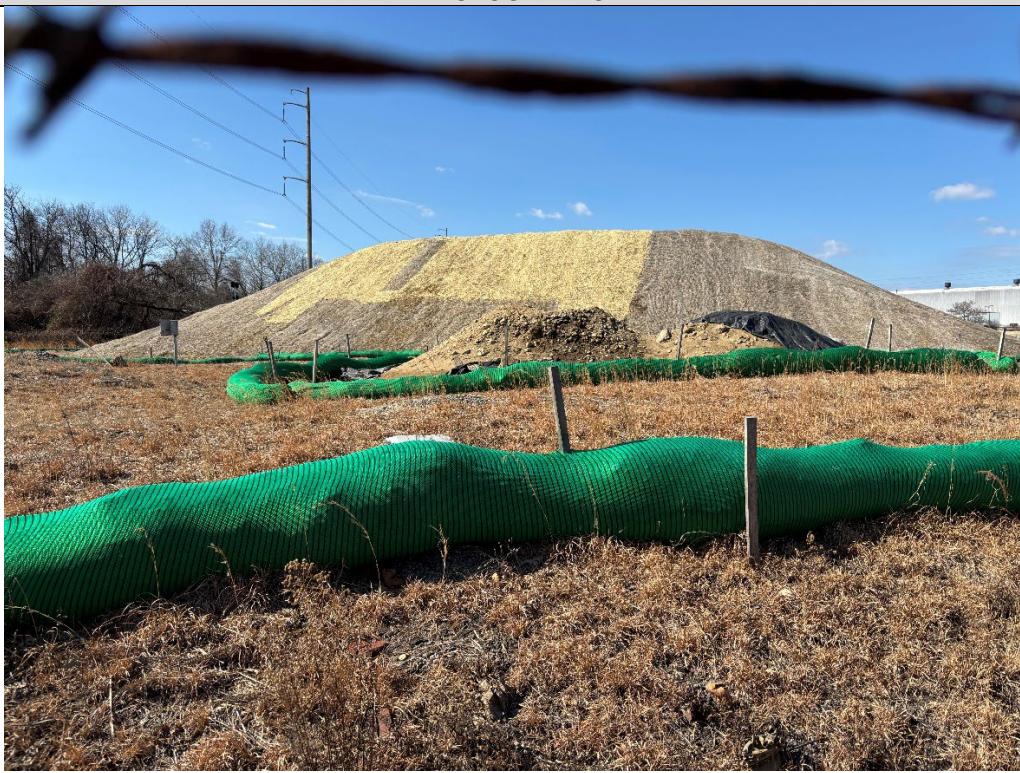
The black tarp covering the small pile of contaminated soil downslope of the large fill dirt stockpile was mostly displaced from the stockpile. Perimeter control (filter sock) around this pile, and the downslope site perimeter, remained intact.

Downslope end of large fill dirt stockpile with erosion blanket present. Small contaminated fill dirt stockpile in front, surrounded by filter sock; with black tarp mostly removed.

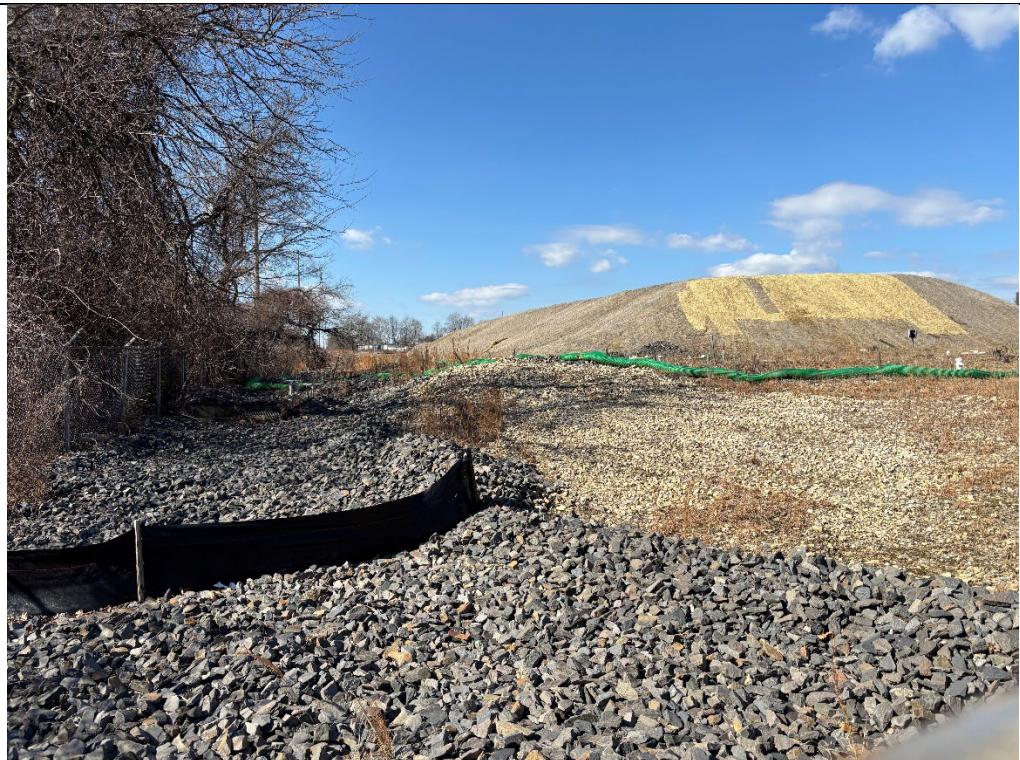
Rear side of large fill dirt stockpile; silt fence along stone-covered swale.

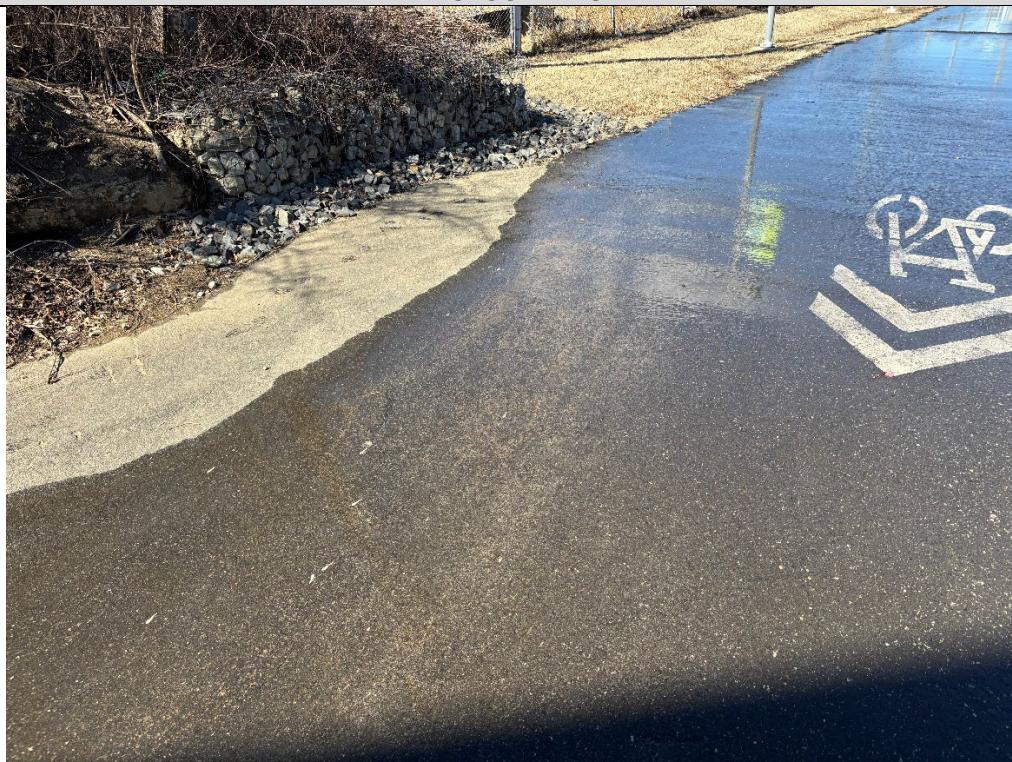
Philadelphia Fire Department was conducting a flushing and/or training activity at a hydrant along 51st St. during this inspection, which resulted in a significant flow of water down the Bartram's Garden trail from the corner of 51st and Botanic Sts. during this inspection.

Sediment staining along Bartram's Garden trail. Philadelphia Fire Department was conducting a flushing and/or training activity at a hydrant along 51st St., causing the wet pavement.

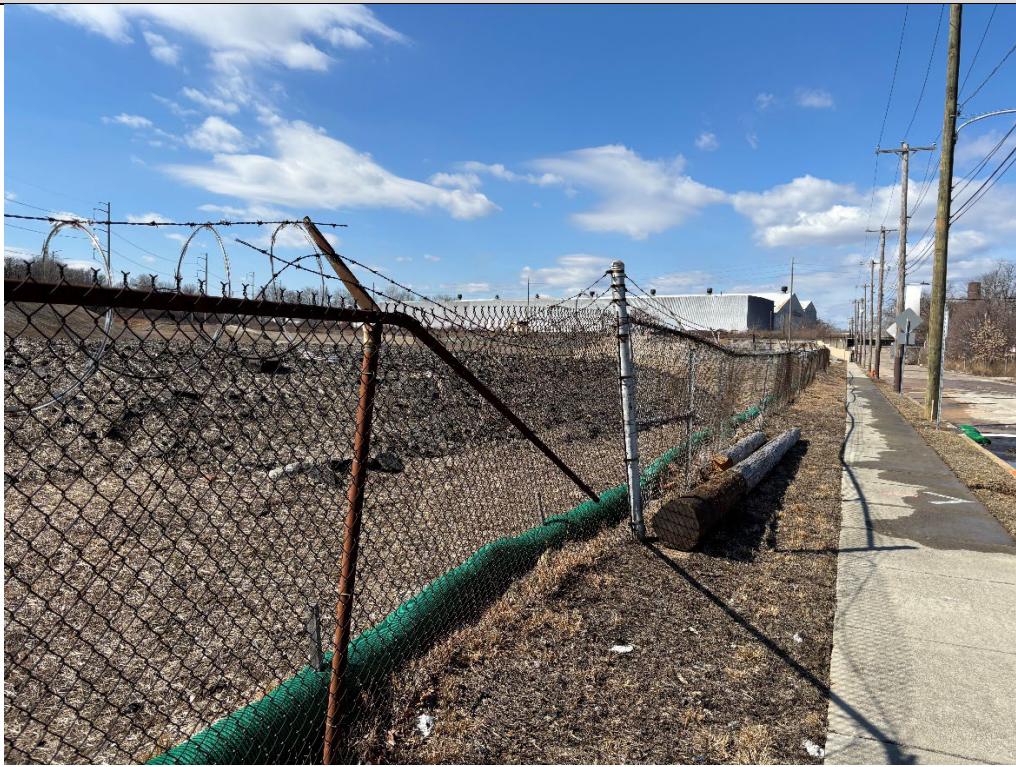
One damaged section of chain-link/barbed wire perimeter security fence was noted.

**Damaged security fence along 51st St.
End of photo log.**
