**Subject: PFBC SIR # 41856
Request for a No Impact Determination for Mussel Species, Fish Species,
and Eastern Red Belly Turtle
Sunoco Pipeline, L.P. - Pennsylvania Pipeline Project (Previously Part of
the Mariner East 2 Pipeline Project)**

Pennsylvania Pipeline Project Map

FIGURES

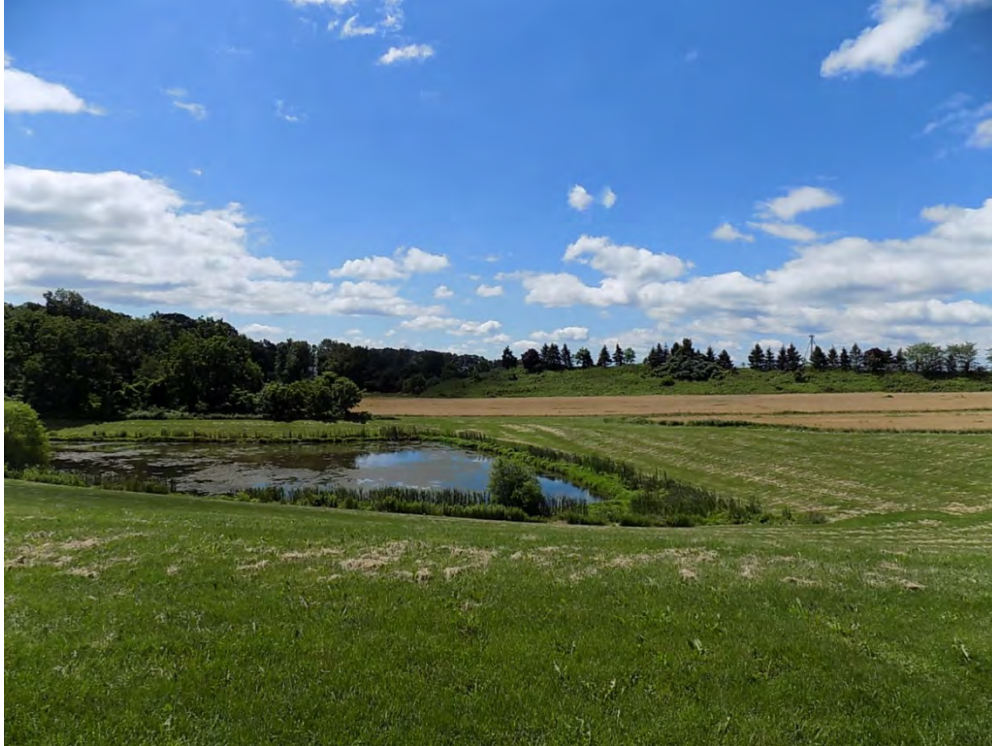
1. View south of stormwater management pond (Pond A3) with CMP riser within Parcel PA-CH-0019.0000-ABTN along the proposed pipeline ROW. Fish and a large common snapping turtle were observed within the pond (June 29, 2015)

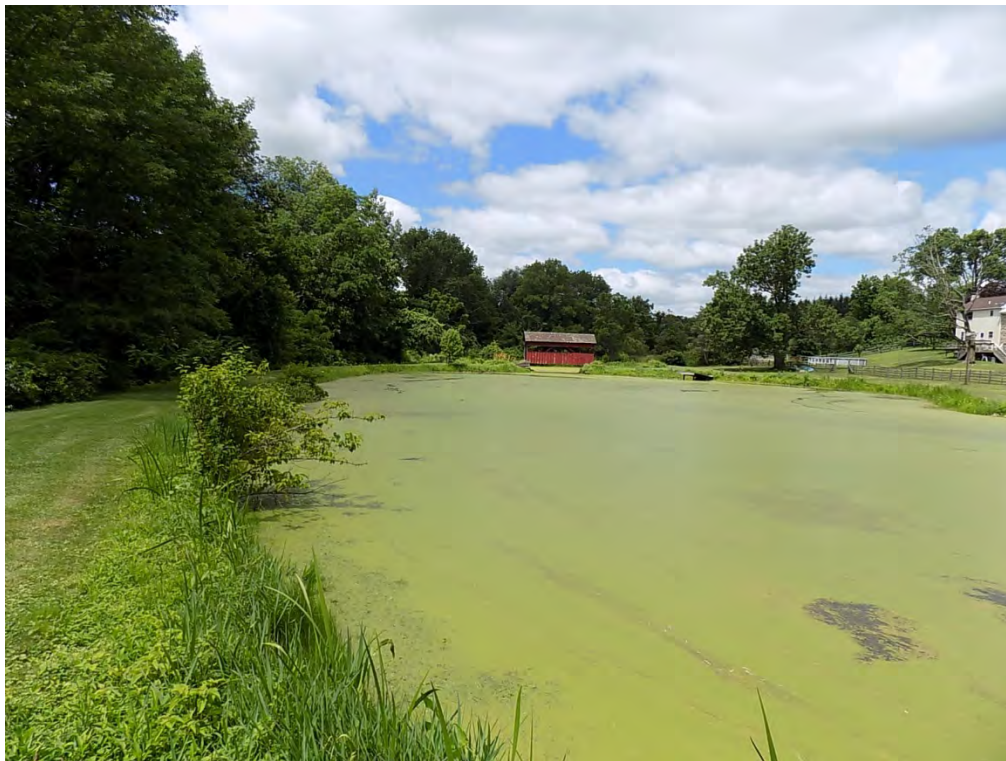
2. View of twin ponds and maintained lawn (potential nesting habitat) within Parcel PA-CH-0022.0000 approximately 60 feet outside the pipeline ROW (June 29, 2015)

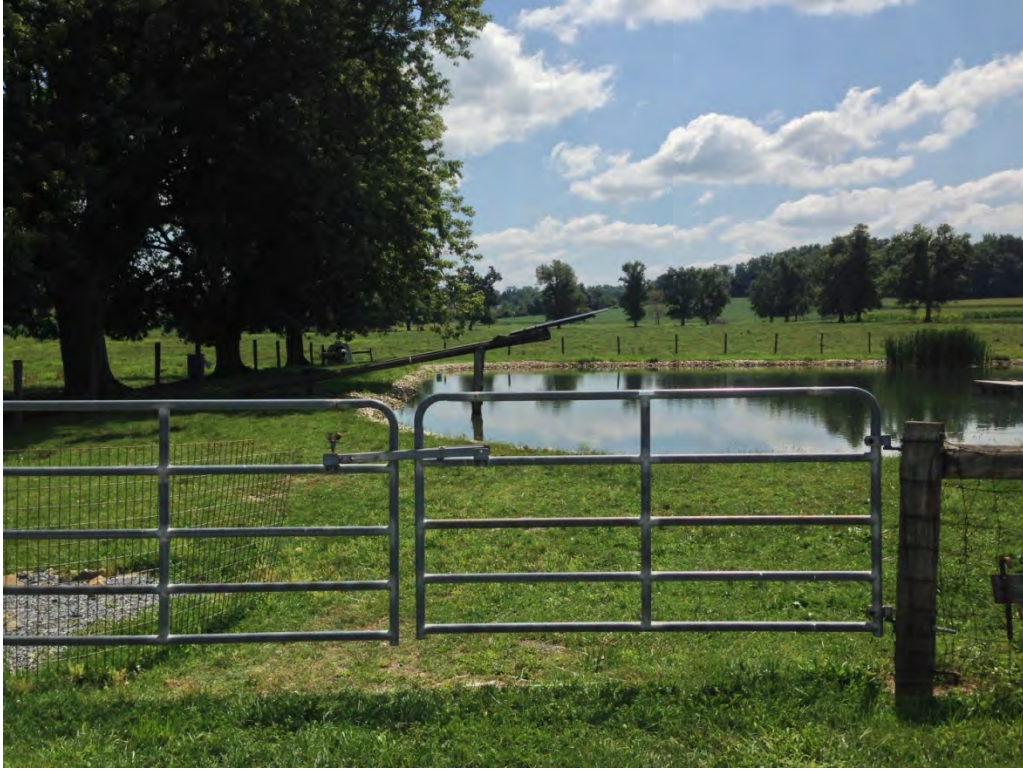
3. View of small man-made pond along Hedge Road approximately 250 feet outside the pipeline ROW (August 25, 2014).

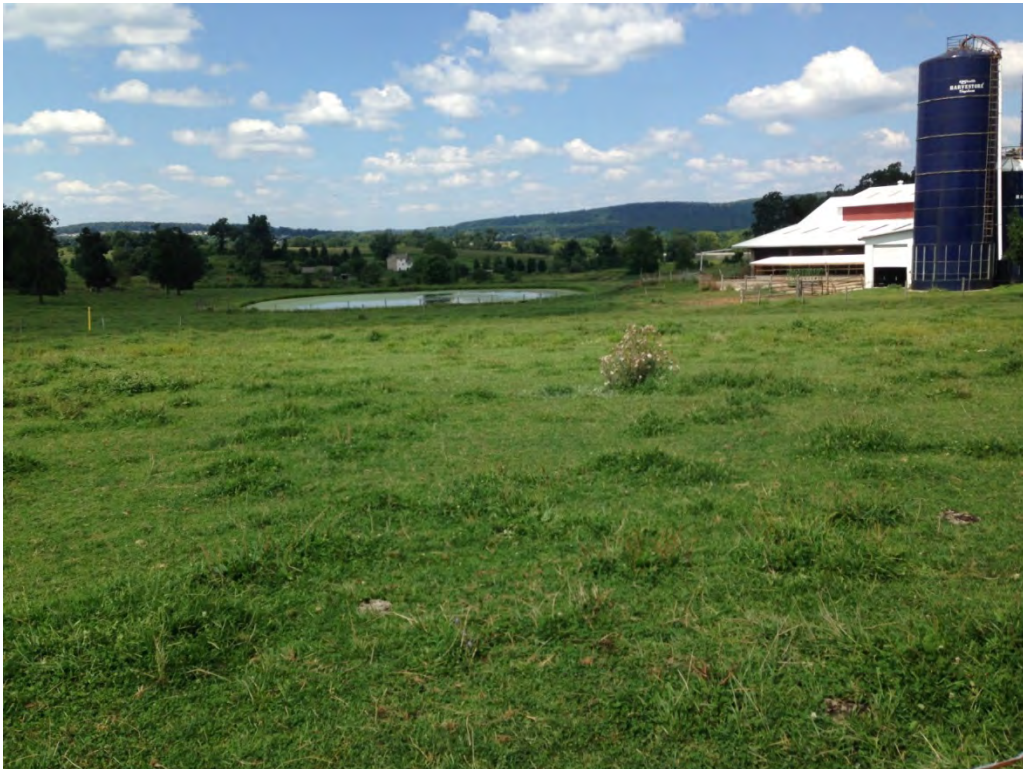
4. View of pond (Pond-A4) within Parcel PA-CH-0032.0000 within the pipeline ROW (August 25, 2014).

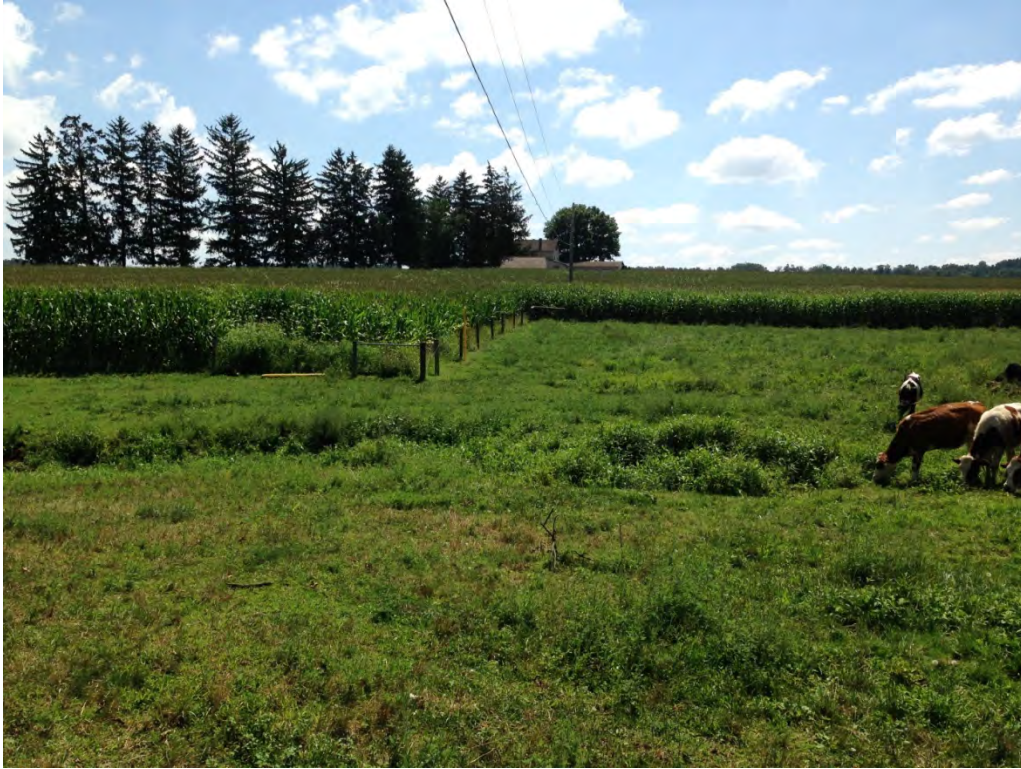
5. View of headwaters stream within an agricultural pasture within Parcel PA-CH-0035.0000 within the pipeline ROW (August 25, 2014).

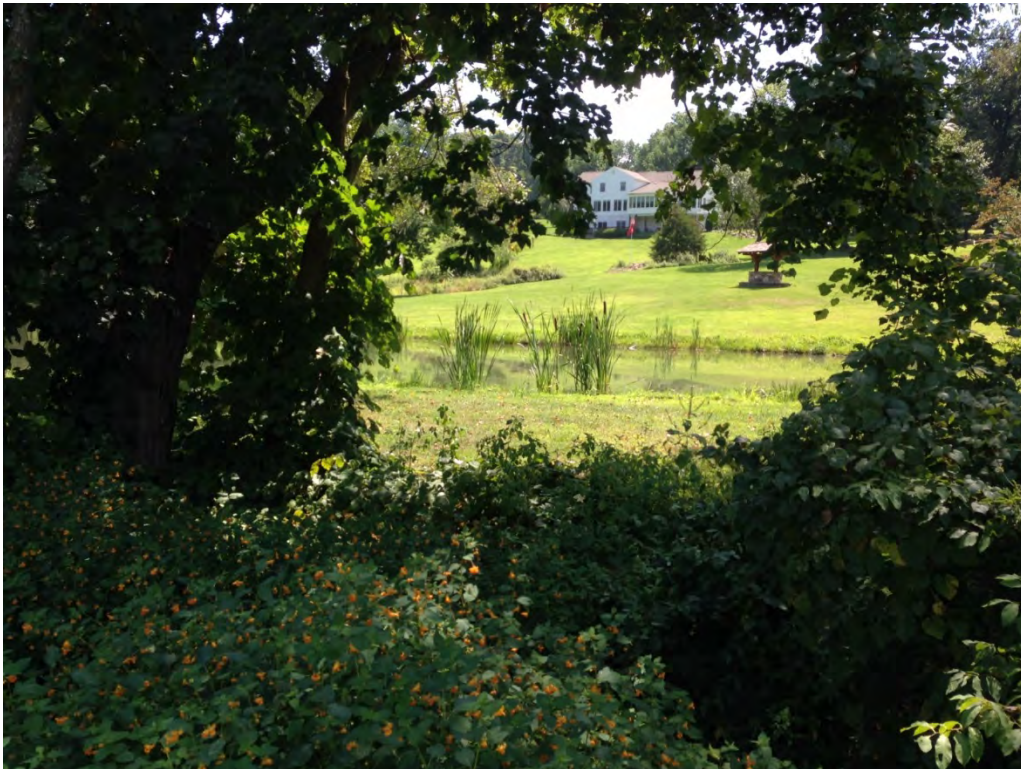
6. View of pond (Pond-B2) and maintained lawn (potential nesting habitat) within Parcel PA-CH-0042.0000-WX approximately 35 feet outside the pipeline ROW (August 25, 2014).

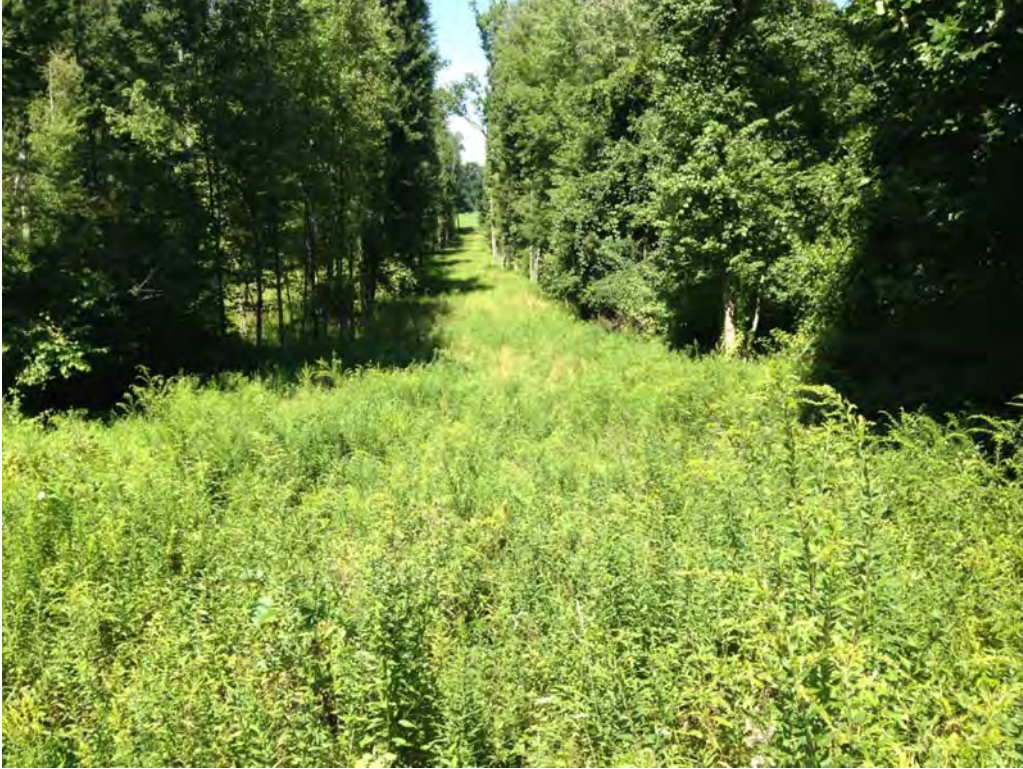
7. View north of wetlands (C49) within the ROW of the pipeline within Parcel PA-CH-0065.0000. Pond XX3 is located approximately 150 feet outside the pipeline ROW (August 25, 2014).

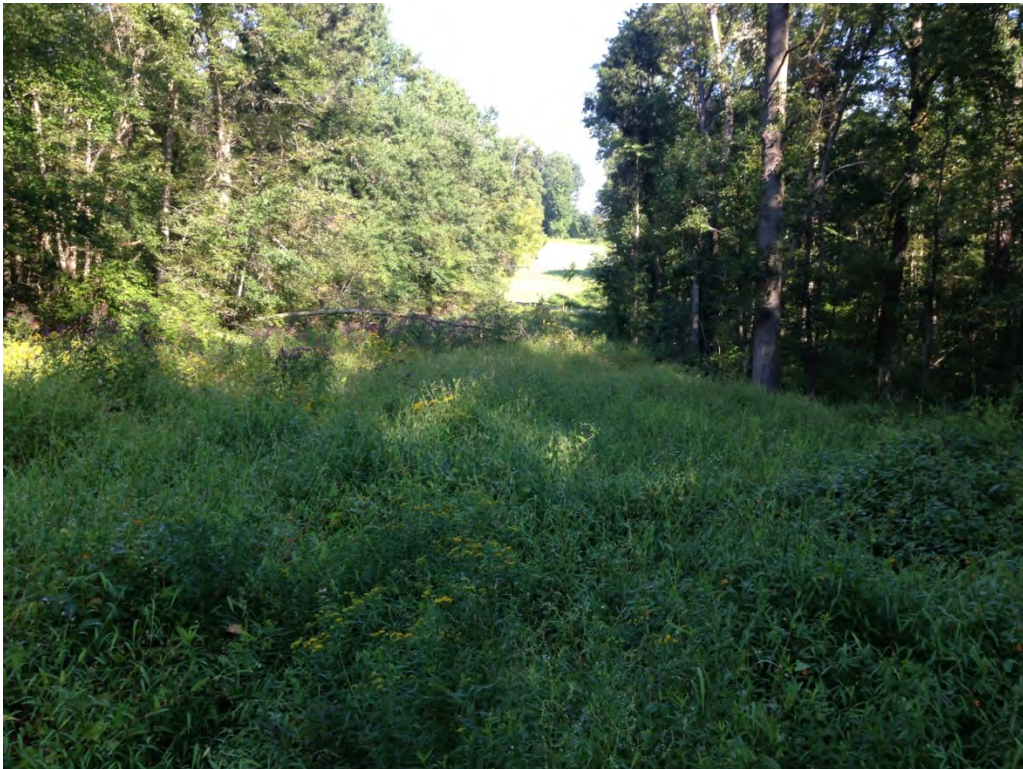
8. View north of wetlands with small headwater stream channels within the ROW of the pipeline within Parcel PA-CH-0072.0000 (August 27, 2014).

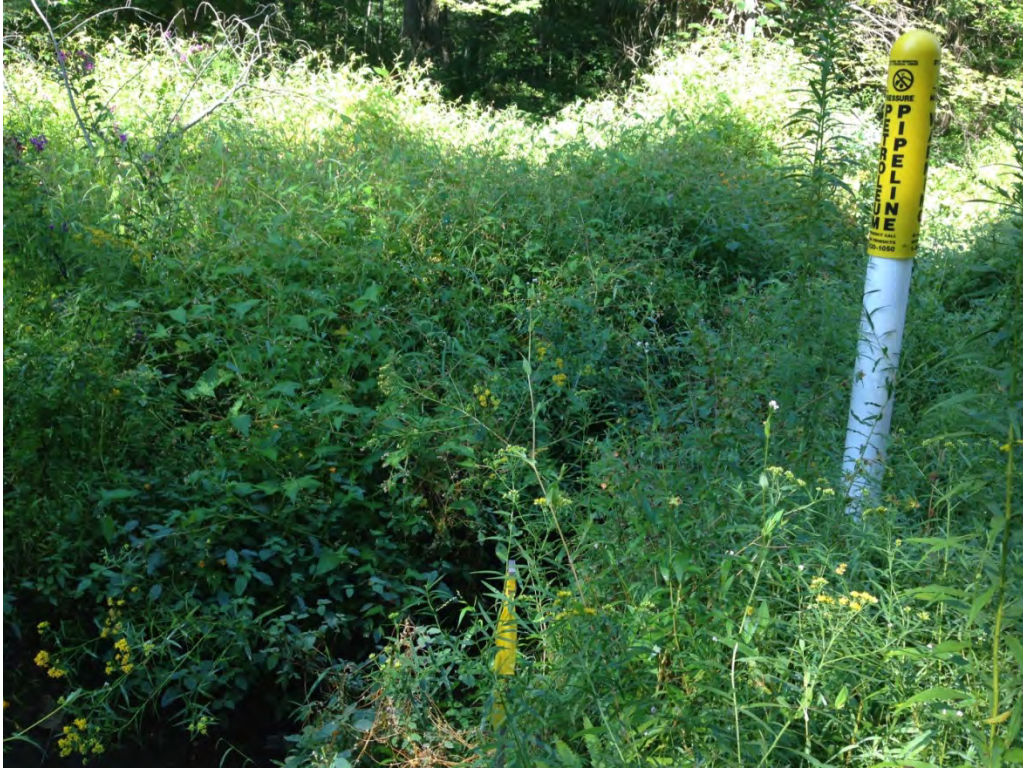
9. View north of a small headwater stream channel (S-B18) within the ROW of the pipeline within Parcel PA-CH-0072.0000 (August 27, 2014).

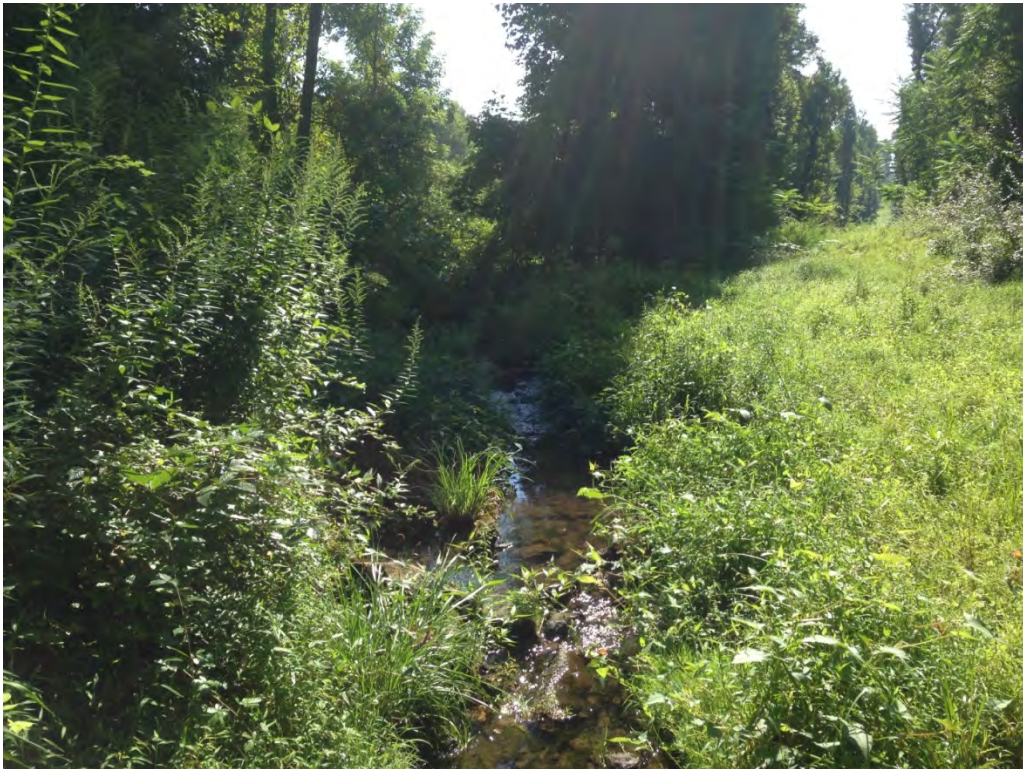
10. View northeast of a small headwater stream channel (S-H9) within the ROW of the pipeline within Parcel PA-CH-0075.0000 (August 27, 2014).

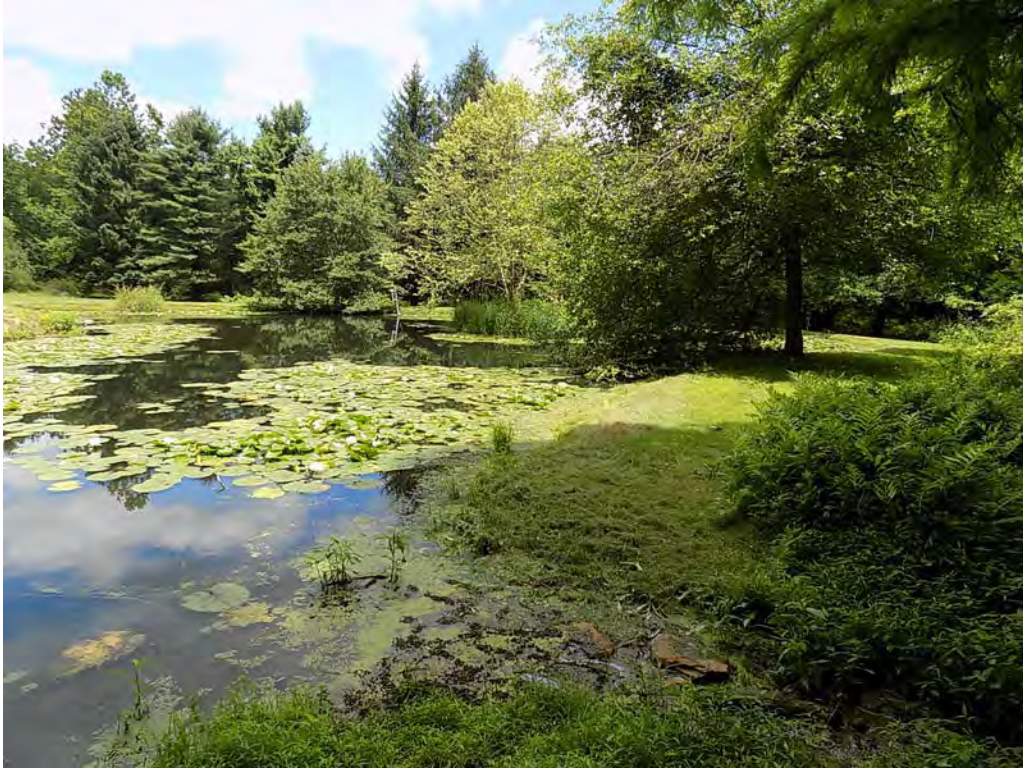
11. View of a pond (Pond XX11) and maintained lawn (potential nesting habitat) within Parcel PA-CH-0086.0000 approximately 175 feet outside the pipeline ROW (June 29, 2015).

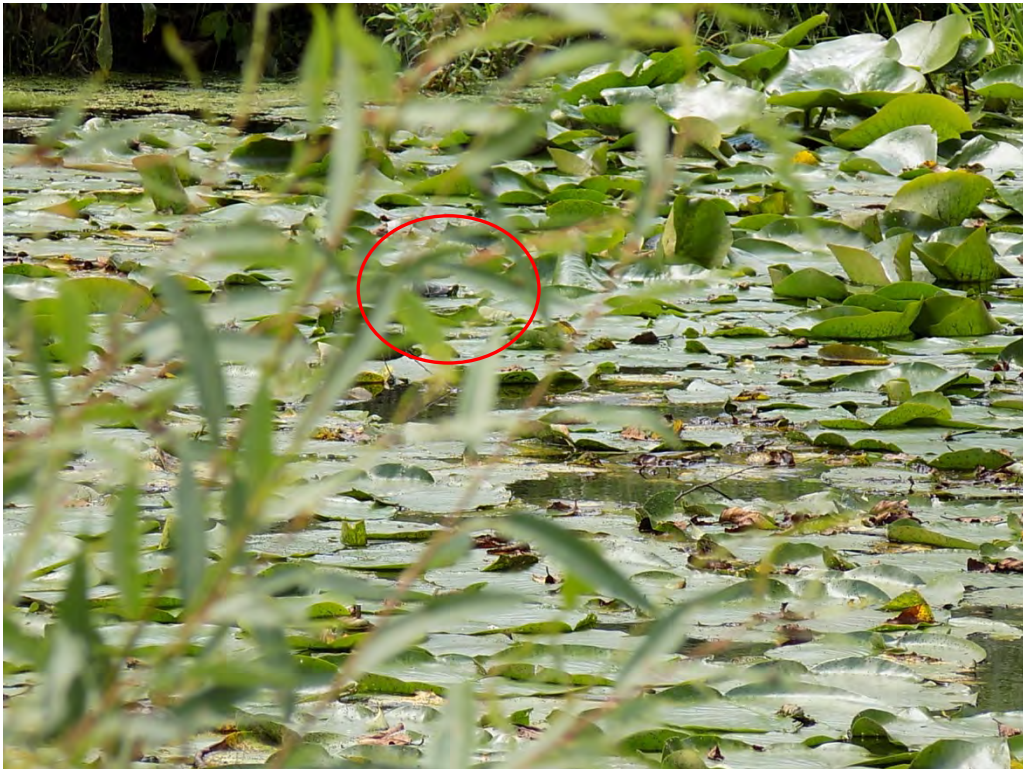
12. View of a basking eastern painted turtle within pond (Pond XX11) within Parcel PA-CH-0086.0000 (June 29, 2015).

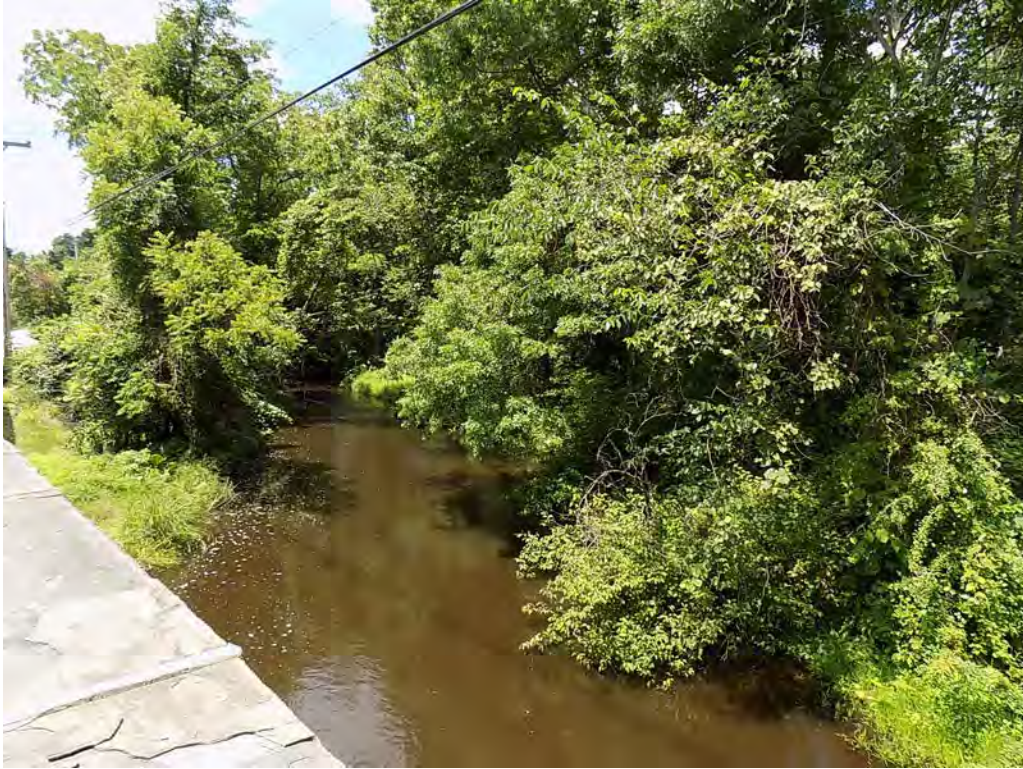
13. View northwest of a stream channel (S-H15) from Styler Road adjacent to the ROW of the pipeline within Parcel PA-CH-0085.0000 (June 29, 2015).

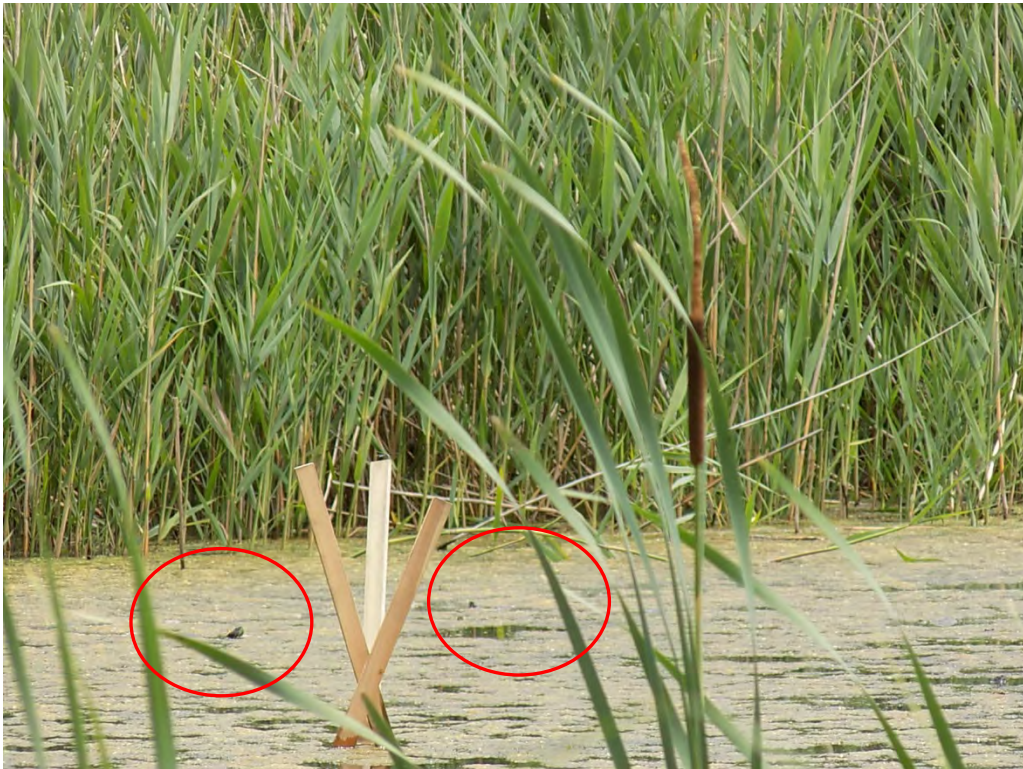
14. View of eastern redbelly turtles and ROW wooded stakes in Marsh Creek (Pond H3) within Parcel PA-CH-0089.0000-WX (June 29, 2015).

- On June 10, 2015, multiple (10+) eastern redbelly turtles were observed basking on logs and swimming in Marsh Creek Lake within parcels PA-CH-0089.000 and PA-CH-0090.000 located in Upper Uwchlan Township, Chester County. In addition to the eastern redbelly turtles, eastern painted turtles were also observed basking on multiple logs throughout the lake.

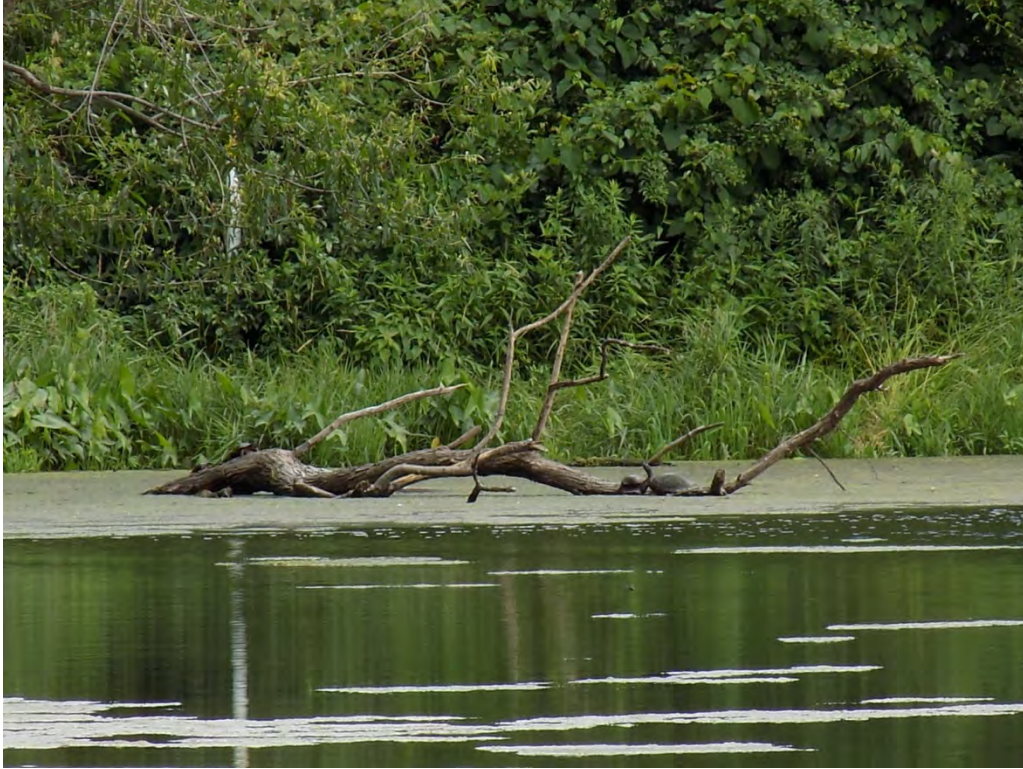
15. View of eastern redbelly turtles basking on a log in Marsh Creek (Pond H3) within Parcel PA-CH-0090.0000 (June 29, 2015).

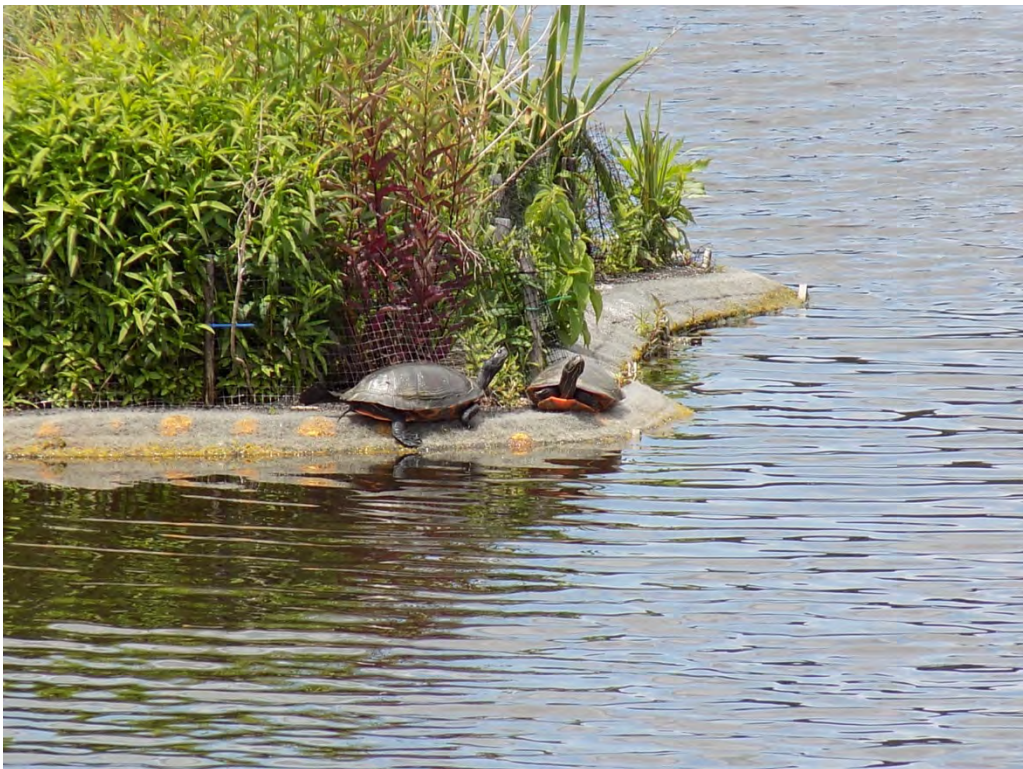
16. View of eastern redbelly turtles basking on floating wetlands in Marsh Creek (H3) along Little Conestoga Road (June 29, 2015).

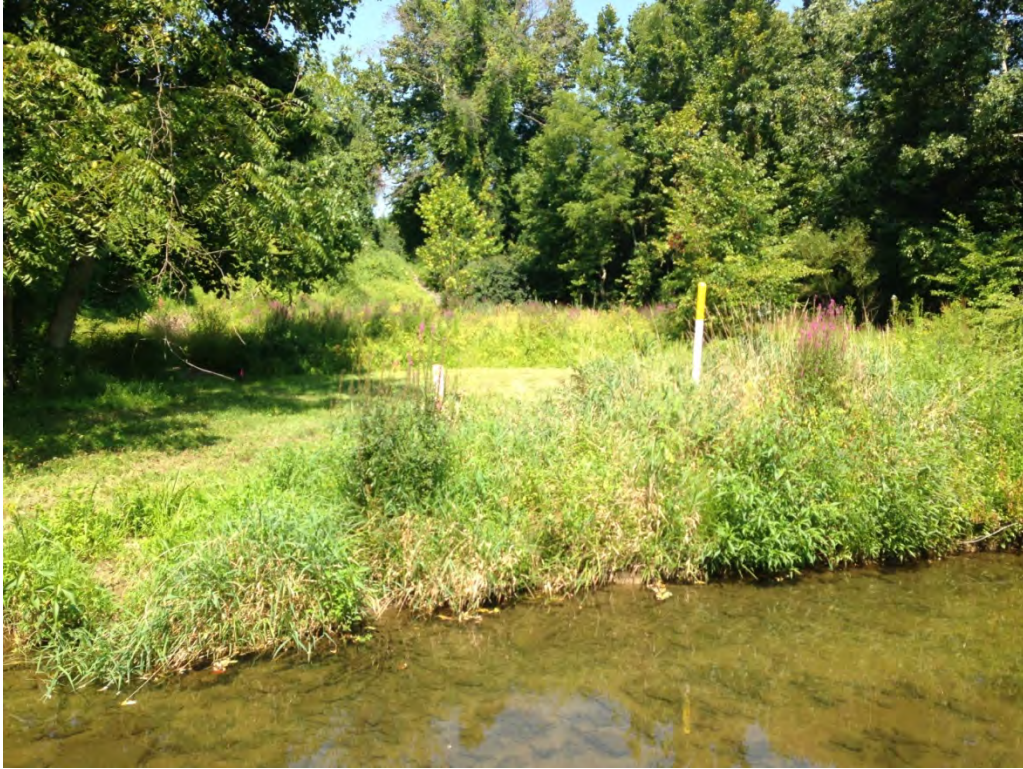
17. View west of a stream channel (S-C73) within the ROW of the pipeline in Parcel PA-CH-0099.0000-WX (August 27, 2015).

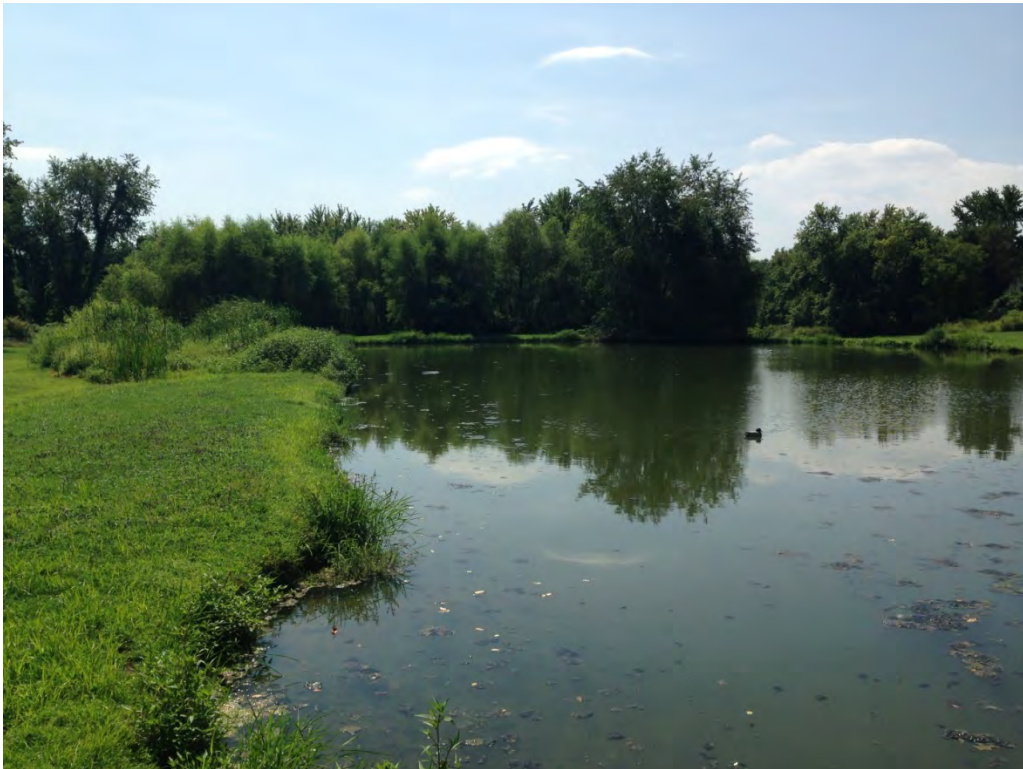
18. View southwest of a pond (Pond H2) within the ROW of the pipeline within Parcel PA-CH-0109.0000. Eastern painted turtles were observed basking within the pond (August 27, 2014).

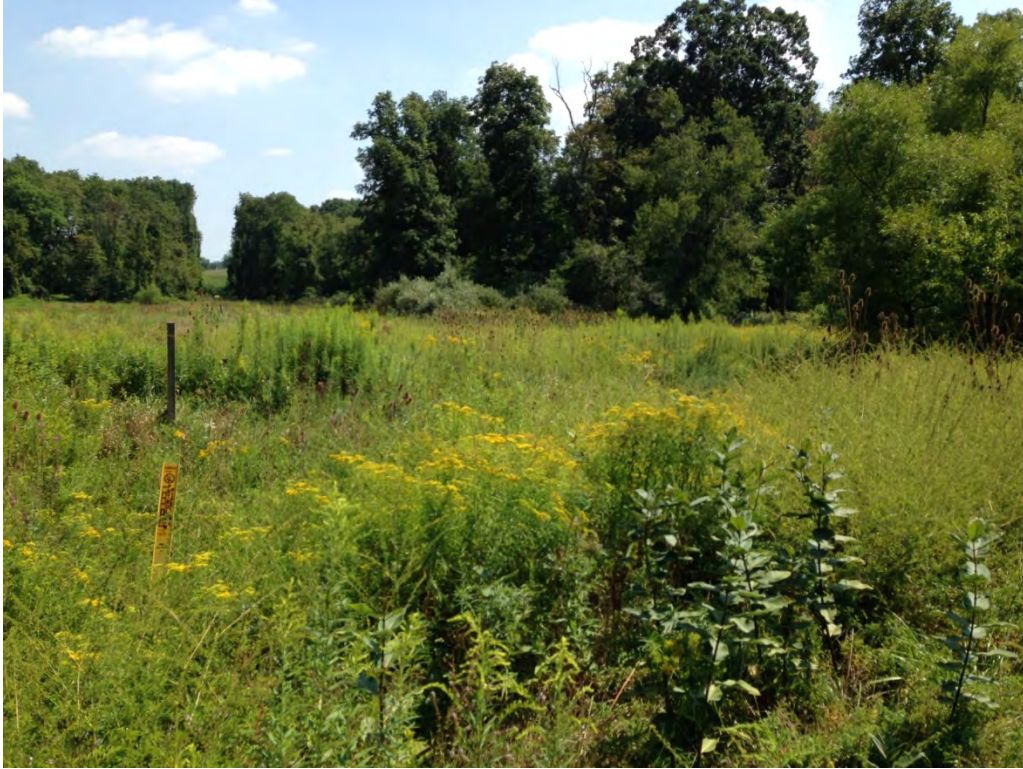
19. View east of a stream channel (S-C96) and emergent wetlands (C47) within the ROW of the pipeline within Parcel PA-CH-0110.0000 (August 27, 2014).

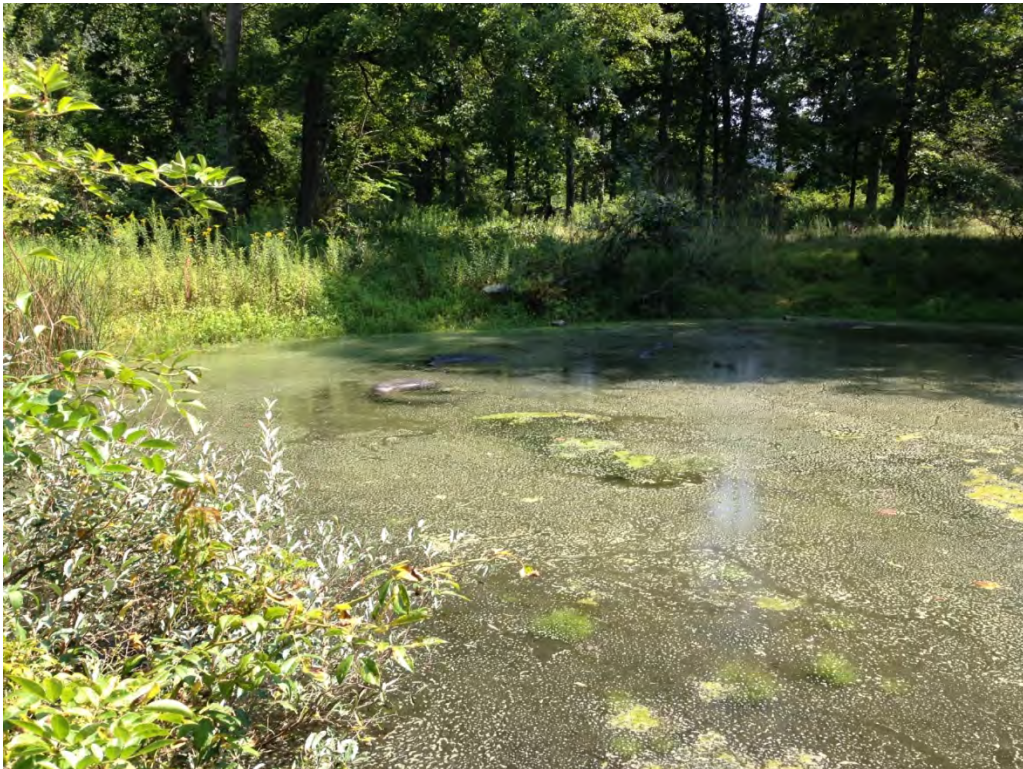
20. View southeast of a vernal pool in wetlands C47 within the ROW of the pipeline within Parcel PA-CH-0110.0000 (August 27, 2014).

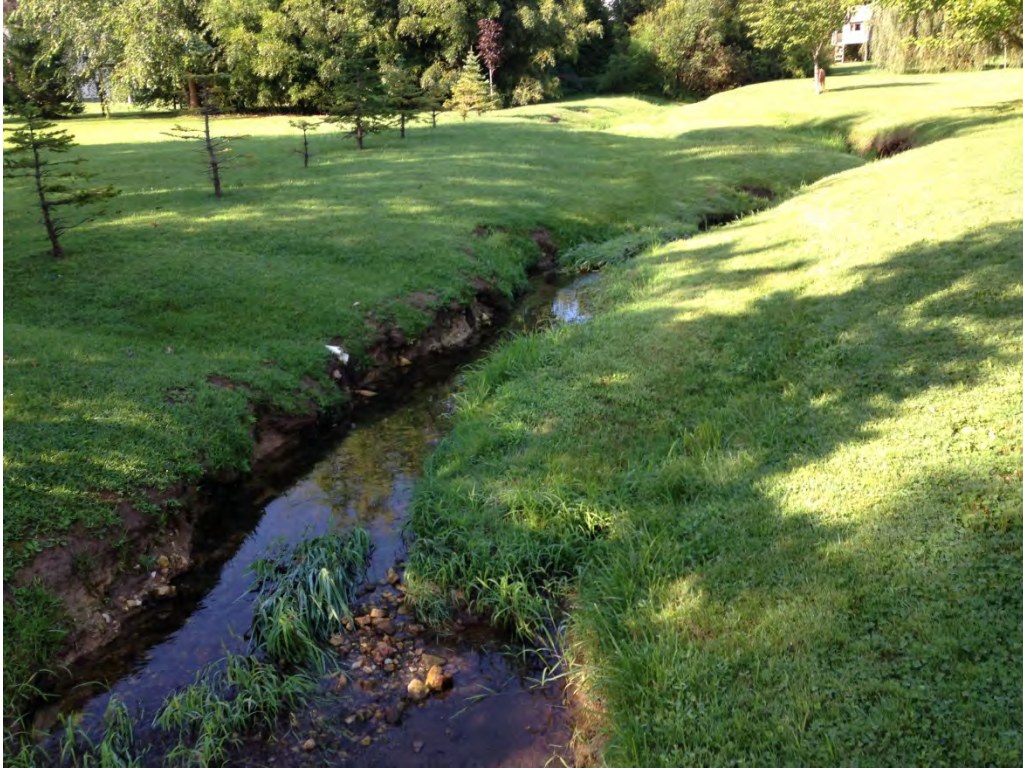
23. View southeast of a small headwaters stream channel (S-C64) and maintained lawn within the ROW of the pipeline within Parcel PA-CH-0157.0000 (September 2, 2014).

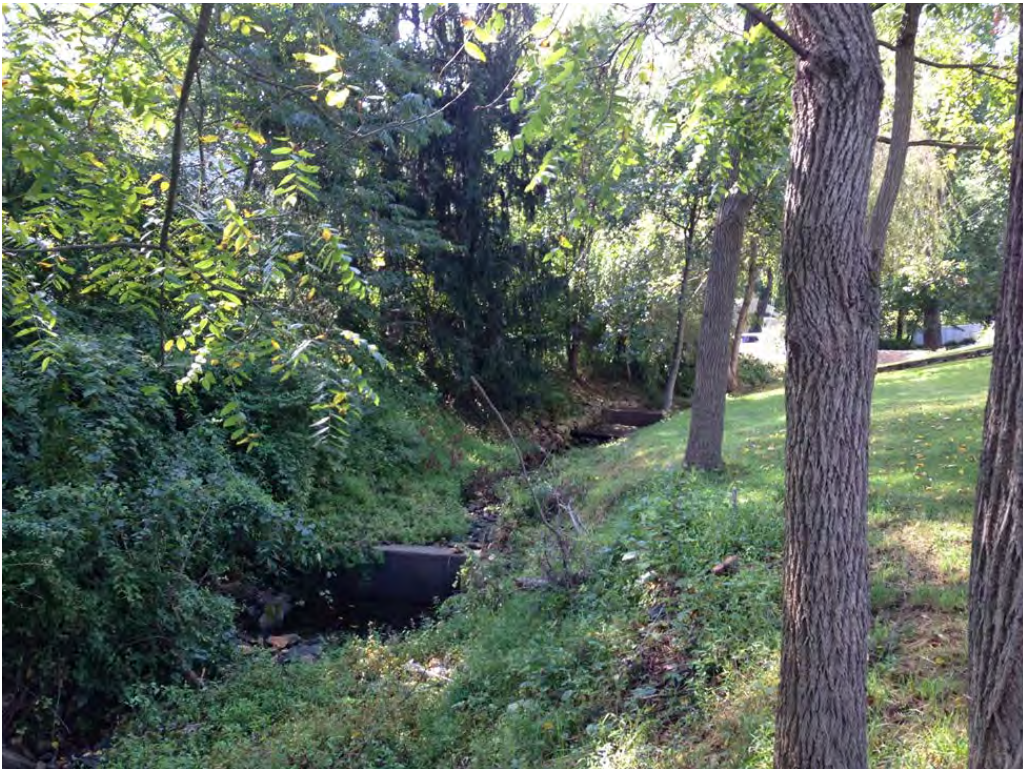
24. View southeast of a historically disturbed small headwaters stream channel (S-C63) within the ROW of the pipeline within Parcel PA-CH-0172.0000-ABTS (September 2, 2014).

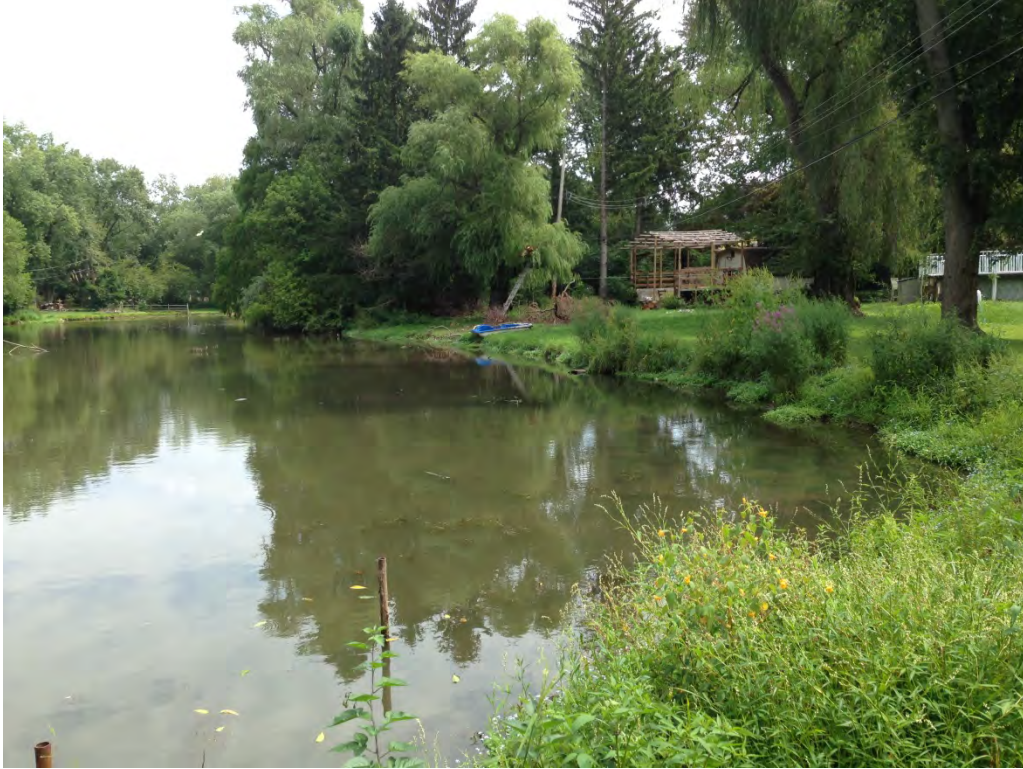
27. View east of a pond (Pond B11) and maintained lawn areas immediately outside the ROW of the pipeline within Parcel PA-CH-0235.0000-WX (September 2, 2014).

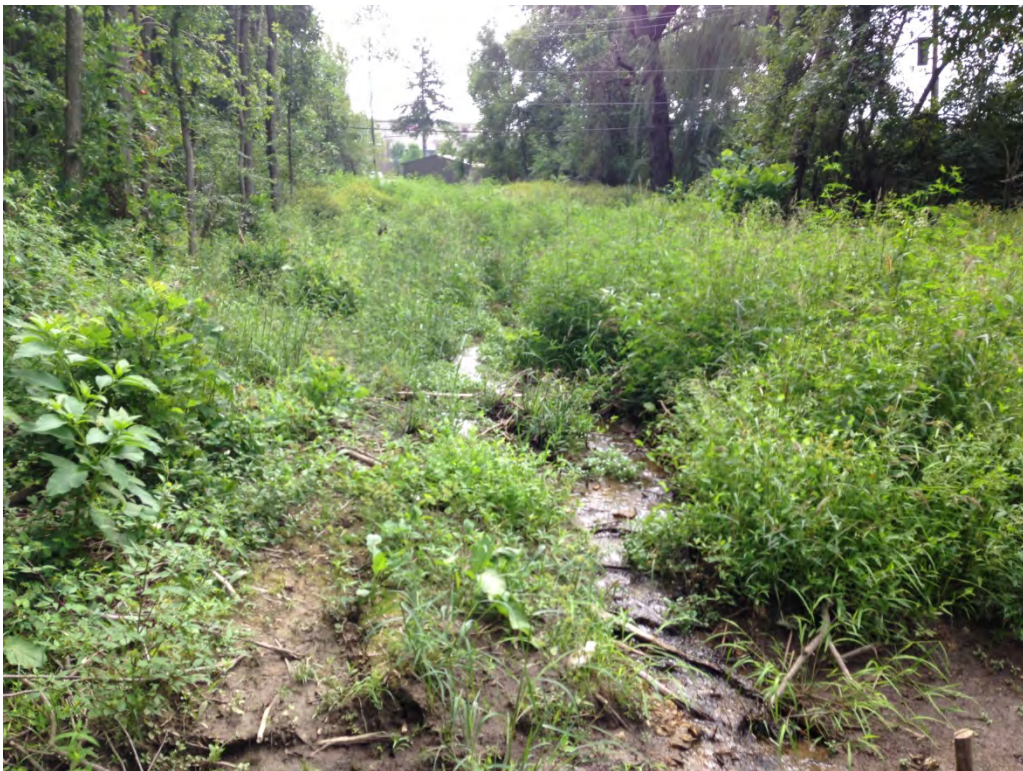
28. View south of a stream channel (S-B79) and emergent wetlands (B71) within the ROW of the pipeline within Parcel PA-CH-0241.0000-ABTW (September 2, 2014).

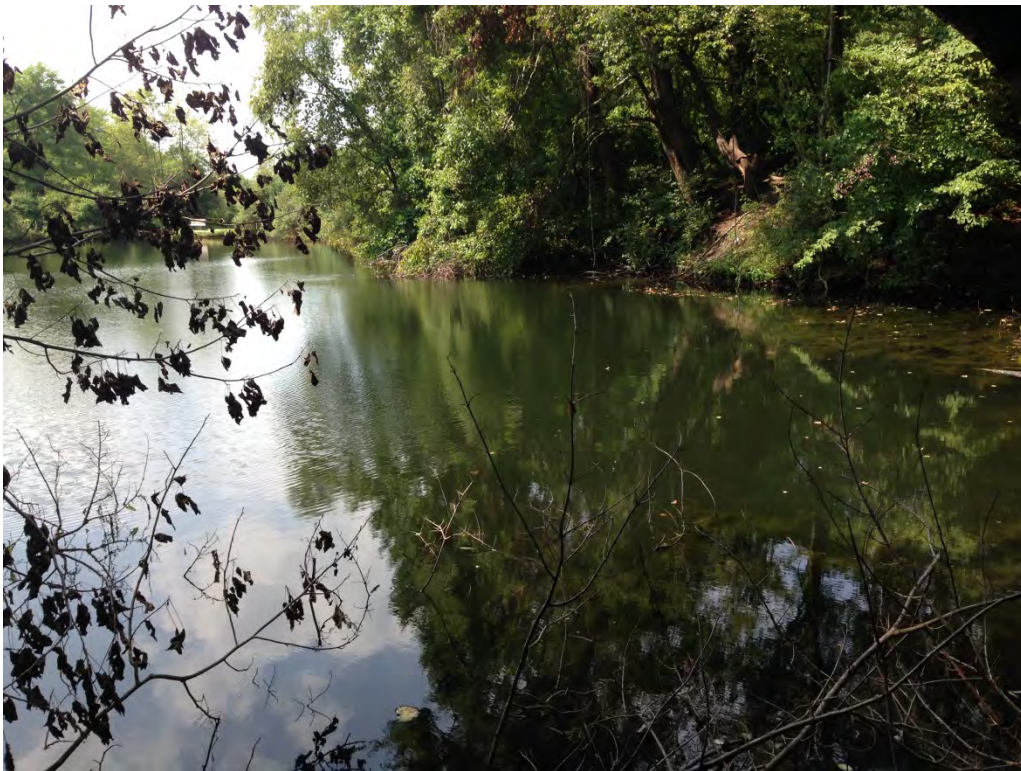
30. View west of Iron Lake (Pond B10) immediately outside the ROW of the pipeline within Parcel PA-CH-0247.0000 (September 2, 2014).

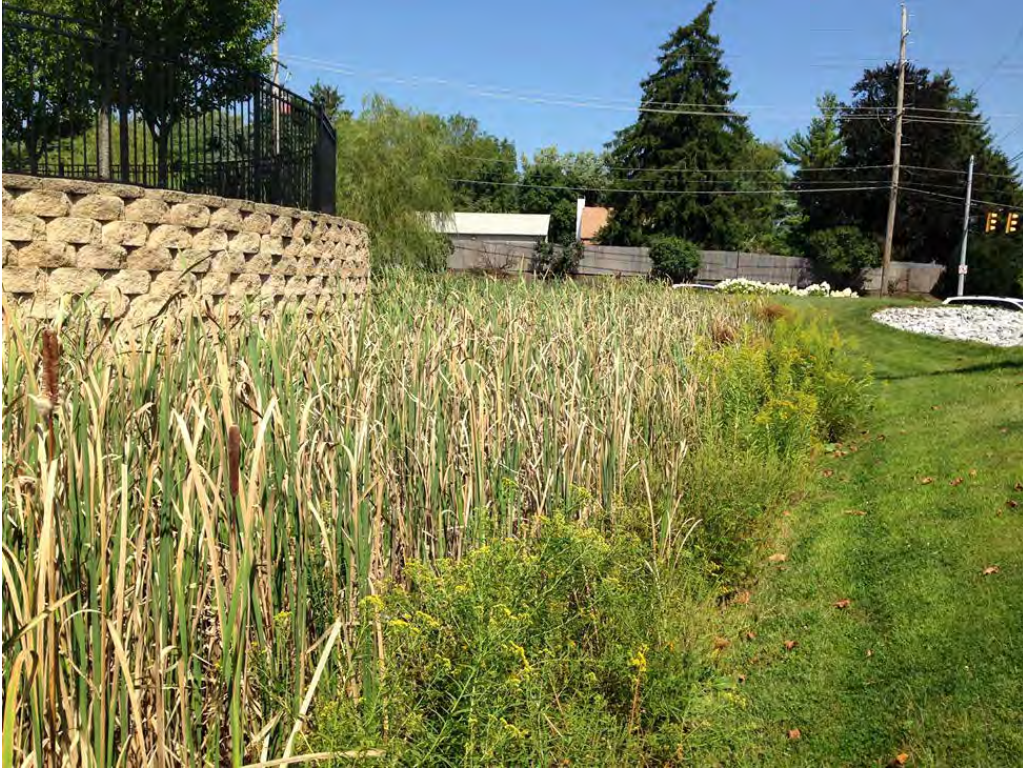
33. View east of emergent wetlands (H30) in a stormwater management basin within the ROW of the pipeline within Parcel PA-CH-0417.0000-RD (September 4, 2014).

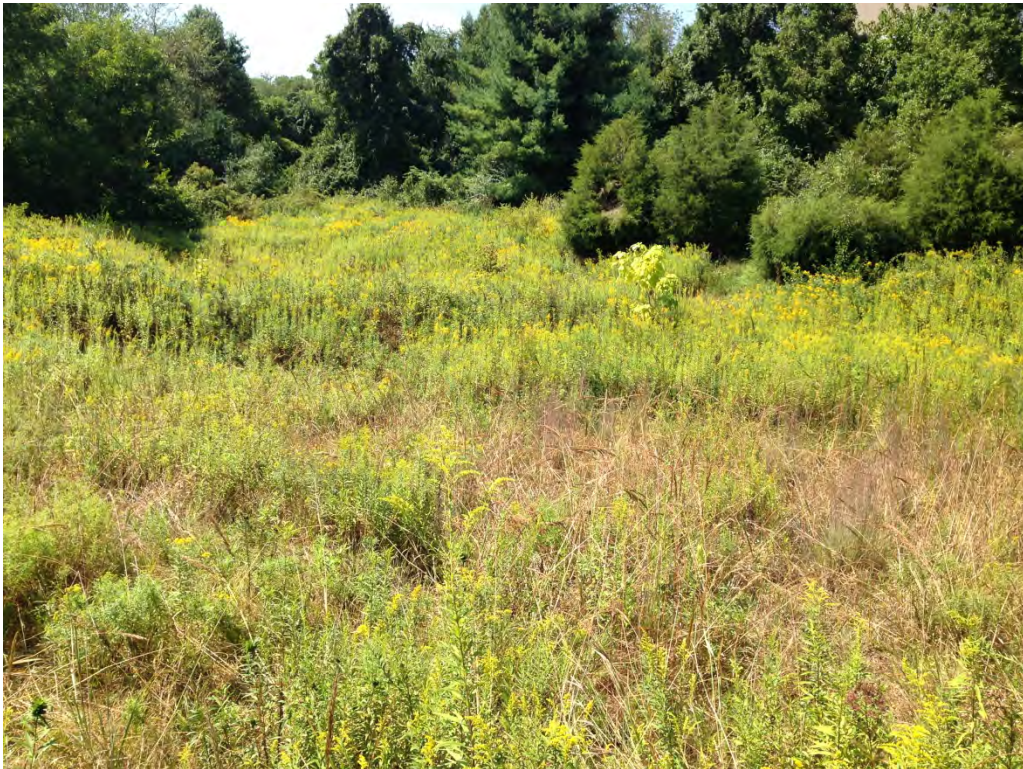
34. View east of emergent wetlands (B35) in a stormwater management basin within the ROW of the pipeline within Parcel PA-CH-0422.0000 (September 4, 2014).

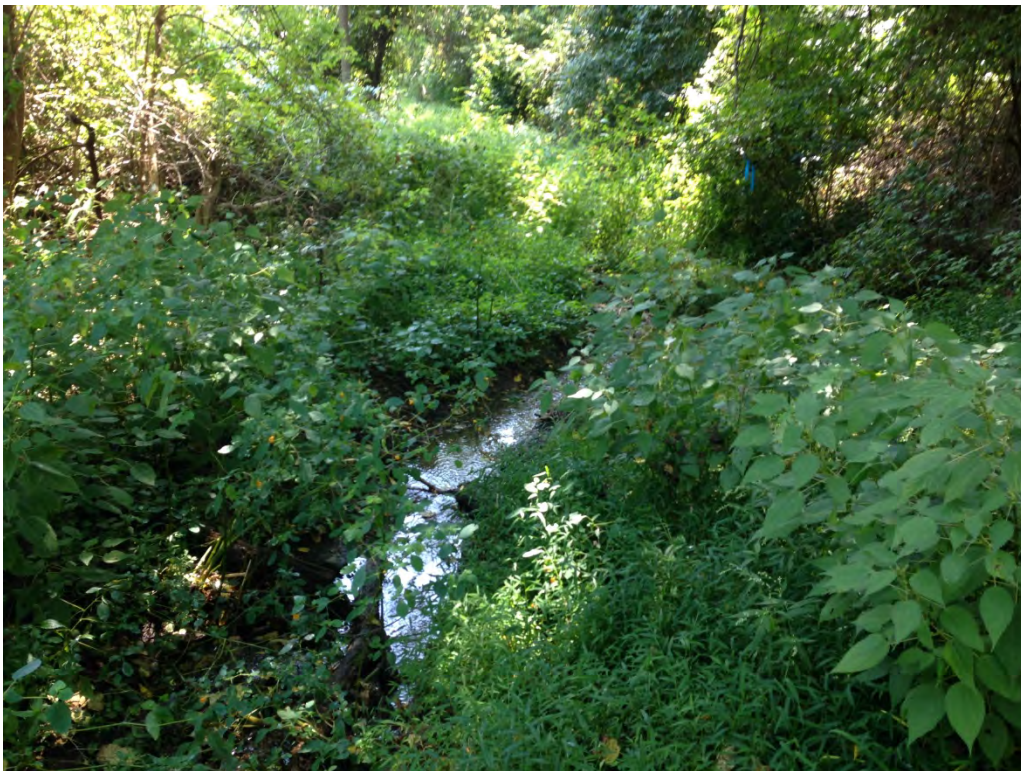
36. View south of a small stream channel (S-B34) and wetlands (B36) within the ROW of the pipeline within Parcel PA-CH-0458.0000-RD (September 4, 2014).
