**Subject: PFBC SIR # 41856
Request for a No Impact Determination for Mussel Species, Fish Species,
and Eastern Red Belly Turtle
Sunoco Pipeline, L.P. - Pennsylvania Pipeline Project (Previously Part of
the Mariner East 2 Pipeline Project)**

Pennsylvania Pipeline Project Map

FIGURES

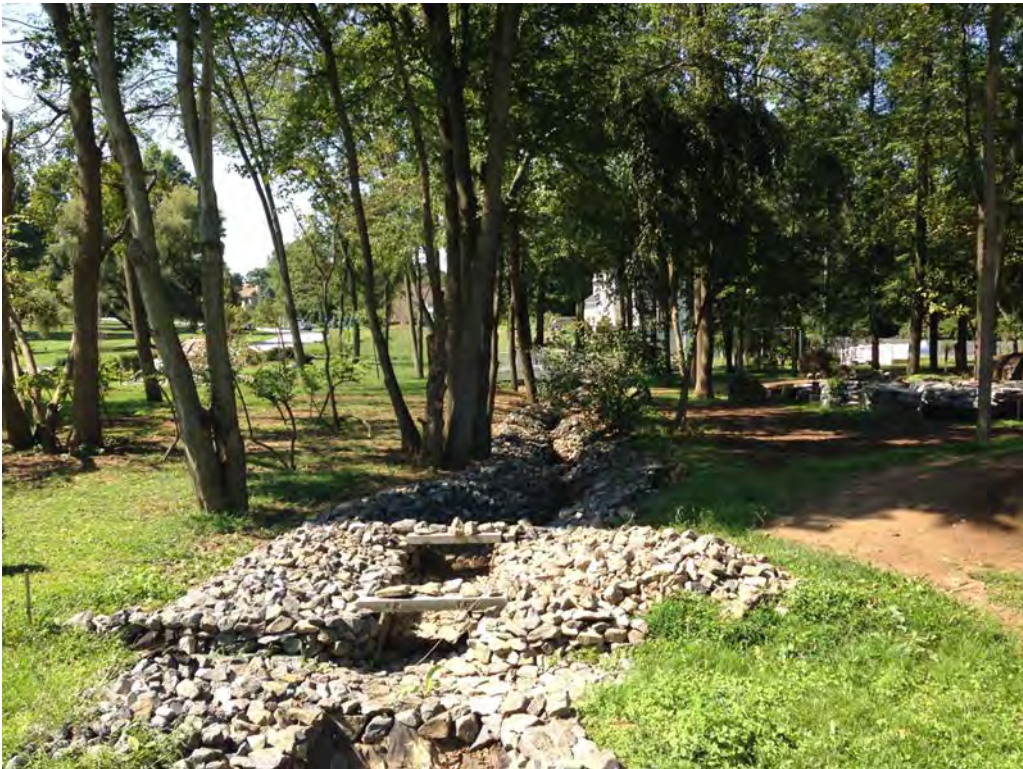
38. View west of a rip-rap channel (S-B34) within the ROW of the pipeline within Parcel PA-DE-0008.0000 (September 4, 2014).

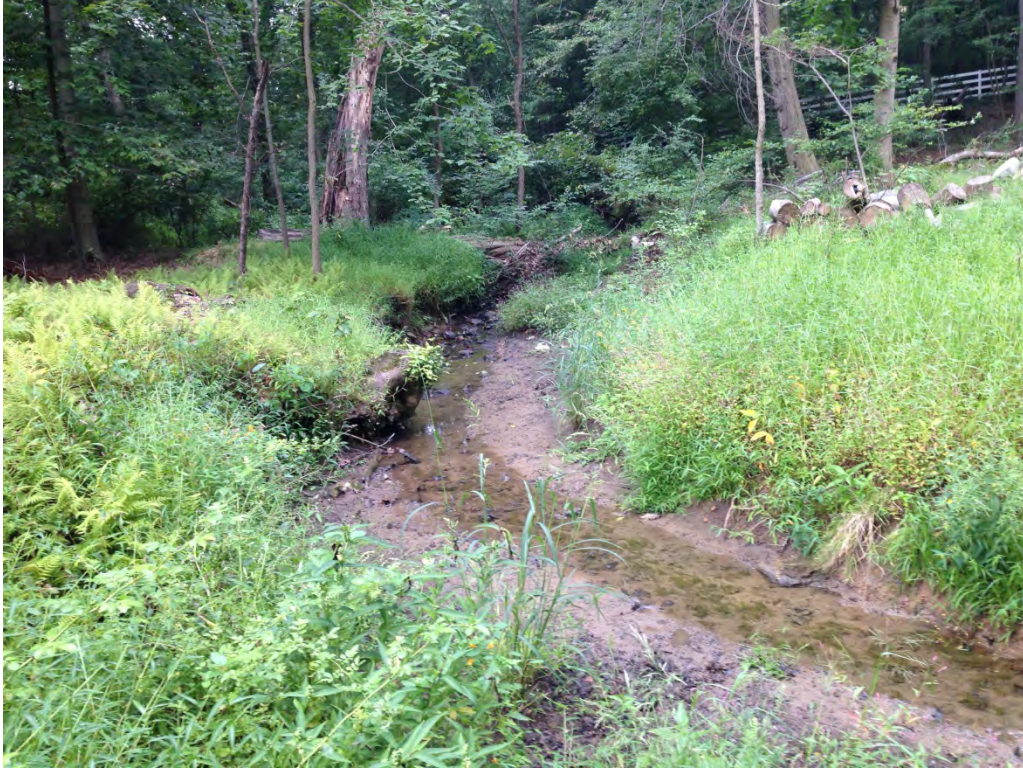
39. View south of a small stream channel (S-B37) within the ROW of the pipeline within Parcel PA-DE-0015.0000-RD (September 5, 2014).

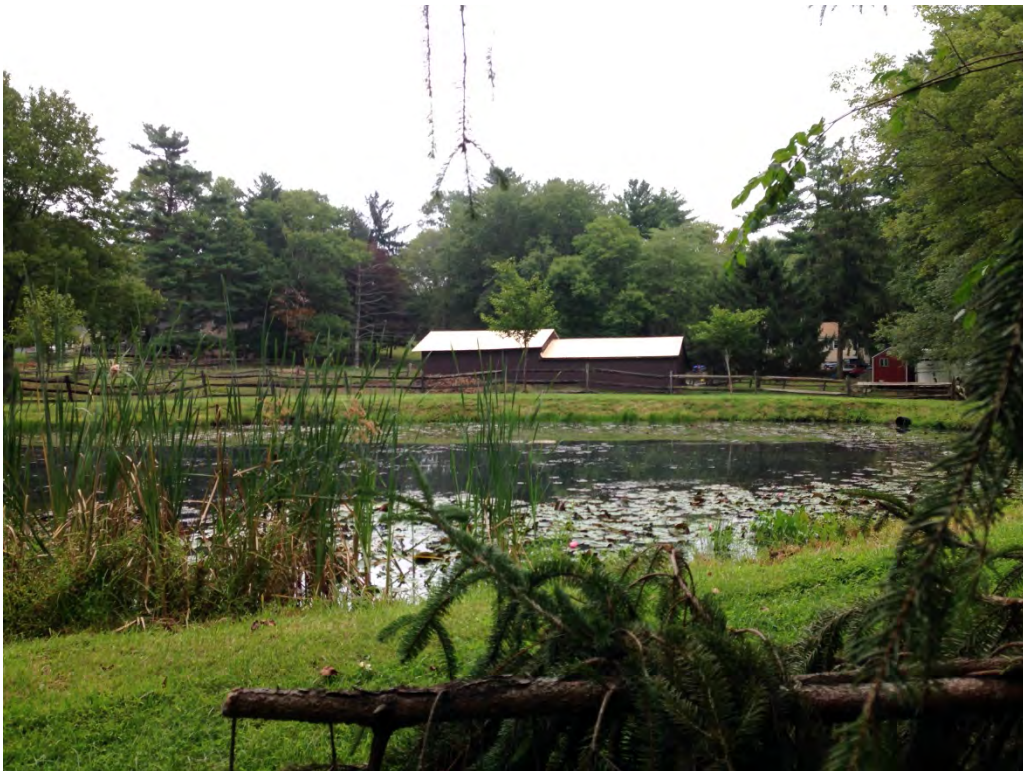
40. View of a pond (Pond XX10) approximately 150 feet outside the ROW of the pipeline within Parcel PA-DE-0017.0000-ABTN (September 5, 2014).

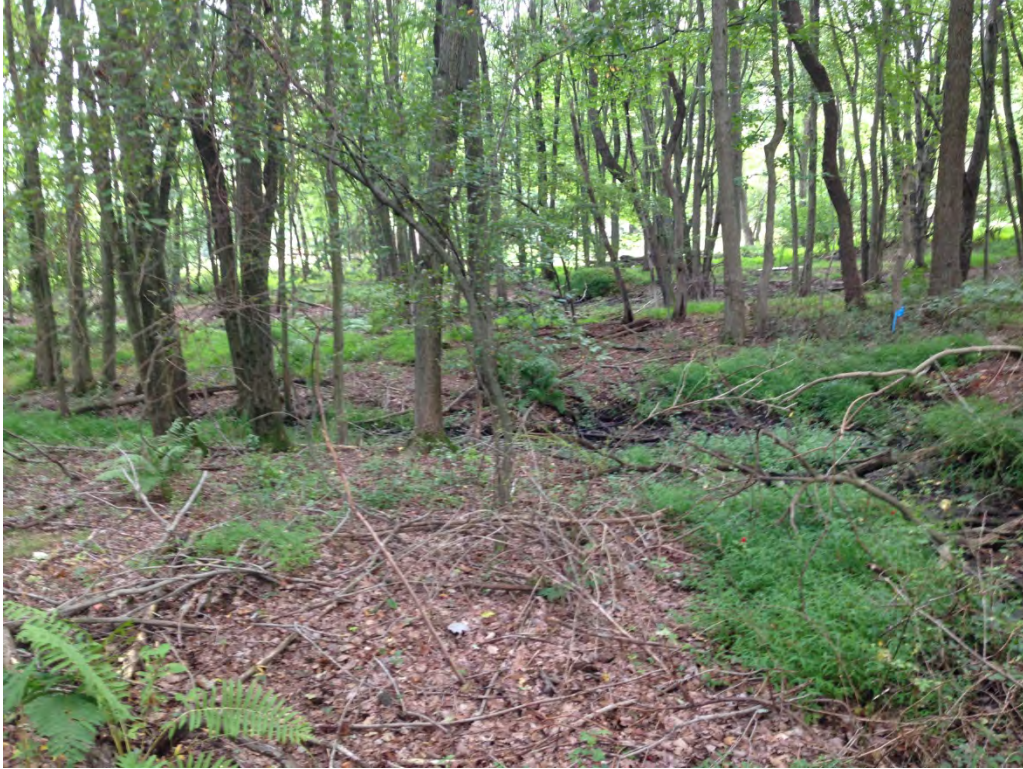
41. View south of a small headwater stream channel (S-B58) and wetlands (B53) within the ROW of the pipeline within Parcel PA-DE-0032.0000 (September 5, 2014).

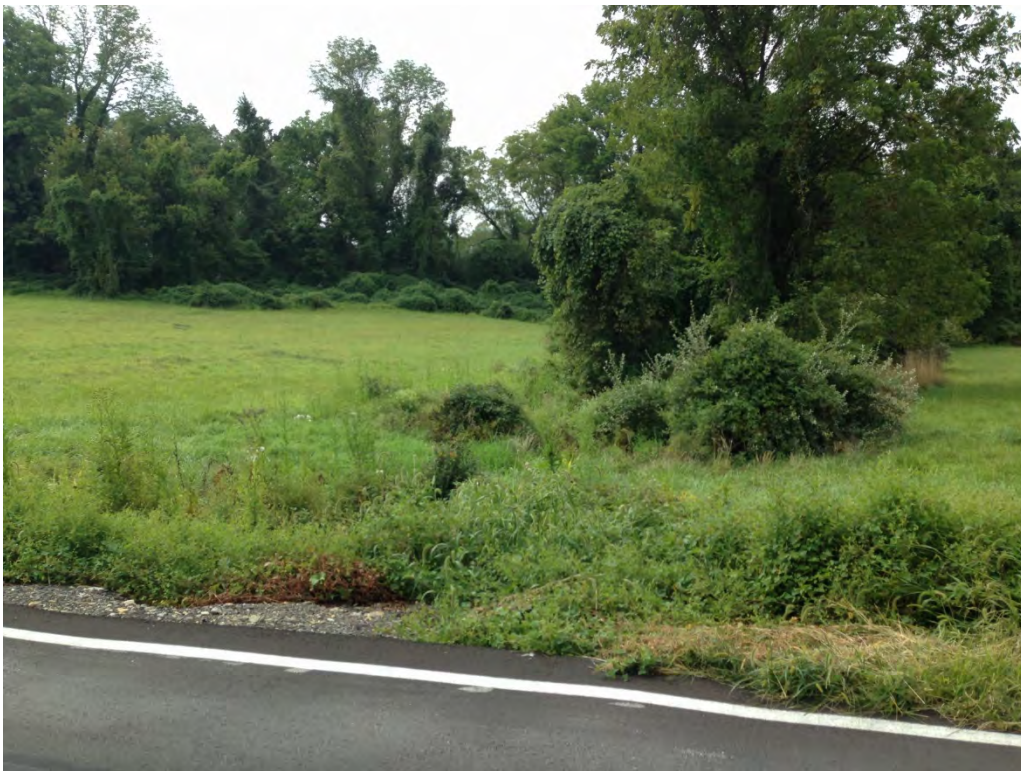
42. View west of a small headwater stream channel (S-C43) within the ROW of the pipeline within Parcel PA-DE-0043.0000 (September 5, 2014).

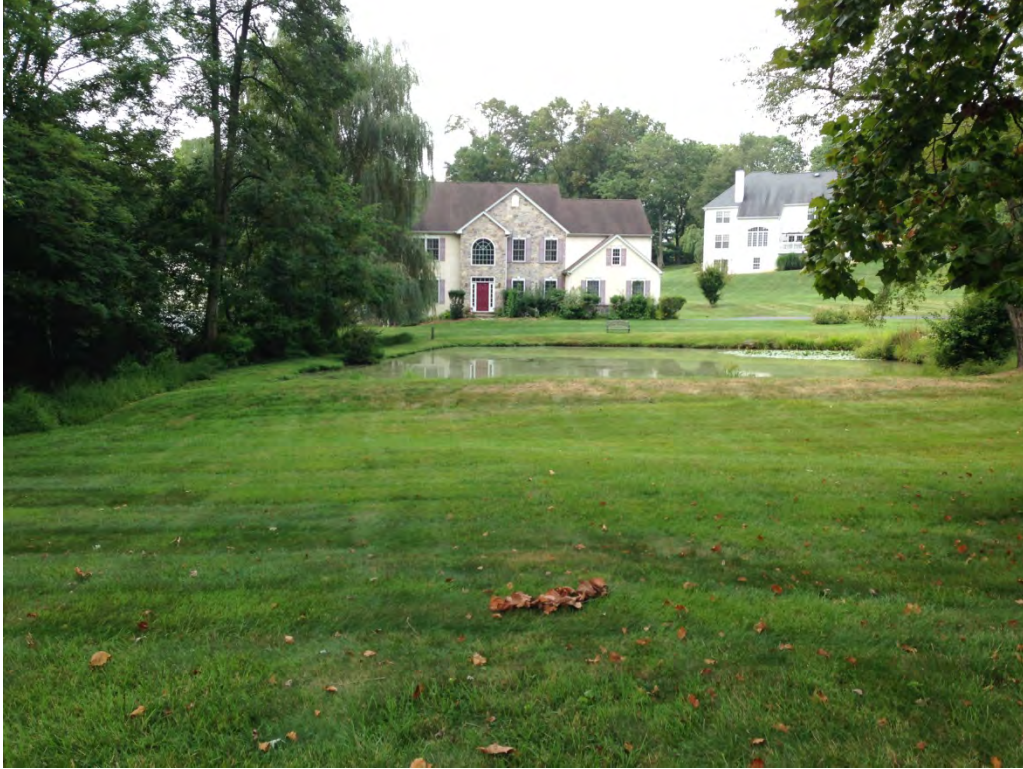
43. View of a pond (Pond XX10) approximately 150 feet outside the ROW of the pipeline within Parcel PA-DE-0017.0000-ABTN (September 5, 2014).

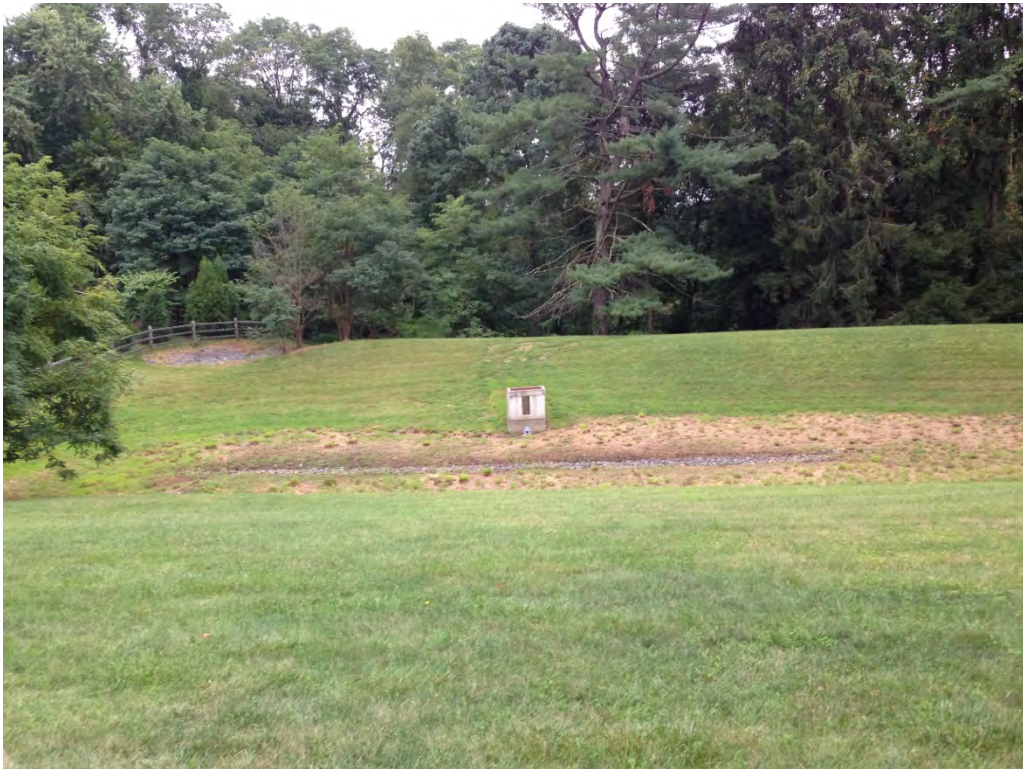
44. View east of emergent wetlands (C20) in a stormwater management basin within the ROW of the pipeline within Parcel PA-DE-0059.0000 (September 9, 2014).

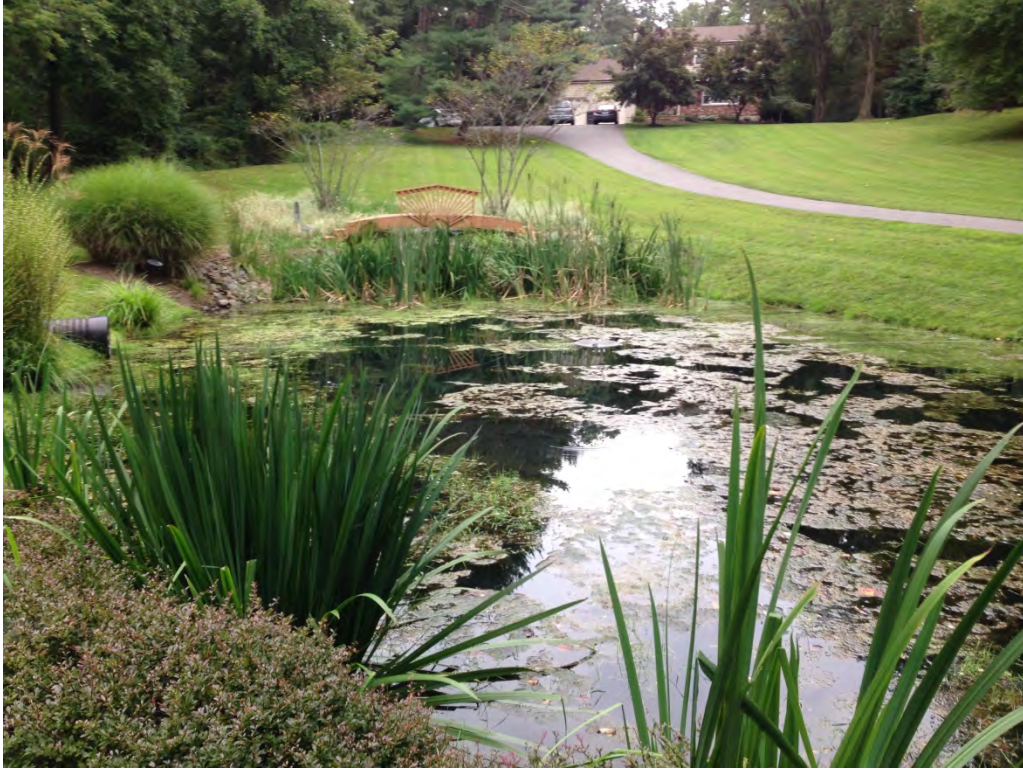
45. View of a small ornamental pond (Pond C6) within the ROW of the pipeline within Parcel PA-DE-0063.0000 (September 9, 2014).

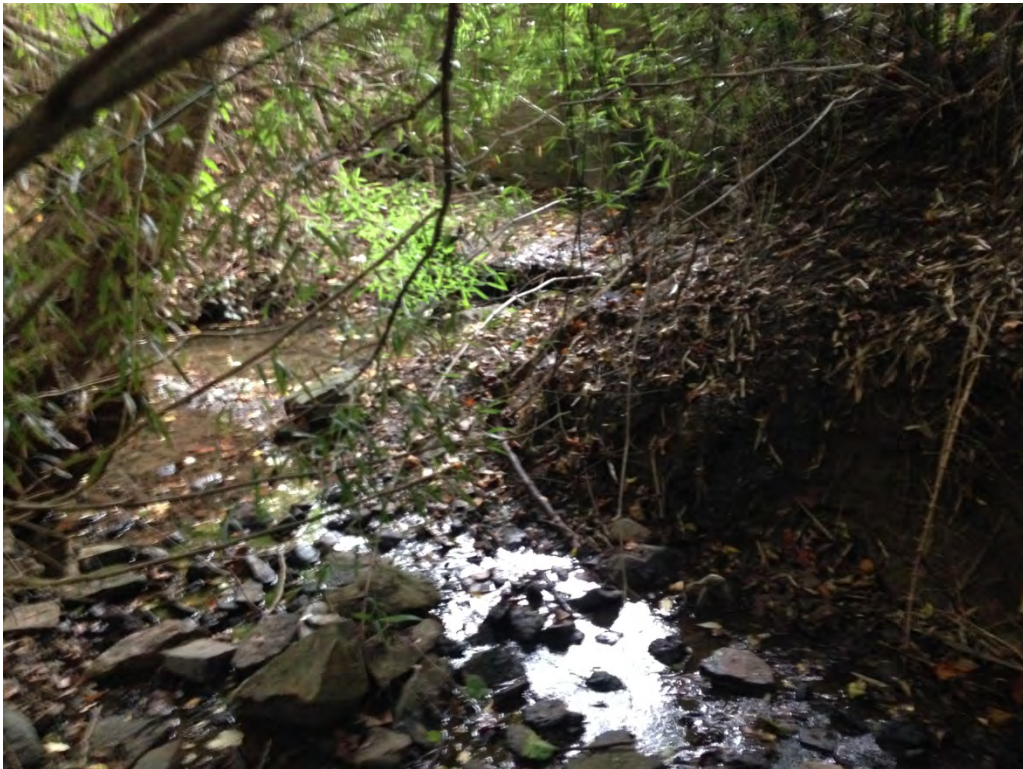
46. View west of a small headwater stream channel (S-C40) that drains Pond C6 within the ROW of the pipeline within Parcel PA-DE-0061.0000-ABTS (September 9, 2014).

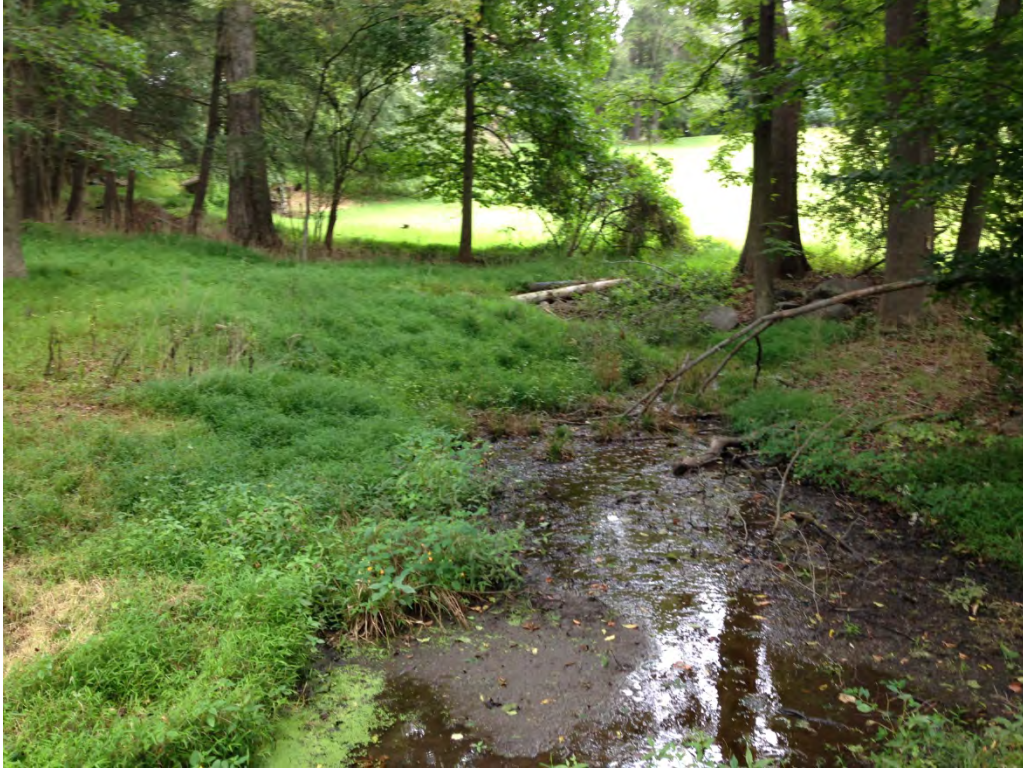
47. View south of a small headwater stream channel (S-C45) and Wetland BA1 within the ROW of the pipeline within Parcel PA-DE-0069.0000 (September 9, 2014).

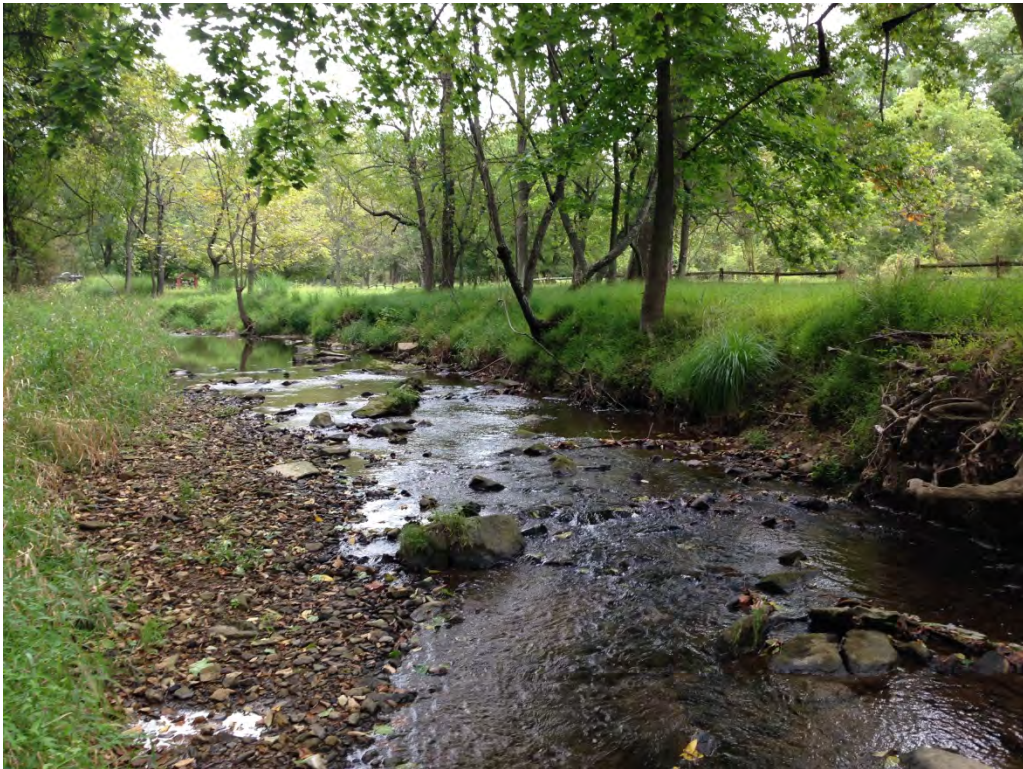
48. View east of a stream channel (S-C44) and Wetland C23 within the ROW of the pipeline within Parcel PA-DE-0069.0000 (September 9, 2014).

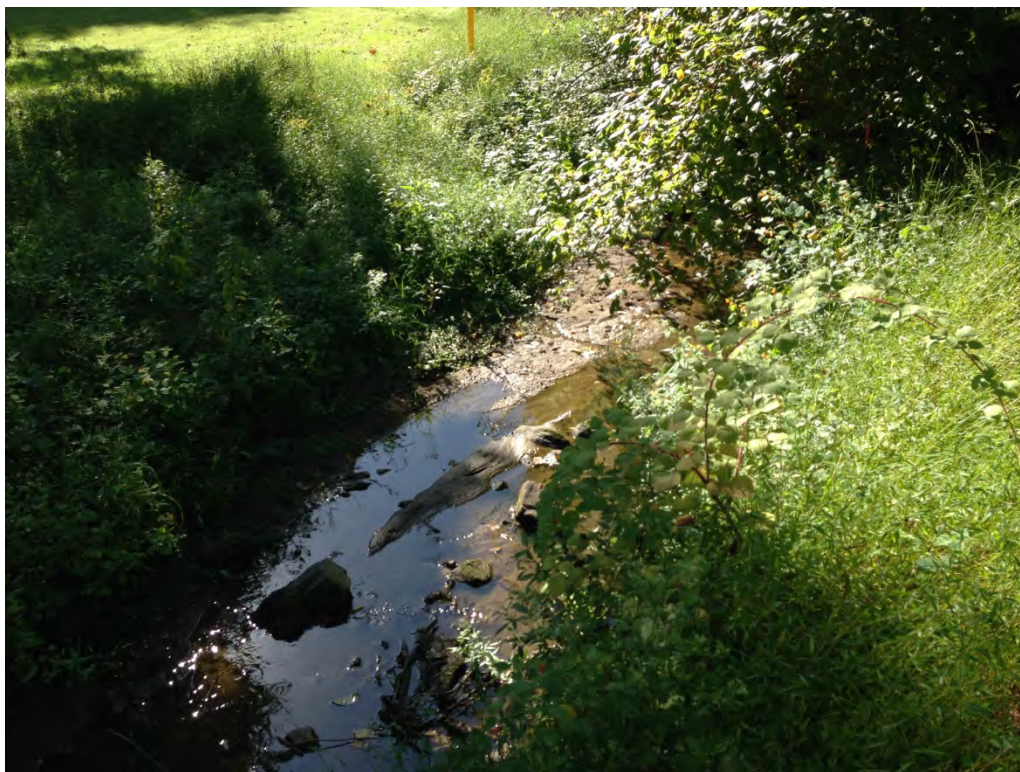
51. View east of a small stream channel (S-I2) within the ROW of the pipeline within Parcel PA-DE-0104.0000-WX (September 10, 2014).

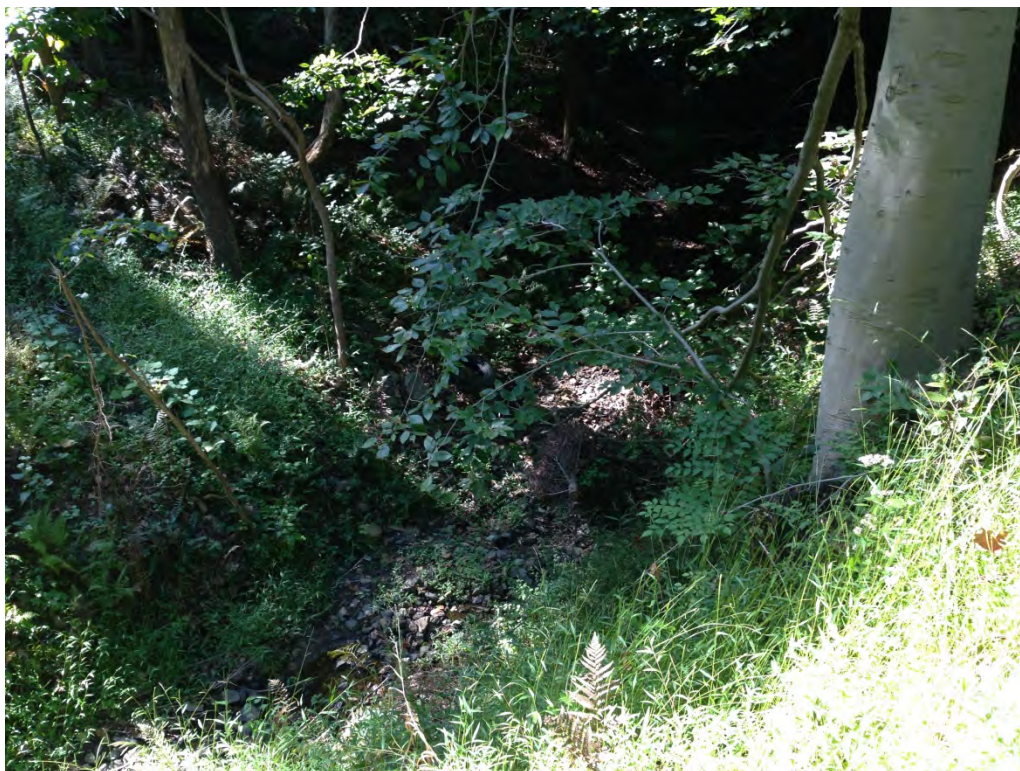
52. View east of a small stream channel (S-I5) within the ROW of the pipeline within Parcel PA-DE-0103.0002-WX (September 10, 2014).

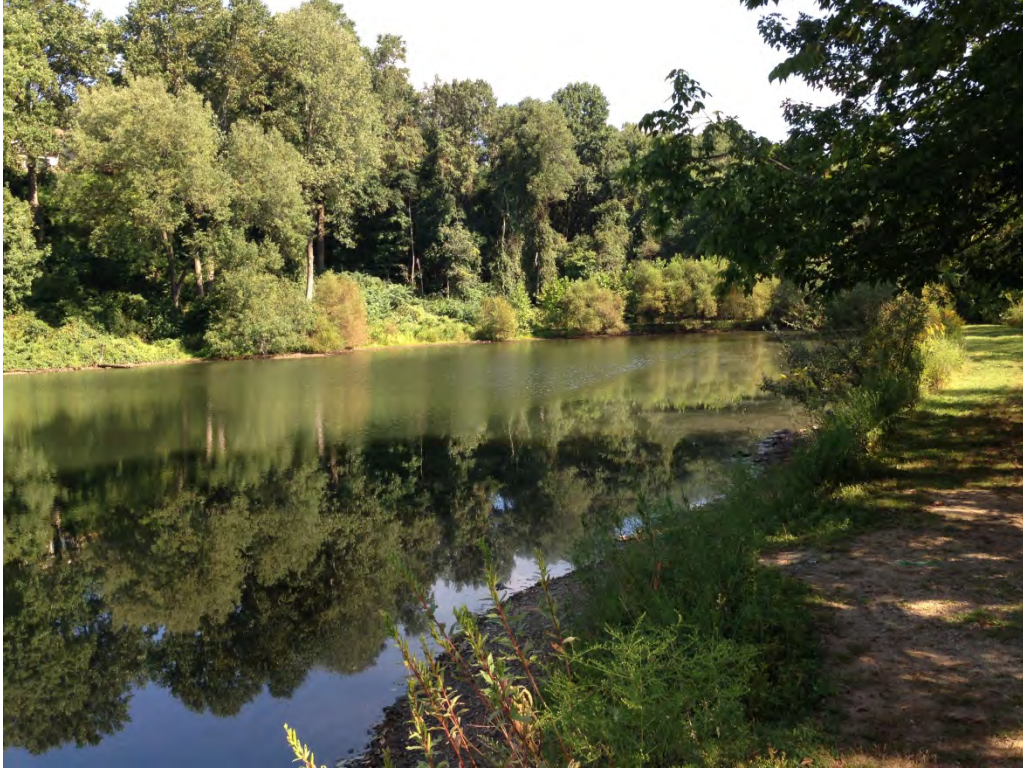
53. View of pond and maintained lawn (potential nesting habitat) approximately 175 feet outside the ROW of the pipeline within Parcel PA-DE-0104.0001 (September 10, 2014).

- On September 10, 2014, multiple (2-3) eastern redbelly turtles were observed basking on a log along the banks of a pond within parcel PA-DE-0104.0001 located in Middletown Township, Delaware County. In addition to the eastern redbelly turtles, a red-eared slider (*Trachemys scripta elegans*), and eastern painted turtles (*Chrysemys picta picta*) were observed basking on multiple logs throughout the pond. The pond is located approximately 175 feet outside the right of way and contains suitable nesting habitat along the edges of the pond berm.

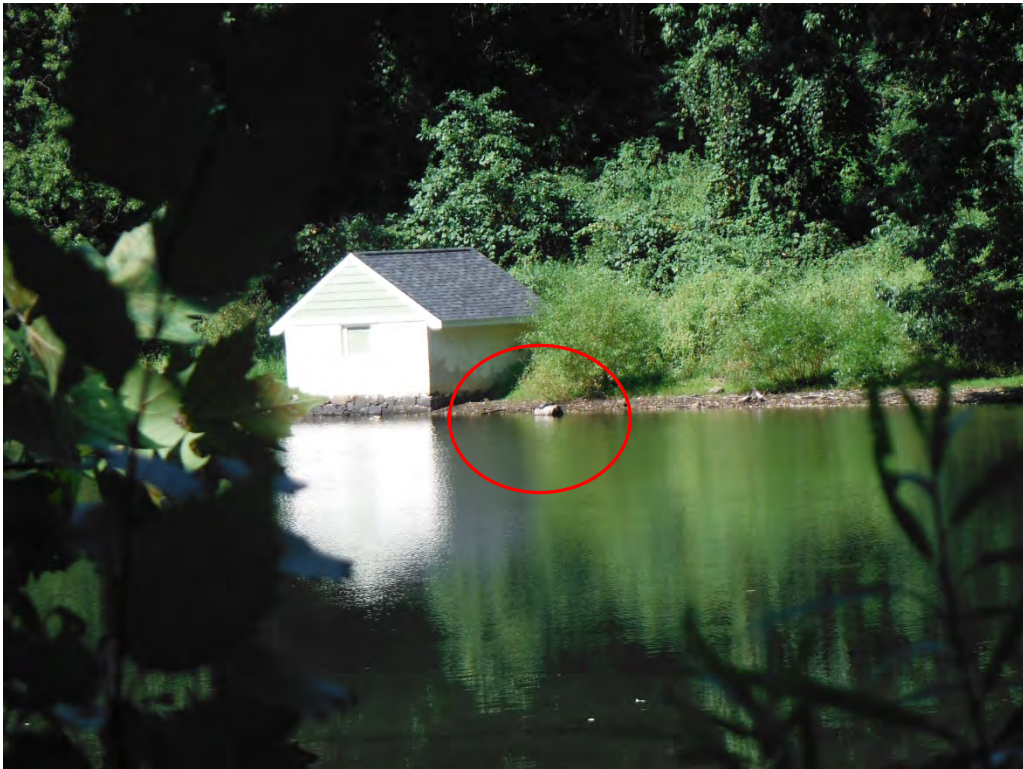
54. View of pond and basking RBT approximately 175 feet outside the ROW of the pipeline within Parcel PA-DE-0104.0001 (September 10, 2014).

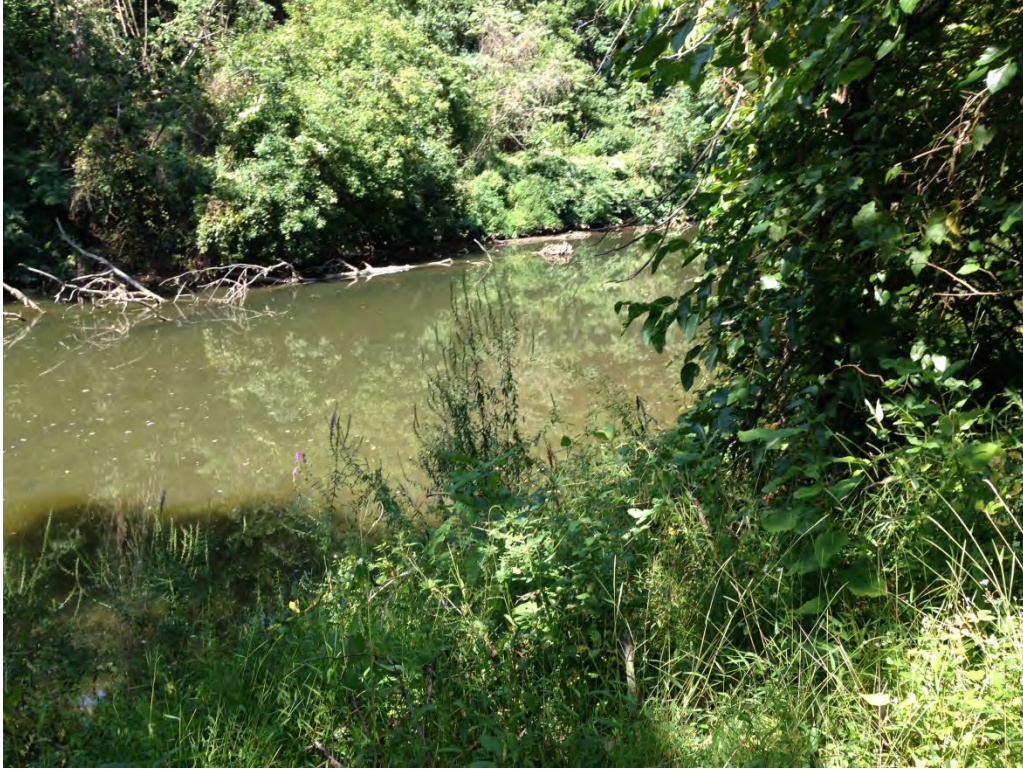
61. View west of Chester Creek (S-H47) immediately upstream of the dam within Parcel PA-DE-0104.0009. Chester Creek is known to contain RBTs (September 10, 2014).

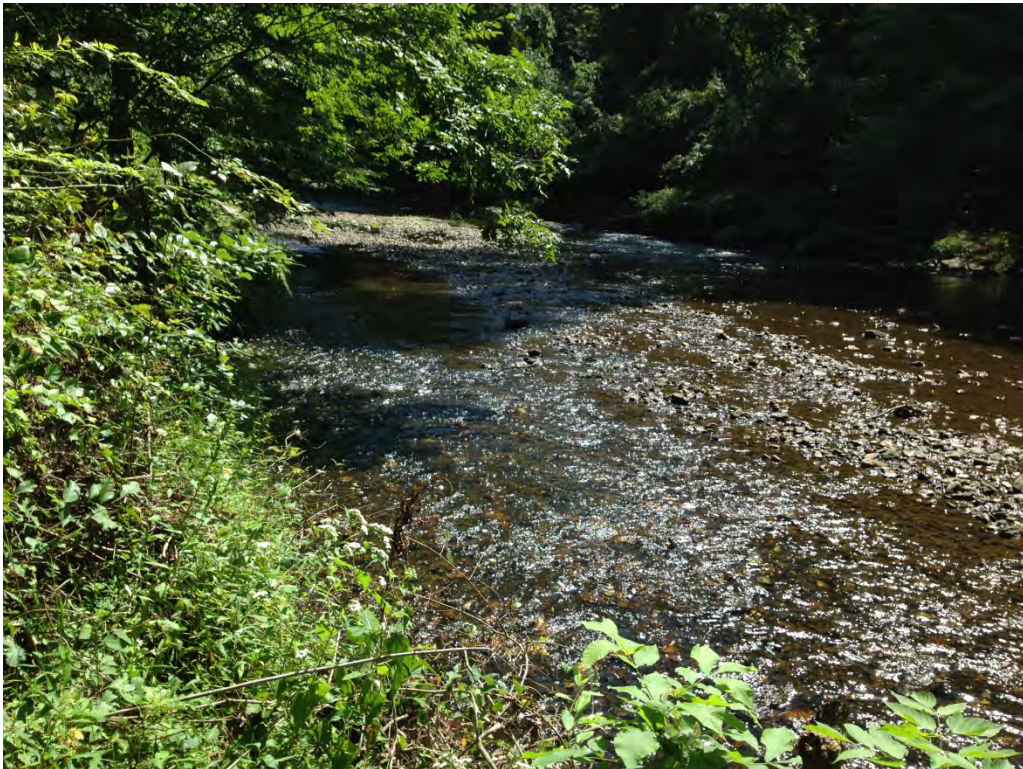
62. View southwest of Chester Creek (S-H47) immediately downstream of the dam within Parcel PA-DE-0104.0009. Chester Creek is known to contain RBTs (September 10, 2014).

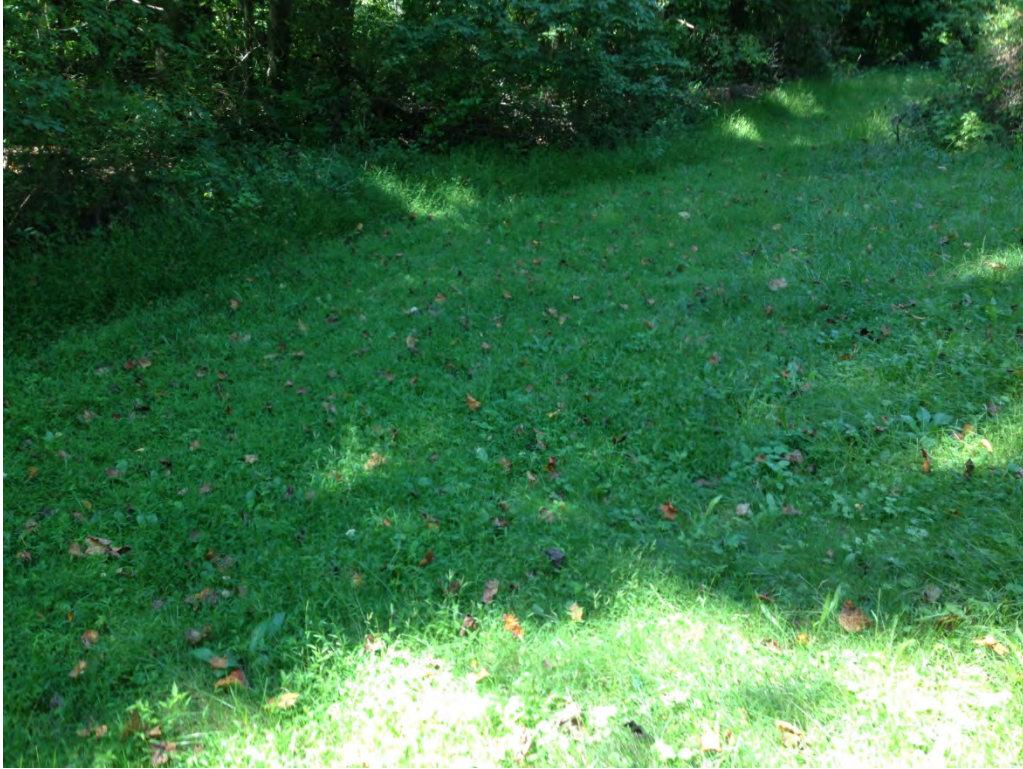
63. View of maintained lawn (potential nesting habitat) adjacent to Chester Creek within the ROW of the pipeline within Parcel PA-DE-0104.0008-RD (September 10, 2014).

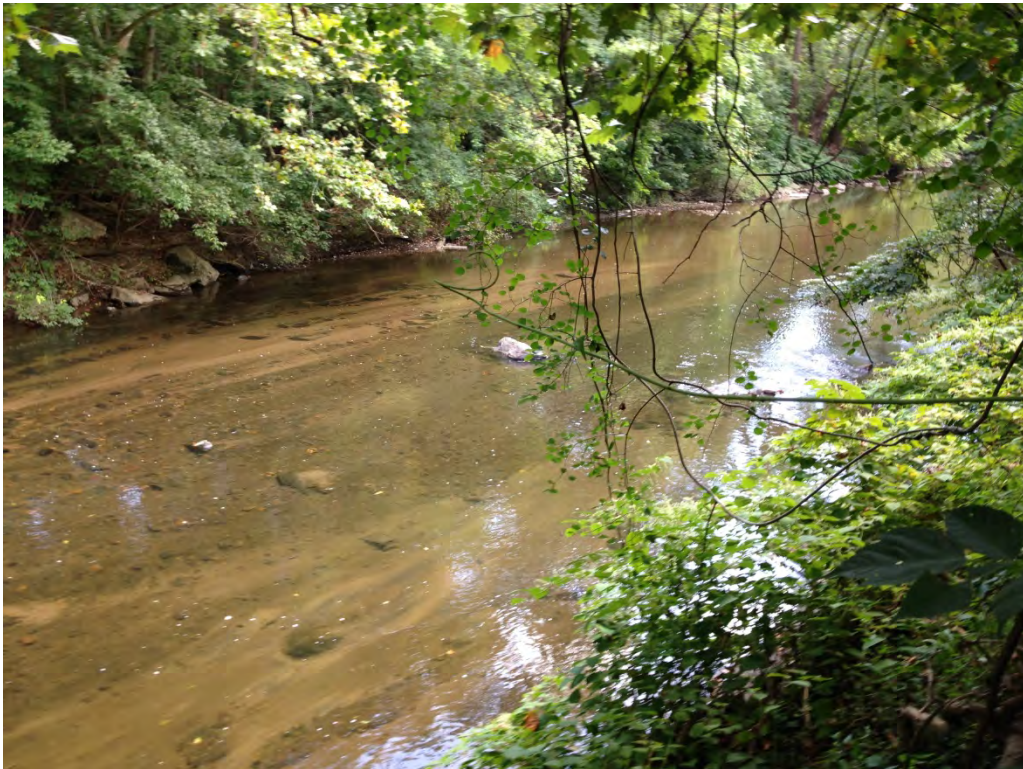
64. View northeast of Chester Creek (S-H41) within the ROW of the pipeline within Parcel PA-DE-0104.0012. (September 10, 2014).

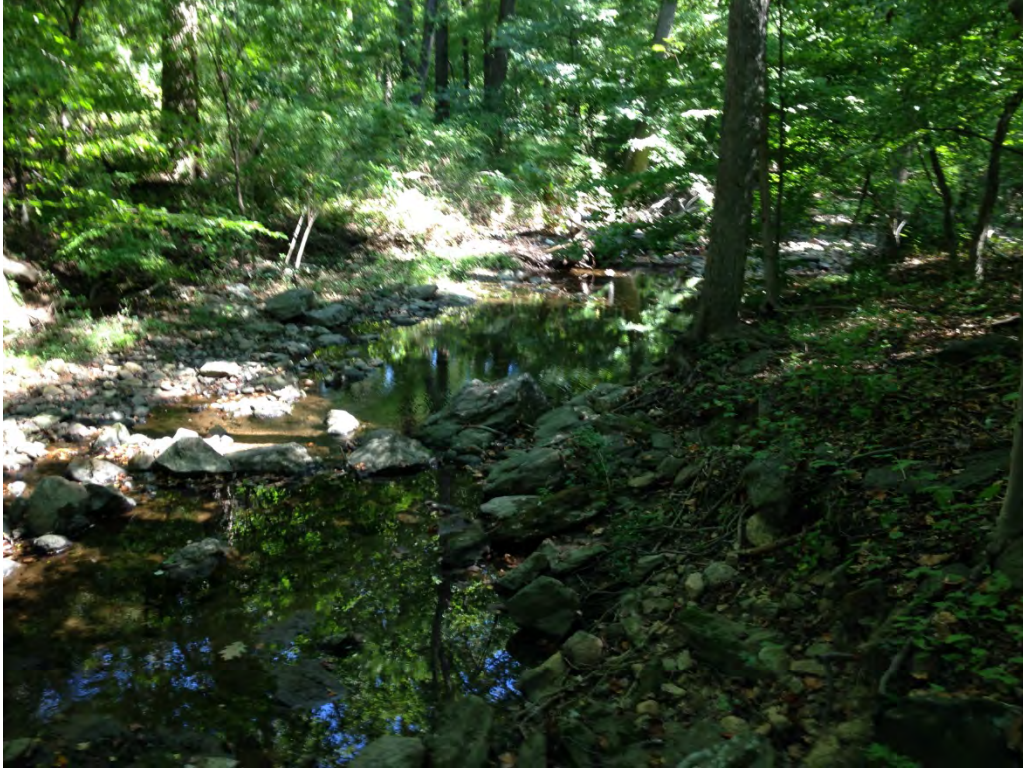
65. View east of a small rocky bottom stream channel (S-H43) within the ROW of the pipeline within Parcel PA- DE-0104.0016 (September 12, 2014).

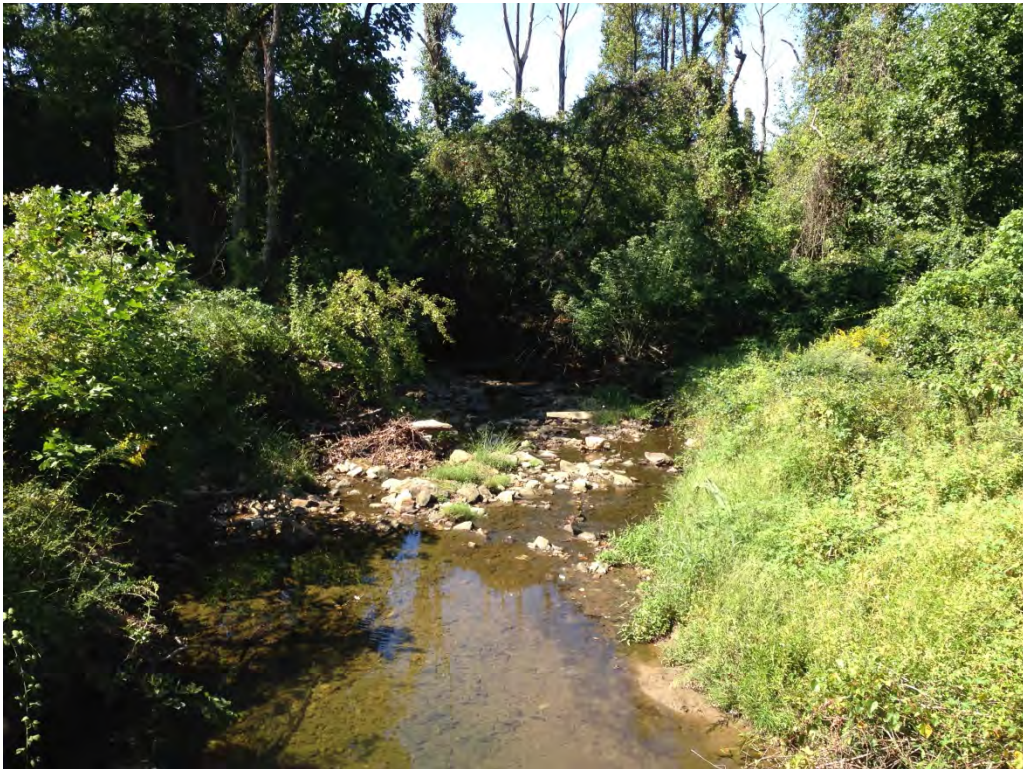
66. View east of a small rocky bottom stream channel (S-H43) within the ROW of the pipeline within Parcel PA- DE-0104.0016 (September 12, 2014).

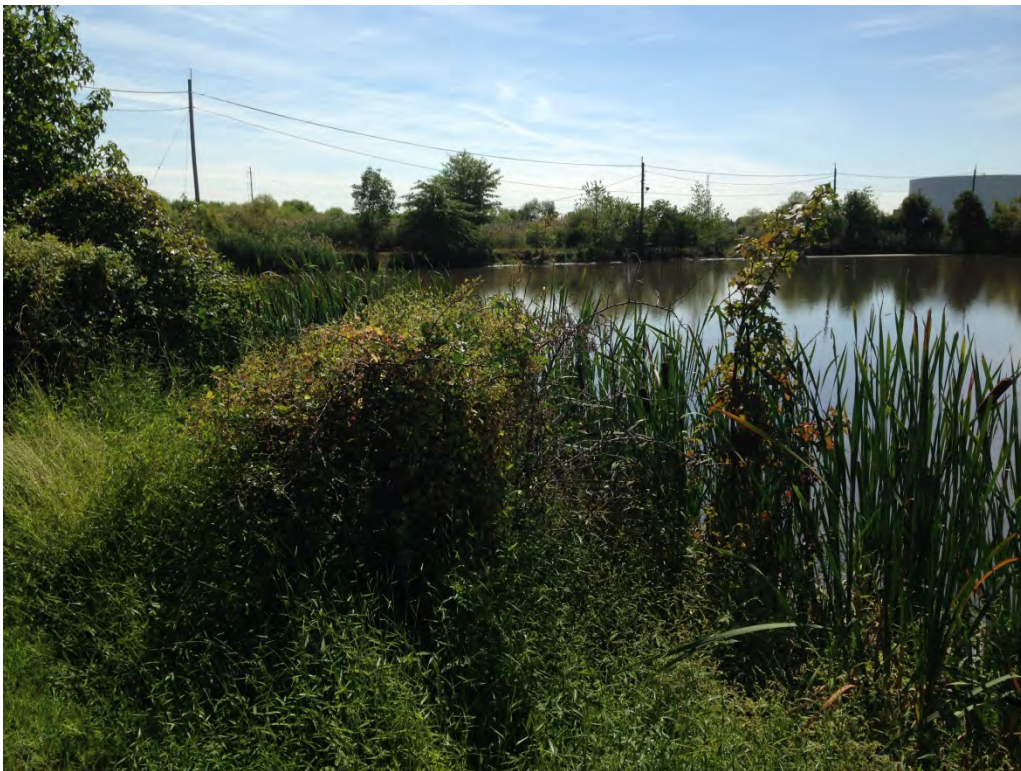
70. View west of Pond I1 (within containment berm) within the ROW of the pipeline within Parcel PA- DE-0150.0000 (Sunoco Refinery) (September 12, 2014).

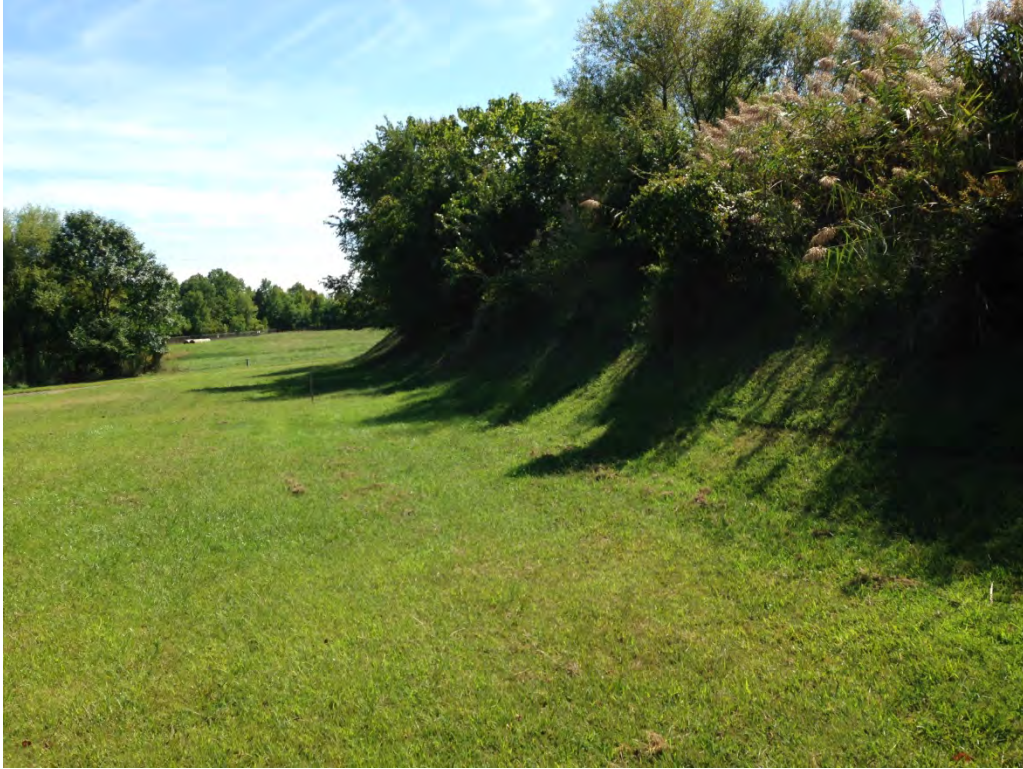
73. View of maintained lawn along the containment berms of Pond I1 and Wetland I7 within the ROW of the pipeline within Parcel PA-DE-0150.0000 (Sunoco Refinery) (September 12, 2014).

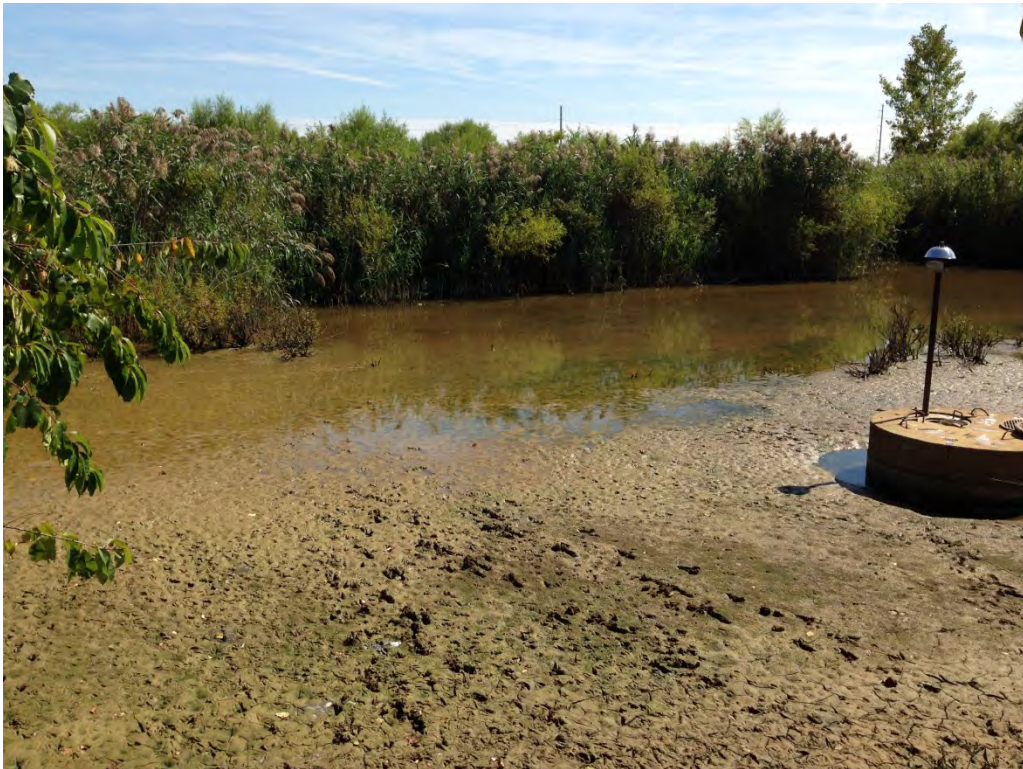
74. View of open water within Wetland I7 in the ROW of the pipeline within Parcel PA-DE-0150.0000 (Sunoco Refinery) (September 12, 2014).

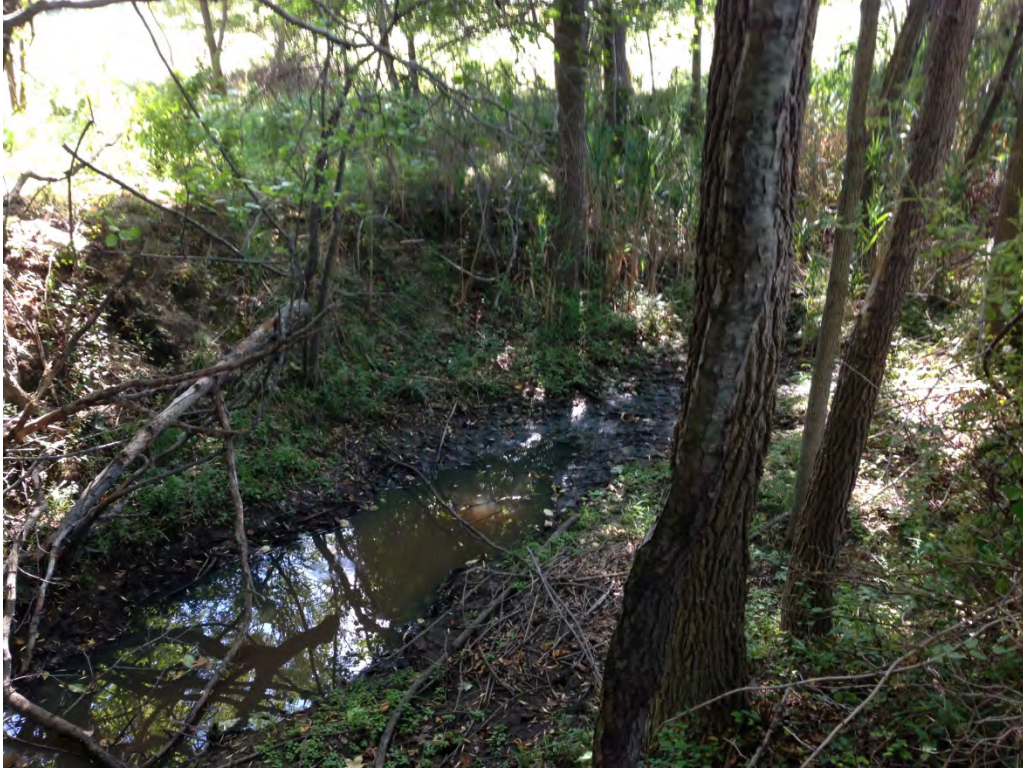
75. View of a forested stream channel (S-I10) within the pipeline ROW Parcel PA- DE-0150.0000 (September 12, 2014).

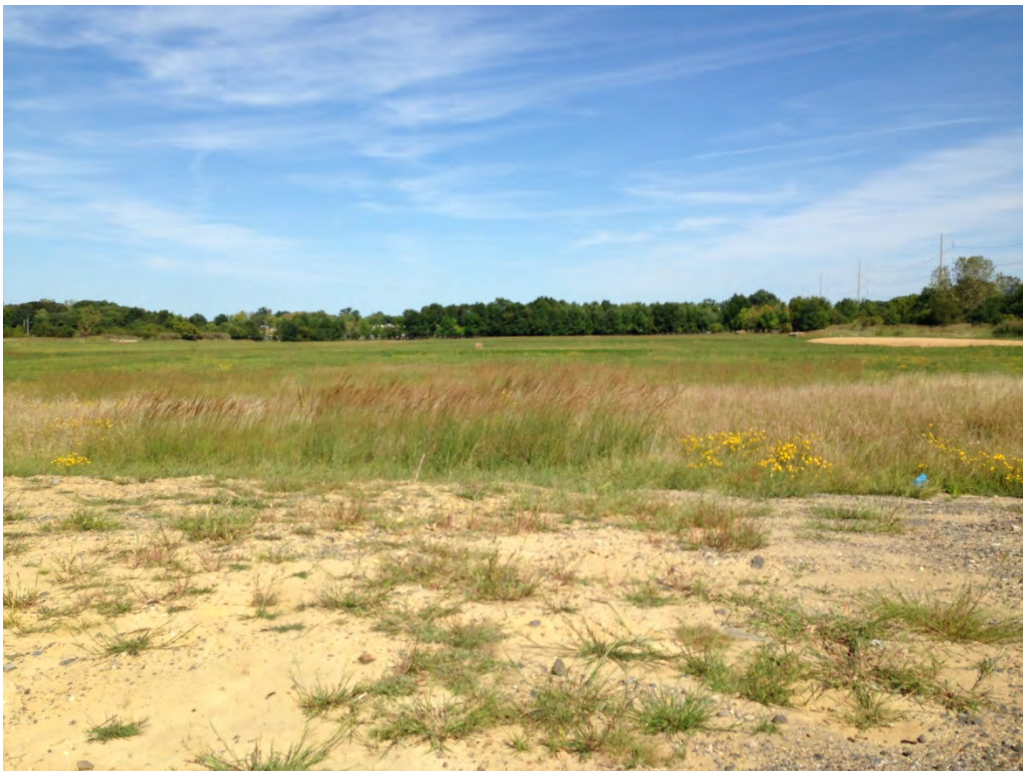
76. View east of emergent wetlands (Wetland-I5) within the pipeline ROW Parcel PA- DE-0150.0000 (September 12, 2014).
