COMMONWEALTH OF PENNSYLVANIA  
DEPARTMENT OF ENVIRONMENTAL PROTECTION  
BUREAU OF ENVIRONMENTAL CLEANUP AND BROWNFIELDS

## NARRATIVE REPORT FORM

Facility Name: Glenwood Drive and Walker RoadPrimary Facility ID: 881609

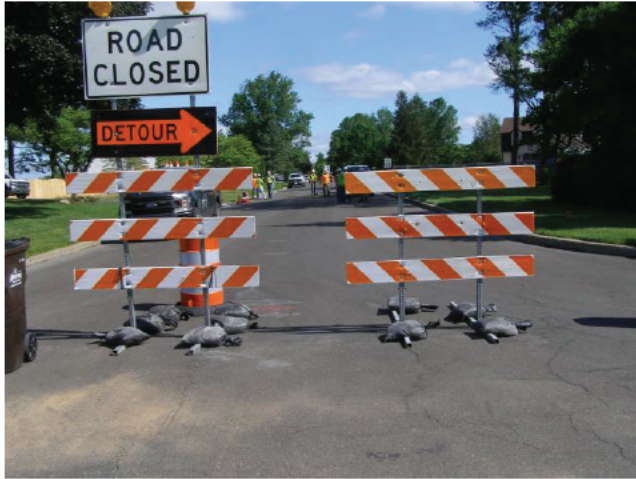
Road closure at Glenwood Drive and Walker Road  
 5-19-25 @ 9:48am

I arrived at the site to observe the well installation activities. As I drove into the neighborhood, I noticed that there were detour signs placed a long Walker Road and Bruce Road.

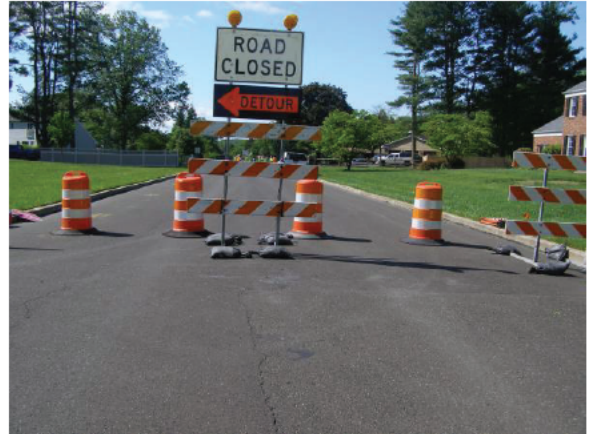
Road closure at Glenwood Drive and Spencer Avenue  
 5-19-25 @ 9:55am

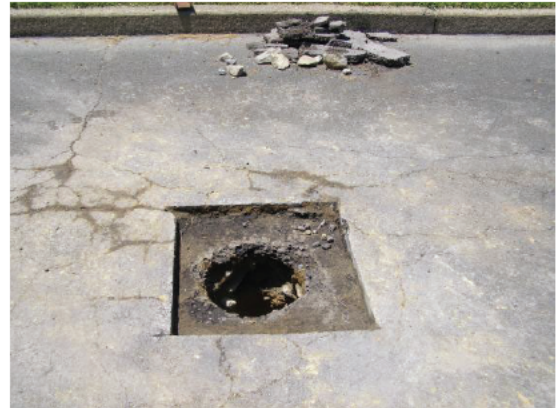
- At 11:29, Parratt and Wolff started to pre-clear the marked recovery wells to a depth of 5-feet below ground surface (bgs)
- During the pre-clearing, a hand auger was used to take a soil sample from each foot to screen for impacts, which were placed in separate zip-lock bags. The bags sat for about 15 minutes then was screened with a PID.

- There were no PID detections except for the first two feet in RW-2 which had a reading of 2.0 ppm.

Recovery well RW-2 after pre-clearing  
 5-19-25 @ 13:07

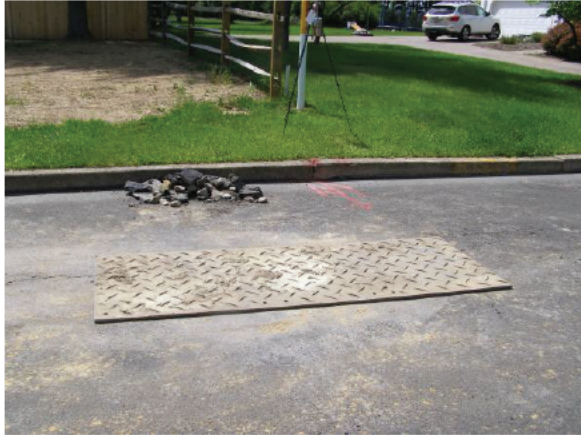
Pre-clearing of recovery well RW-3 covered  
5-19-25 @ 14:29

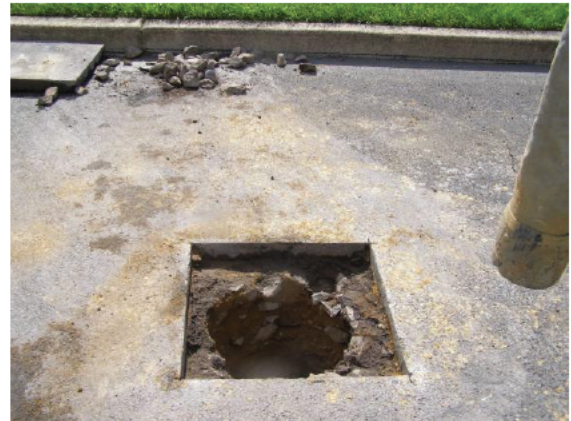
Recovery well RW-4 pre-cleared  
5-19-25 @ 16:10

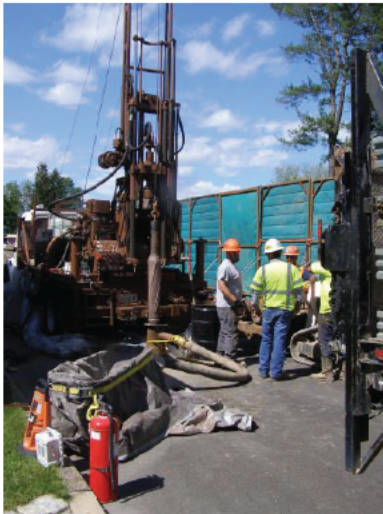
- At 13:29, the drill rig arrived at the site. They set up above RW-2 and used hollow-stem auger drilling method to clear the first 5 feet.
- The soil from the drilling was initially placed on the plastic tarp under the drill rig, but later was transferred to a 55-gallon drum.

Drill rig over recovery well RW-2  
5-19-25 @ 15:25

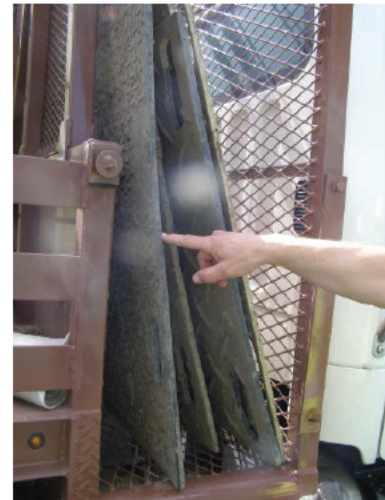
Covers being used to cover pre-cleared wells  
5-19-25

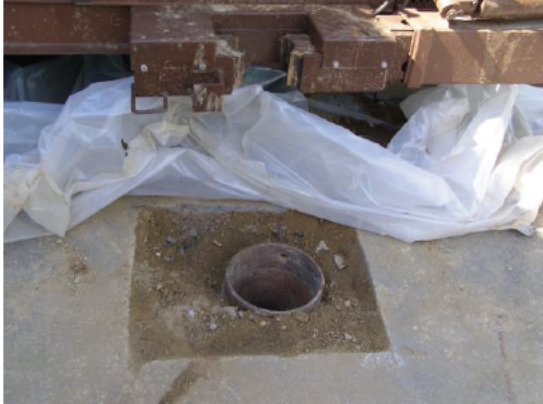
- Due to the late arrival of the drill rig, there was no drilling performed. The hole in RW-2 had a piece of steel casing left in to keep the hole from collapsing in overnight.

Recovery well RW-2 with auger to keep from caving in  
5-19-25 @ 16:14

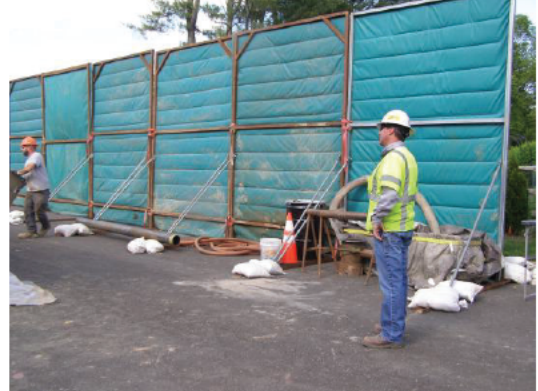
- I confirmed with ET and GES before I answered [REDACTED] questions, that the barriers will remain up until the installation of the recovery wells have been completed, and that the monitoring in [REDACTED] well during the drilling is to ensure that the well water level is not affected.

Sound barrier along Glenwood Drive after drilling activities had finished  
5-19-25 @ 16:18

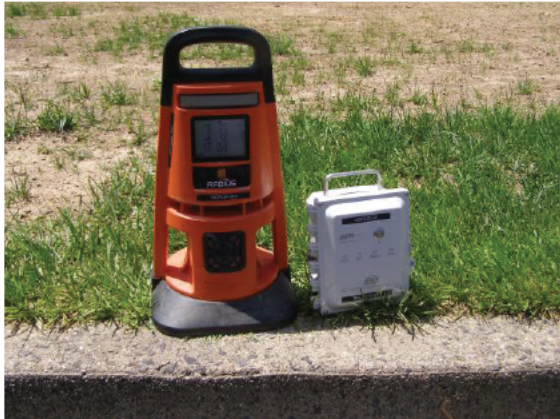
- I saw a resident of [REDACTED] and gave a brief description of what they were using and why.
- There was a small orange monitoring that was placed next to each recovery well that was being pre-cleared, that gave a PID reading and levels of CO, H<sub>2</sub>S, LEL and O<sub>2</sub>.

Monitoring device located next to each recovery well while being pre-cleared  
5-19-25 @ 13:24
