NARRATIVE REPORT FORM

Facility Name: Glenwood Drive and Walker Road

Primary Facility ID: 881609

The purpose of today's site visit was to observe the morning measuring and gauging event that is performed daily on the pre-determined residential potable wells and all four recovery wells. The GES crew was onsite upon my arrival at 9:10 setting up at the [REDACTED] residence.

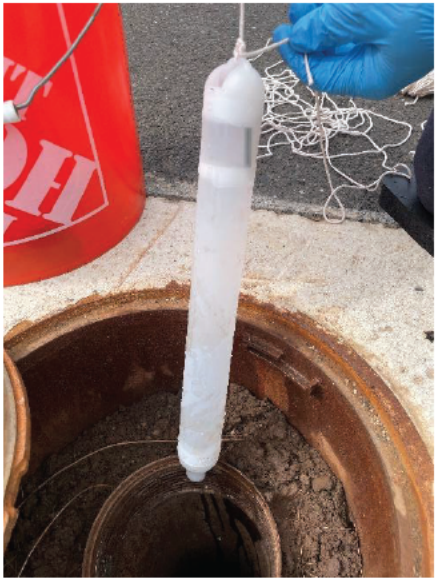
Photo 1: RW-4 Bailer Check Side View

- The GES crew put a bottom loading, clear, plastic bailer down RW-4 per my request. There was no noticeable sheen on the water and no odors (Photo 1)

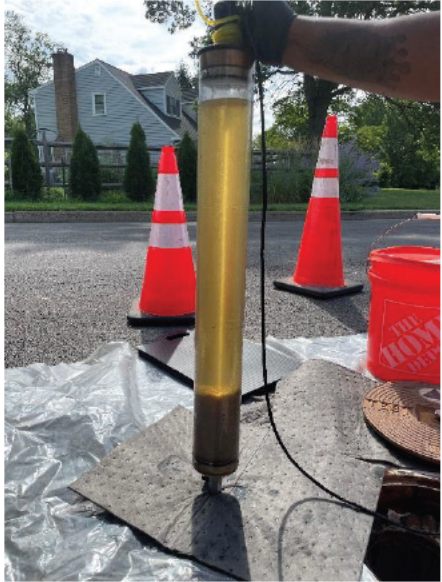
Photo 2: RW-2 Skimmer

- When gauging the recovery wells RW-2 and RW-3, the gauging is performed while the passive skimmer systems are in place in the well.
- The skimmer at RW-2 was completely full of product and a cloudy substance at the bottom. This did not appear to be silt or sediment. The GES crew stated they have seen this occur multiple times in RW-2 (Photo 2 and 3).

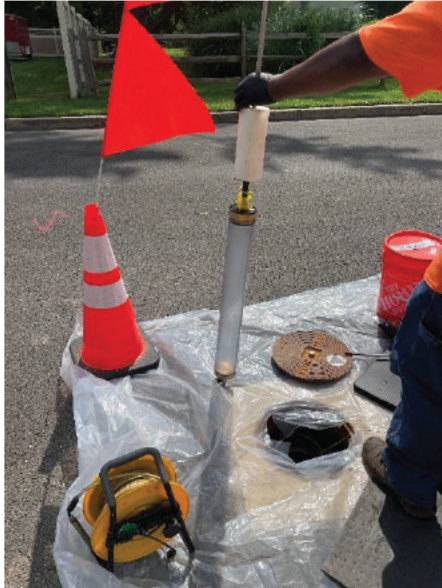
Photo 4: RW-3 Empty Skimmer

- The skimmer at RW-3 was completely empty (Photo 4). There was approximately 0.05 feet of product existing in the well around the skimmer when it was gauged.
