NARRATIVE REPORT FORM
Facility Name: Glenwood Drive and Walker Road

Primary Facility ID: 881609 _____

MAPS / PHOTOGRAPHS / ATTACHMENTS

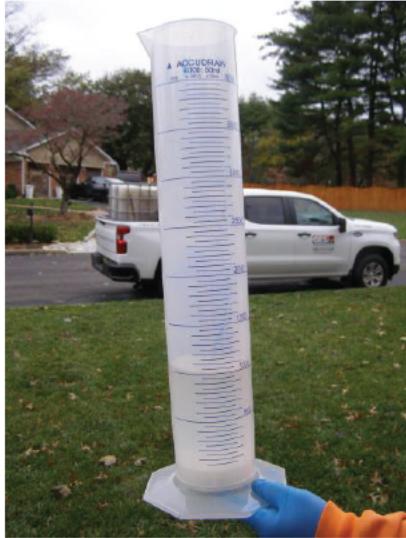
- There was a detectable amount of LNAPL gauged, the well was bailed and placed in the graduated cylinder to measure the LNAPL, which was approximately 5mL.
- No LNAPL sample was able to be collected to sample.

Bailed water from former potable well on [REDACTED]
 10-20-25 @ 9:13

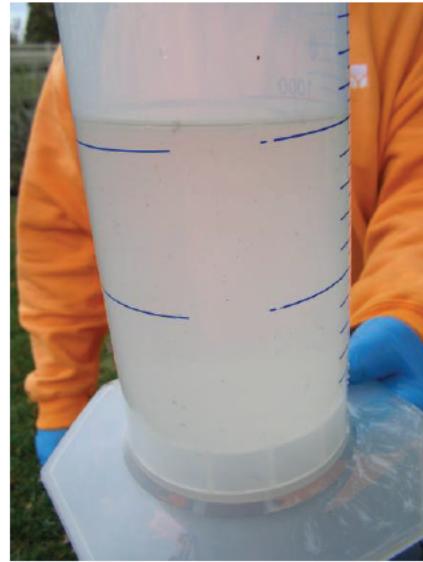
Minimal LNAPL from former potable well at [REDACTED]
 10-20-25 @ 9:14

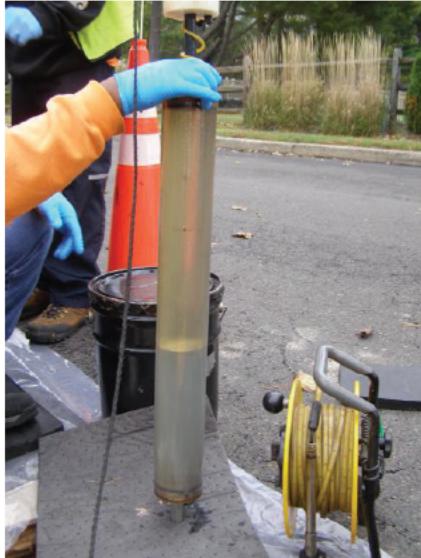
- Depth to LNAPL/water was gauged before and after the skimmer was removed.
- A LNAPL sample was collected at 9:56 to be analyzed.
- There was 1,750mL of LNAPL which was measured to be from the skimmer.
- All water and LNAPL was placed in a designated metal bucket to be disposed of later.

Skimmer removed from recovery well RW-2 on Glenwood Drive
 10-20-25 @ 9:52

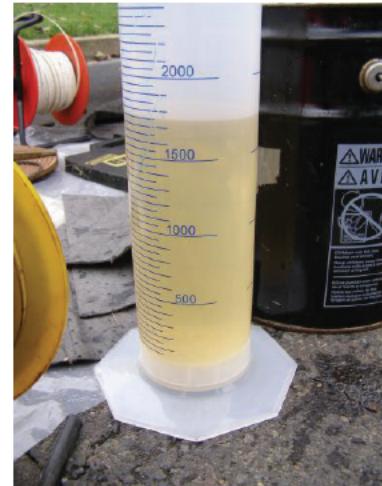
Amount of LNAPL recovered from RW-2 (1,750 mL)
 10-20-25 @ 9:55

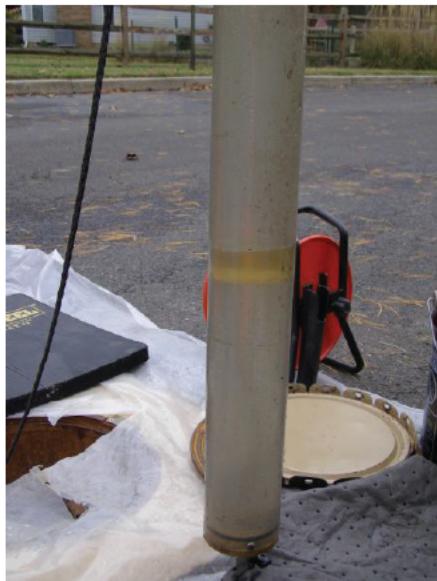
- Depth to LNAPL/water was gauged before and after the skimmer was removed.
- A LNAPL sample was collected at 10:06 to be analyzed.
- There was 115mL of LNAPL which was measured to be from the skimmer.
- All water and LNAPL was placed in a designated metal bucket to be disposed of later.

Skimmer removed from recovery well RW-3 on Glenwood Drive
 10-20-25 @ 10:02

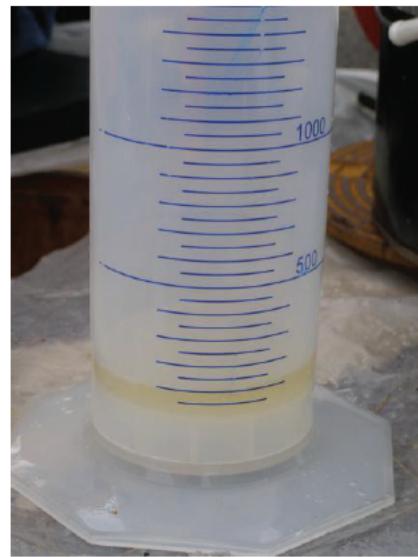
Amount of LNAPL recovered from RW-3 (100 mL)
 10-20-25 @ 10:06
