August 3, 2023

Subject: **SUPPLEMENTAL FIELD EXPLORATION MEMO**
SOLEBURY TOWNSHIP - BUCKS COUNTY, PA
NEW HOPE CRUSHED STONE & LIME COMPANY, INC. (NHCS)
QUARRY DISCHARGE OUTLET

SUPPLEMENTAL TEST PIT LOGS

SUPPLEMENTAL TEST PIT PHOTOGRAPHS

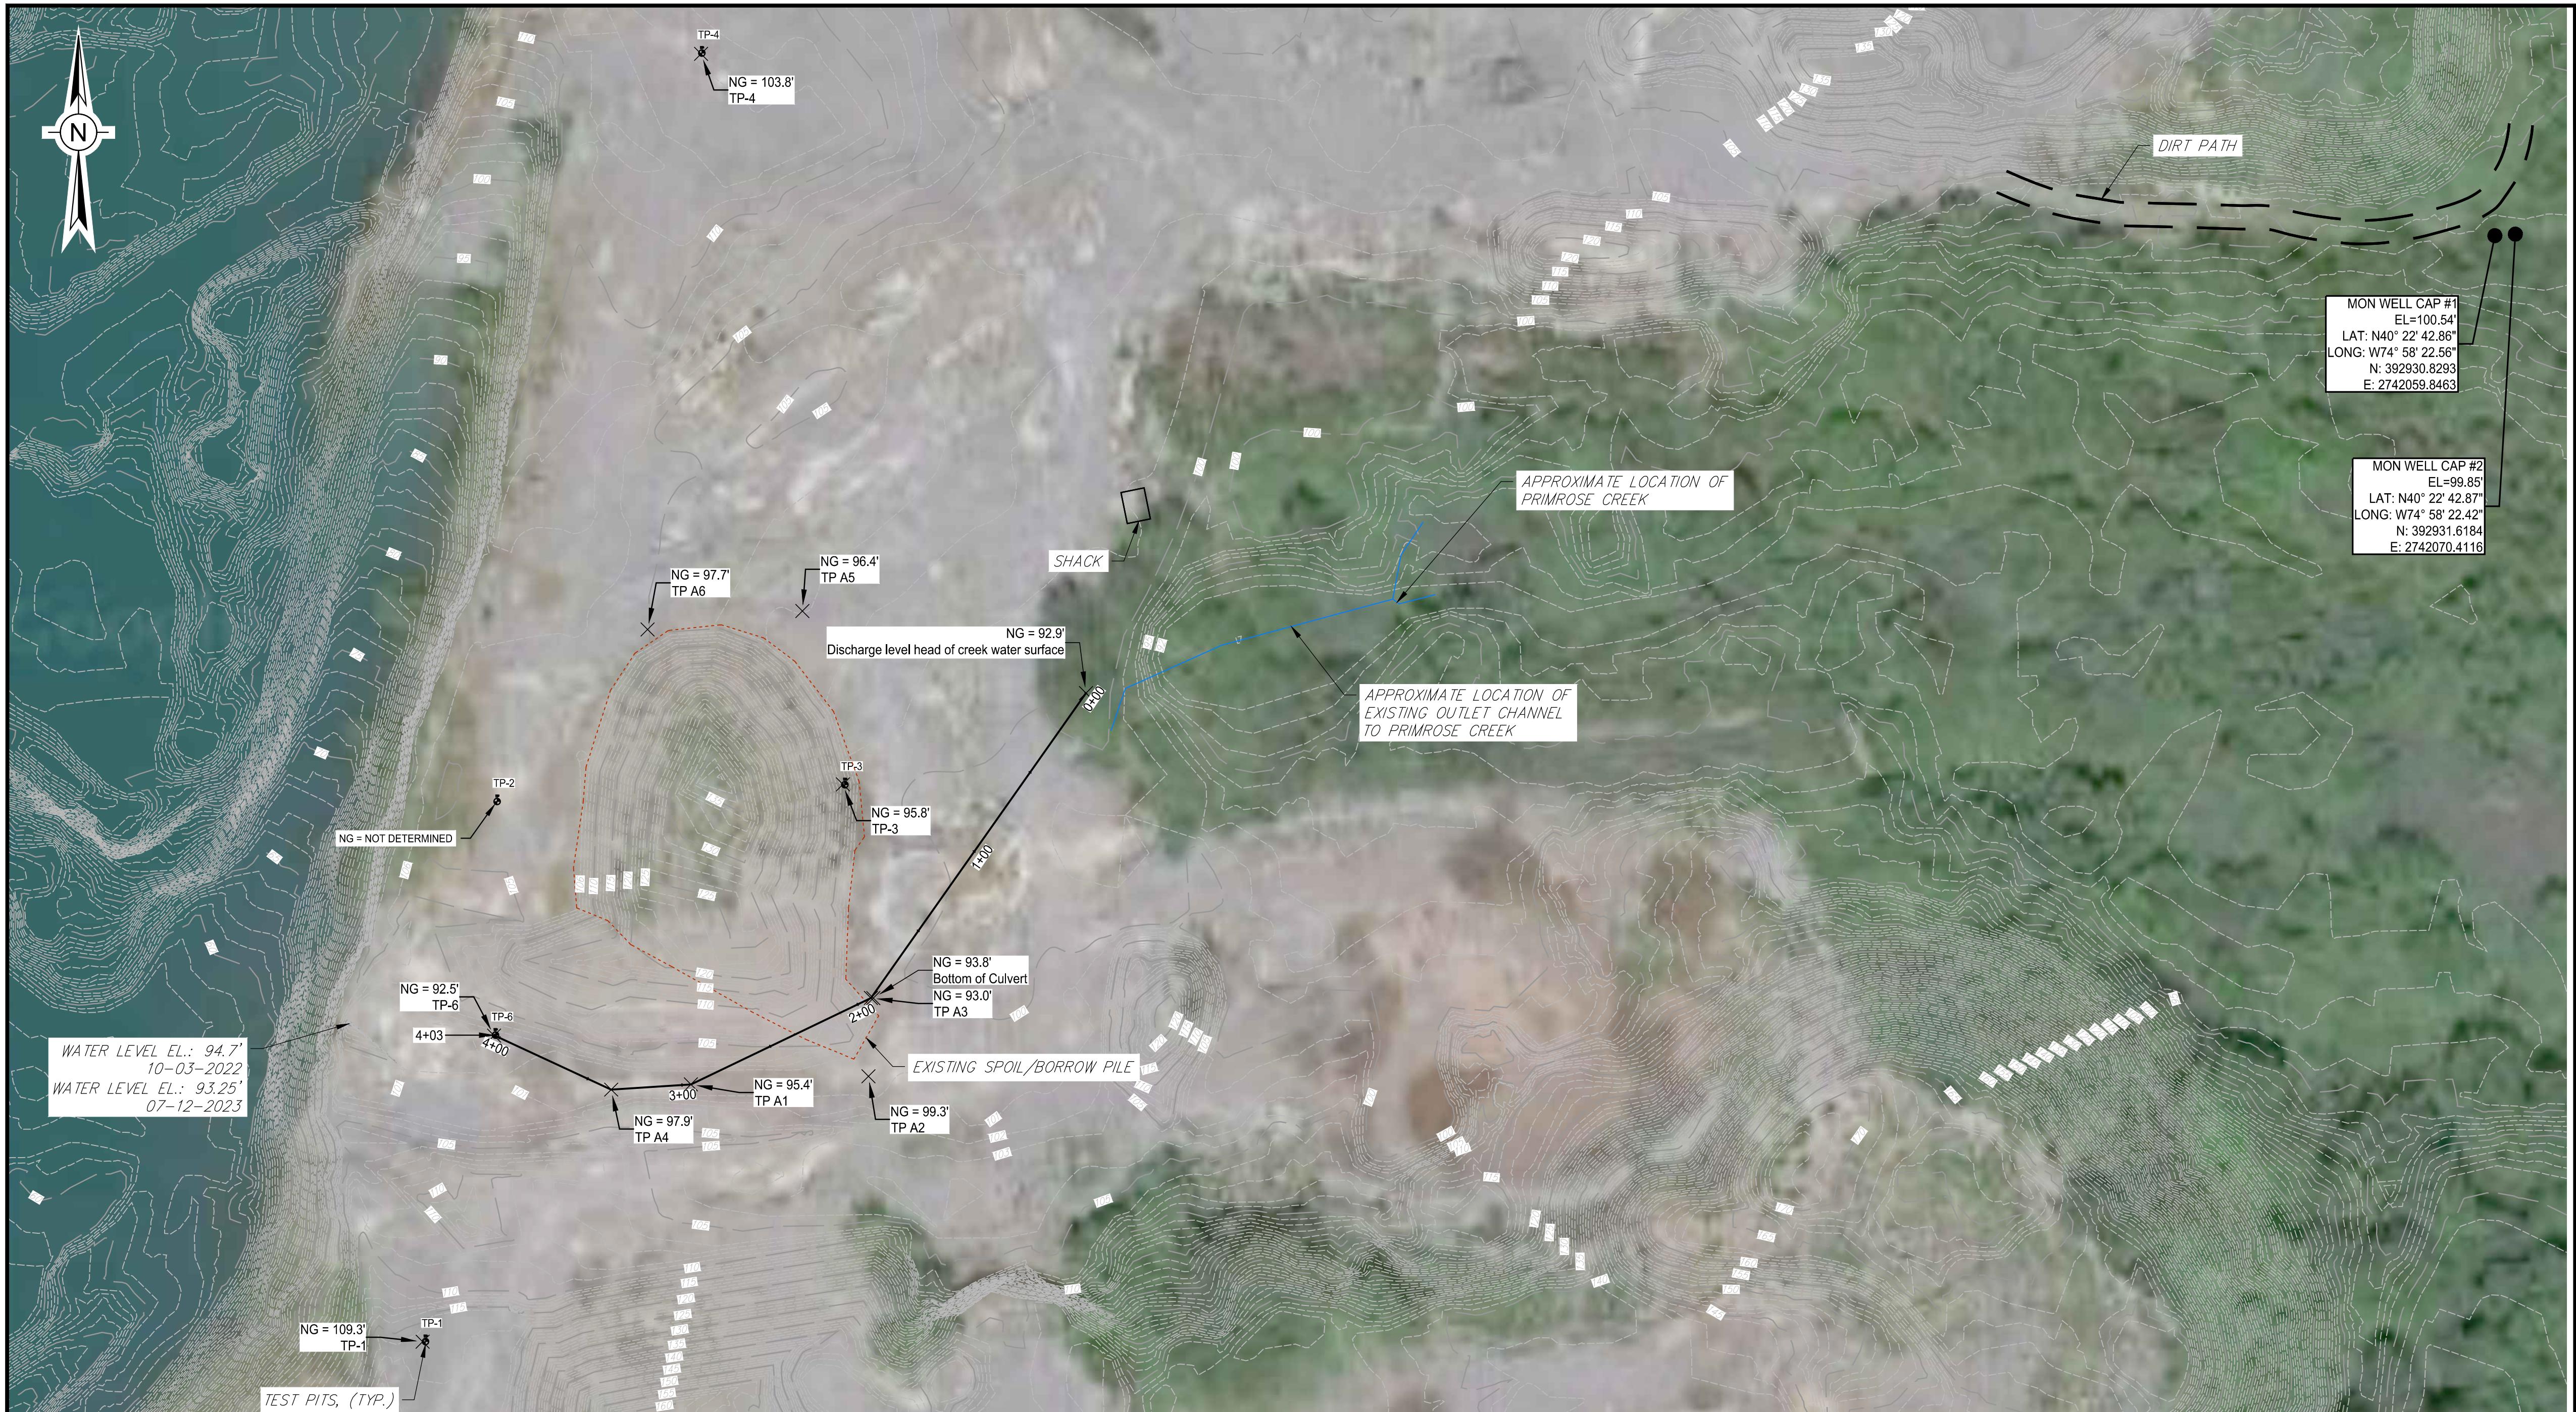
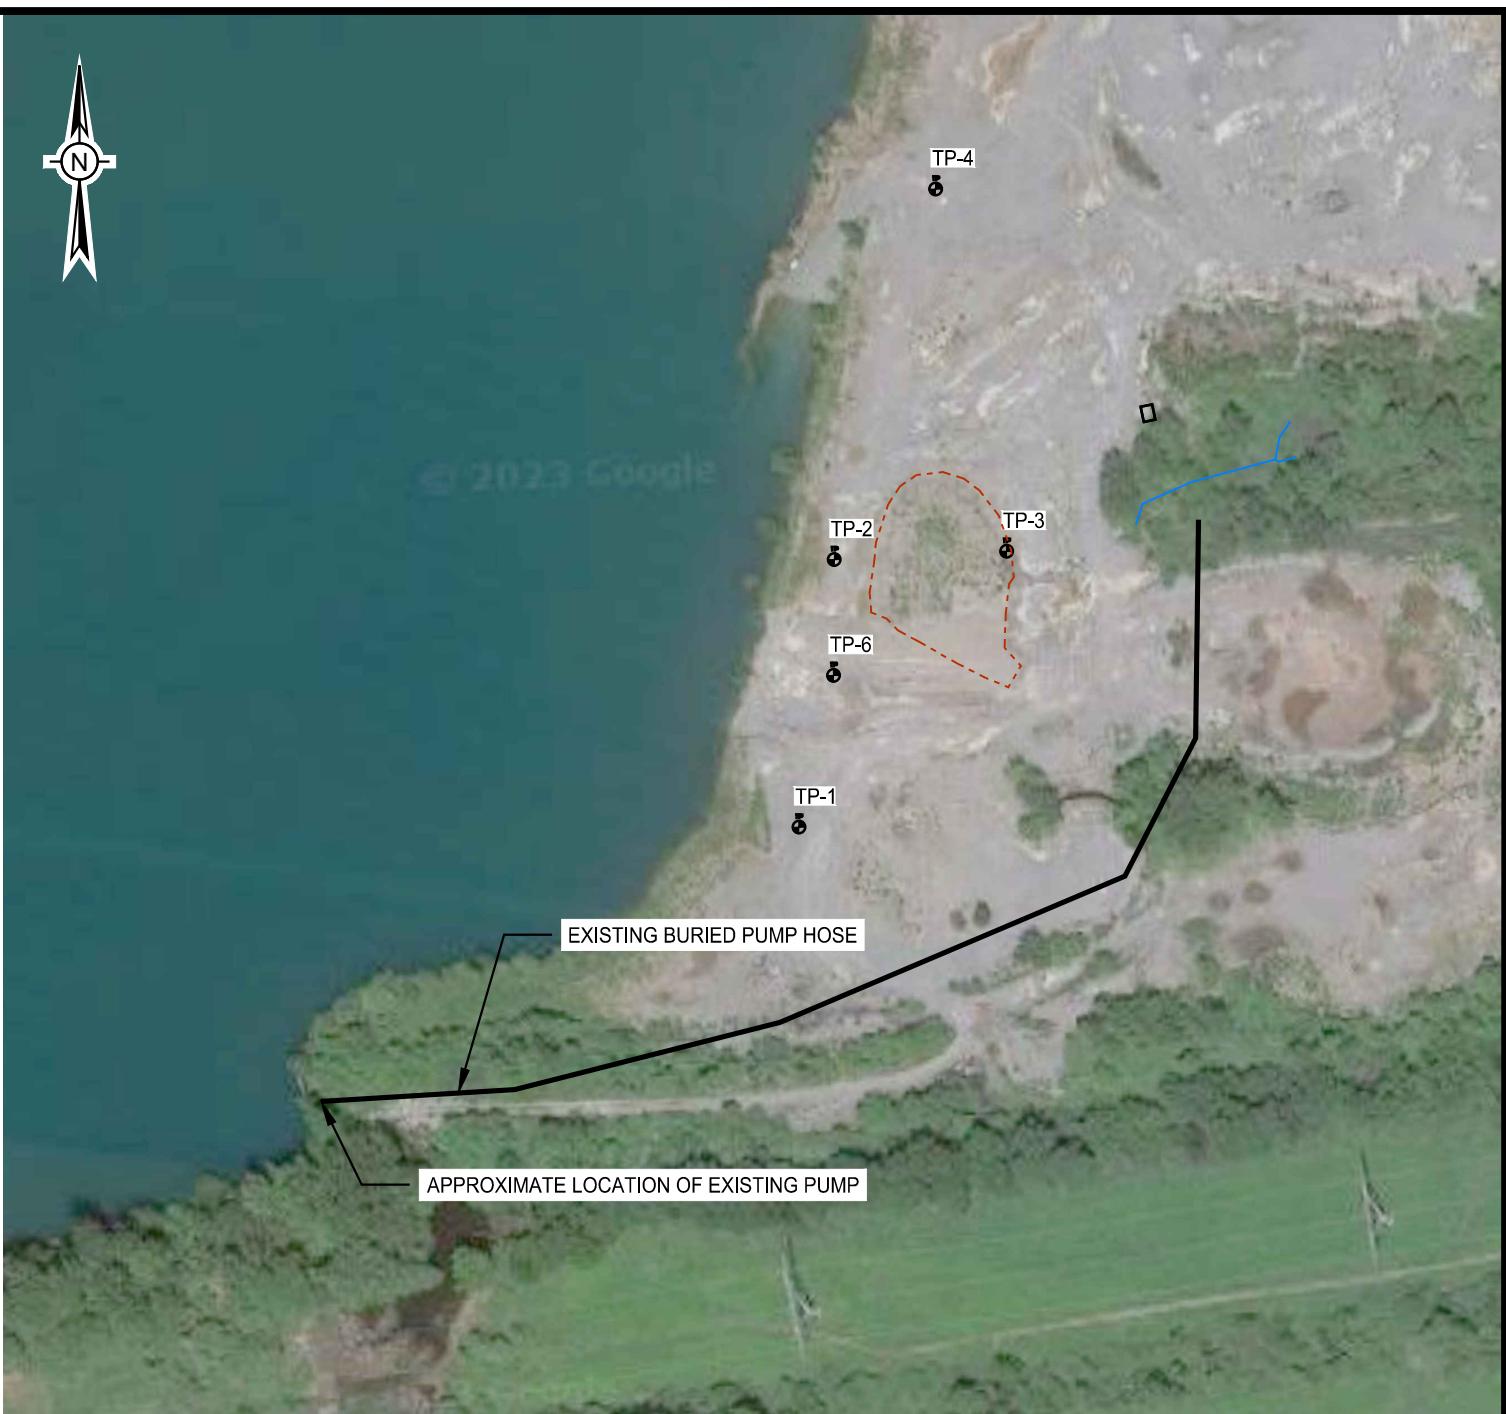
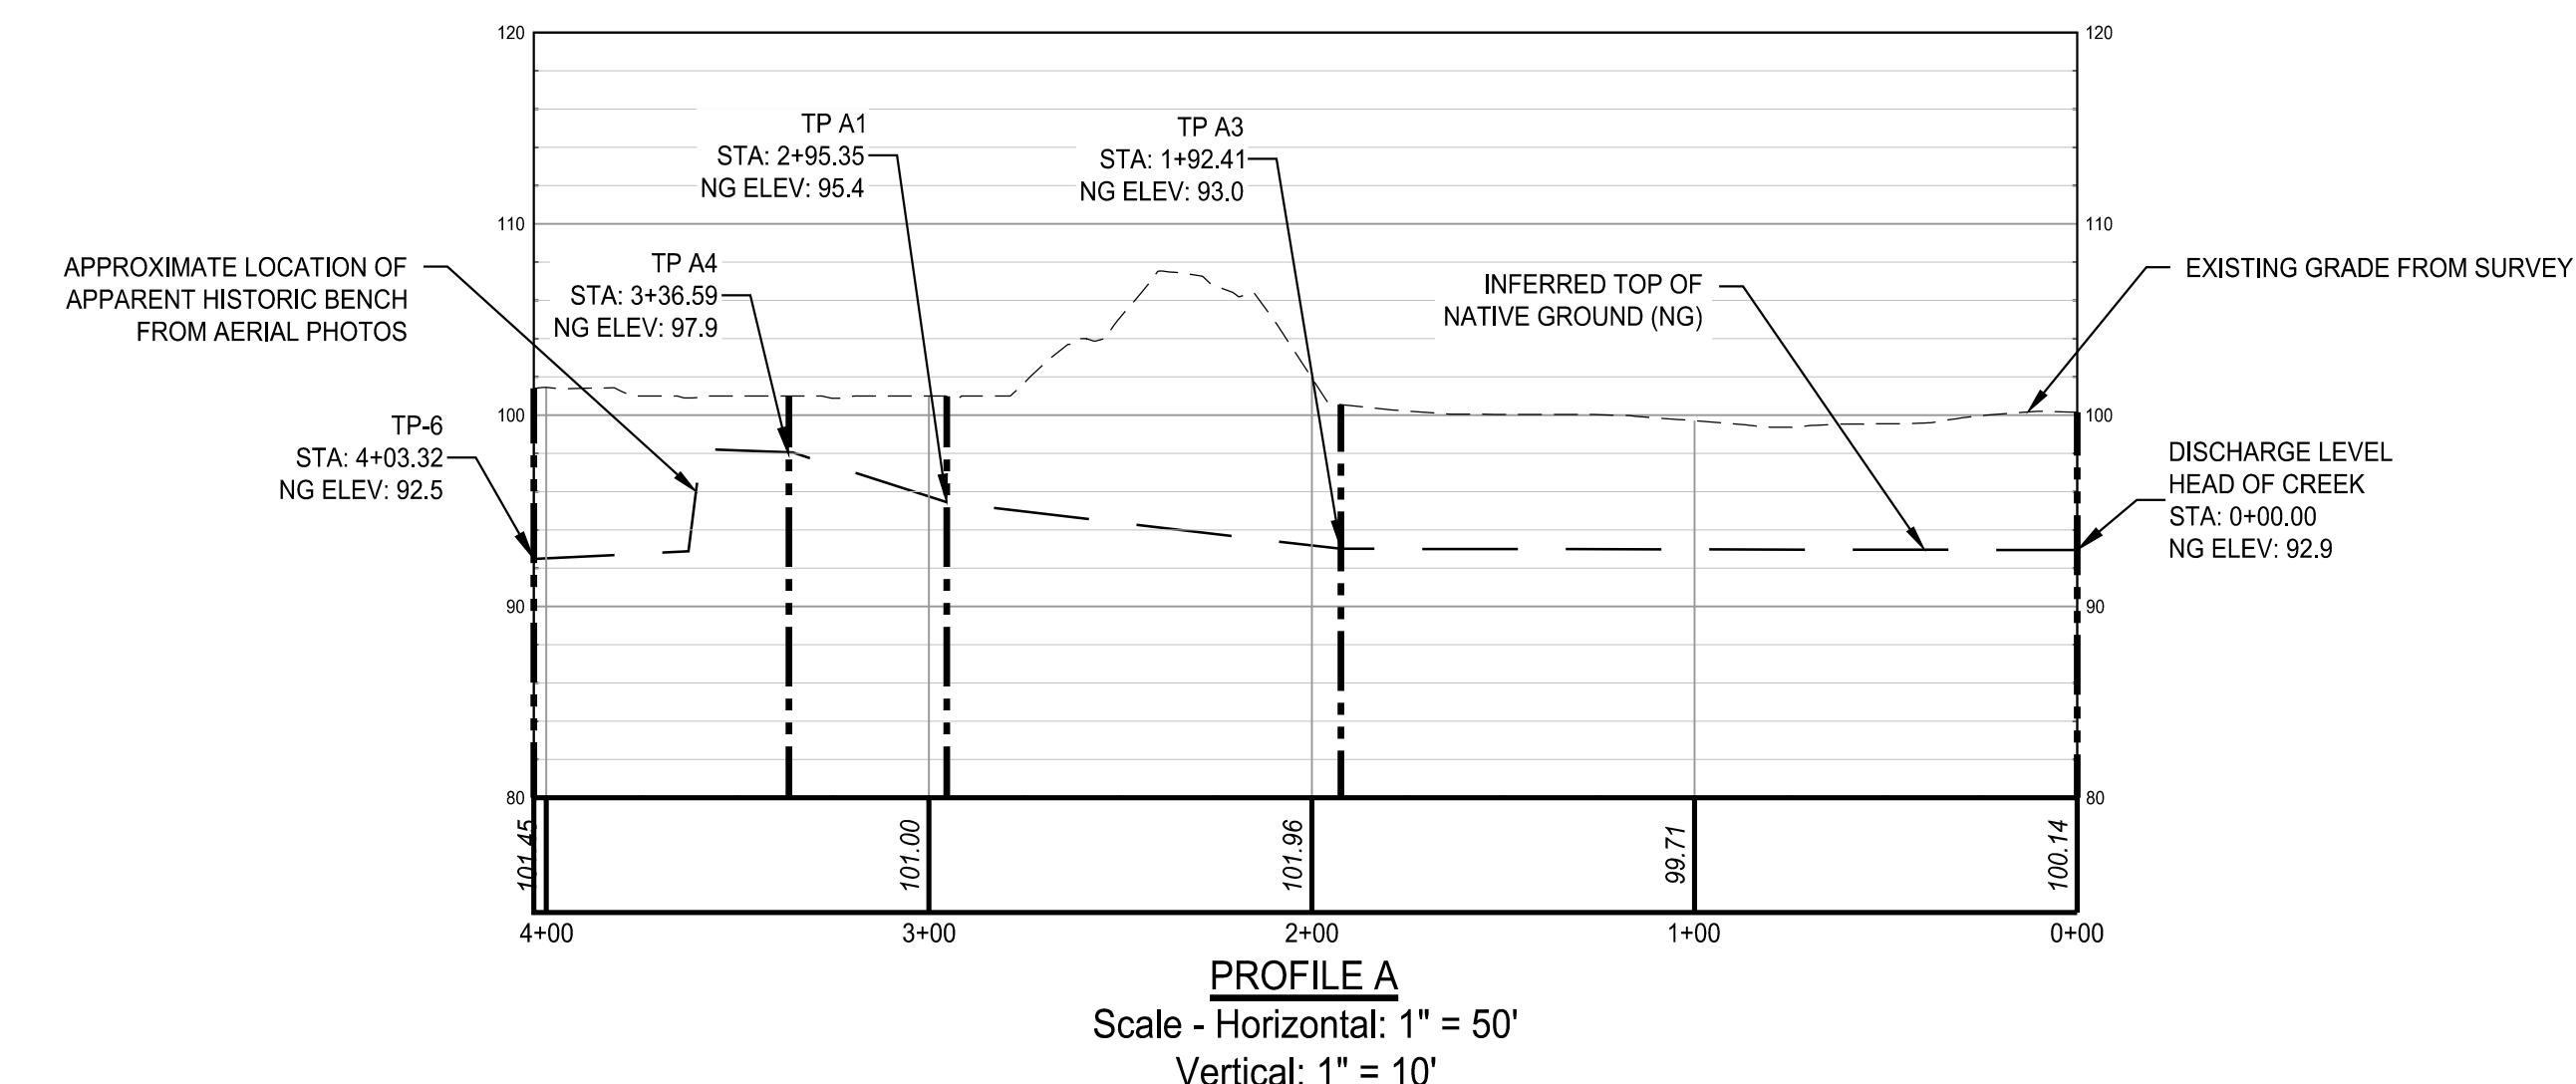
SITE PLAN

Test pit locations were jointly selected by Tetra Tech and DMO along an existing channel that was put in place by DMO. Exploration locations were field located by Tetra Tech personnel with an EOS Arrow Gold and iPad with active cellular service. All test pits were excavated until native ground was determined. The test pits, and soil interval elevations presented in this memo are based upon the GPS unit coordinates and elevations together. Previous test pit locations and elevations were based on topographic survey performed in October 2022. A plan of the test pits can be found on the attached Site Plan. A summary of test pits is provided on Table 1.

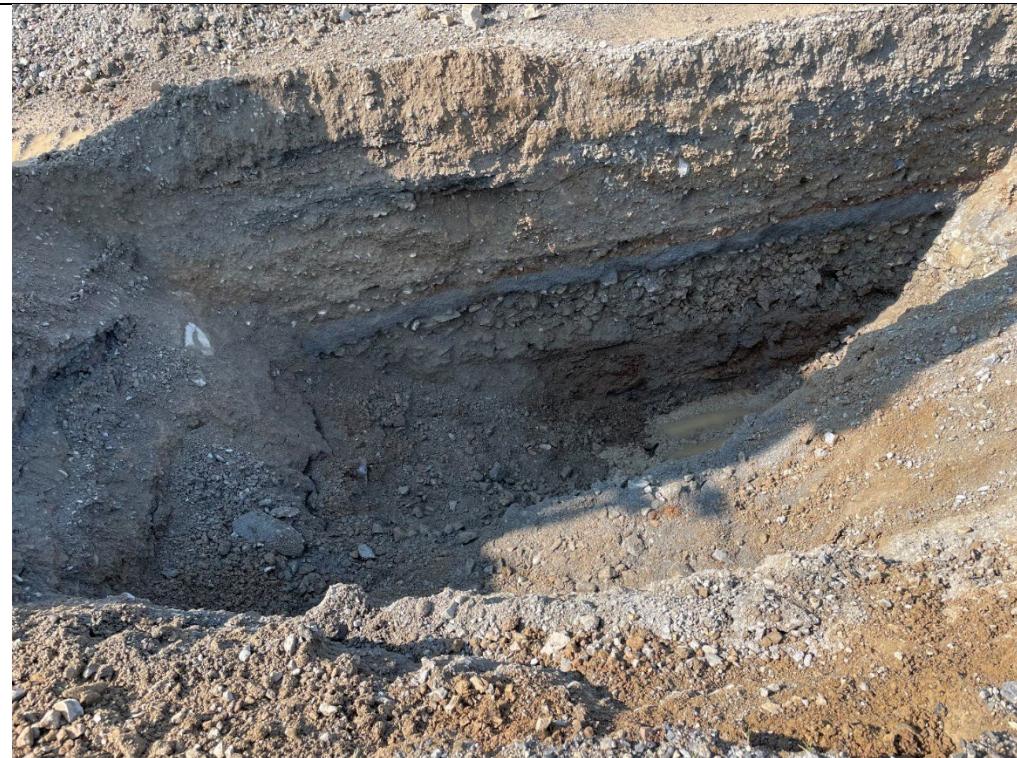
Photograph No. 1

Project: New Hope Crushed Stone & Lime Company - New Hope, PA 18938			Project Code 212c-pb-02541	TP-A1					
Sheet No. 1 of 1			Date Started 7/12/2023						
Test Pit Location: 40.37745219, -74.97631863			Field Rep M. J. Byle, E. DiFatta						
G.S. Elevation (ft msl): 101			Date Completed 7/12/2023						
Equipment Used:			Note Depths of Seepage Inflow Comment on Trench Stability & Unraveling of Sidewalls						
Test Pit Dimensions (ft):		L x W x D							
DEPTH (feet)	SAMPLE NO. and TYPE	USCS SYMBOL	DESCRIPTION OF MATERIAL	U.C.S. (tsf) ⁽¹⁾	WATER CONTENT (%)	LIQUID LIMIT (%)	PLASTIC LIMIT (%)	PI (dim)	FINER No. 200 (%)
	gp		Crushed stone 100						
2	gp		Sand and gravel with angular stone fill 98						
4	sp		Sand 97.5						
4	gp		Angular cobbles 96						
6	sp		Sand, coarse angular 95.5						
6	sm		Native red brown silty sand with gravel oriented to bedding with organic soil 93.5						
8			Bottom of Test Pit 7.2'

Description: TP-A1

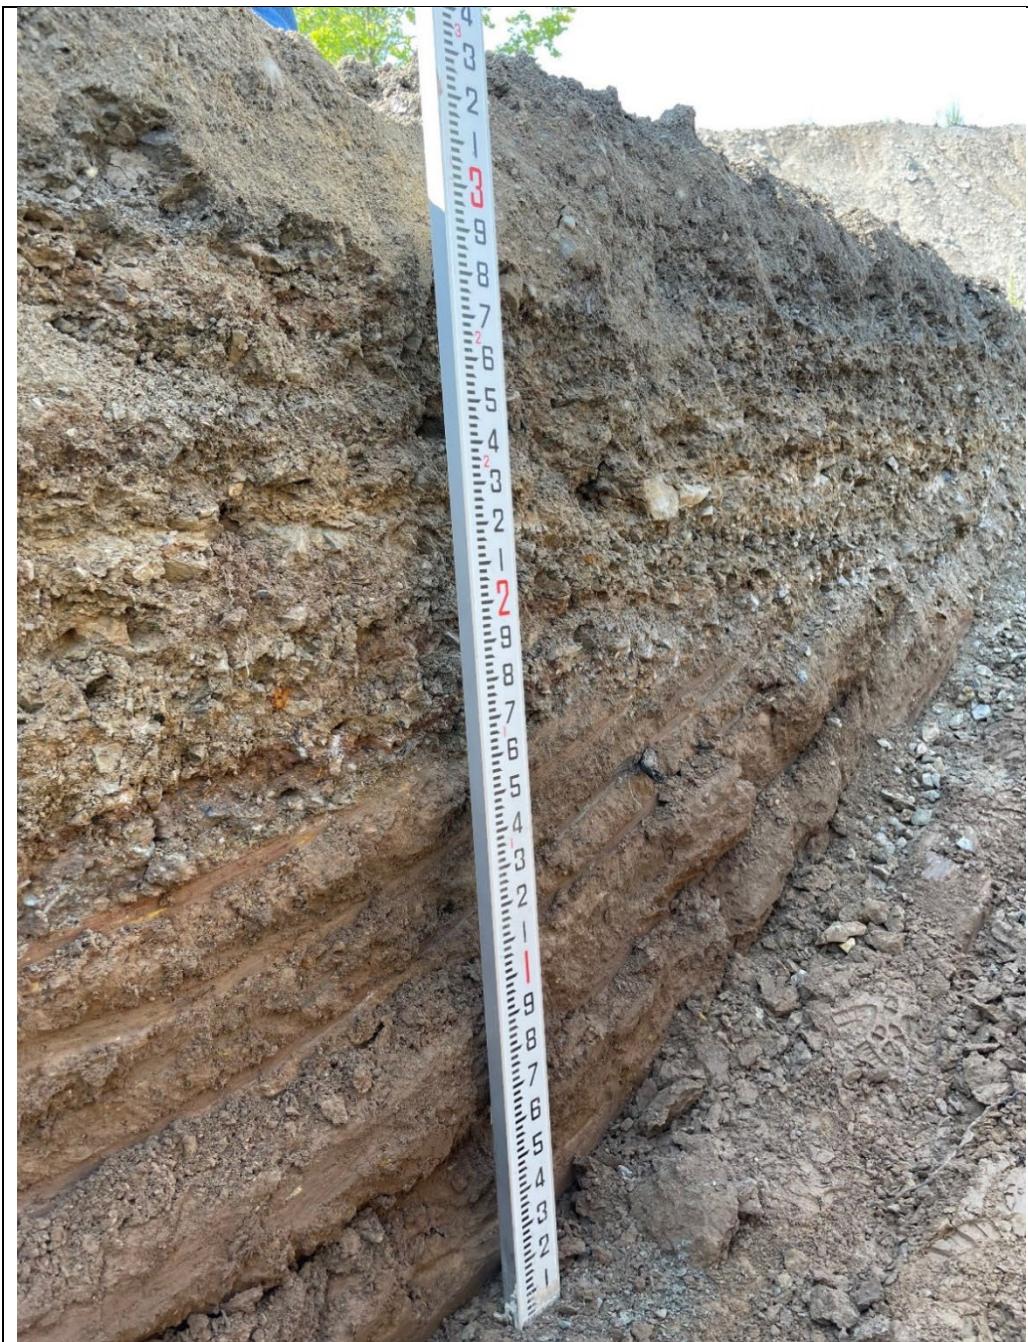
Photograph No. 2

Project: New Hope Crushed Stone & Lime Company - New Hope, PA 18938			Project Code 212c-pb-02541		TP-A2					
			Sheet No. 1 of 1		Date Started 7/12/2023					
Test Pit Location: 40.37745580, -74.97598984			Field Rep M. J. Byle, E. DiFatta		Date Completed 7/12/2023					
G.S. Elevation (ft msl): 101										
Equipment Used:			Note Depths of Seepage Inflow Comment on Trench Stability & Unraveling of Sidewalls							
Test Pit Dimensions (ft):			L x W x D							
DEPTH (feet)	SAMPLE NO. and TYPE	USCS SYMBOL	DESCRIPTION OF MATERIAL	U.C.S. (tsf) ⁽¹⁾	WATER CONTENT (%)	LIQUID LIMIT (%)	PLASTIC LIMIT (%)	PI (dim)	FINER No. 200 (%)	
		gp	Angular gravel and cobble fill

99.5							
2		ml	Native silt brown with roots							
			97.7							
4			Bottom of Test Pit 3.3'							
6										
8										
10										
THE STRATIFICATION LINES REPRESENT THE APPROXIMATE BOUNDARY LINES BETWEEN SOIL TYPES. IN SITU, THE TRANSITION MAY BE GRADUAL. --- INTERPRETATIONS BY OTHERS MIGHT DIFFER ---

Description: TP-A2

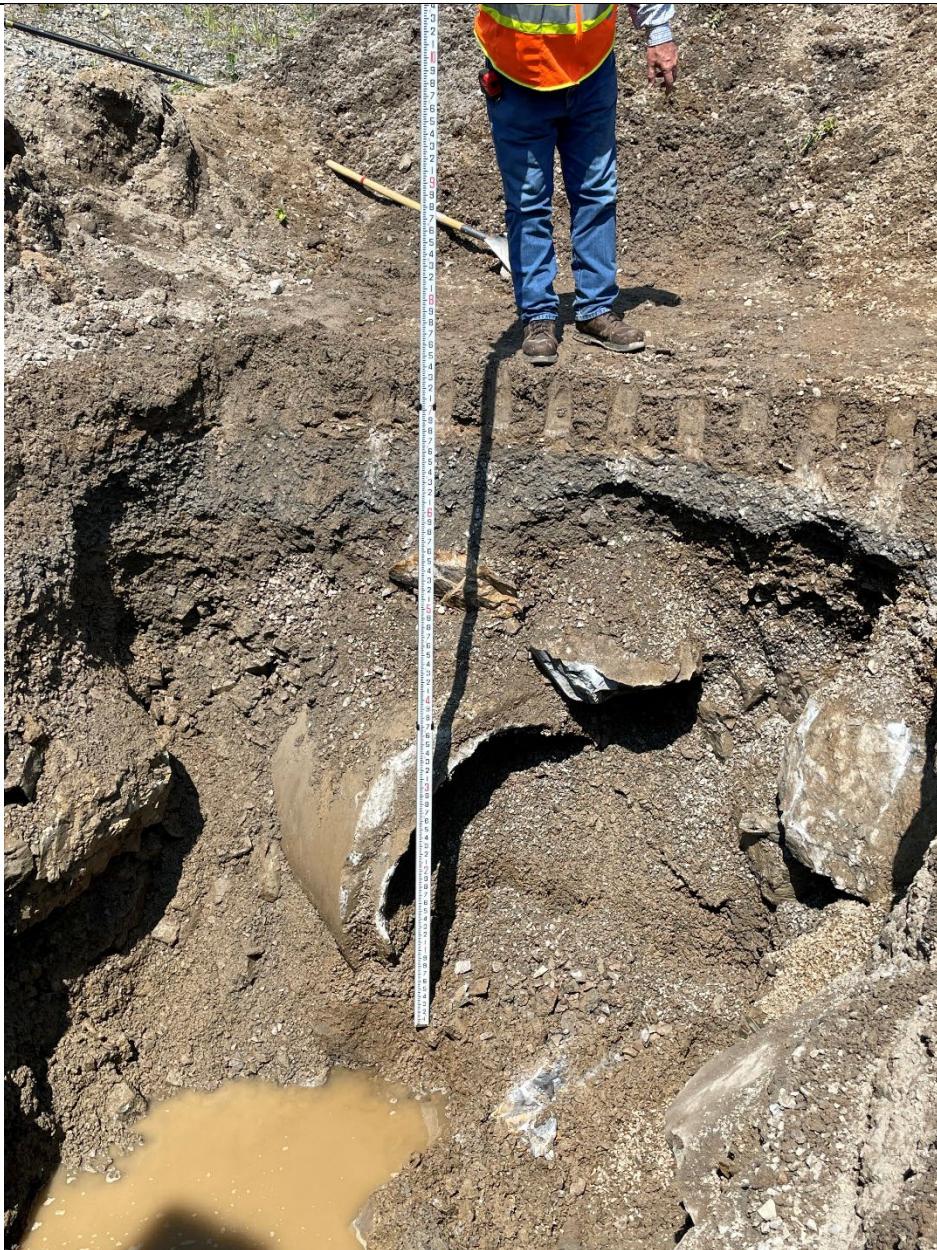
Photograph No. 3

Project: New Hope Crushed Stone & Lime Company - New Hope, PA 18938			Project Code 212c-pb-02541			TP-A3					
			Sheet No. 1 of 1			Date Started 7/12/2023					
Test Pit Location: 40.37756646, -74.97598070 G.S. Elevation (ft msl): 100.3			Field Rep M. J. Byle, E. DiFatta			Date Completed 7/12/2023					
Equipment Used:			<i>Note Depths of Seepage Inflow</i> <i>Comment on Trench Stability & Unraveling of Sidewalls</i>								
Test Pit Dimensions (ft):			<i>L x W x D</i>								
DEPTH (feet)	SAMPLE NO. and TYPE	USCS SYMBOL	DESCRIPTION OF MATERIAL EL (ft): GWT EL:		U.C.S. (tsf) ⁽¹⁾	WATER CONTENT (%)	LIQUID LIMIT (%)	PLASTIC LIMIT (%)	PI (dim)	FINER No. 200 (%)	
2	gp		Mixed fill. Encountered 36" RCP apparently used for stream crossing bedded in screenings (angular pea stone)								
4	ml		Native red brown silt located at invert of pipe and in west face of excavation.								
6			93.1 Bottom of Test Pit 8'

8			92.3								
10			Bottom of Test Pit 8'								
THE STRATIFICATION LINES REPRESENT THE APPROXIMATE BOUNDARY LINES BETWEEN SOIL TYPES. IN SITU, THE TRANSITION MAY BE GRADUAL. --- INTERPRETATIONS BY OTHERS MIGHT DIFFER ---

Description: TP-A3

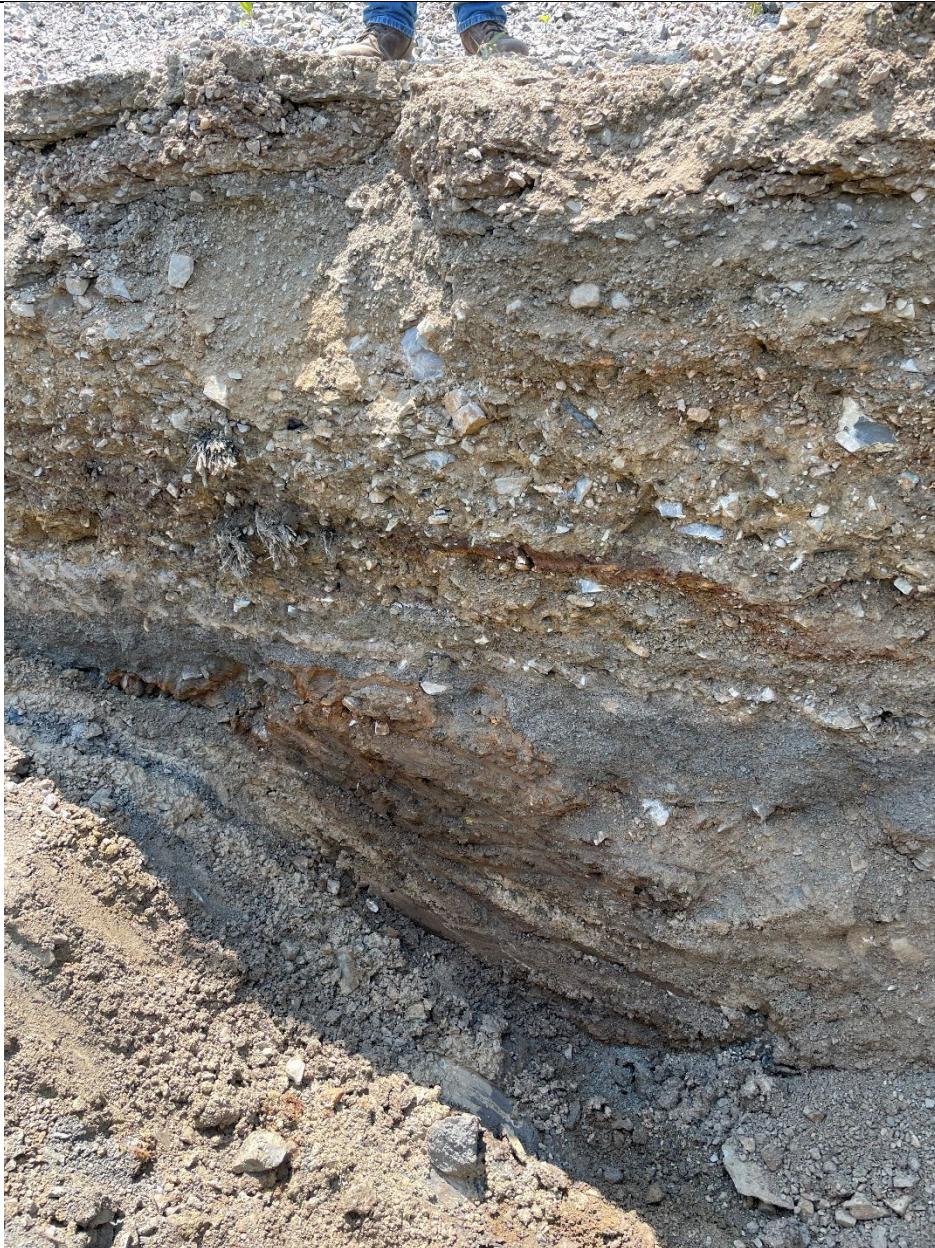
Photograph No. 4

Project: New Hope Crushed Stone & Lime Company - New Hope, PA 18938			Project Code 212c-pb-02541			TP-A4					
			Sheet No. 1 of 1			Date Started 7/12/2023					
Test Pit Location: 40.37744832, -74.97646655			Field Rep M. J. Byle, E. DiFatta			Date Completed 7/12/2023					
G.S. Elevation (ft msl): 101.2											
Equipment Used:			<i>Note Depths of Seepage Inflow</i> <i>Comment on Trench Stability & Unraveling of Sidewalls</i>								
Test Pit Dimensions (ft):			L x W x D								
DEPTH (feet)	SAMPLE NO. and TYPE	USCS SYMBOL	DESCRIPTION OF MATERIAL		U.C.S. (tsf) ⁽¹⁾	WATER CONTENT (%)	LIQUID LIMIT (%)	PLASTIC LIMIT (%)	PI (dim)	FINER No. 200 (%)	
			EL (ft):		GWT EL:						
			Mixed gravelly fill								
2		gp	98								
4			Native silt with trace organics								
6		ml	94.8								
			Bottom of Test Pit 6.4'								
8											
10											
THE STRATIFICATION LINES REPRESENT THE APPROXIMATE BOUNDARY LINES BETWEEN SOIL TYPES. IN SITU, THE TRANSITION MAY BE GRADUAL. --- INTERPRETATIONS BY OTHERS MIGHT DIFFER ---

Description: TP-A4

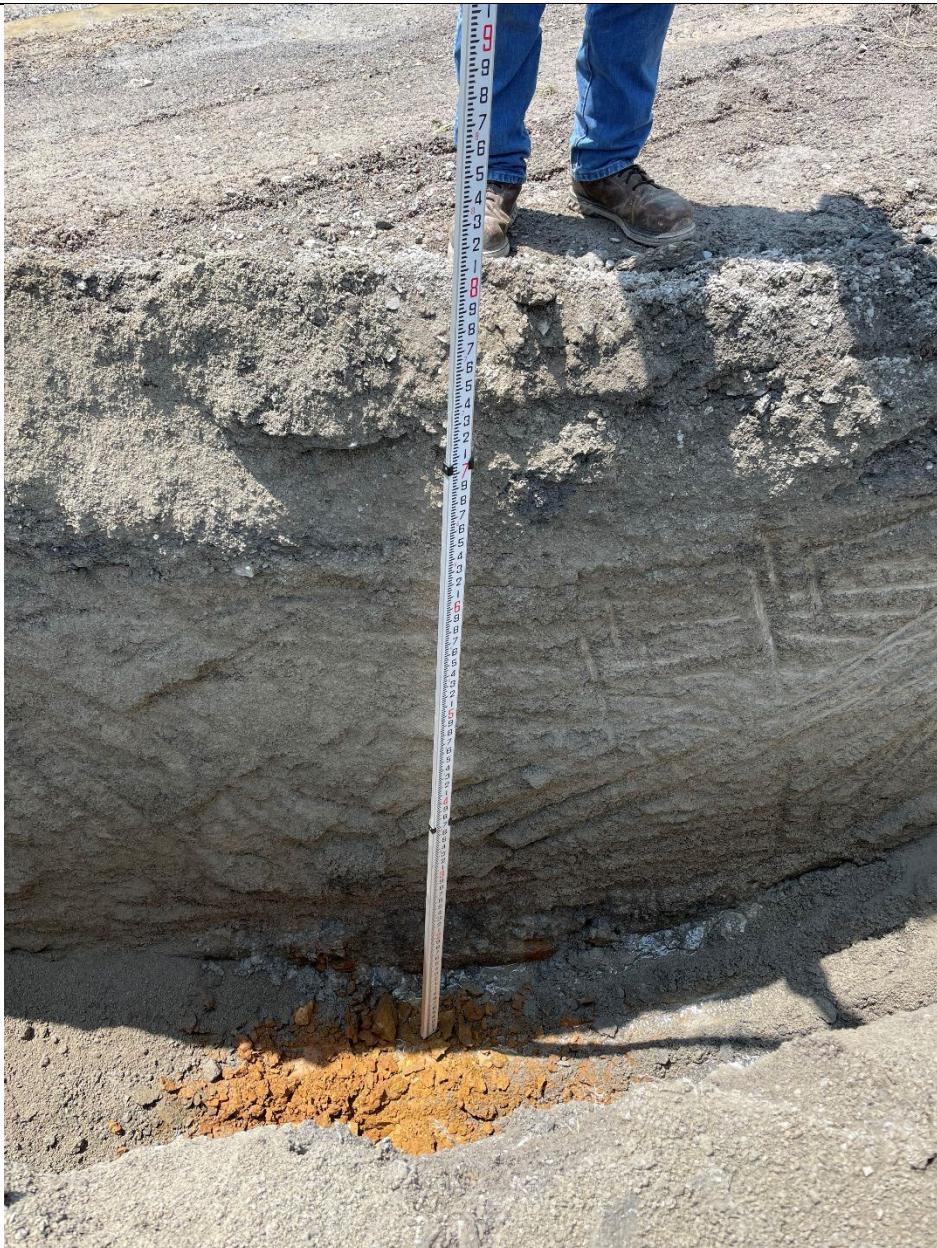
Photograph No. 5

Project: New Hope Crushed Stone & Lime Company - New Hope, PA 18938			Project Code 212c-pb-02541			TP-A5					
			Sheet No. 1 of 1			Date Started 7/12/2023					
Test Pit Location: 40.37811709, -74.97608500			Field Rep M. J. Byle, E. DiFatta			Date Completed 7/12/2023					
G.S. Elevation (ft msl): 103.2											
Equipment Used:			Note Depths of Seepage Inflow Comment on Trench Stability & Unraveling of Sidewalls								
Test Pit Dimensions (ft):			L x W x D								
DEPTH (feet)	SAMPLE NO. and TYPE	USCS SYMBOL	DESCRIPTION OF MATERIAL		U.C.S. (tsf) ⁽¹⁾	WATER CONTENT (%)	LIQUID LIMIT (%)	PLASTIC LIMIT (%)	PI (dim)	FINER No. 200 (%)	
2		sp	Gray sand								
4											
6

96.5								
8		ml	Native yellow brown silt, mottled								
			95.5								
10			Bottom of Test Pit 7.7'								
THE STRATIFICATION LINES REPRESENT THE APPROXIMATE BOUNDARY LINES BETWEEN SOIL TYPES. IN SITU, THE TRANSITION MAY BE GRADUAL. --- INTERPRETATIONS BY OTHERS MIGHT DIFFER ---

Description: TP-A5

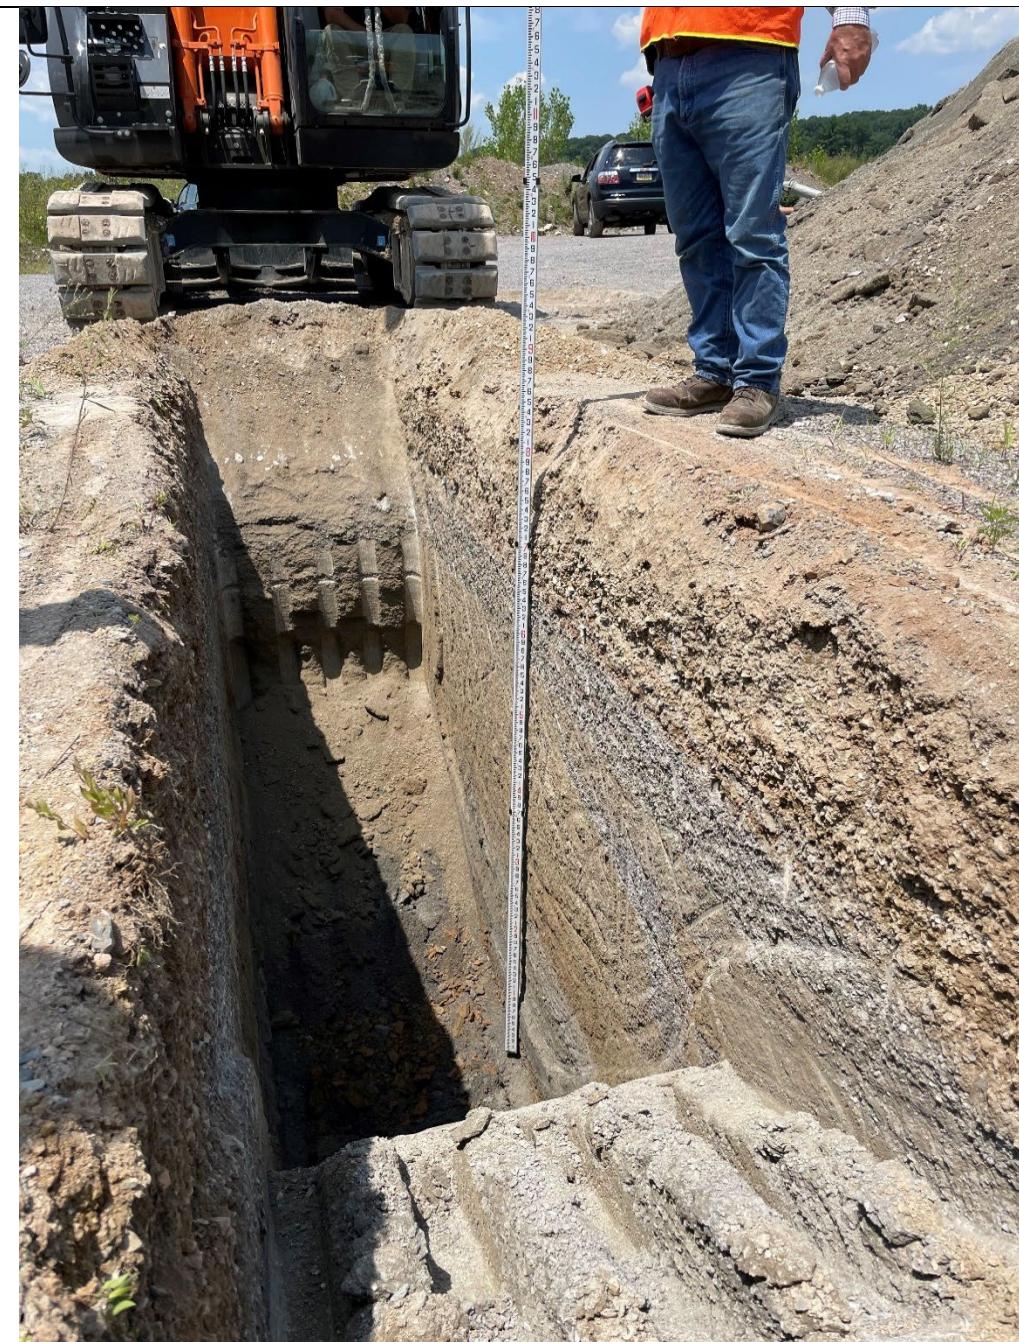
Photograph No. 6

Project: New Hope Crushed Stone & Lime Company - New Hope, PA 18938			Project Code 212c-pb-02541			TP-A6					
			Sheet No. 1 of 1			Date Started 7/12/2023					
Test Pit Location: 40.37809782, -74.97637233 G.S. Elevation (ft msl): 105.8			Field Rep M. J. Byle, E. DiFatta			Date Completed 7/12/2023					
Equipment Used: Test Pit Dimensions (ft): <table border="1" style="display: inline-table; vertical-align: middle;"> <tr><td></td><td></td><td></td></tr> </table> L x W x D									<i>Note Depths of Seepage Inflow</i> <i>Comment on Trench Stability & Unraveling of Sidewalls</i>		
DEPTH (feet)	SAMPLE NO. and TYPE	USCS SYMBOL	DESCRIPTION OF MATERIAL EL (ft): GWT EL:		U.C.S. (tsf) ⁽¹⁾	WATER CONTENT (%)	LIQUID LIMIT (%)	PLASTIC LIMIT (%)	PI (dim)	FINER No. 200 (%)	
2			Fill sand cobbles angular gravel								
4		sp	Native yellow brown shaley silt and clay								
8		cl	97.8								
10			97.3		Bottom of Test Pit 8.5'						
THE STRATIFICATION LINES REPRESENT THE APPROXIMATE BOUNDARY LINES BETWEEN SOIL TYPES. IN SITU, THE TRANSITION MAY BE GRADUAL. --- INTERPRETATIONS BY OTHERS MIGHT DIFFER ---

Description: TP-A6
