## HRS DOCUMENTATION RECORD COVER SHEET

**Site Name:** Nockamixon TCE

## HAZARD RANKING SYSTEM (HRS) SCORE SUMMARY SHEET

Scenario Name: Groundwater and soil contamination affecting water supplies and indoor air quality

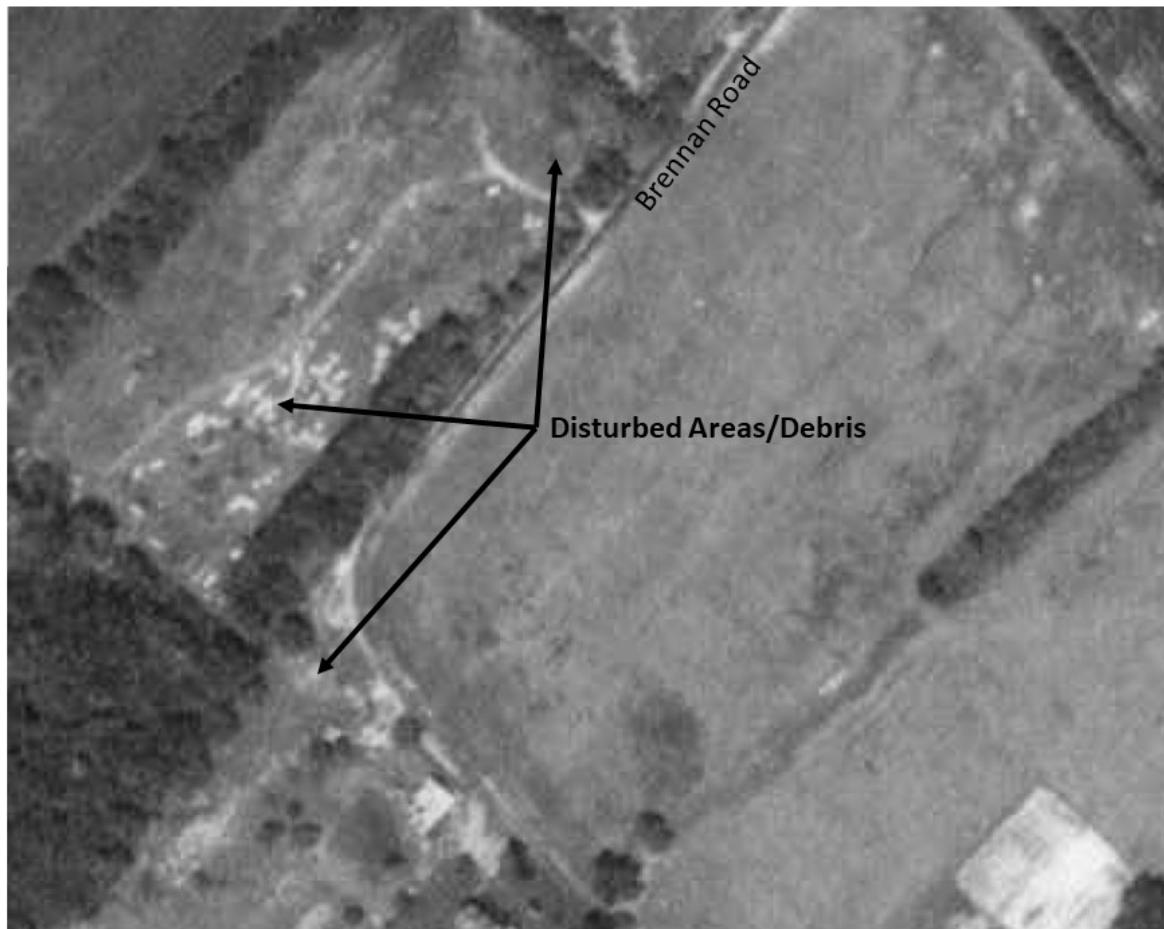
Figure 3  
Nockamixon TCE Site  
1971 Aerial Photo

The Schulberger farm property was reportedly used for the disposal of septic tank wastes and for the storage of drums containing unknown materials in the 1970s (Ref. 5, pp. 2-1 to 2-4). Aerial photographs from the 1970s also revealed nearby land disturbances and debris in a field area near Brennan Road (Figure 3 and Figure 4) (Ref. 6, Appendix A). The Schulberger farm property was subdivided into eight parcels in 1978. After the parcels were passed to the heirs of William Schulberger, the owners/heirs made efforts to consolidate drums, which remained on the ground surface at the Site. Review of historical aerial photos taken between 1964 and 1981 suggests that wastes may have been deposited or buried at several areas on the Schulberger farm property (Ref. 6, p. 9 & 10).

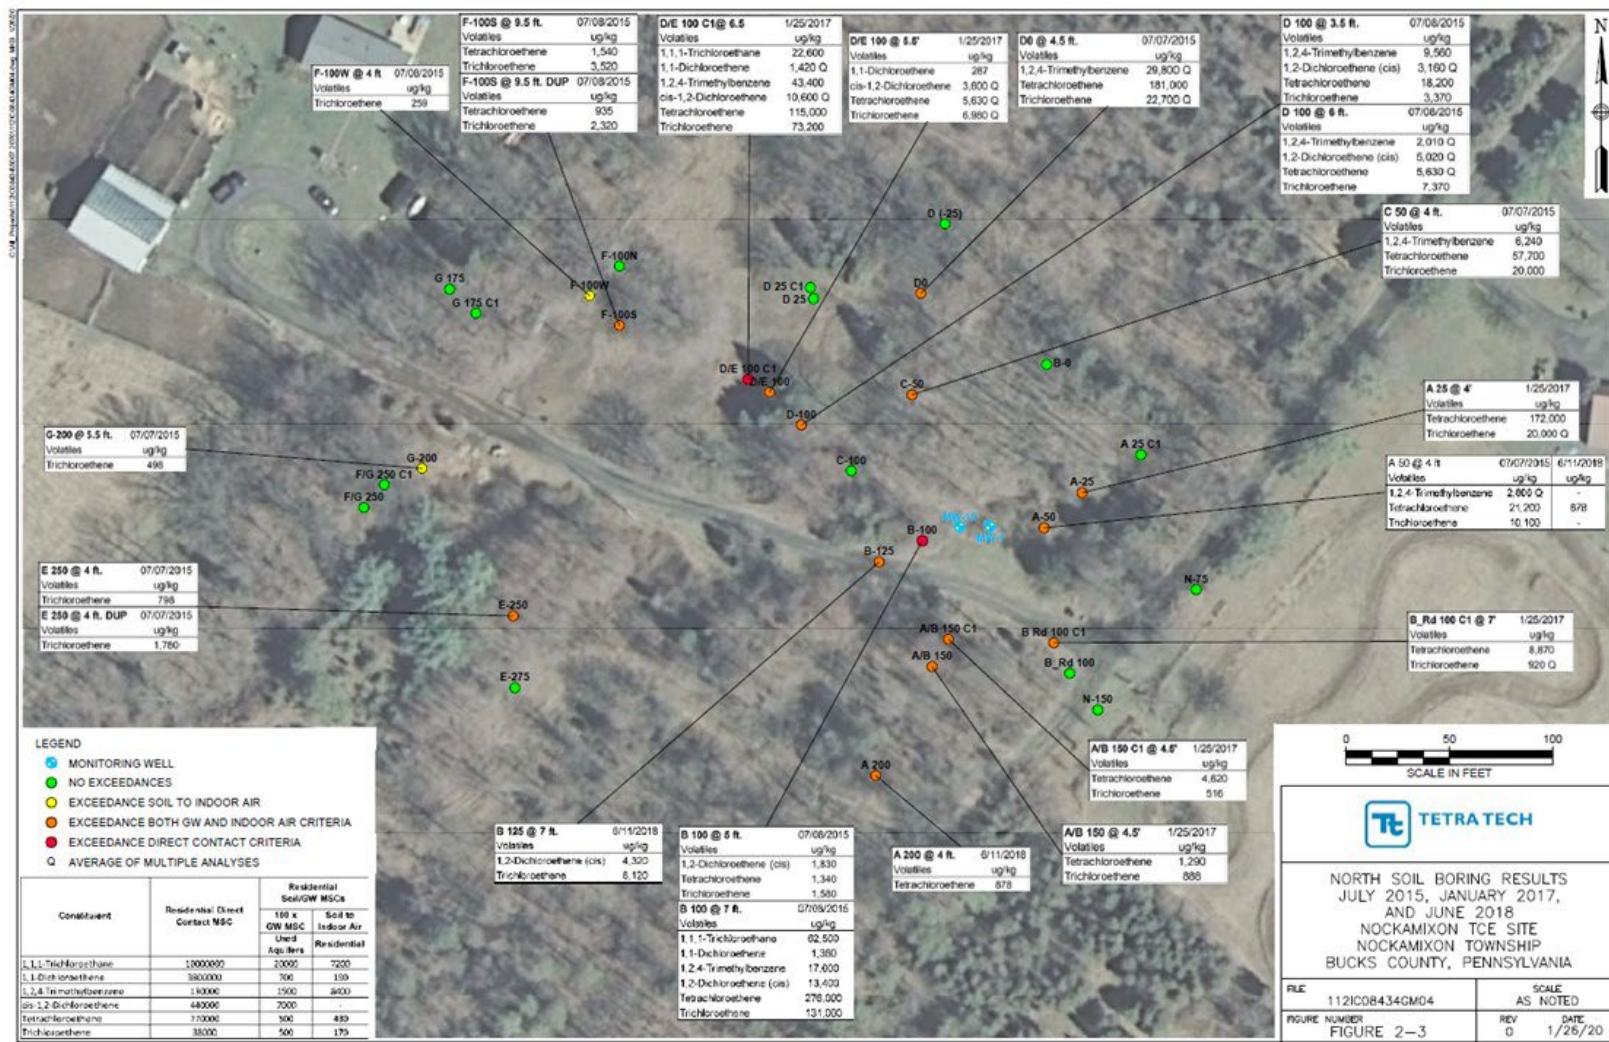
Figure 6  
Soil Sample  
Results  
North Hotspot

Ref. 9, Fig. 2-3

The soil exposure pathway was not scored. While soil impacts have been identified in the contaminant source area, these impacts are present in the sub surface (Ref. 9, Figs. 2-3 & 2-4). Because soil contamination was not identified in surface soil (i.e., 0 – 2 ft.), the soil exposure pathway is not a

Two areas of soil contamination (shown separately in Figures 6 and 7) have been identified as sources of the groundwater contamination. These sources have been combined into a single source area shown on Figure 8 (Ref, 12, Appendix E, Fig. E1). The conceptual site model prepared by GES suggests that chemicals released in the soil hotspot areas may have migrated in bedrock fractures, resulting in a larger source area, which encompasses both soil hotspot areas (Ref, 12, Appendix E, p. 7).

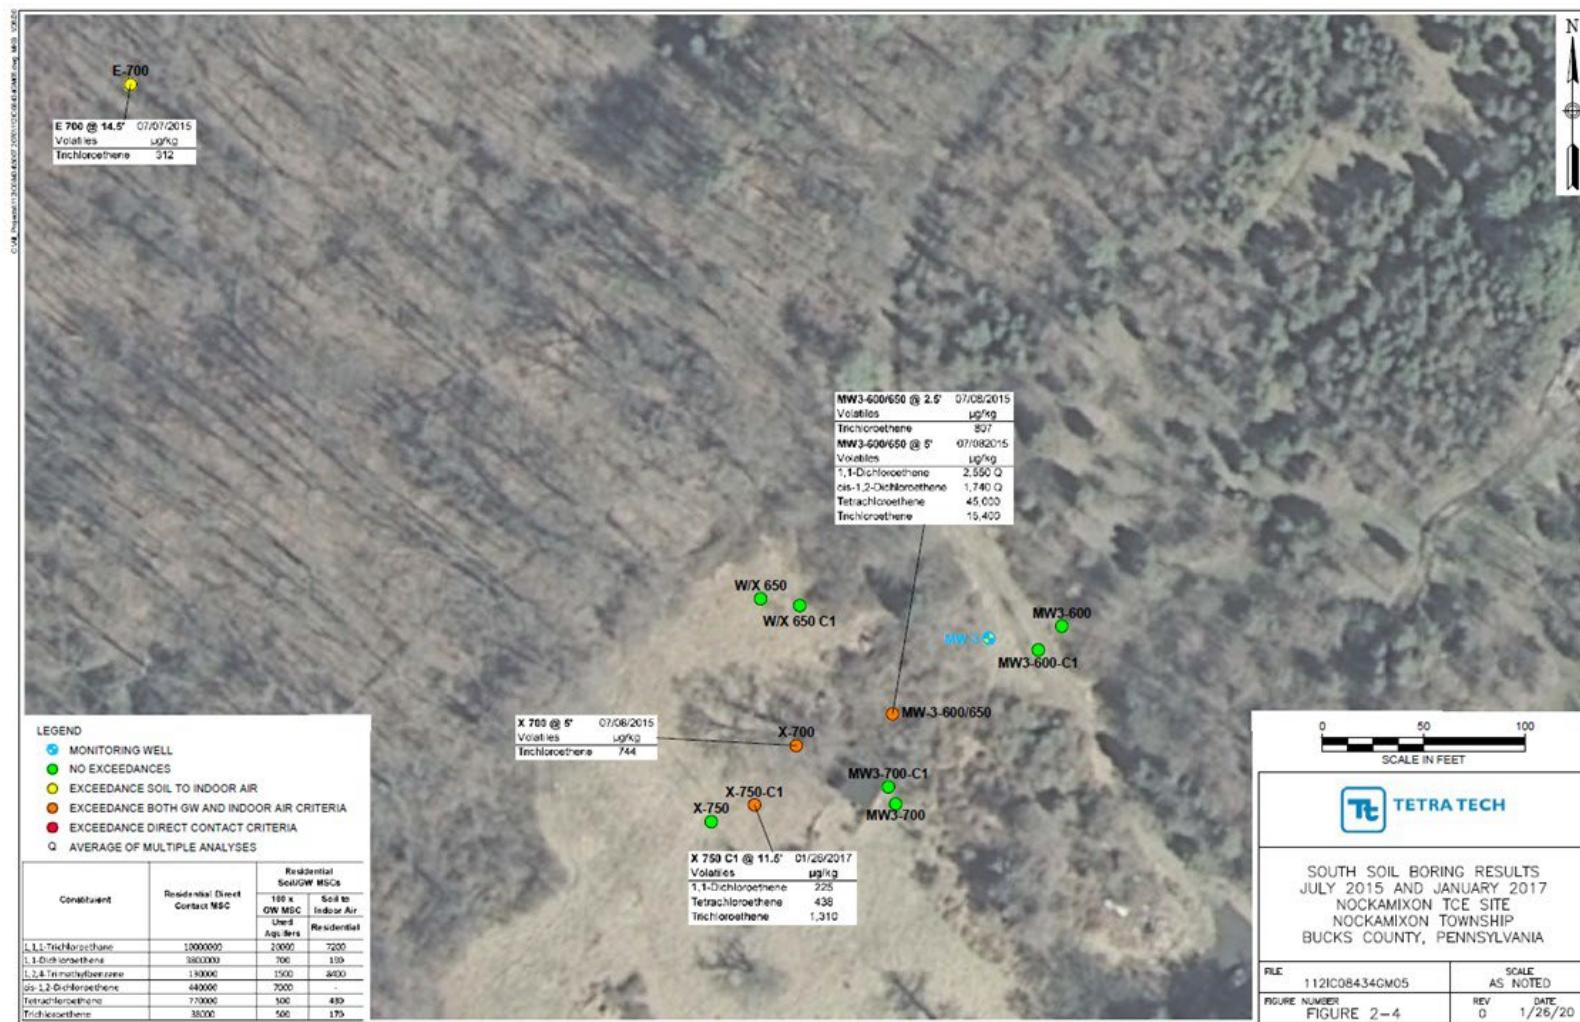
Figure 7  
Soil Sample  
Results  
South Hotspot

Ref. 9, Fig. 2-4

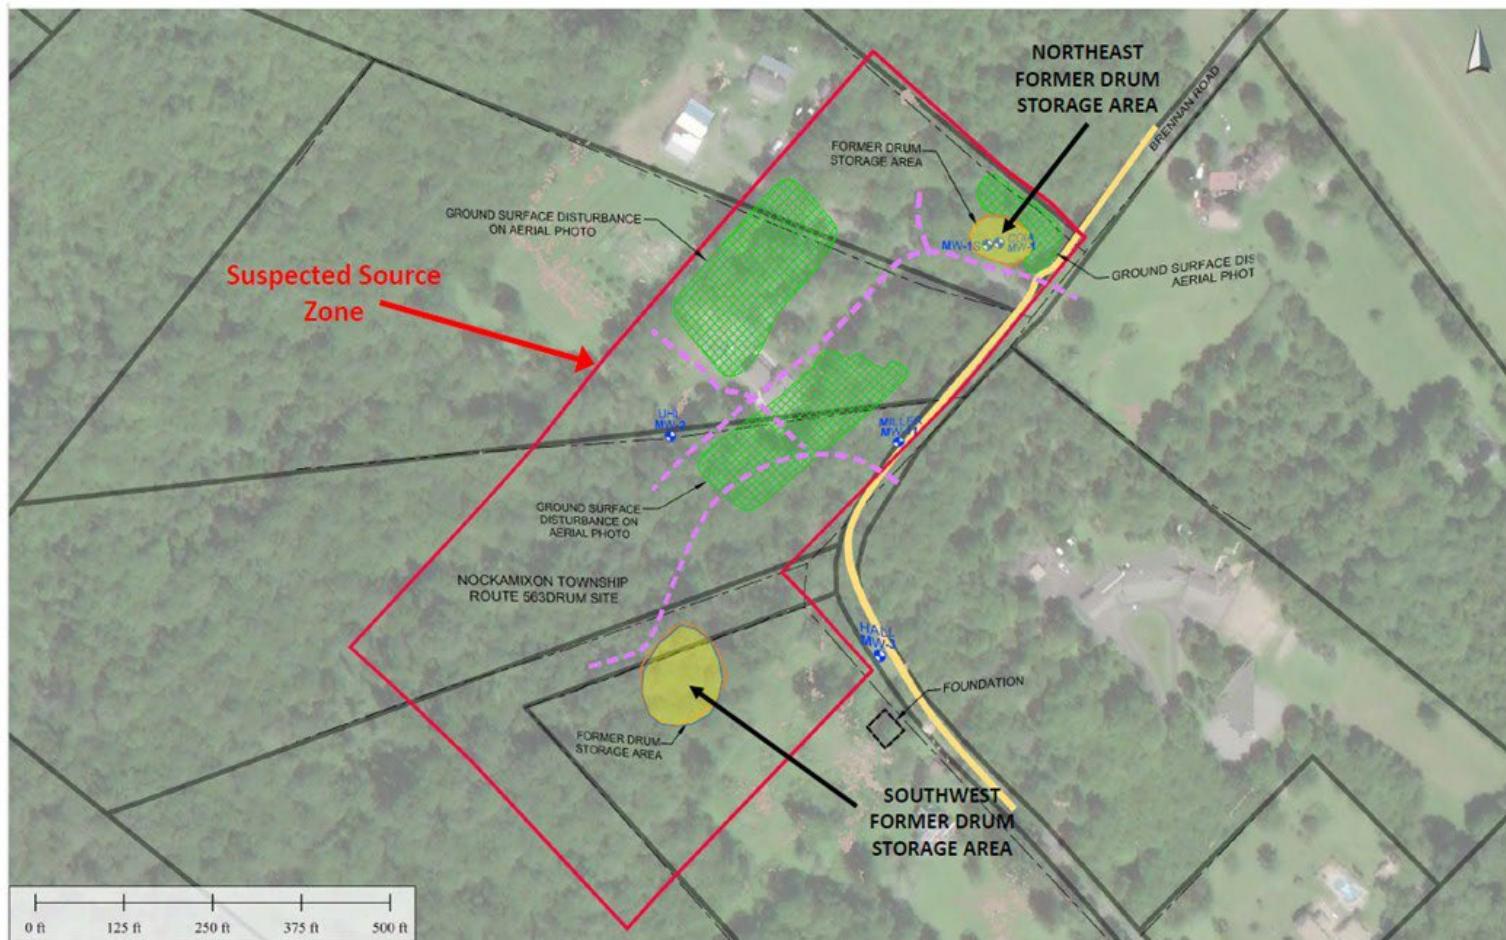
**Figure 8**  
**Suspected Source**  
**Zone**

Ref. 12, Appendix E, Fig. E-2

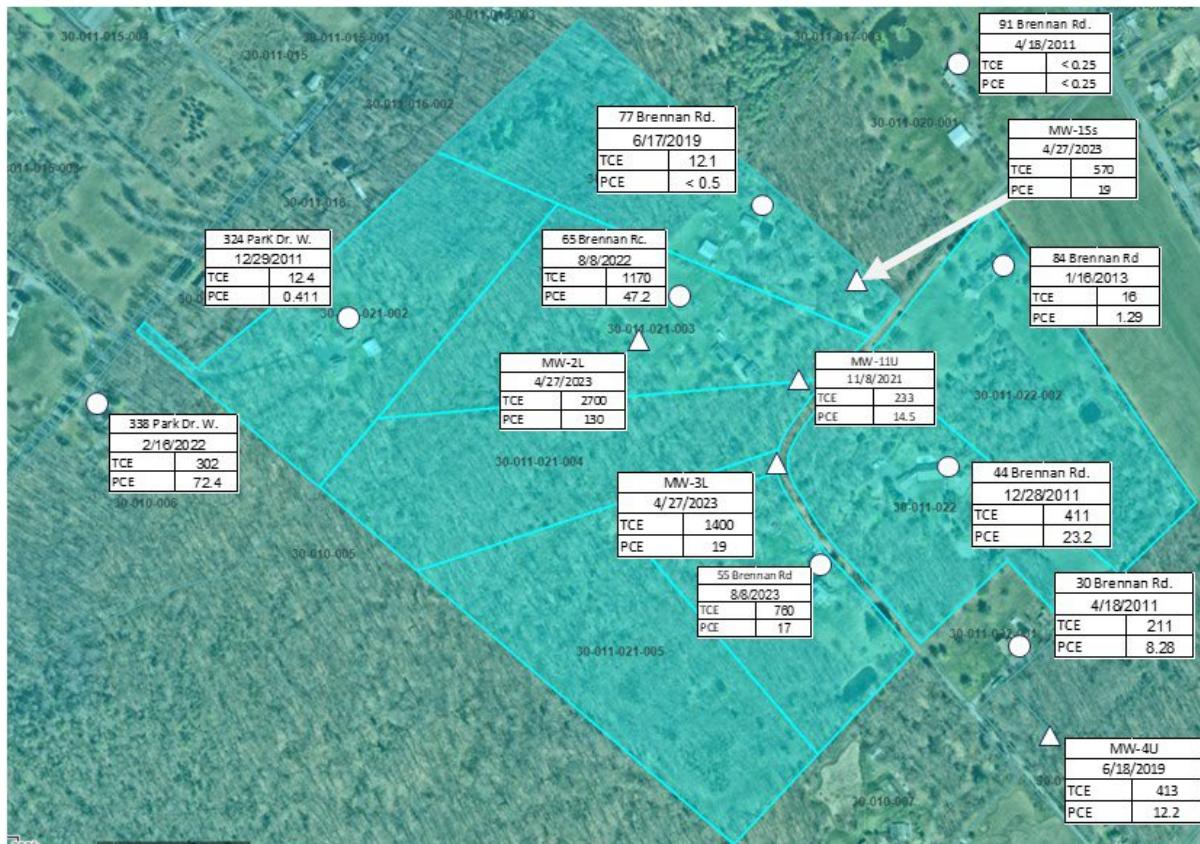
**Figure 9**

Nockamixon TCE Site  
Fmr. Schulberger Farm Area  
TCE & PCE Concentrations  
In Groundwater Samples

○ Residential Well  
△ Monitoring Well

Notes:  
TCE – Trichloroethene  
PCE – Tetrachloroethene

All results are expressed in  
Micrograms/liter (ug/l)

To establish that indoor air concentrations of TCE at the Site constitute an observed exposure they must be attributable to subsurface contamination (Ref. 1, Table 2-3). As shown on Figure 4, a maximum TCE concentration of 131,000 micrograms per kilogram (μg/kg) was detected in soil boring B-100, collected at a depth of 7 feet below ground surface (ft. bgs). (Ref. 37, p. 3). The maximum concentration of TCE detected in soil gas at the Site was 3,310,000 micrograms per cubic meter (μg/m<sup>3</sup>) at soil gas sampling location SG-1 (Ref 37, p. 2) (See Figure 13.) The maximum TCE concentration detected in groundwater at the Site (2,700 ug/l) occurred at MW-2L, located within the source zone, and shown on Figure 9 (Ref. 27, p. 4).

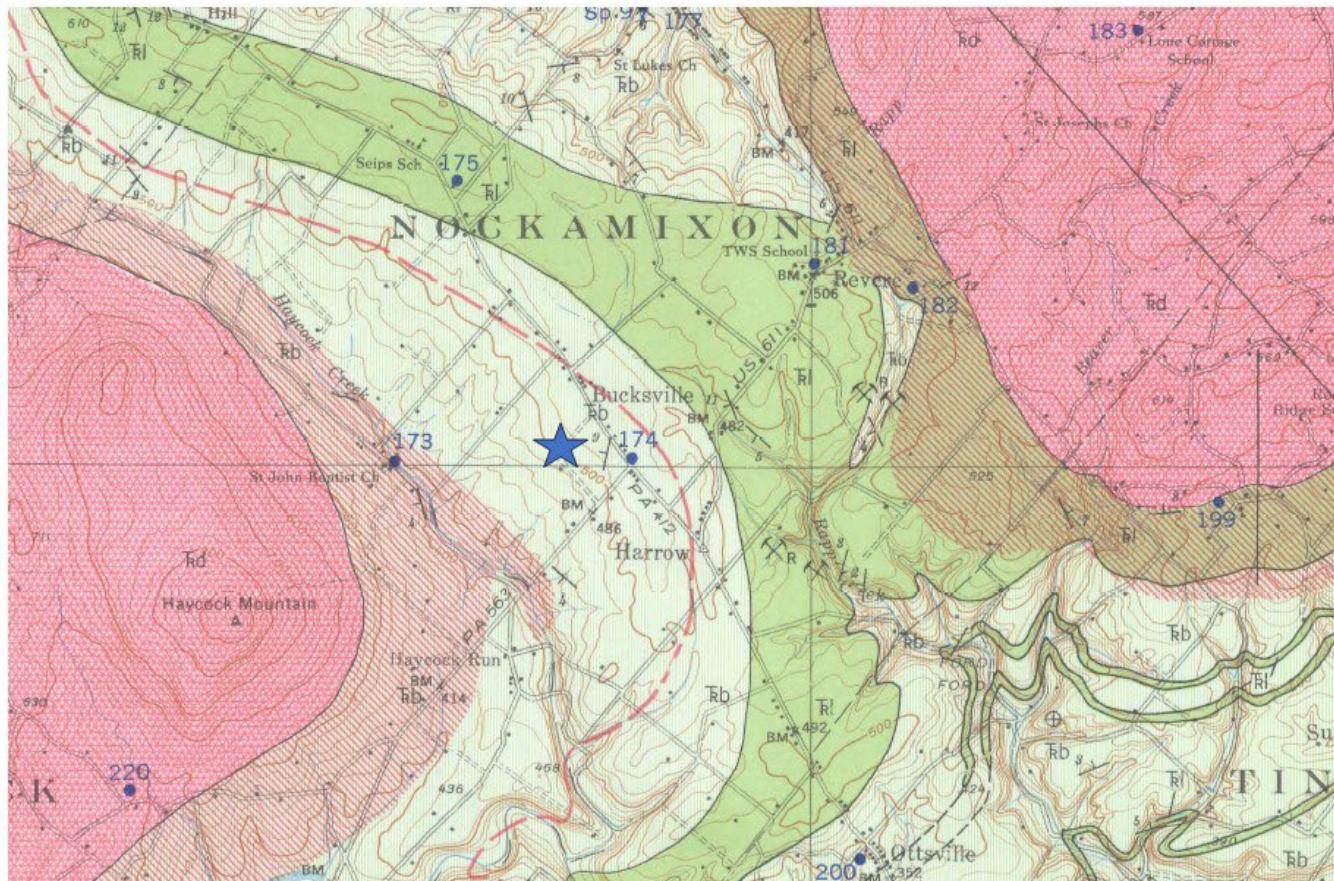
**Figure 10**  
Nockamixon TCE Site  
Geologic Map

Diabase  
Igneous sills and dikes intruding Triassic and older sedimentary rocks

Brunswick lithofacies  
Red shales and sandstones grading upward into limestone,  $Tl_c$ , and quartzite,  $Tq_c$ . Conglomerates along the northwest margin. Altered to black hornfels adjacent to diabase intrusives

Lockatong lithofacies  
Gray to black argillite, grades laterally into Brunswick. Altered to black hornfels adjacent to diabase intrusives

Site/Source Location

The Brunswick Formation contains water under both water-table and semiartesian conditions in the weathered zone, which may extend to depths of 600 feet or more. A water-table aquifer of low permeability, comprising the highly weathered zone occurs to depths of about 250 feet; and one or

more rather permeable artesian aquifers, consisting of beds of partly altered rock rarely more than 20 feet thick, occur to depths of about 600 feet. In both types of aquifers, the saturated voids are believed to be vertical joint fractures enlarged by solution. The water table aquifer contains many more fractures than the semiartesian aquifers, but the near-surface rocks have been so thoroughly decomposed that many of the cracks are filled with clay residual from the weathering of the shale (Ref 29, p. 34).

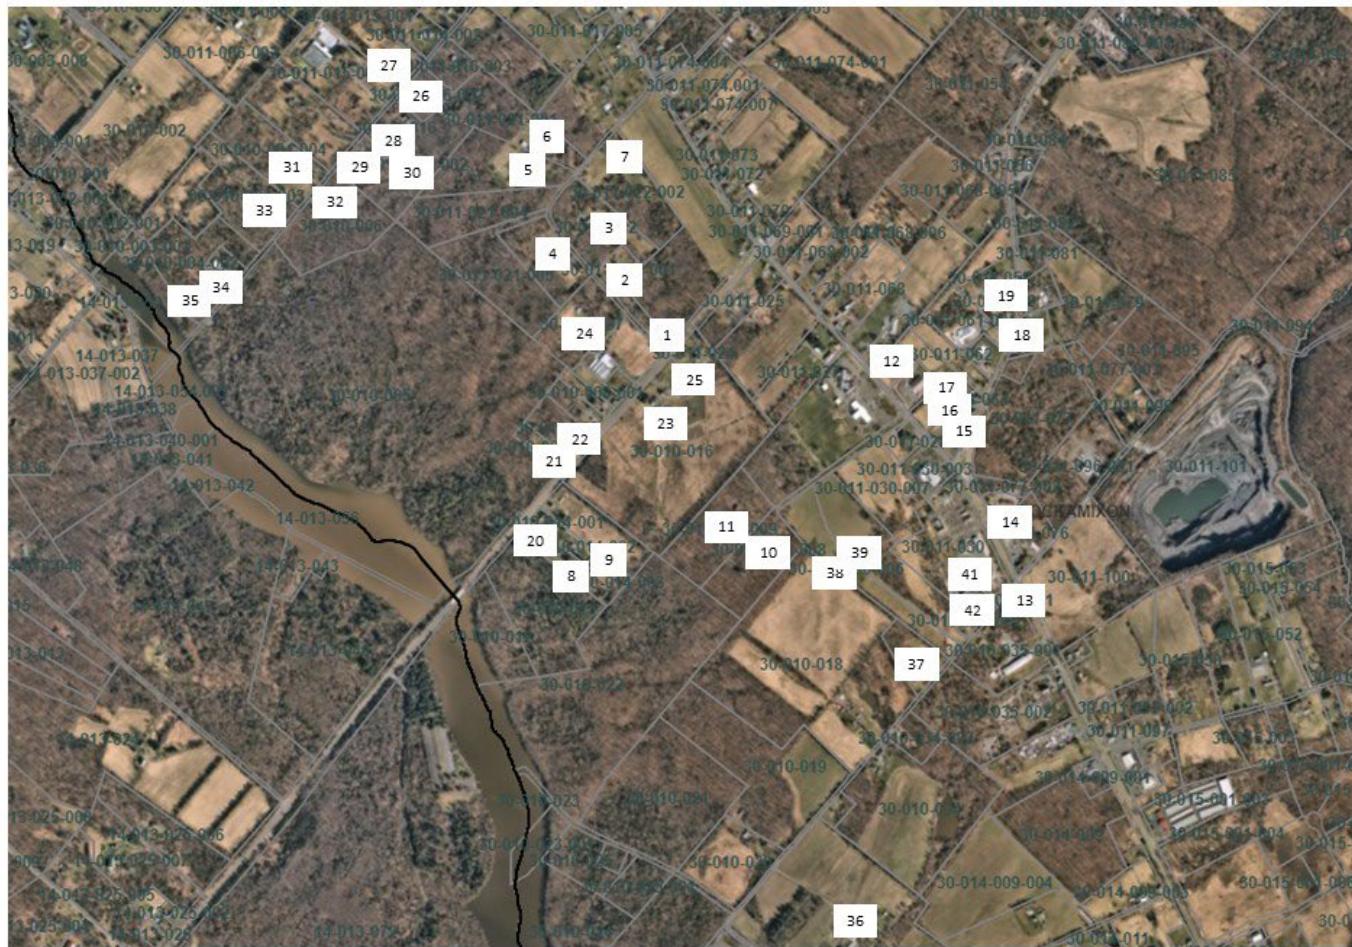
**Figure 11**  
**Nockamixon TCE HSCA Site**  
**Groundwater Migration Pathway**  
**Level 1 Exposures**  
 (See Table 3-2)

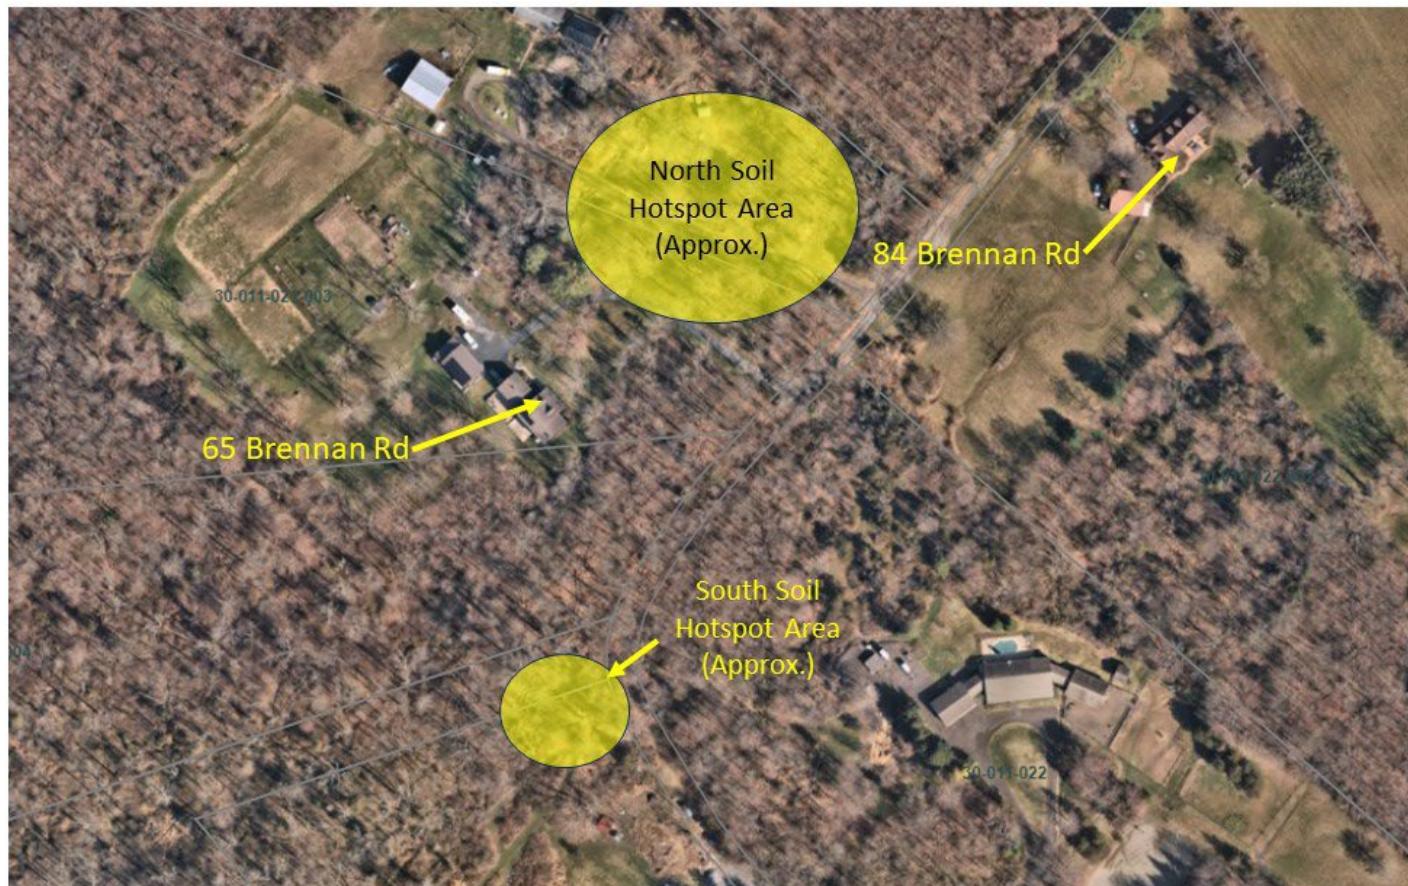
**Figure 12**  
**Nockamixon TCE HSCA Site**  
**Sub Slab Intrusion Pathway**  
**Observed Exposures**  
(See Table 5-12)

At the Site, there is one documented area of exposure (AOE) where two residential structures are subject to indoor air contamination resulting from subsurface intrusion, as shown on Figure 13. The AOE is delineated based on residential structures that had observed exposures of site attributable TCE, as documented through indoor air sampling (see Observed Exposure by Chemical Analysis below and Figure 13). The occupied residential structures are located at 65 and 84 Brennan Road and are located above the area of soil gas and/or groundwater contamination described above. Based upon concentrations of TCE detected in these residences vapor mitigation systems were activated at 84 and 65 Brennan Road on December 10, 2018, and March 14, 2019, respectively (Ref. 9, p. 2-8).

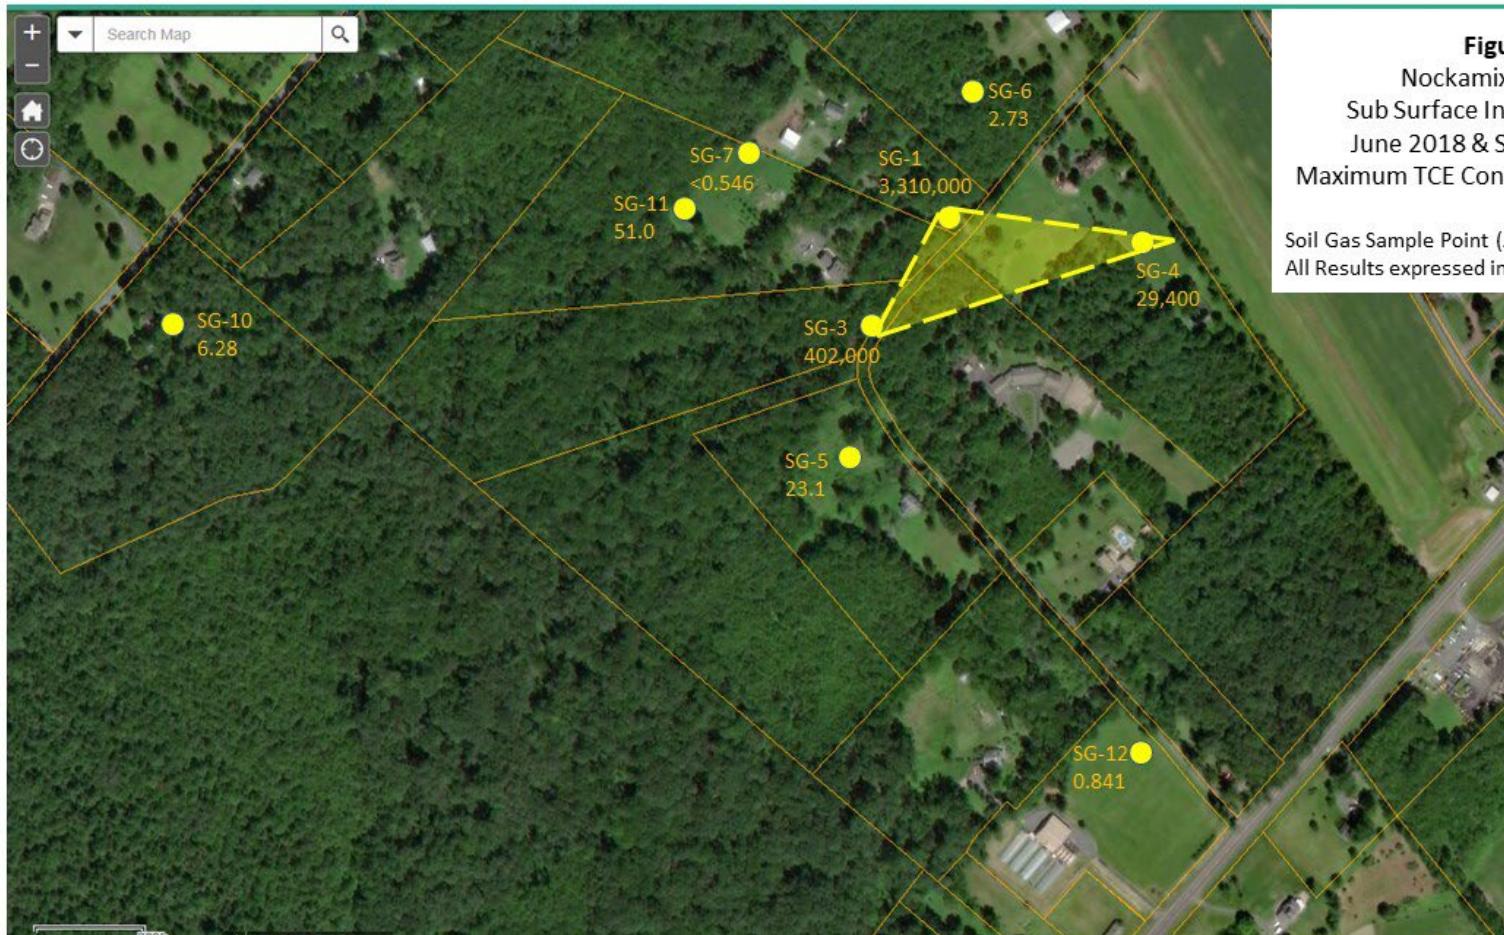
**Figure 13**  
 Nockamixon TCE Site  
 Sub Surface Intrusion Pathway  
 June 2018 & September 2019  
 Maximum TCE Concentrations - Soil Gas

Soil Gas Sample Point (Approx.)  
 All Results expressed in ug/m<sup>3</sup>

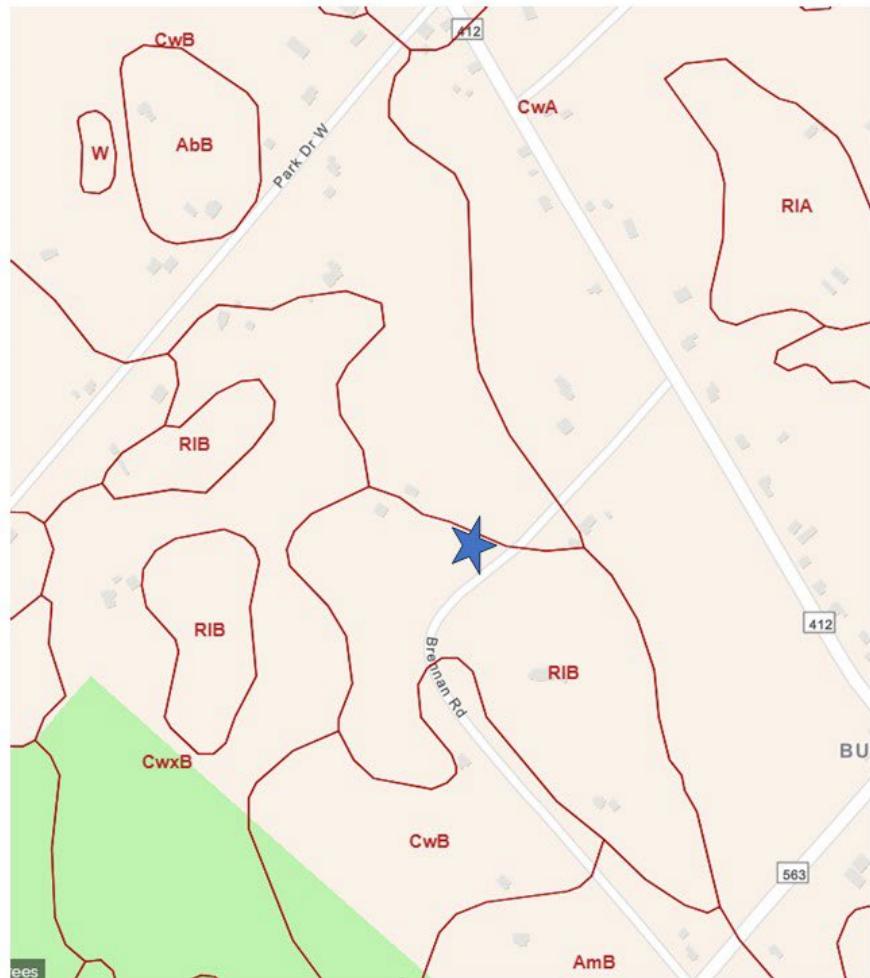
**Figure 14**  
**Nockamixon TCE HSCA Site**  
**Source Area Soil Types**

★ Approximate Center of Source Area

**CwB** Croton silt loam 3 to 8 percent slopes (Ref. 33, p. 27)

**RIB** Reaville channery silt loam 3 to 8 percent slopes (Ref. 33, p. 30)

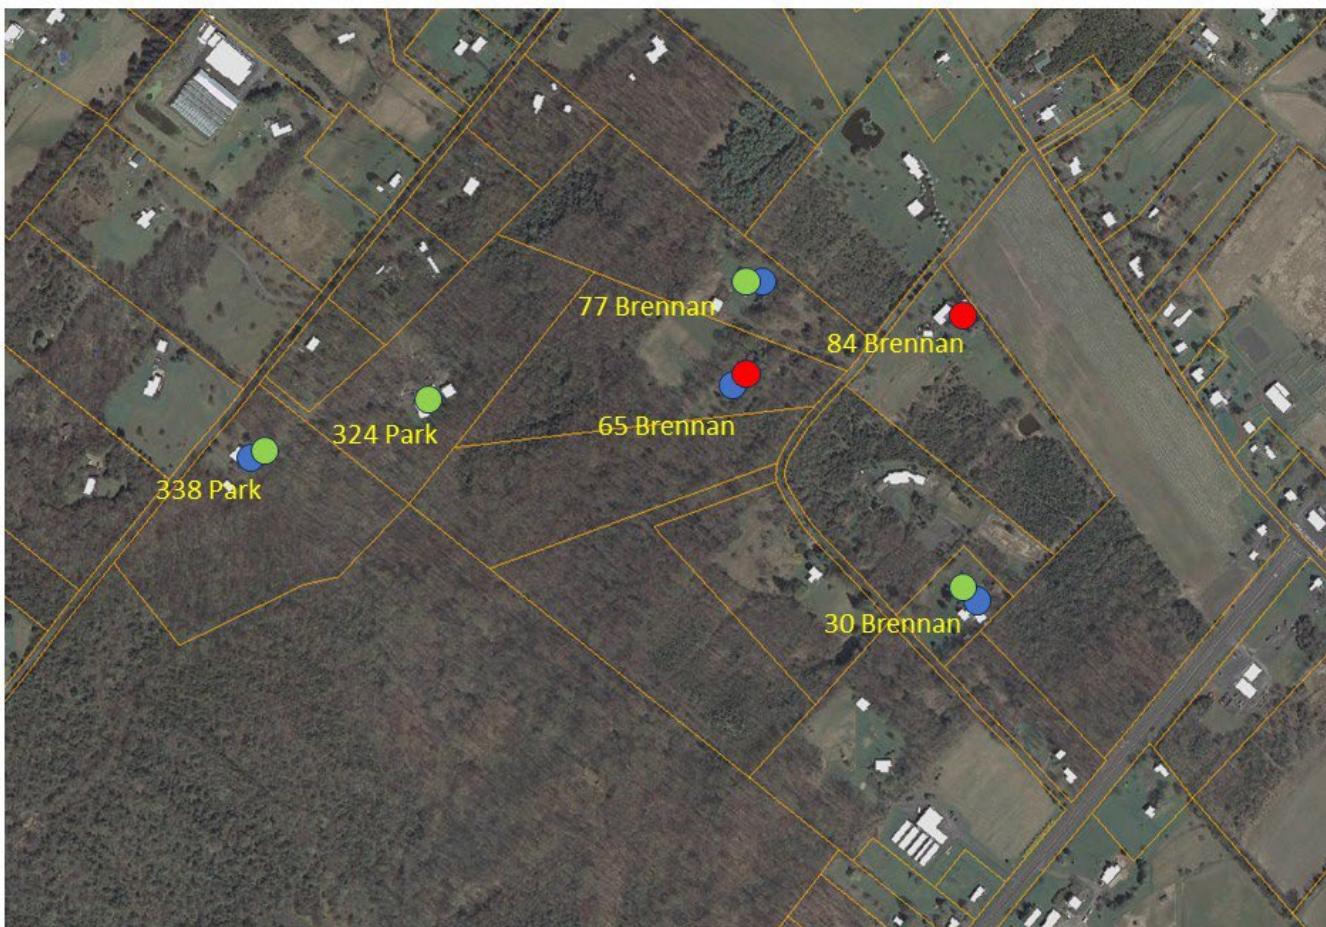
**Figure 15**  
**Nockamixon TCE HSCA Site**  
**Sub Surface Intrusion Pathway**  
**Exposure, Background and**  
**Ambient Sample Locations**

- Confirmed Exposure
- Background Location
- Ambient Location

To establish that one or more observed exposures has occurred at the Site, indoor air concentrations of TCE must be equal to or greater than the quantitation limit when TCE is not detected in background samples (Ref. 1, Table 2-3). Indoor air samples collected at structures, which are more distant from the area of sub surface soil gas contamination shown on Figure 13 are considered representative of background conditions. In addition to samples collected during the first two indoor air sampling events, follow up background samples were collected in February 2018 at 77 Brennan Road and 338 Park Drive West. Locations of these background indoor air samples with respect to observed exposure samples are shown on Figure 15. Table 5-13 summarizes the results of indoor air samples collected from these background locations.
