Subject: COMMENT RESPONSE - Phase I Application for Hazardous Waste Landfill
No. 7
MAX Environmental Technologies, Inc. – Yukon Facility
South Huntingdon Township, Westmoreland County, Pennsylvania
CEC Project 170-822.2240
I.D. No. PAD004835146
APS No. 1071176
AUTH No. 1410078

**HAZARDOUS WASTE LANDFILL NO. 7
MAX ENVIRONMENTAL TECHNOLOGIES, INC.
SOUTH HUNTINGDON TOWNSHIP,
WESTMORELAND COUNTY, PENNSYLVANIA**

This report presents the findings of a wetland and stream delineation completed by Civil & Environmental Consultants, Inc. (CEC) for the Hazardous Waste Landfill No. 7 Project located in South Huntingdon Township, Westmoreland County, Pennsylvania (Figure WDR-1). The project consists of a proposed landfill development to the north of the existing Impoundment No. 5. CEC conducted the wetland and stream delineation at the request of Max Environmental Technologies, Inc. (MAX).

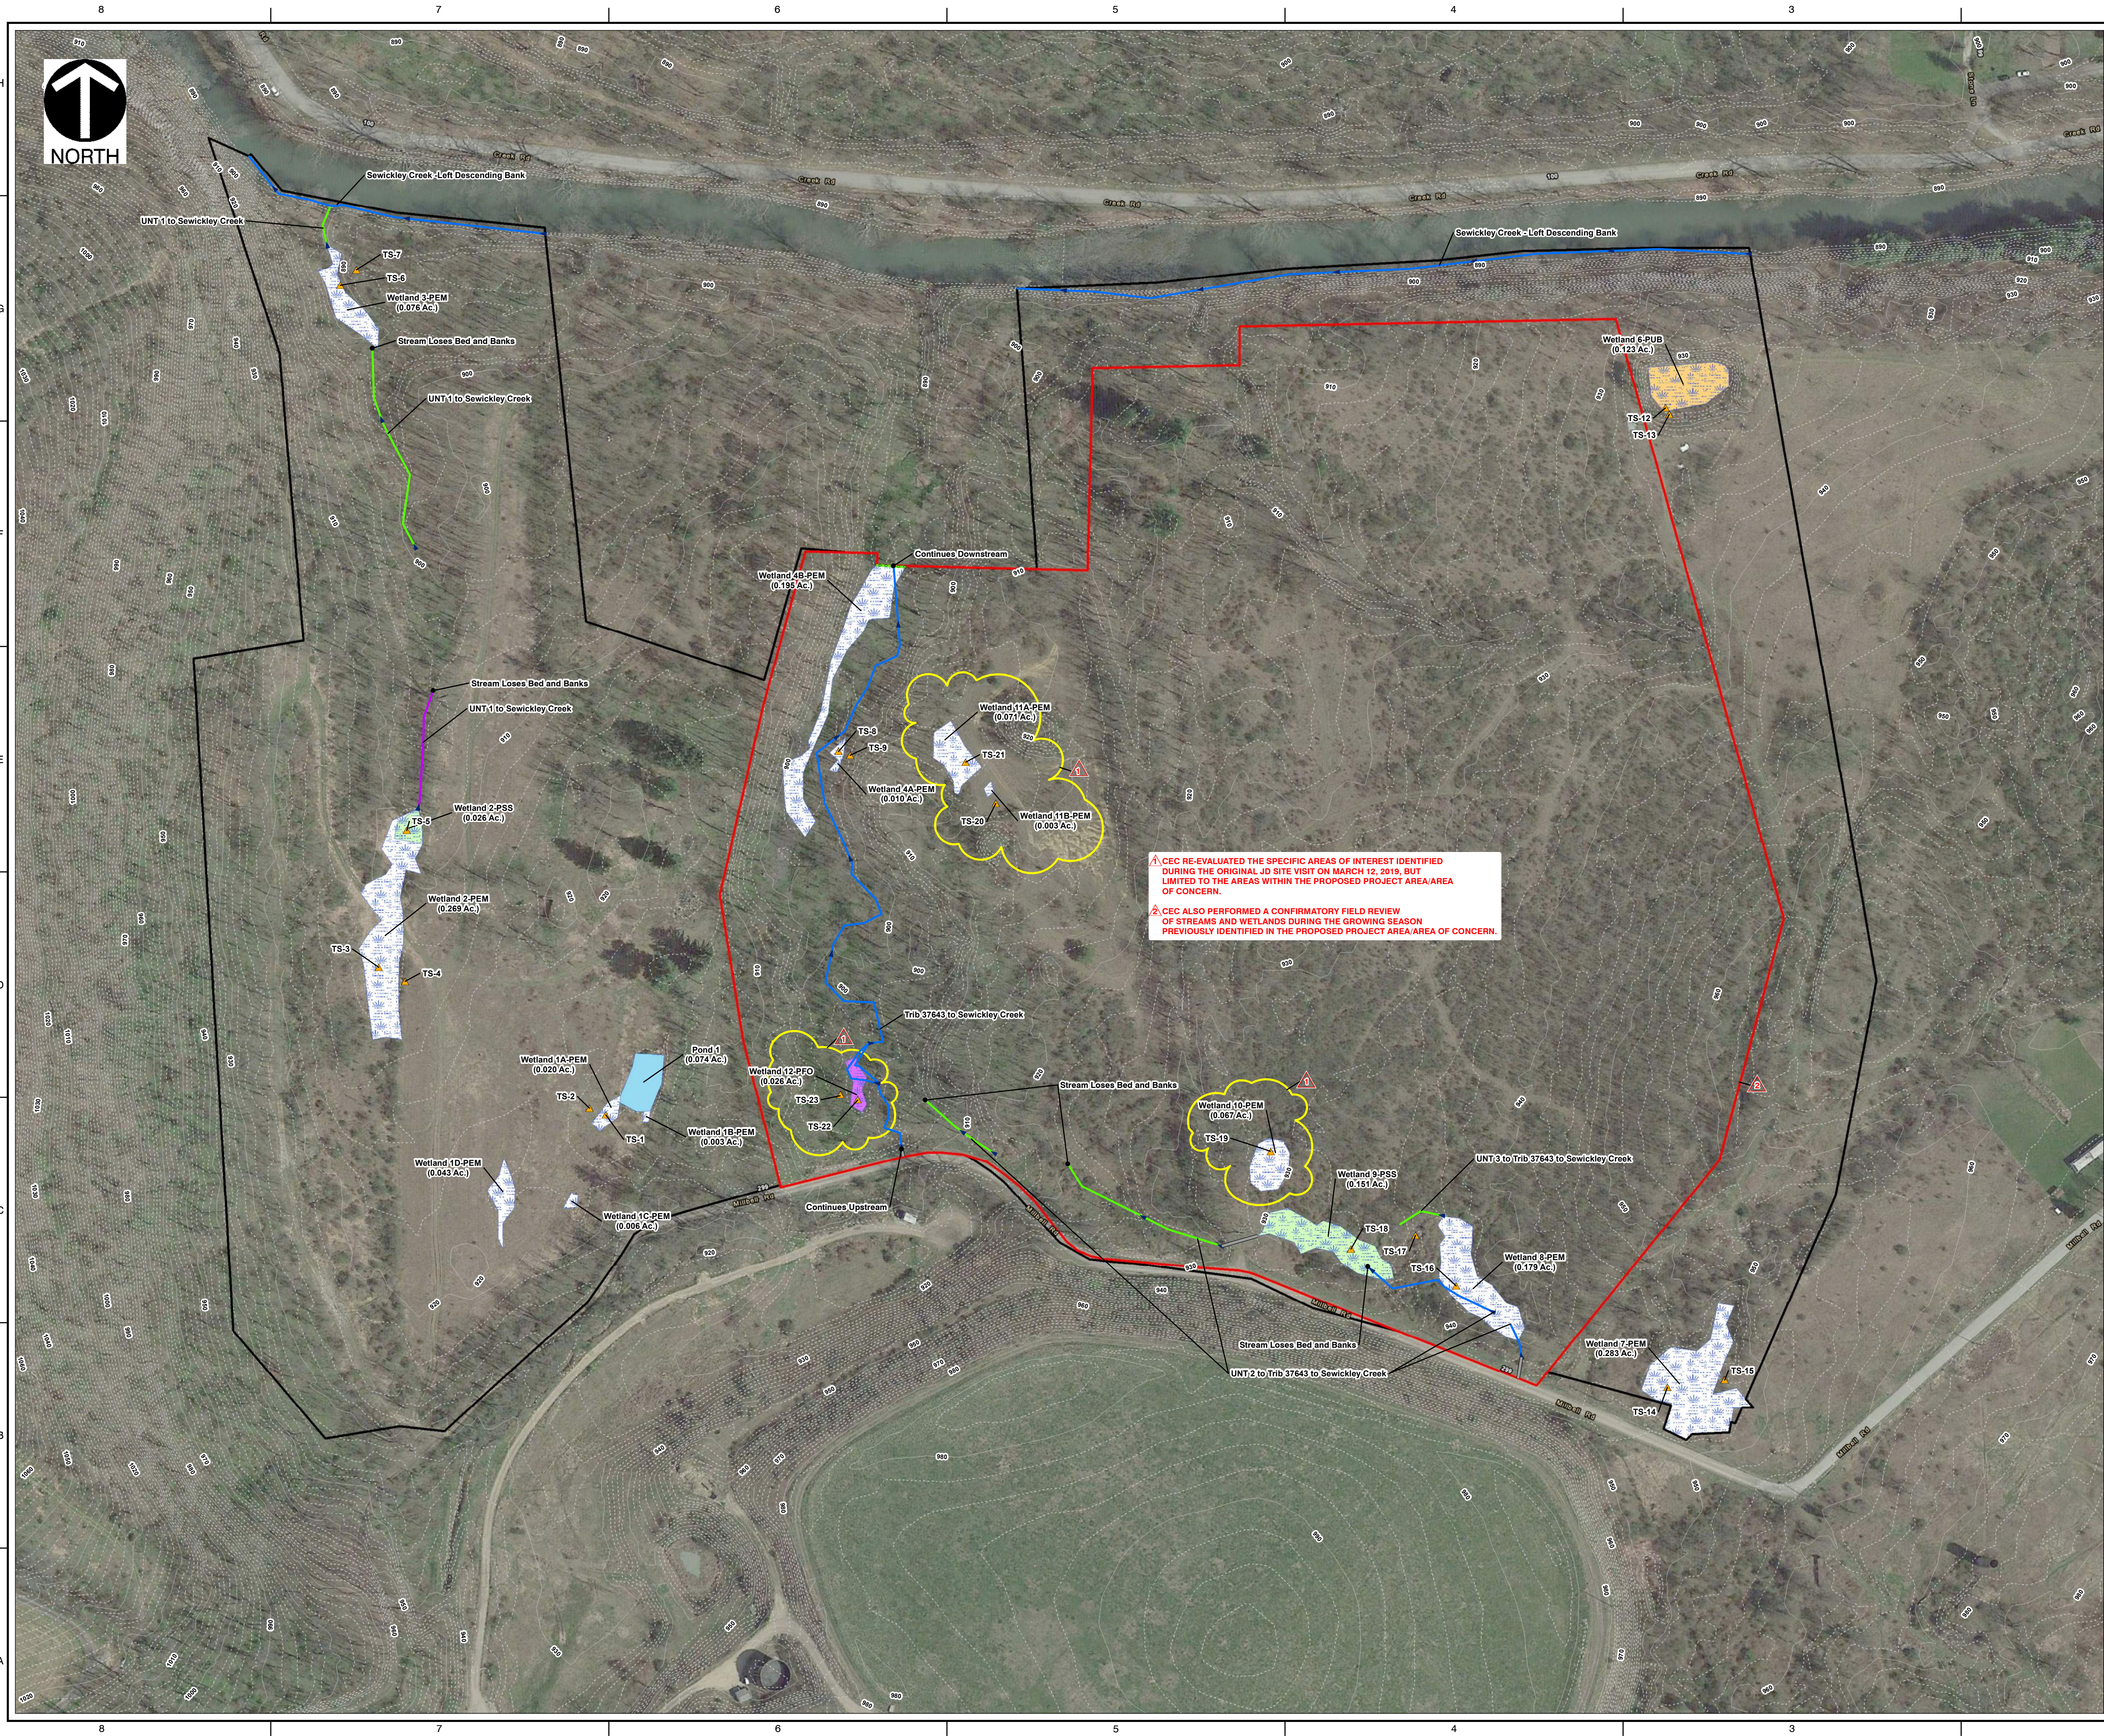
REVISION RECORD		
NO	DATE	DESCRIPTION
1	08/12/2019	REVISED PER ADDITIONAL CEC SITE VISIT WETLAND RE-EVALUATION CONDUCTED ON 8/13/2019 PER REQUEST OF USACE/PAEP AS A FOLLOW-UP TO THE FIELD JURISDICTIONAL DETERMINATION MEETING HELD ON 8/13/2019.
SUBMITTAL RECORD		
NO	DATE	DESCRIPTION

As such, this revised WSDR is being submitted following additional onsite wetland and stream delineations performed by CEC on August 13, 2019. As noted in the revised report, CEC has delineated additional wetland areas (Wetlands 10, 11A, 11B, and 12) and stream segments (braided channel of Trib 37643 to Sewickley Creek). CEC trusts the attached is sufficient to allow the USACE to complete their jurisdictional determination of the proposed project area/area of concern. However, if you feel that another onsite meeting is required to complete your review, MAX will

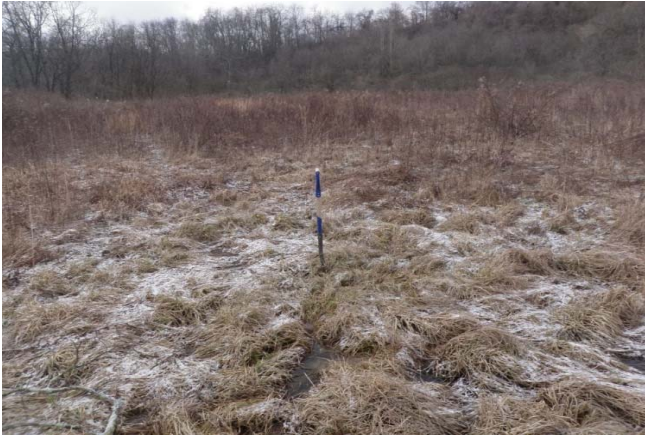
Photo 1: Test Site 1, Wetland 1A.
Facing southwest - March 8, 2018

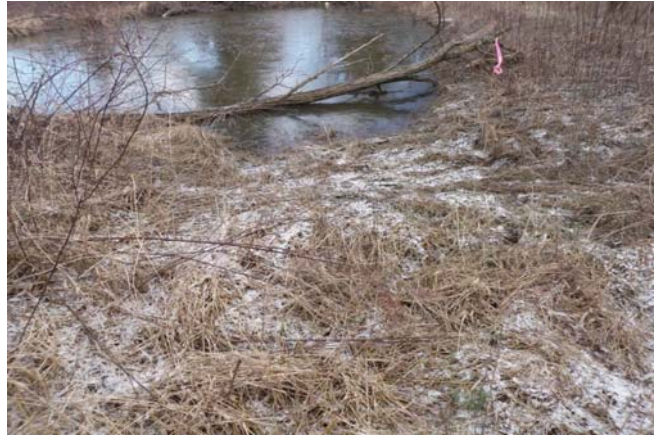
Photo 2: Wetland 1B.
Facing north - March 8, 2018

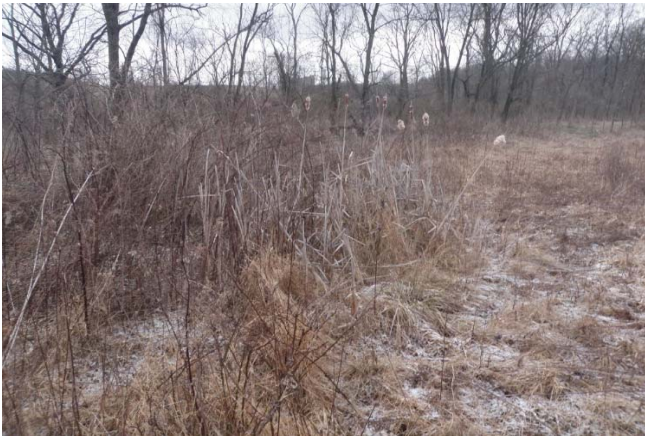
Photo 3: Wetland 1C.
Facing southwest - March 8, 2018

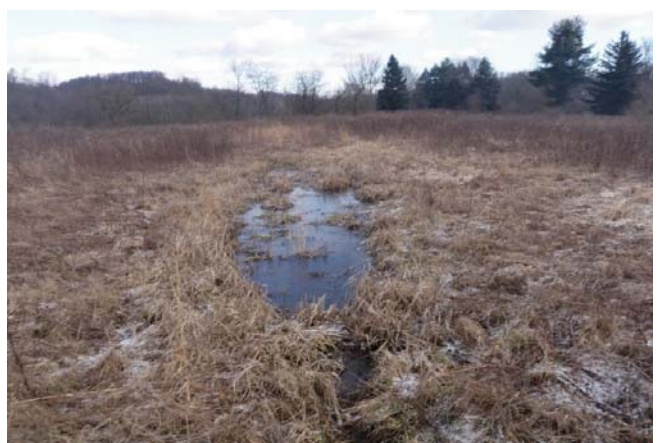
Photo 4: Wetland 1D.
Facing north - March 8, 2018

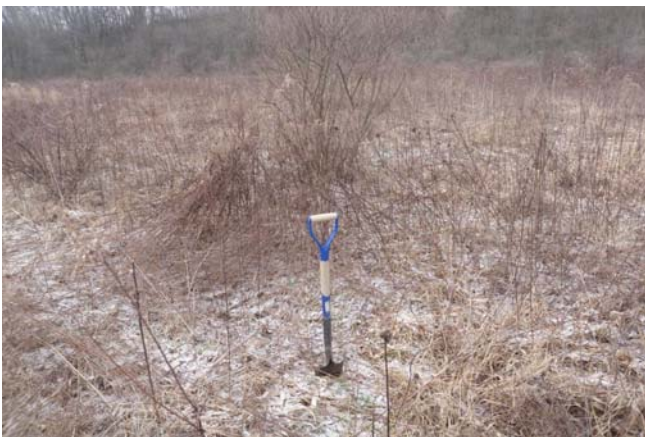
Photo 5: Test Site 2, non-wetland.
Facing west - March 8, 2018

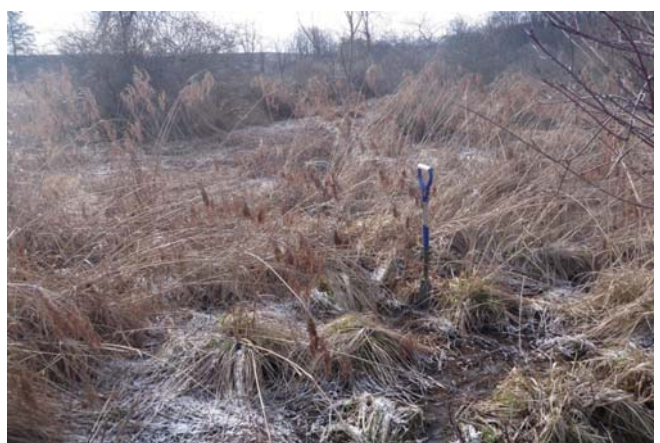
Photo 6: Test Site 3, Wetland 2, PEM portion.
Facing south - March 8, 2018

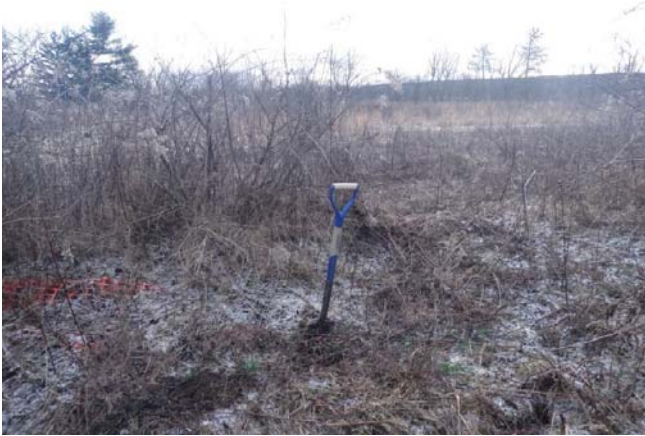
Photo 7: Test Site 4, non-wetland.
Facing east - March 8, 2018

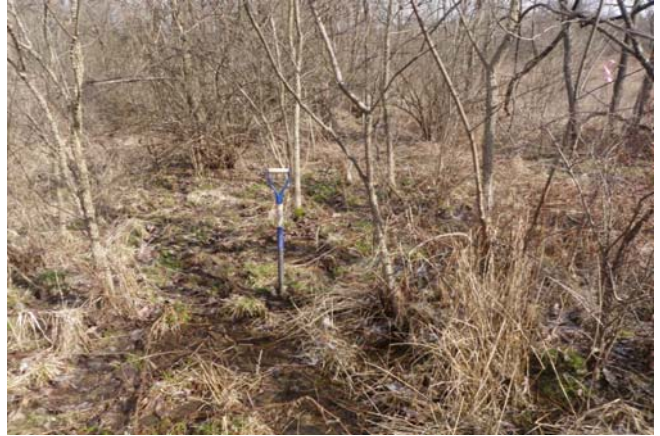
Photo 8: Test Site 5, Wetland 2, PSS portion.
Facing north - March 8, 2018

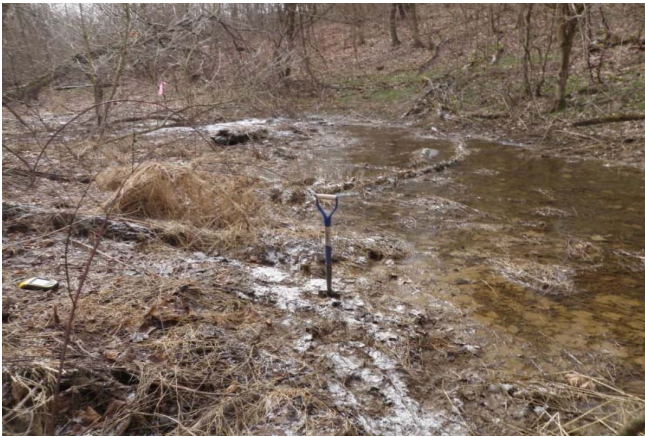
Photo 9: Test Site 6, Wetland 3.
Facing south - March 8, 2018

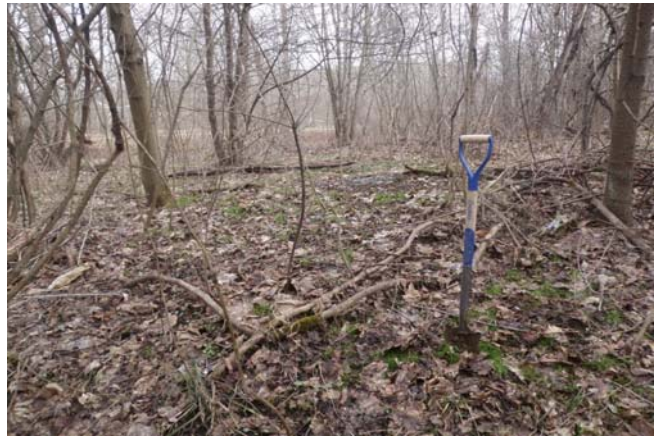
Photo 10: Test Site 7, non-wetland.
Facing northeast - March 8, 2018

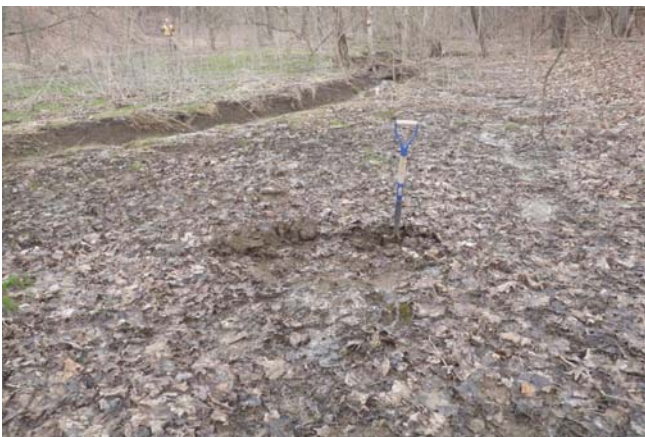
Photo 11: Test Site 8, Wetland 4A.
Facing north - March 8, 2018

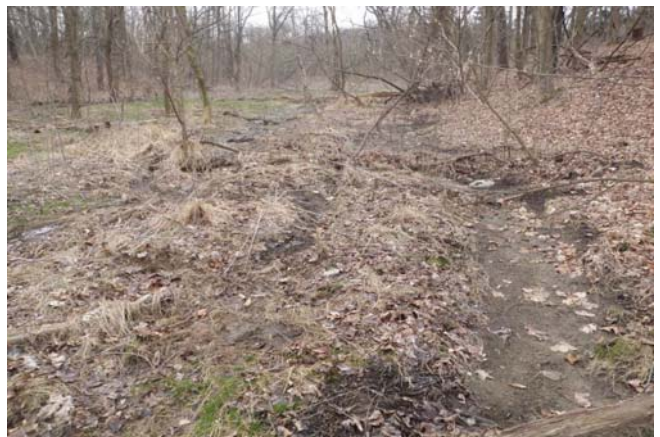
Photo 12: Wetland 4B.
Facing south - March 8, 2018

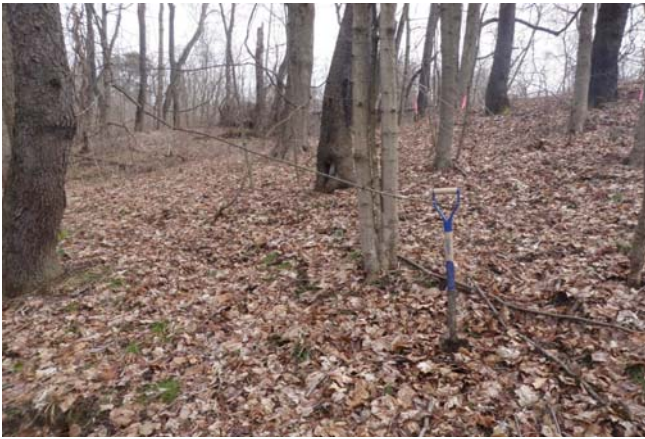
Photo 13: Test Site 9, non-wetland.
Facing east - March 8, 2018

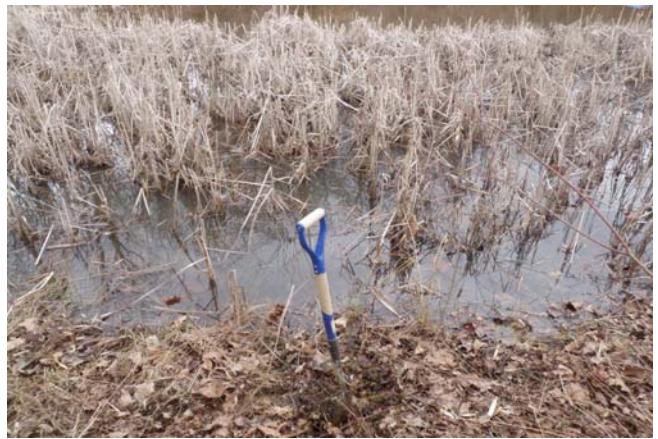
Photo 14: Test Site 12, Wetland 6.
Facing northeast - March 8, 2018

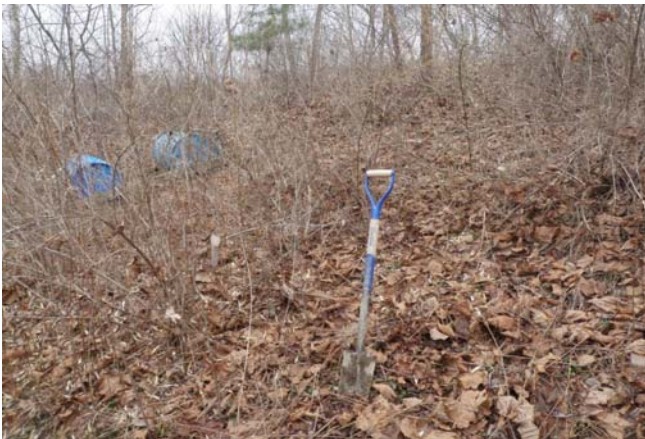
Photo 15: Test Site 13, non-wetland.
Facing east - March 8, 2018

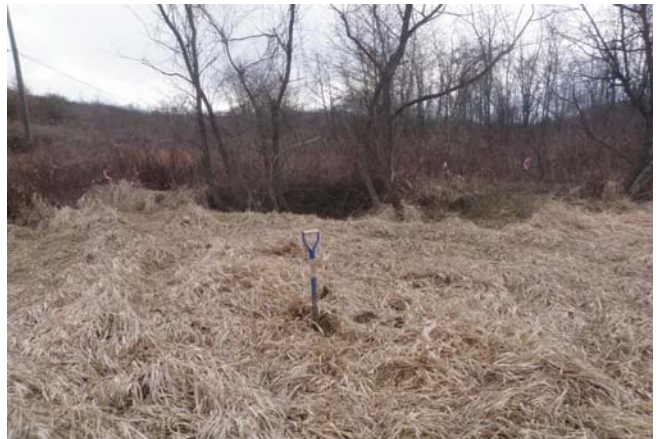
Photo 16: Test Site 14, Wetland 7.
Facing west - March 8, 2018

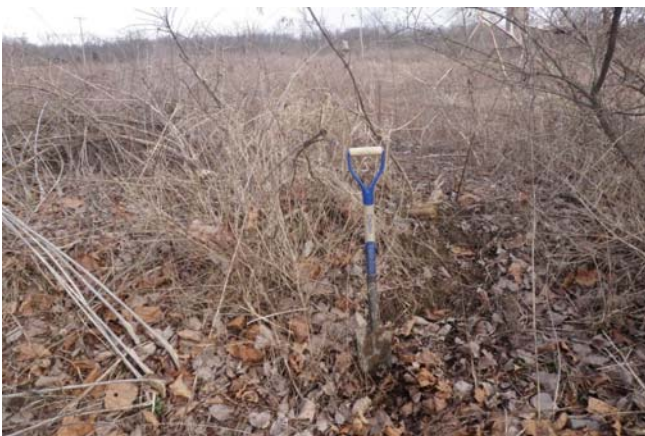
Photo 17: Test Site 15, non-wetland.
Facing east - March 8, 2018

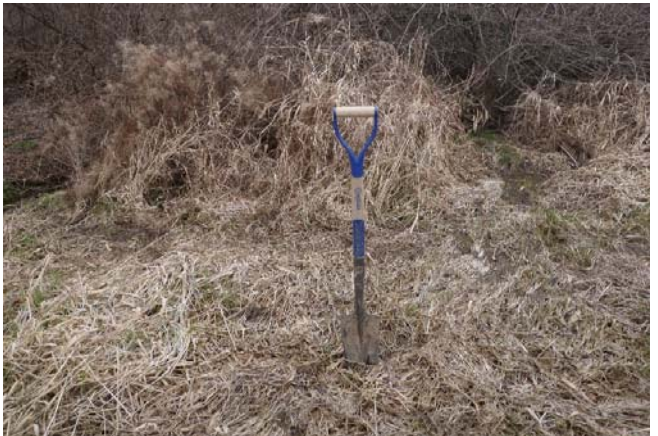
Photo 18: Test Site 16, Wetland 8.
Facing west - March 12, 2018

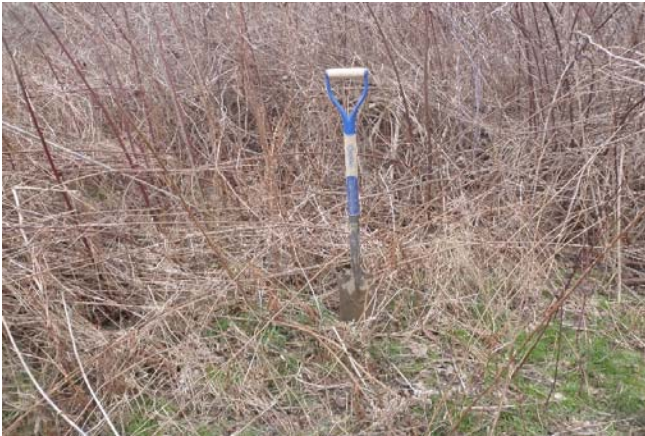
Photo 19: Test Site 17, non-wetland.
Facing south - March 12, 2018

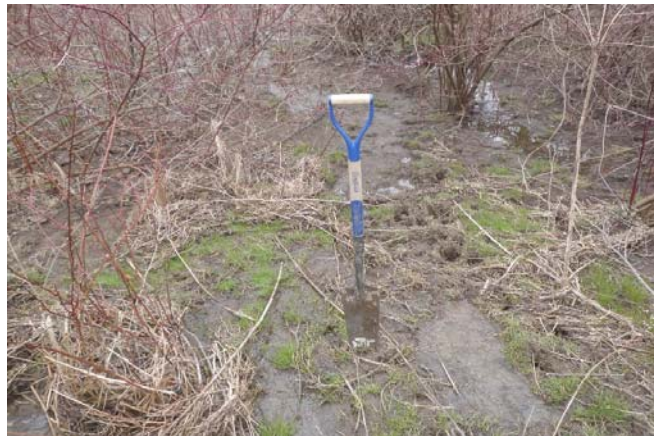
Photo 20: Test Site 18, Wetland 9.
Facing north - March 12, 2018

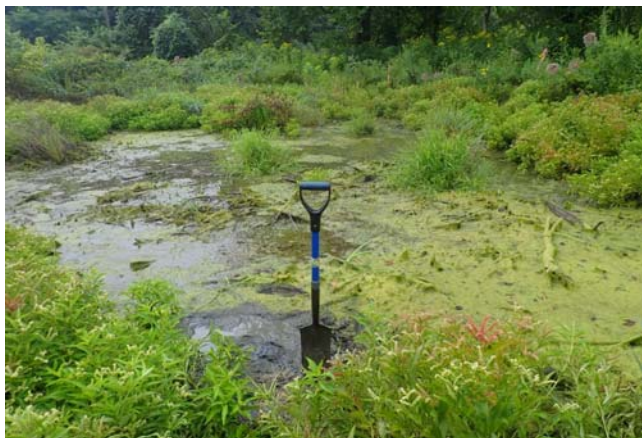
Photo 21: Test Site 19, Wetland 10.
Facing southwest - August 13, 2019

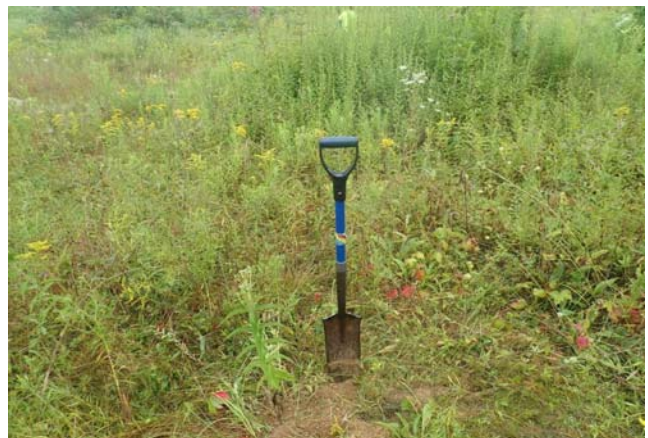
Photo 22: Test Site 20, non-wetland.
Facing southeast - August 13, 2019

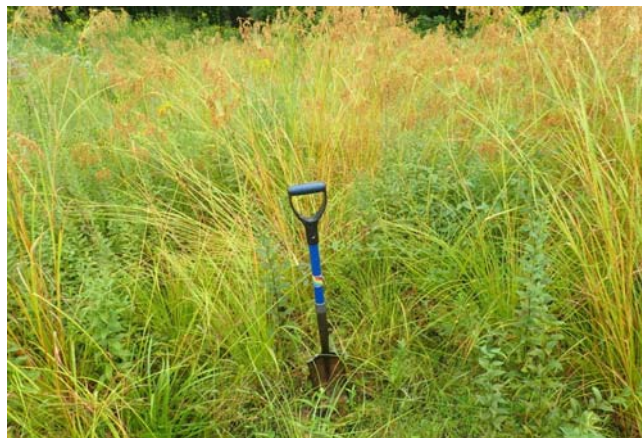
Photo 23: Test Site 21, Wetland 11A.
Facing northwest - August 13, 2019

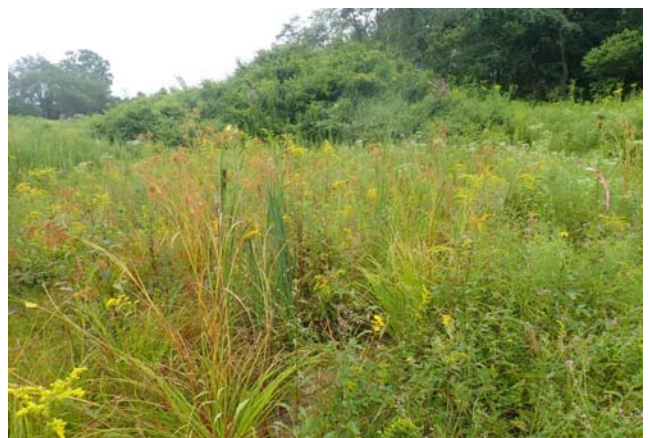
Photo 24: Wetland 11B
Facing south - August 13, 2019

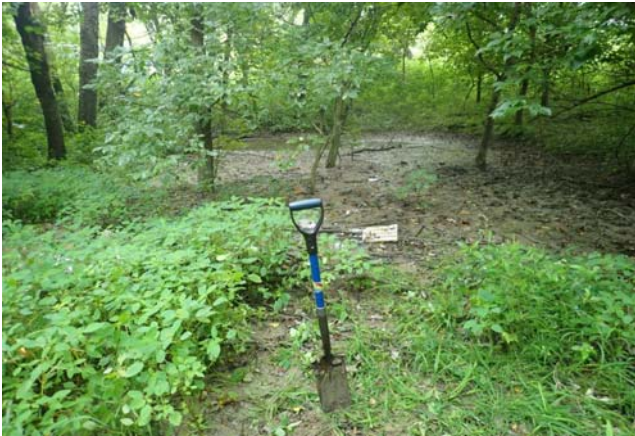
*Photo 25: Test Site 22, Wetland 12.
Facing south - August 13, 2019*

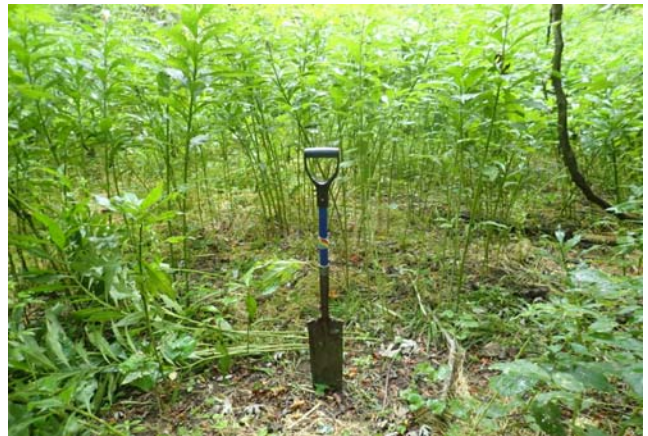
*Photo 26: Test Site 23, non-wetland.
Facing northwest - August 13, 2019*

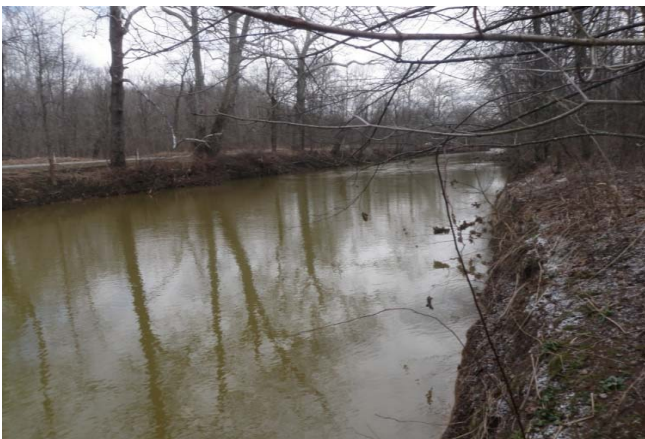
*Photo 27: Sewickley Creek.
Facing upstream - March 8, 2018*

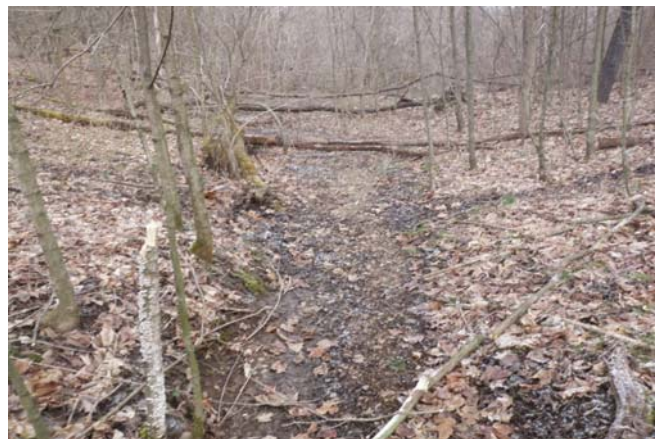
*Photo 28: UNT 1 to Sewickley Creek, ephemeral
portion. Facing downstream - March 8, 2018*

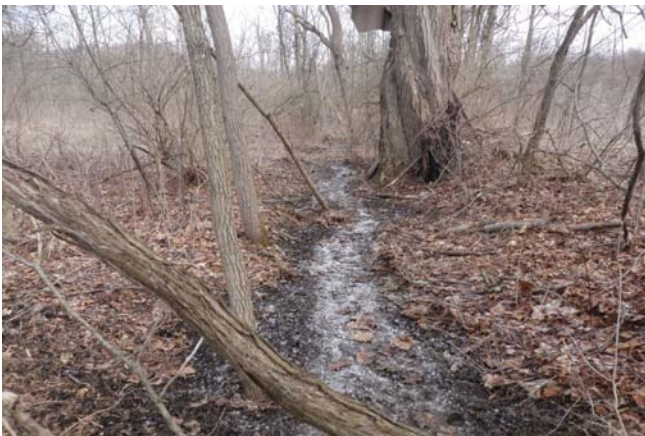
*Photo 29: UNT 1 to Sewickley Creek, intermittent
portion. Facing downstream - March 8, 2018*

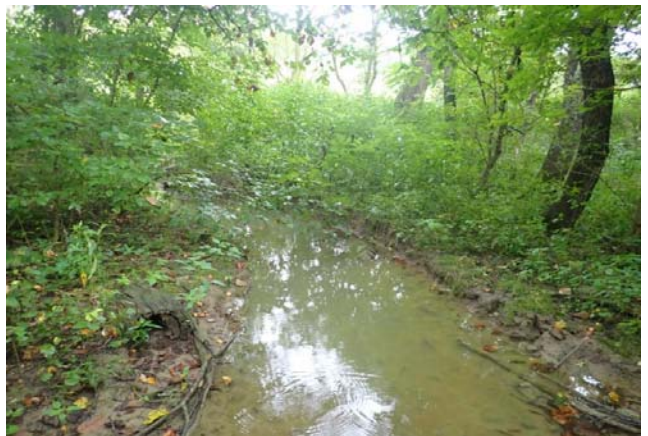
*Photo 30: Trib 37643 to Sewickley Creek.
Facing upstream - August 13, 2019*

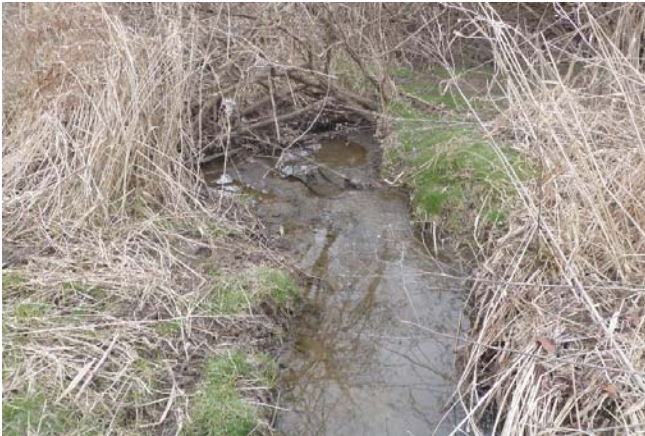
Photo 31: UNT 2 to Trib 37643 to Sewickley Creek,
perennial portion. Facing downstream - March 12, 2018

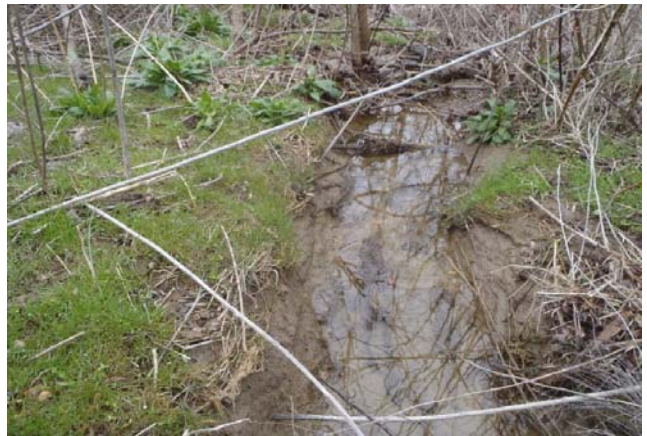
Photo 32: UNT 2 to Trib 37643 to Sewickley Creek,
ephemeral portion. Facing upstream - April 9, 2018

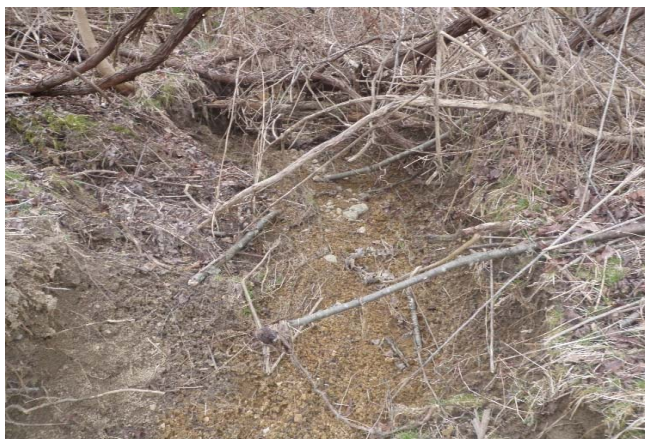
Photo 33: UNT 3 to Trib 37643 to Sewickley Creek.
Facing downstream - March 12, 2018

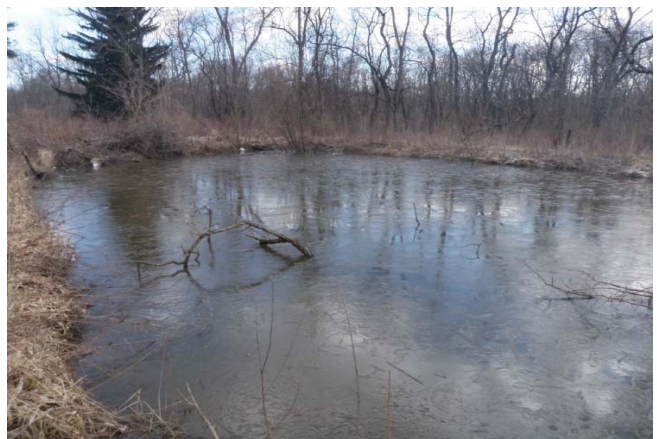
Photo 34: Pond 1.
Facing northeast - March 8, 2018

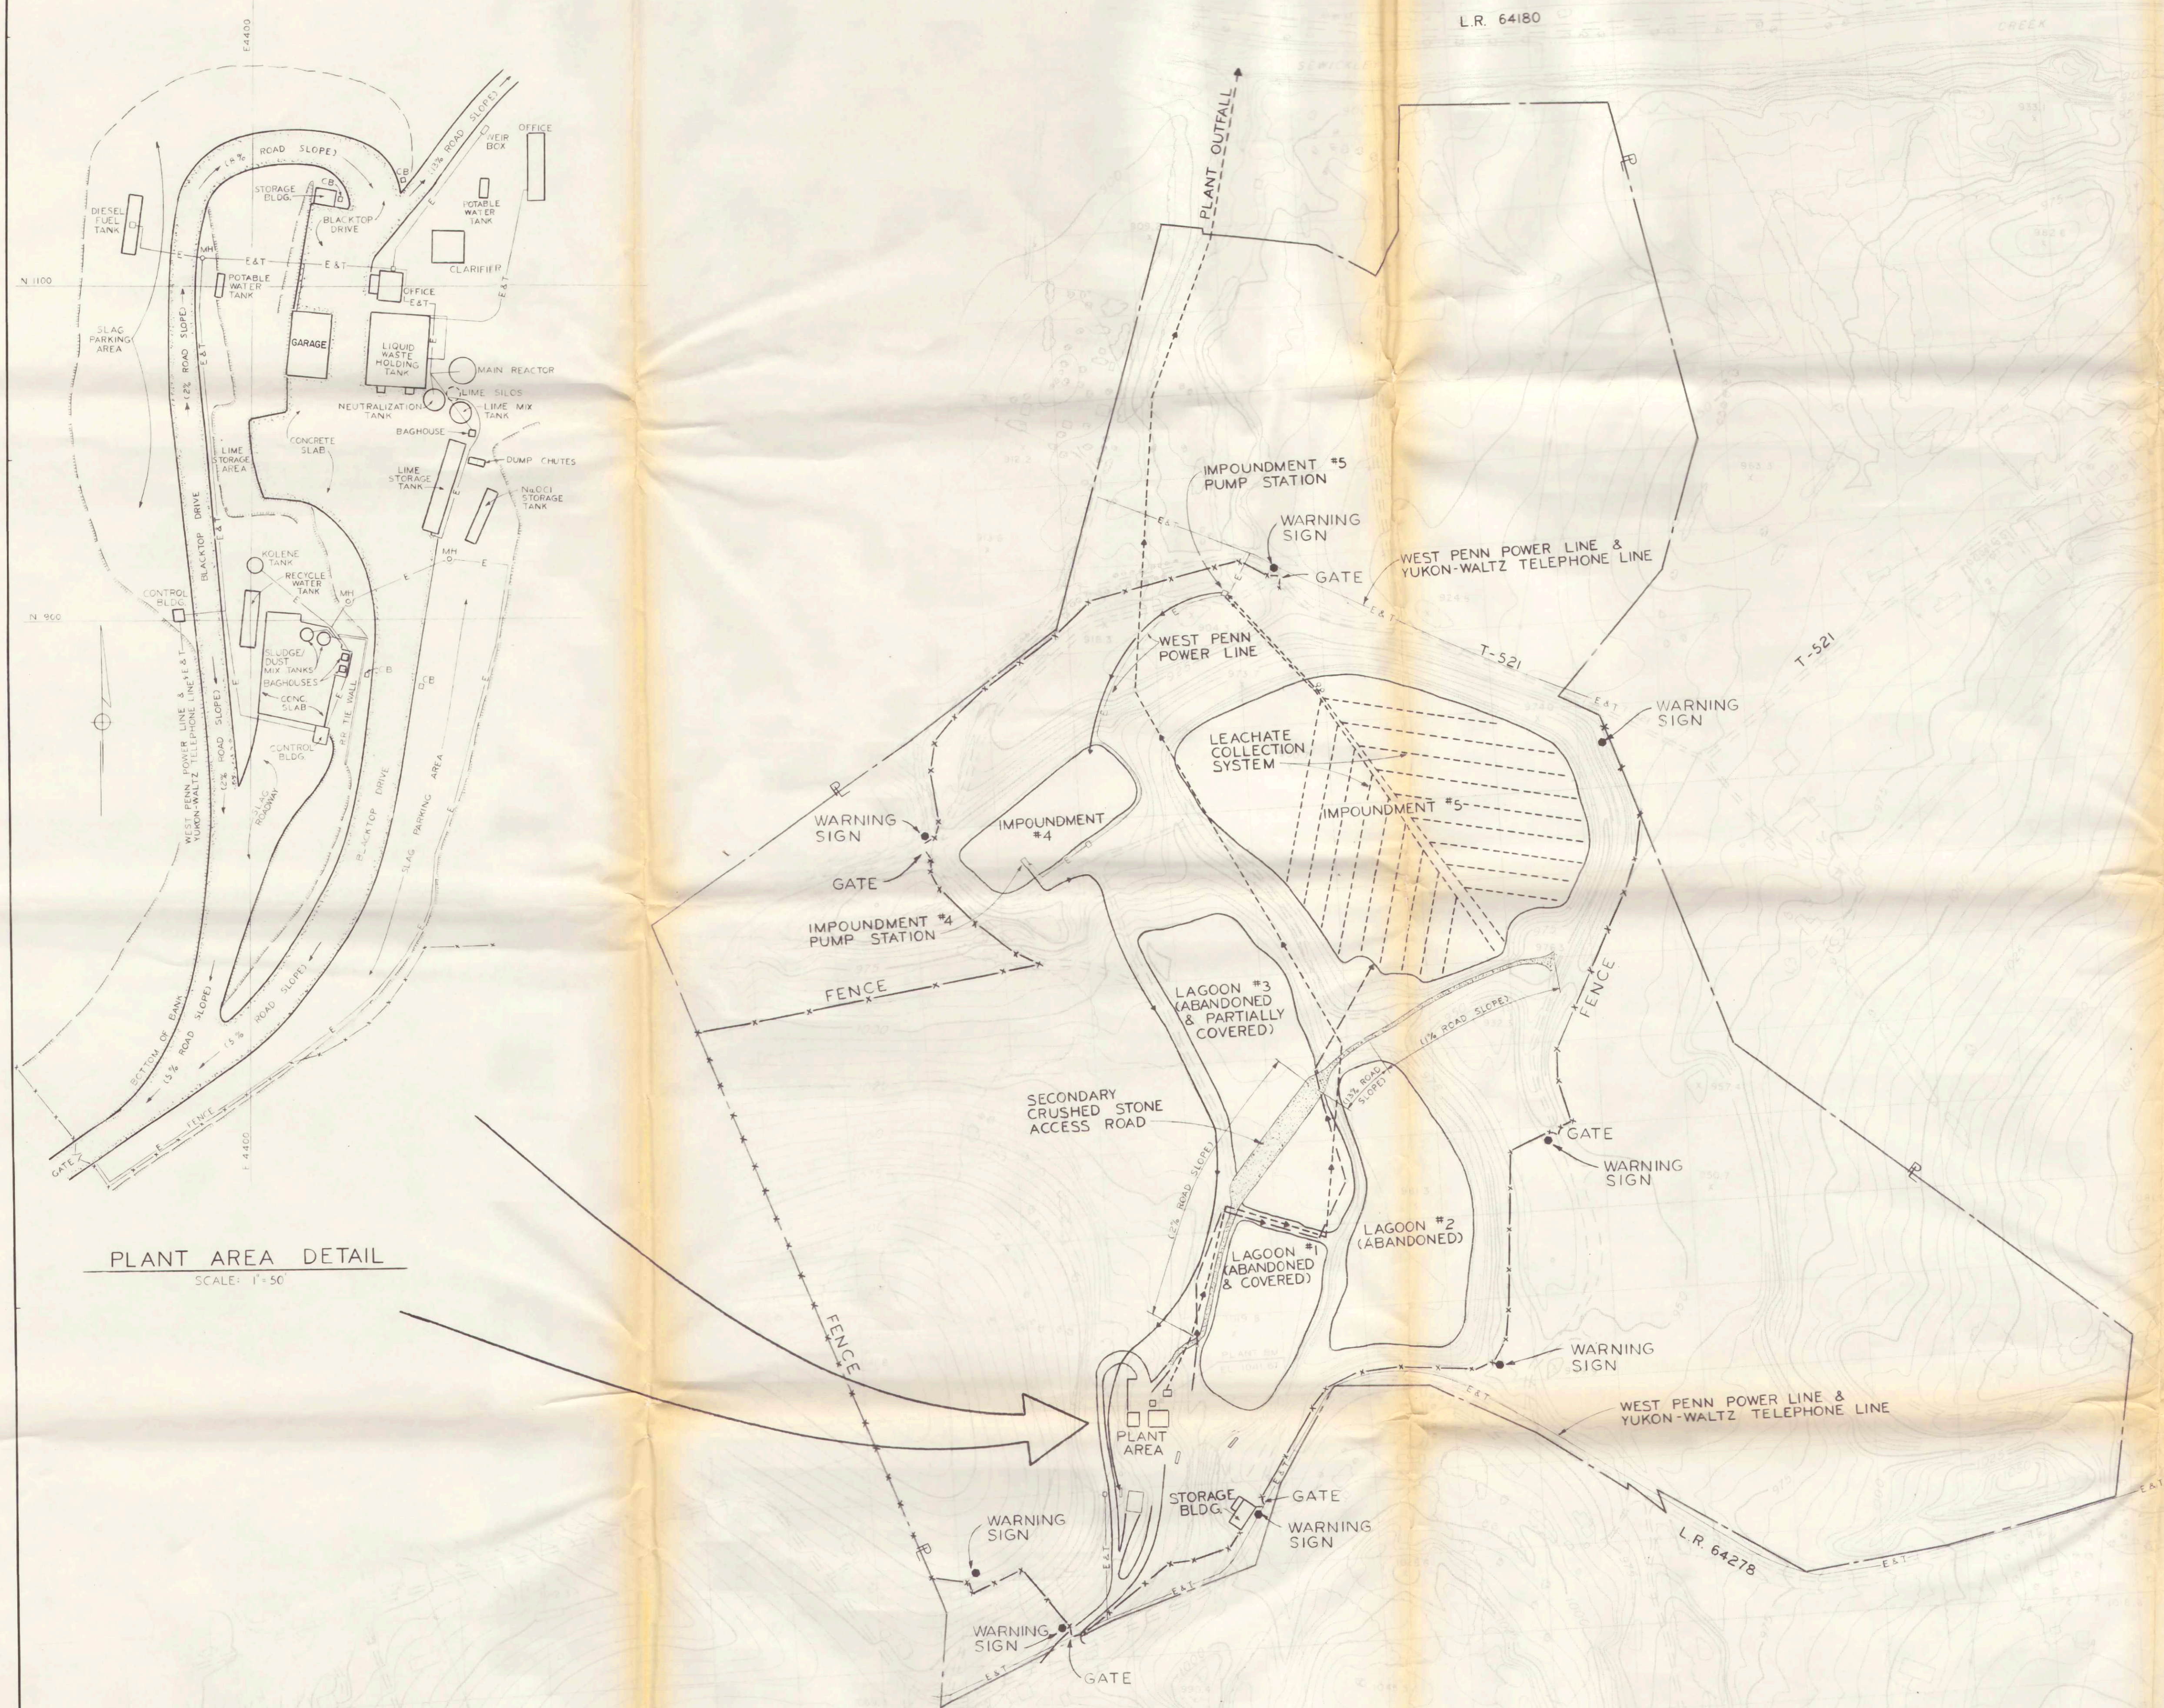
DRAWING No. 1
MILL SERVICE, INC.
YUKON PLANT

PLANT AREA DETAIL
SCALE: 1"=50'

GENERAL ARRANGEMENT

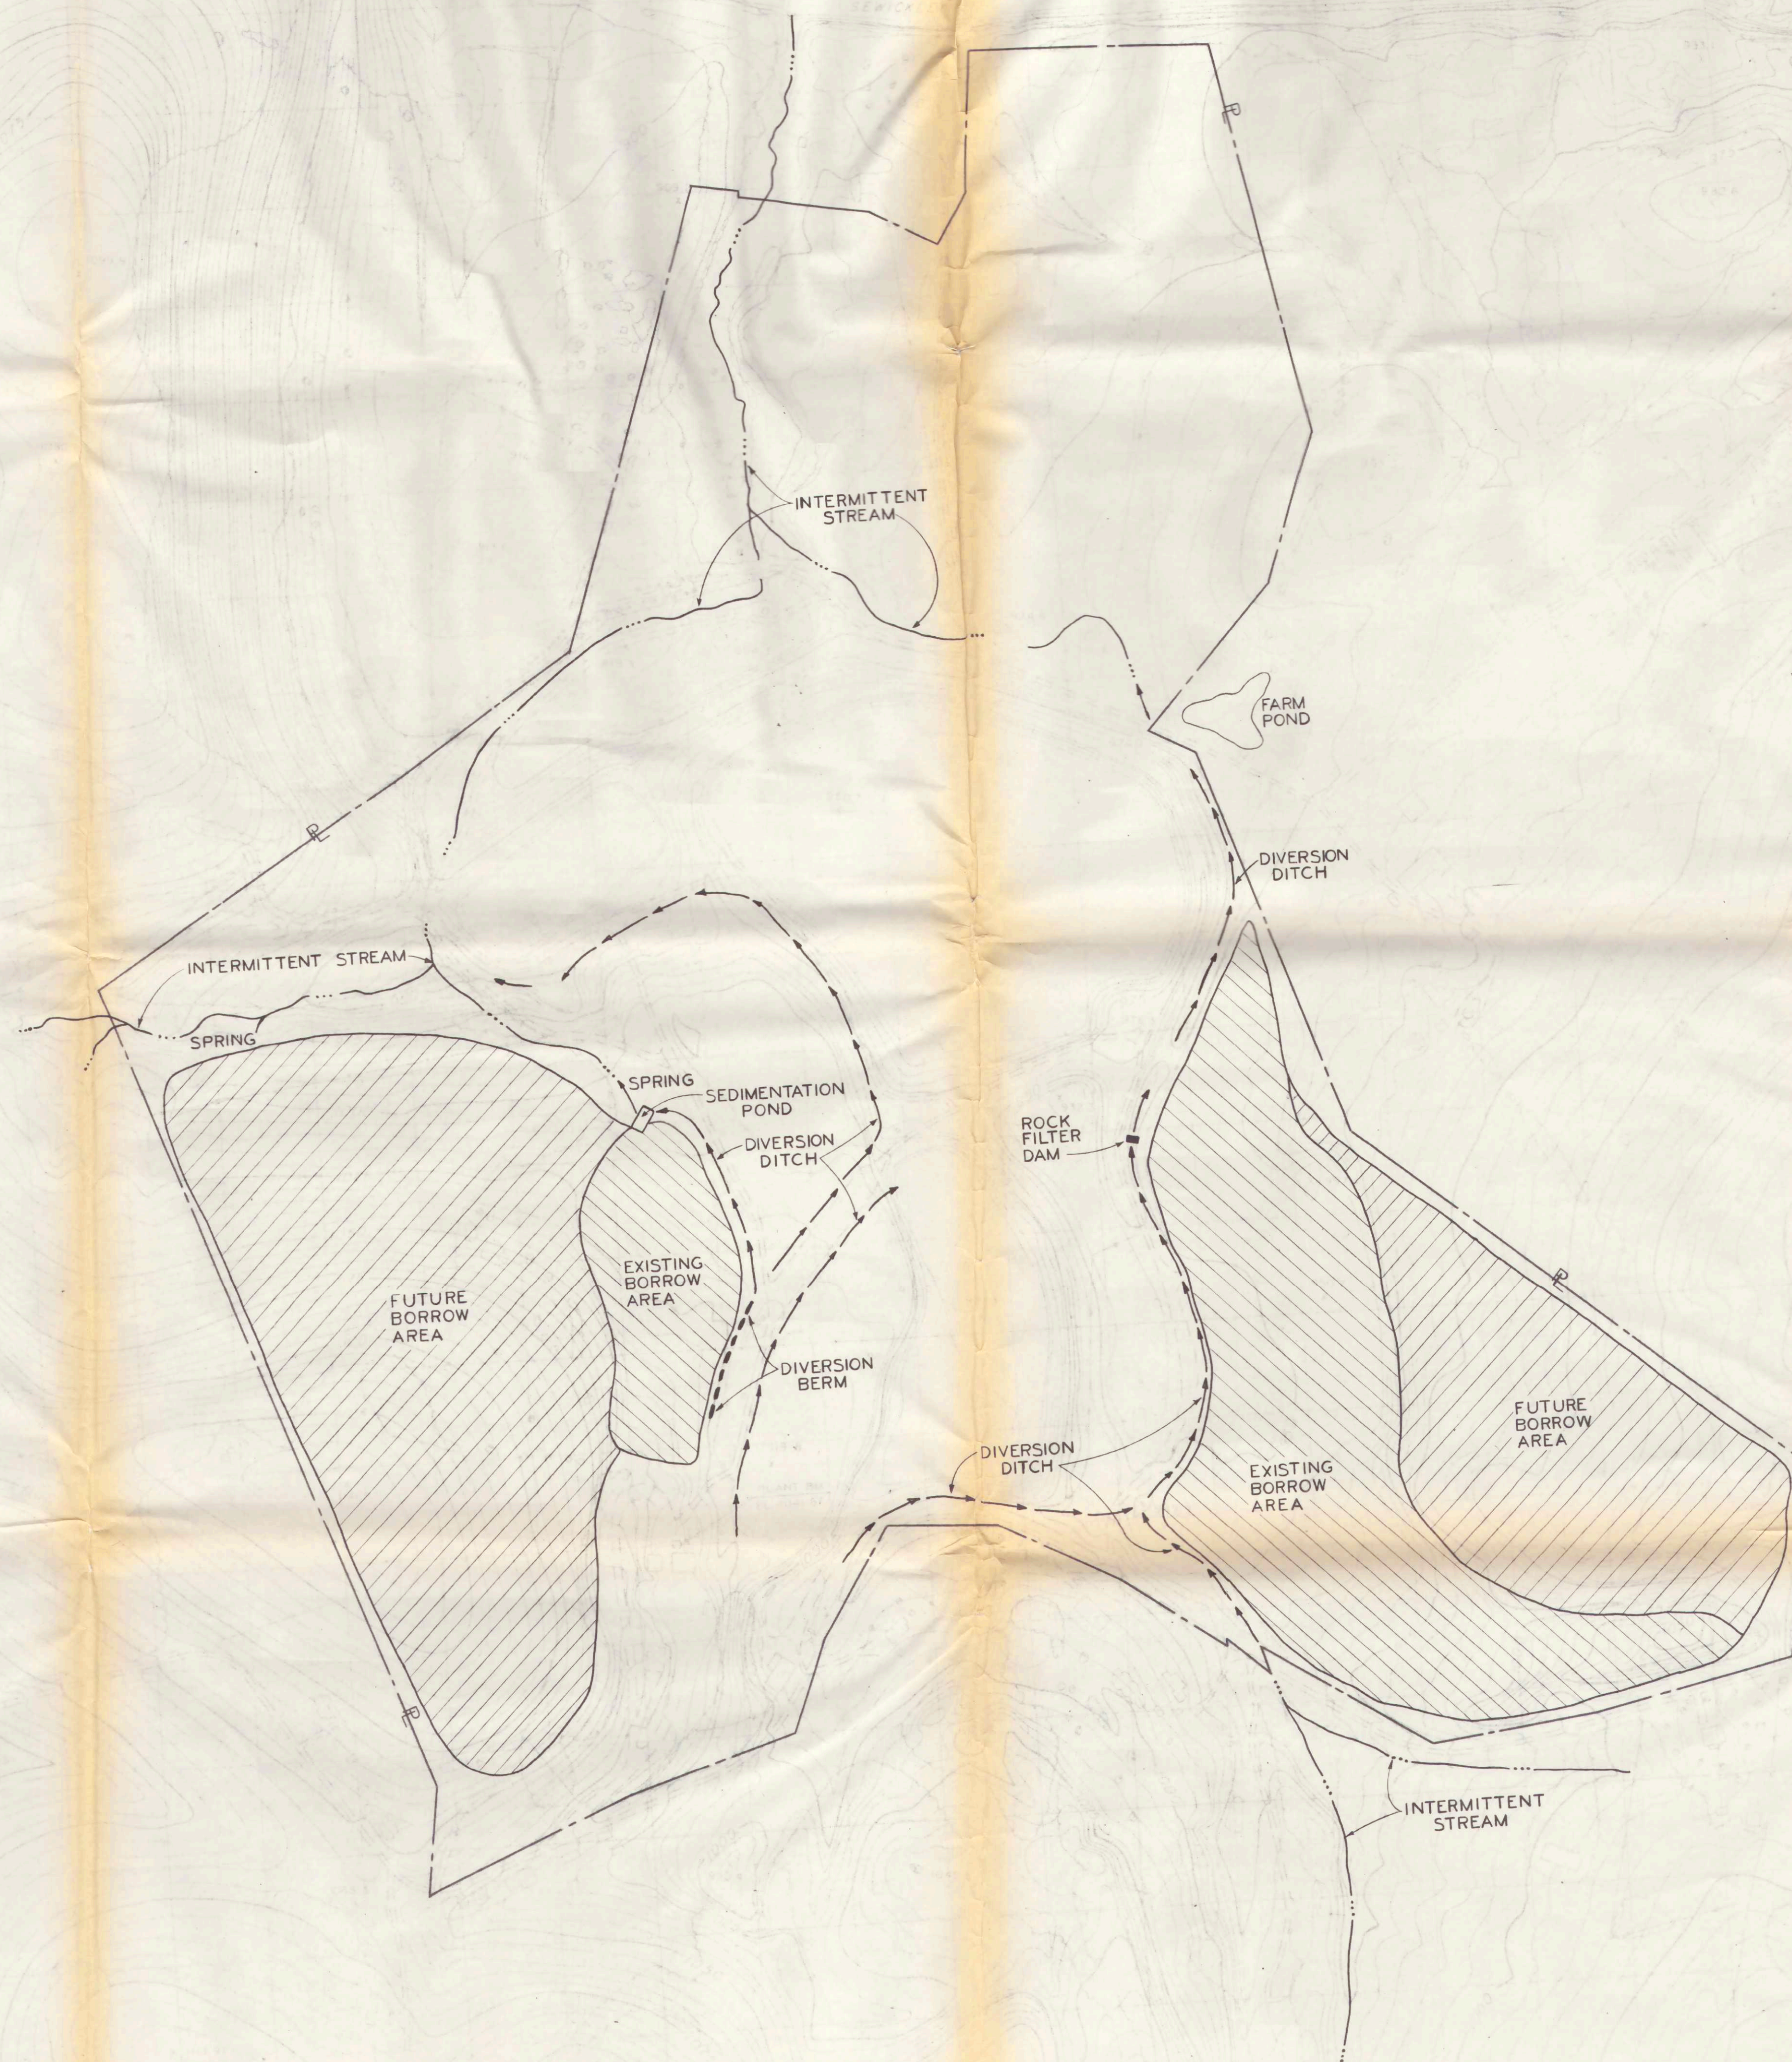
DRAWING No 2
MILL SERVICE, INC.
YUKON PLANT
SURFACE WATER MANAGEMENT
EROSION CONTROL & BORROW AREAS
SCALE: 1"=200'

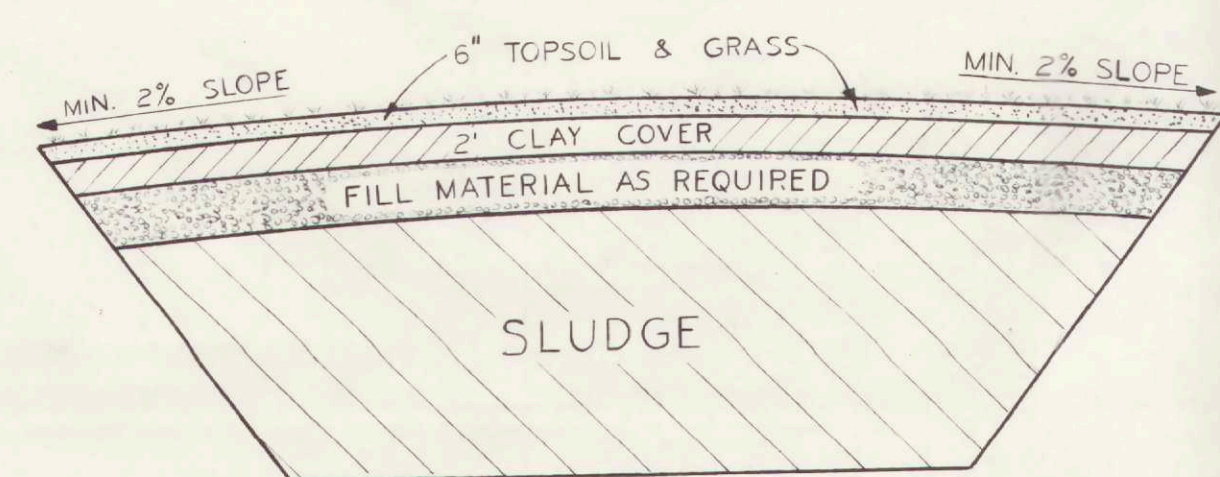
TYPICAL IMPOUNDMENT COVER FILL DETAIL
