Wetland Delineation and Watercourse Identification Report

WEST FIELD

BLACK LICK AND CENTER TOWNSHIPS
INDIANA COUNTY, PENNSYLVANIA

Michael Baker International, Inc.

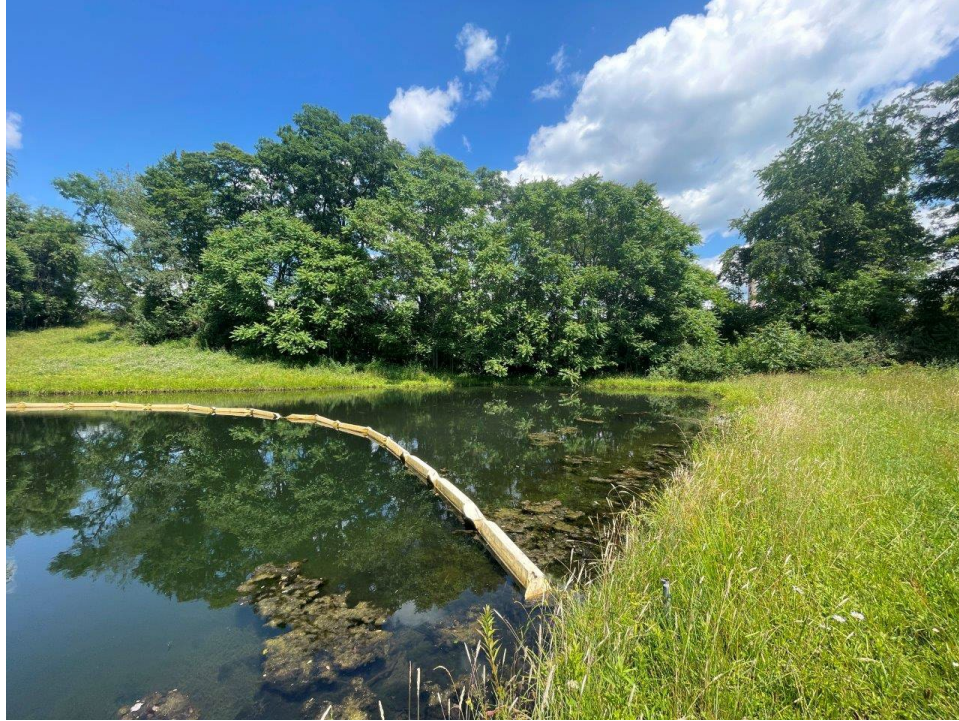
Photograph 1 – Overview of treatment pond inlet in the northern study extent. The treatment pond conveys stream S-01 (facing northwest).

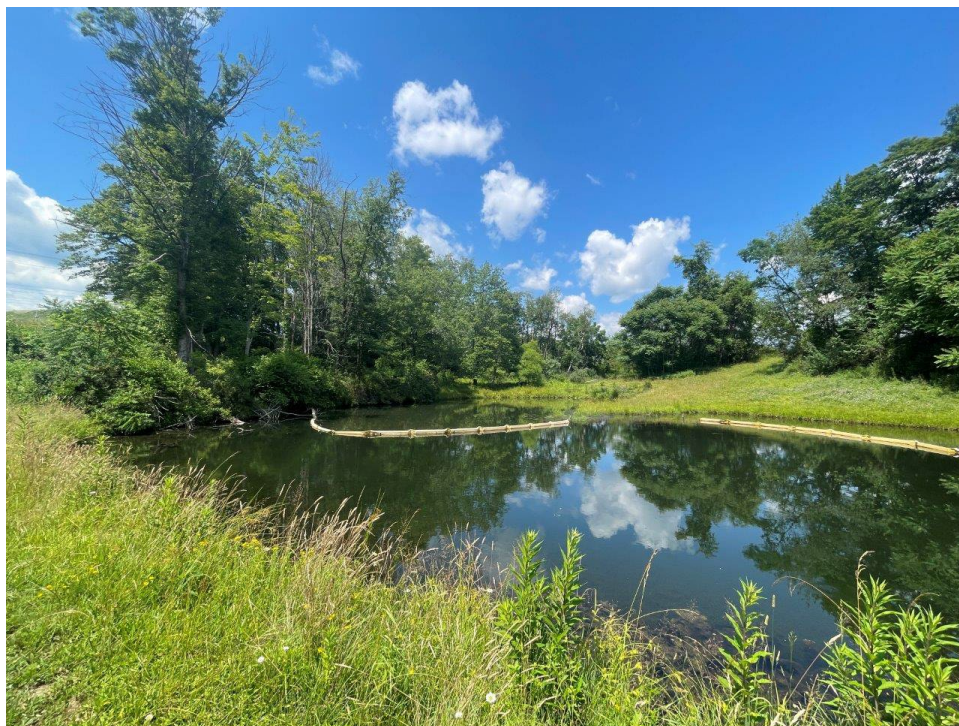
Photograph 2 – Overview of treatment pond in northern study area. The treatment pond conveys stream S-01 (facing north).

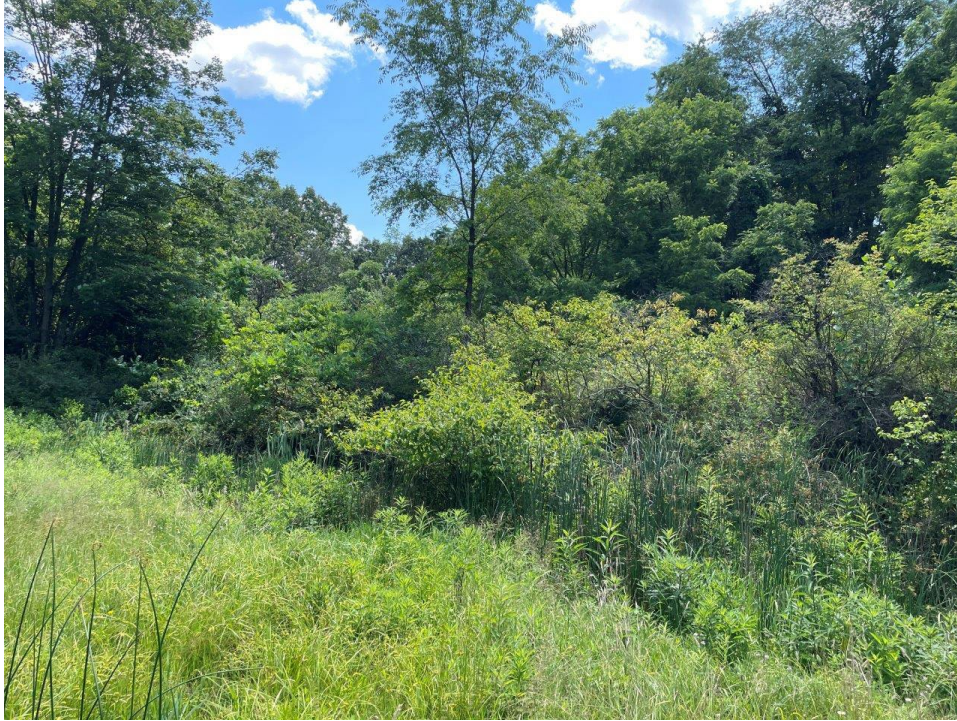
Photograph 3 – Overview of treatment pond outlet, conveying flow downstream to stream S-01.
(facing west and downstream).

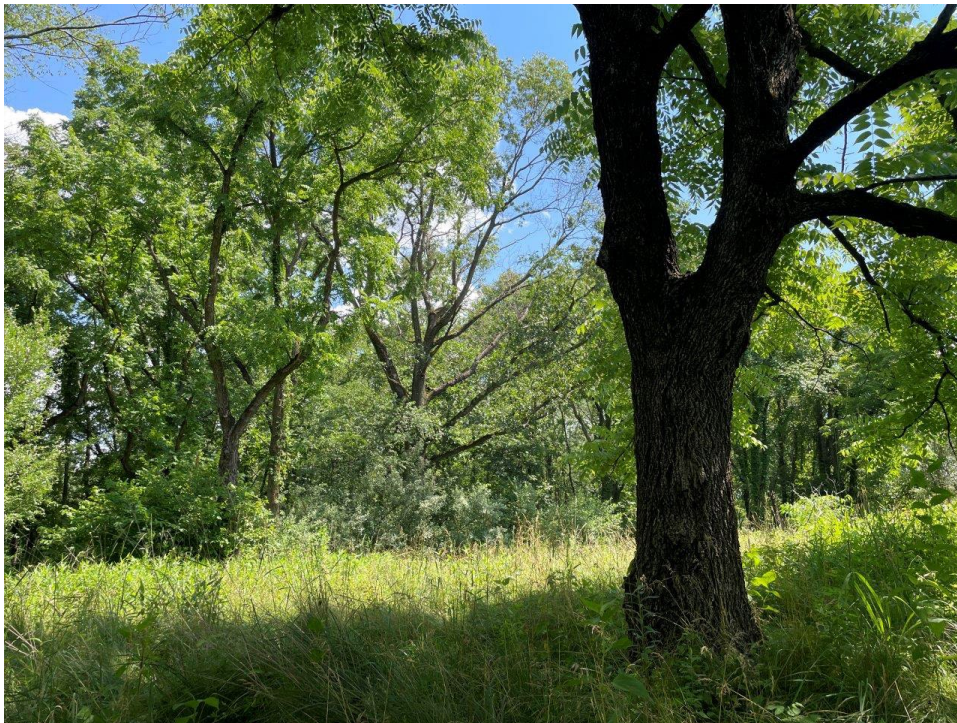
Photograph 4 – Overview of upland sample point STP-03 adjacent to Coal Rd.
(facing northwest).

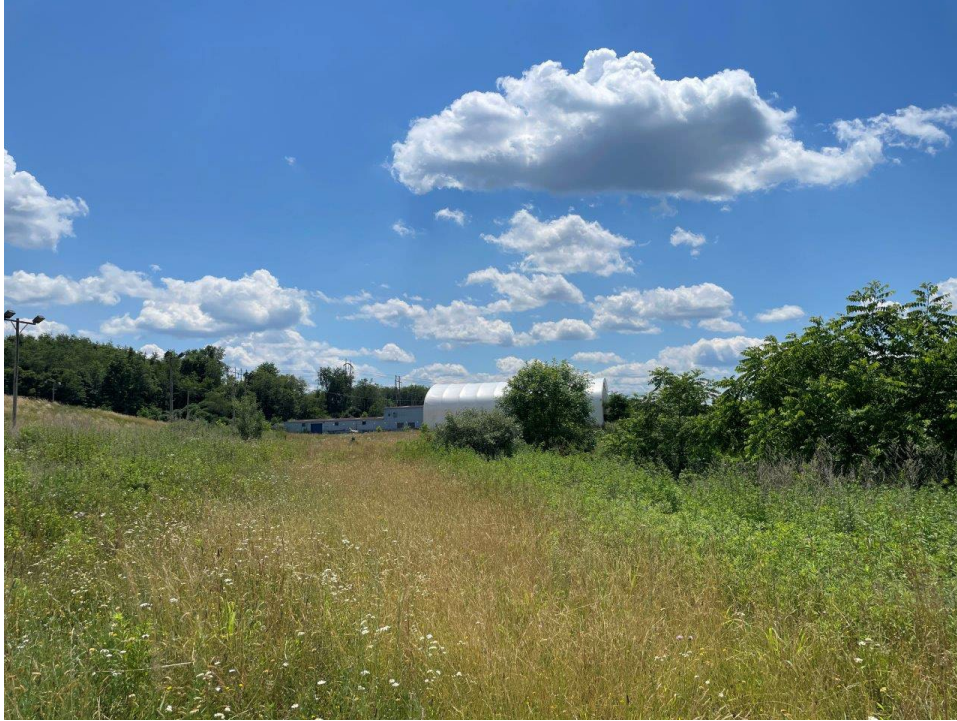
Photograph 5 – Overview of upland area adjacent to previously existing commercial infrastructure in the northern central study area (facing southwest).

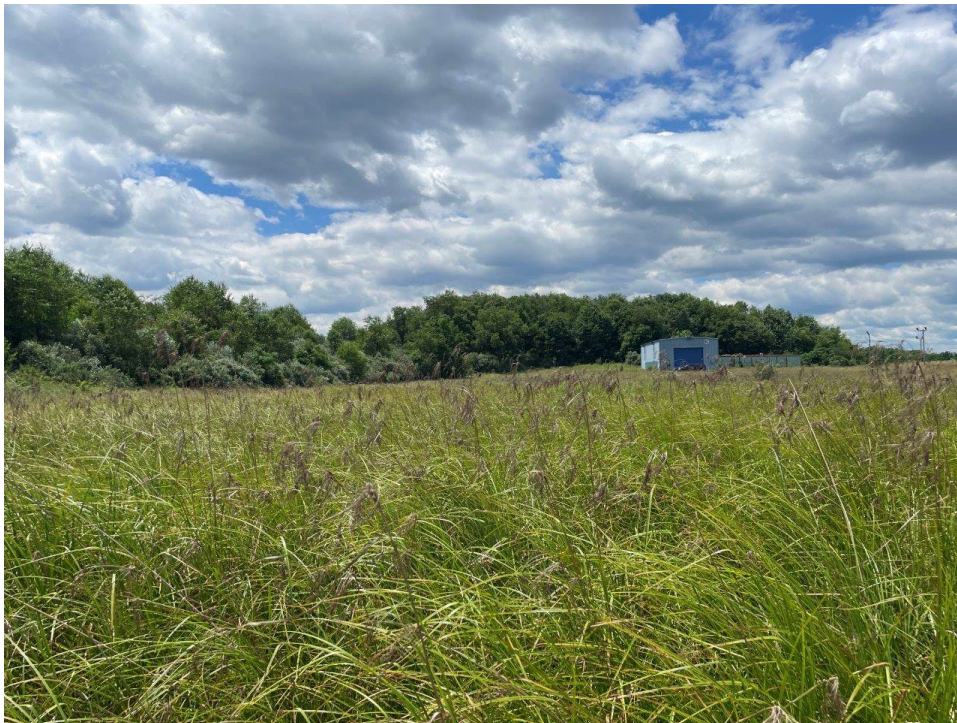
Photograph 6 – Overview of upland sample point STP-02 and surrounding vegetation (facing southwest).

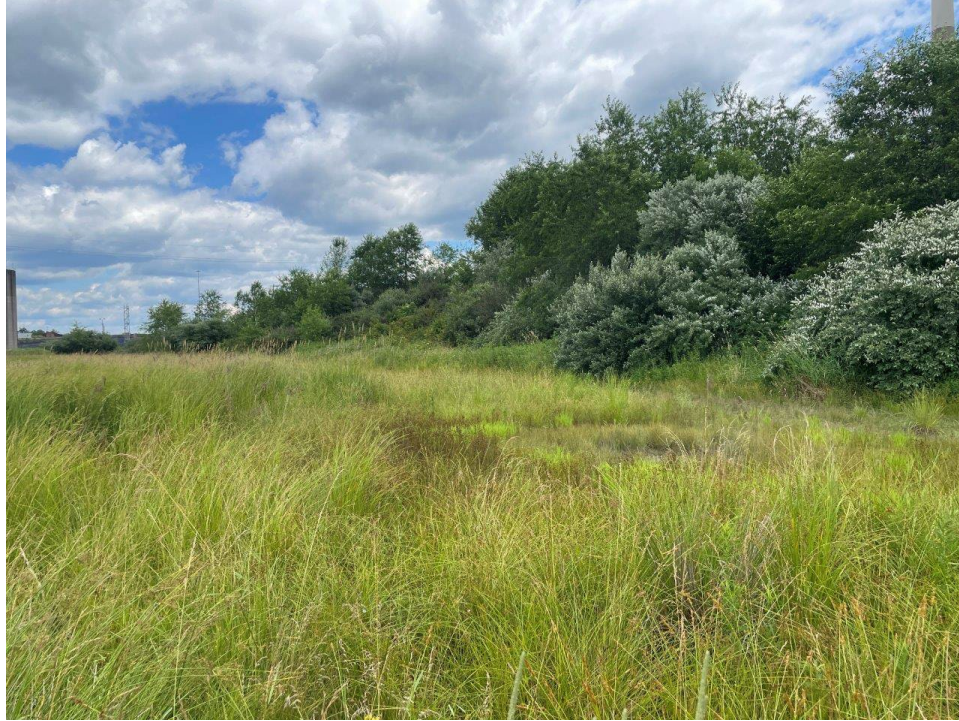
Wetland W-01 is a 0.780-acre PEM wetland located in the northeastern extent of the study area in a depression adjacent and downslope to a previously developed commercial area. Hydrology and soil are disturbed from previous land development, causing water to drain and collect adjacent to a gravel roadway. Hydrological indicators included an algal crust, surface soil cracks, oxidized rhizospheres on living roots, and geomorphic position. Within the wetland depression, vegetation consisted almost entirely of facultative wet and obligate indicator species. Dominant wetland vegetation consisted of *Scirpus cyperinus* (wool grass). Other predominate wetland plant species included *Carex vulpinoidea* (fox sedge), *Agrostis stolonifera* (creeping bent grass), and *Juncus acuminatus* (sharp-fruited rush). Soils were significantly disturbed; texture consists of silty clay loam (SiCL) and exhibited several redox concentrations.

Photograph 7 – Overview of PEM wetland W-01 and wetland sample point STP-01 in the northeastern study area (facing southeast).

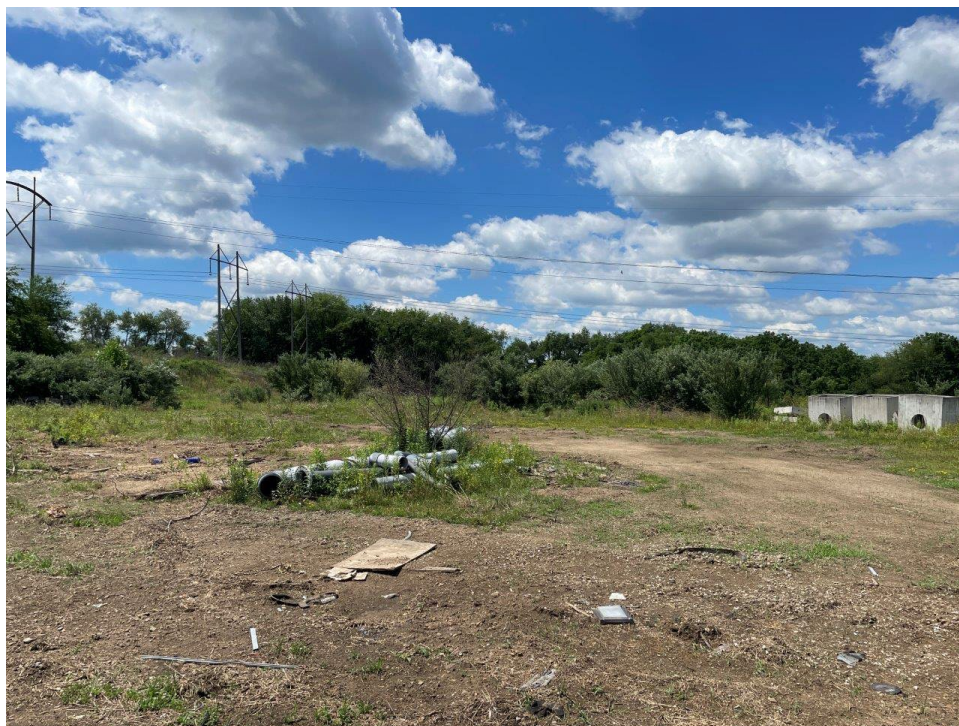
Photograph 8 –View of area west of existing commercial infrastructure in the central study area (facing southwest).

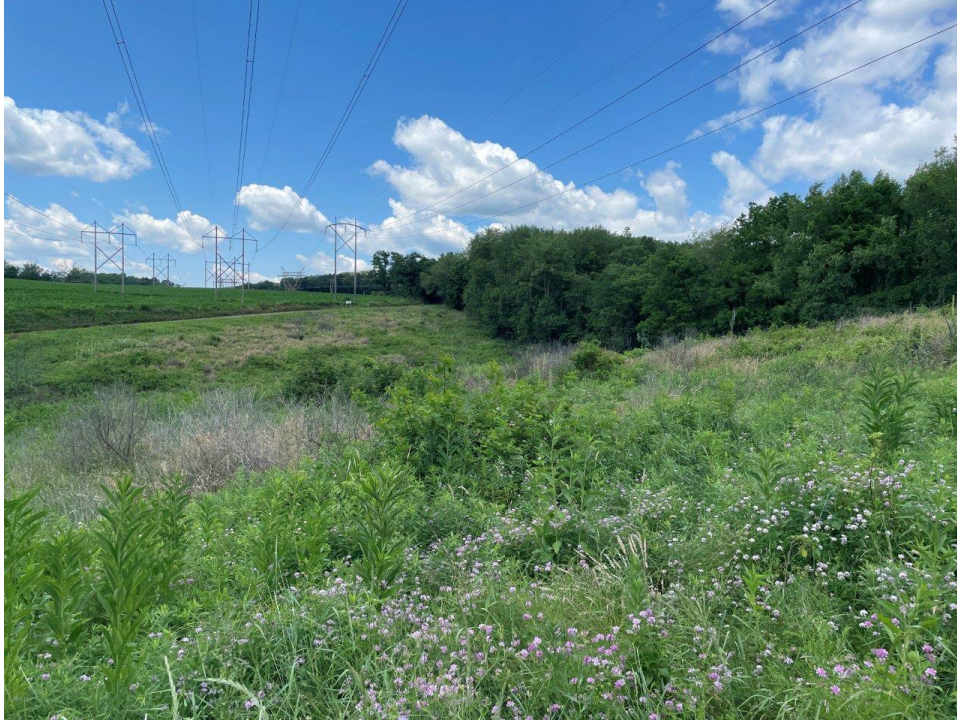
Photograph 9 – Overview of central study area above stream S-01 looking towards Coal Road (facing northwest).

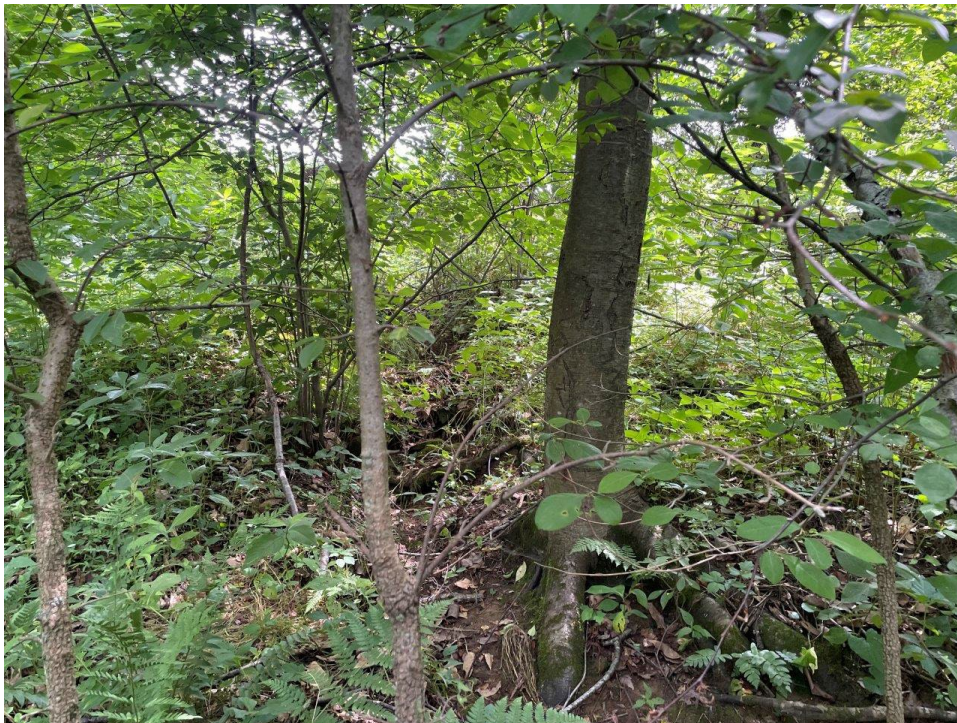
S-01a is a high-gradient PER stream originating in the central study area. Stream S-01a receives hydrology from surface runoff and groundwater, and generally flows west until its confluence with S-01. Stream S-01a has a designated use of CWF.

Photograph 10 –View of stream S-01a as it approaches the confluence of S-01 (facing upstream).

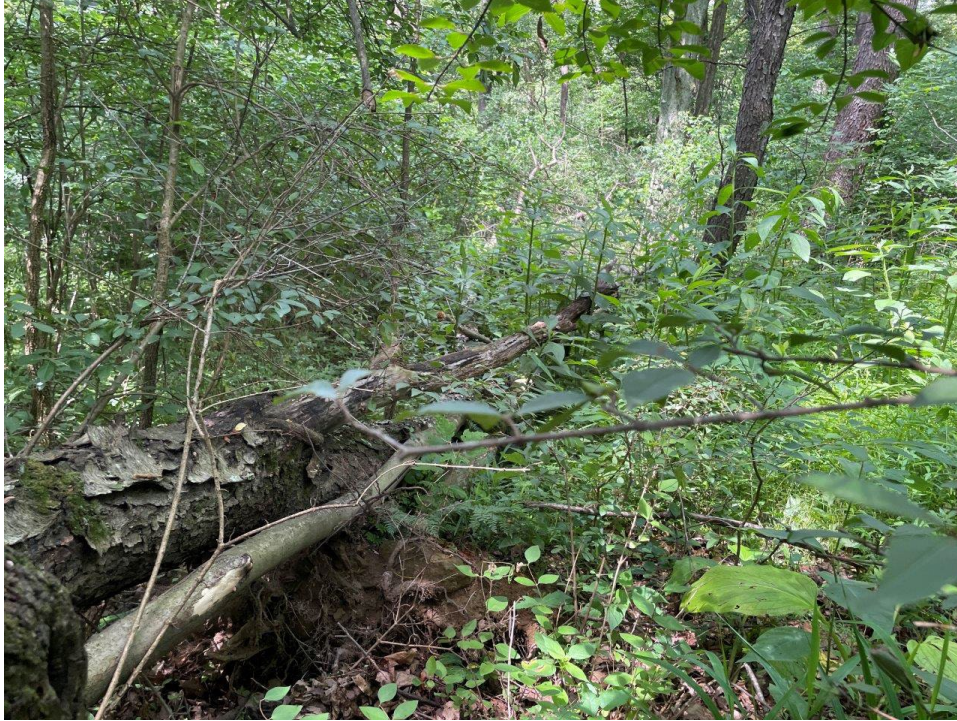
Photograph 11 – Overview of stream S-01a
(facing downstream).

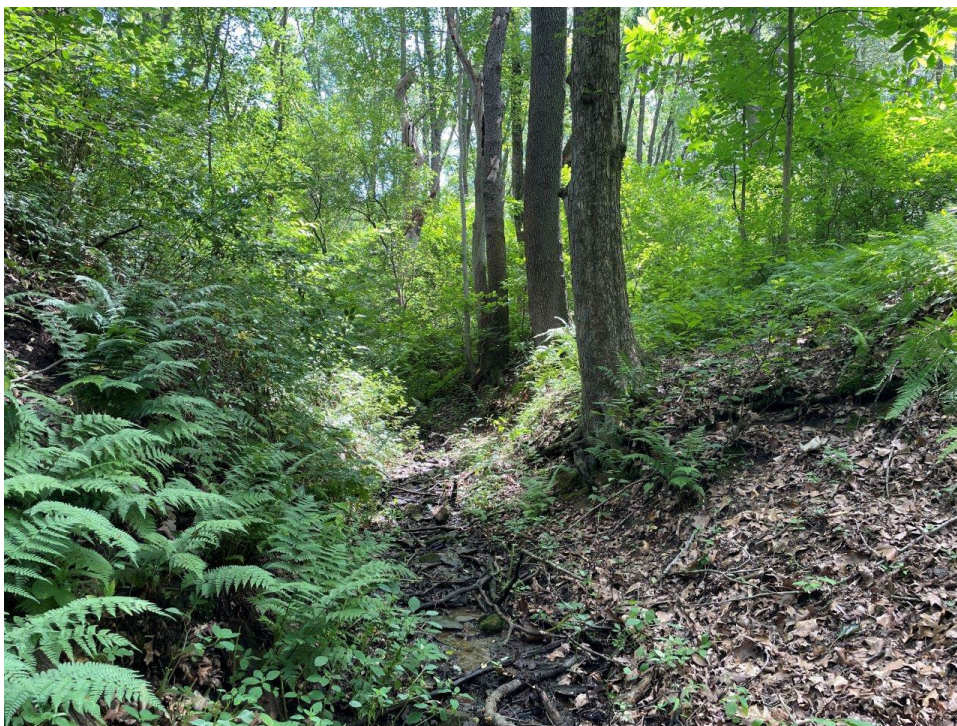
S-01b is a high-gradient PER stream originating in the central study area. Stream S-01b receives hydrology from surface runoff and groundwater, and generally flows west inside the study area until its confluence with S-01b. Stream S-01b has a designated use of CWF.

Photograph 12 – Overview of stream S-01b in the central western study area
(facing downstream).

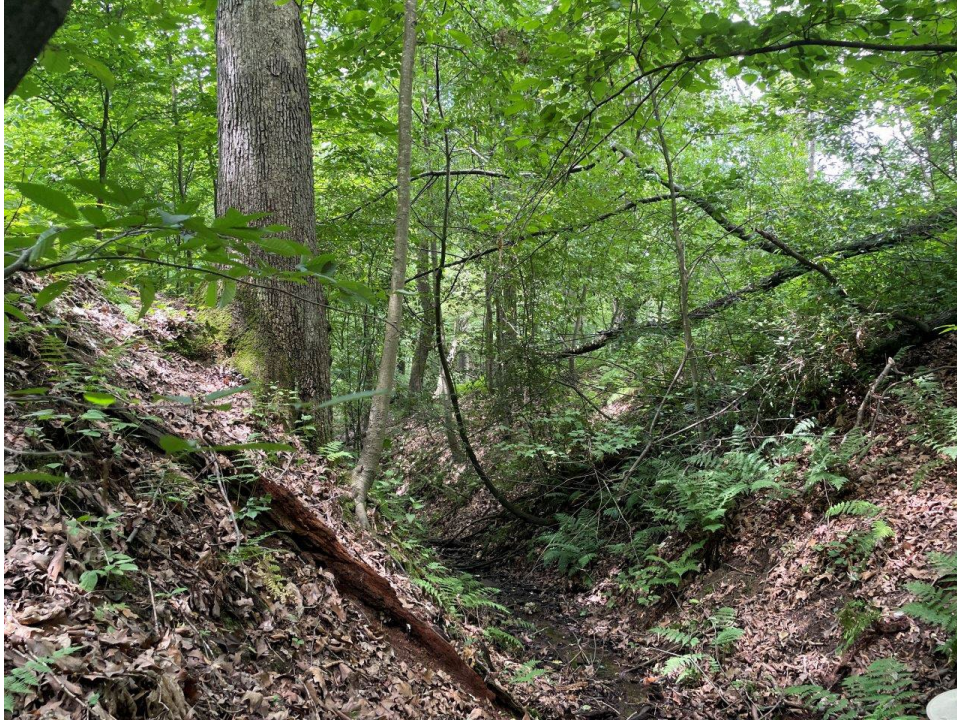
Photograph 13 – Overview of stream S-01b
(facing upstream).

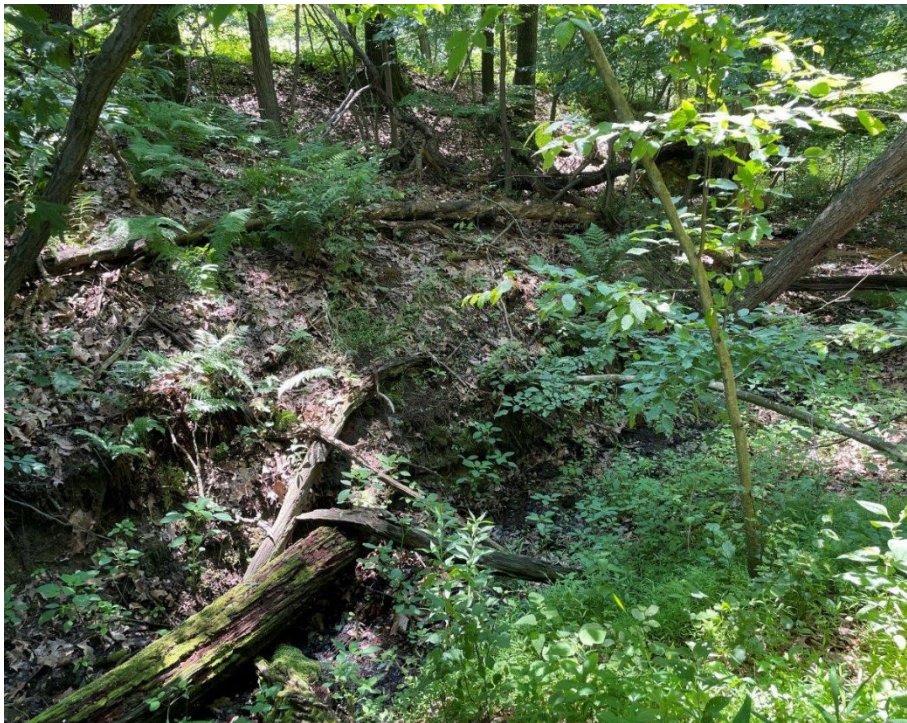
S-01c is a high-gradient PER stream originating in the central-western portion of the of the study area. Stream S-01c receives hydrology from surface runoff and groundwater, and generally flows northwest inside the study area until its confluence with S-01. Stream S-01c has a designated use of CWF.

Photograph 14 – Overview of stream S-01c
(facing downstream).

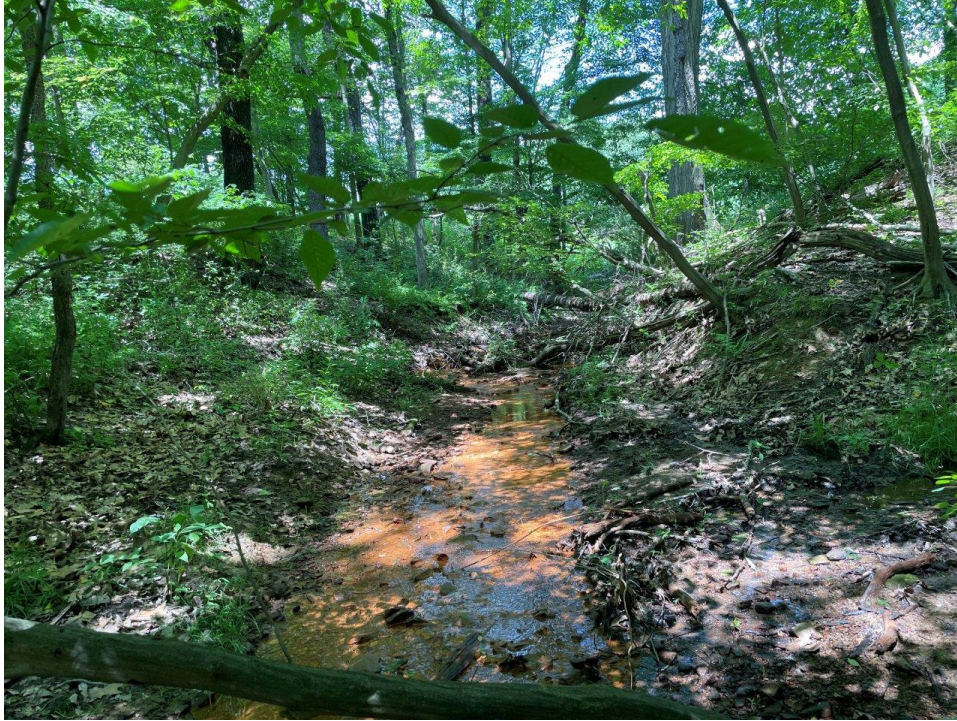
Photograph 15 – Overview of the confluence of stream S-01c and S-01 (facing upstream).

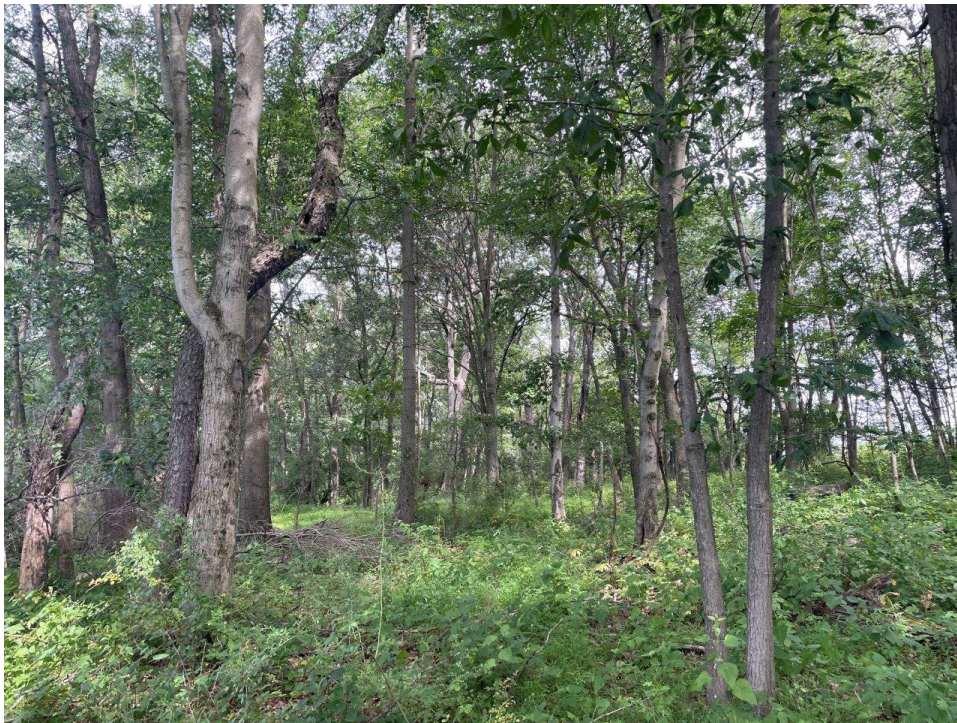
Photograph 16 – Overview of wooded area adjacent to agricultural fields and Coal Rd. in the central western study area (facing south).

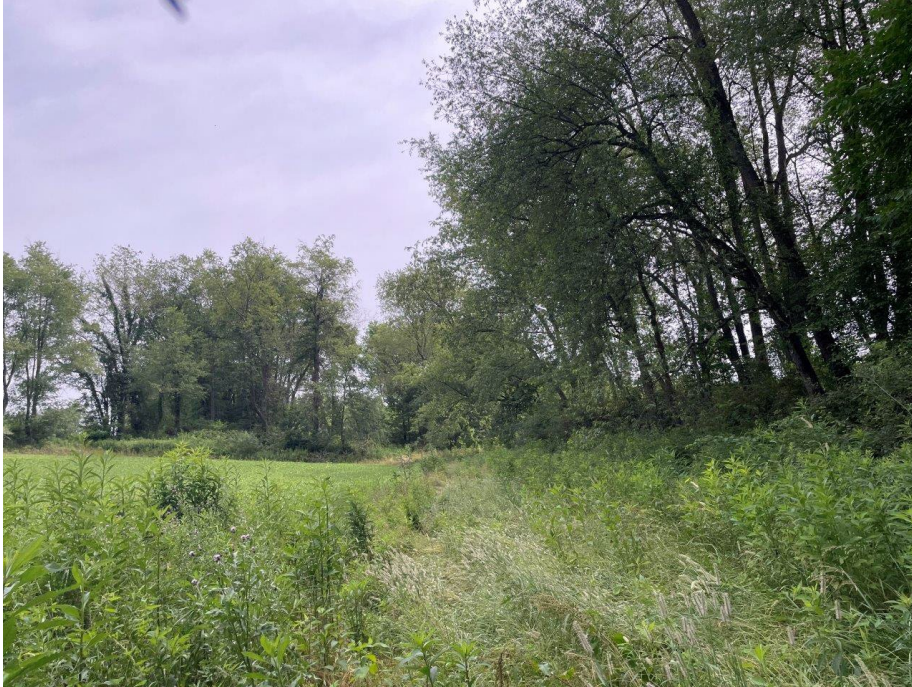
Photograph 17 – Overview of upland area on the wooded fringe of agricultural field in the southern central study area (facing southeast).

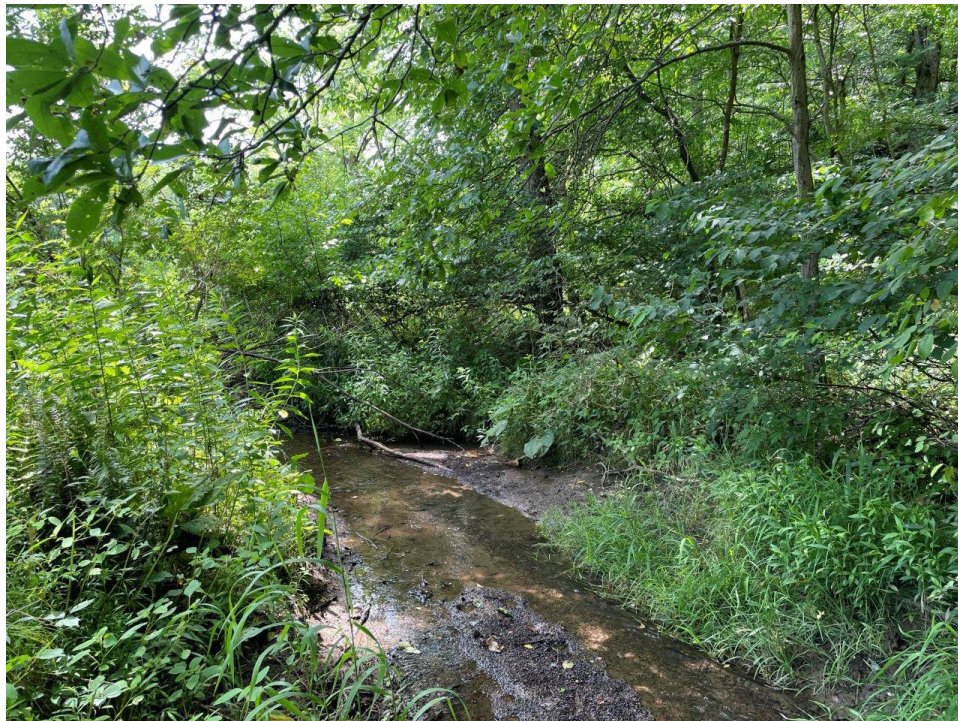
S-02 (Trib 44070 to Blacklick Creek) is a high-gradient PER stream located in the southwestern portion of the study area. S-02 originates in the southern central portion of the study area, generally flowing southwest until it exits the study area on its southern boundary. Hydrology is received from surface runoff and groundwater. Stream S-02 has a designated use of CWF.

Photograph 18 – Overview of stream S-02 in the southwestern study area extent (facing downstream).

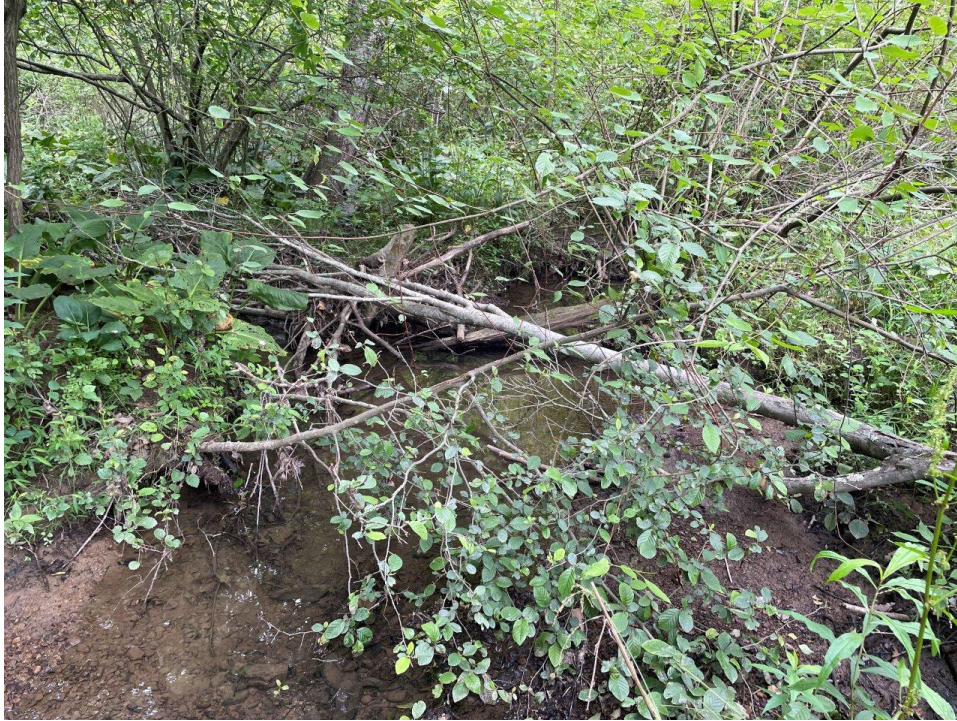
Photograph 19 – Overview of stream S-02 in the southwestern study area extent (facing upstream).

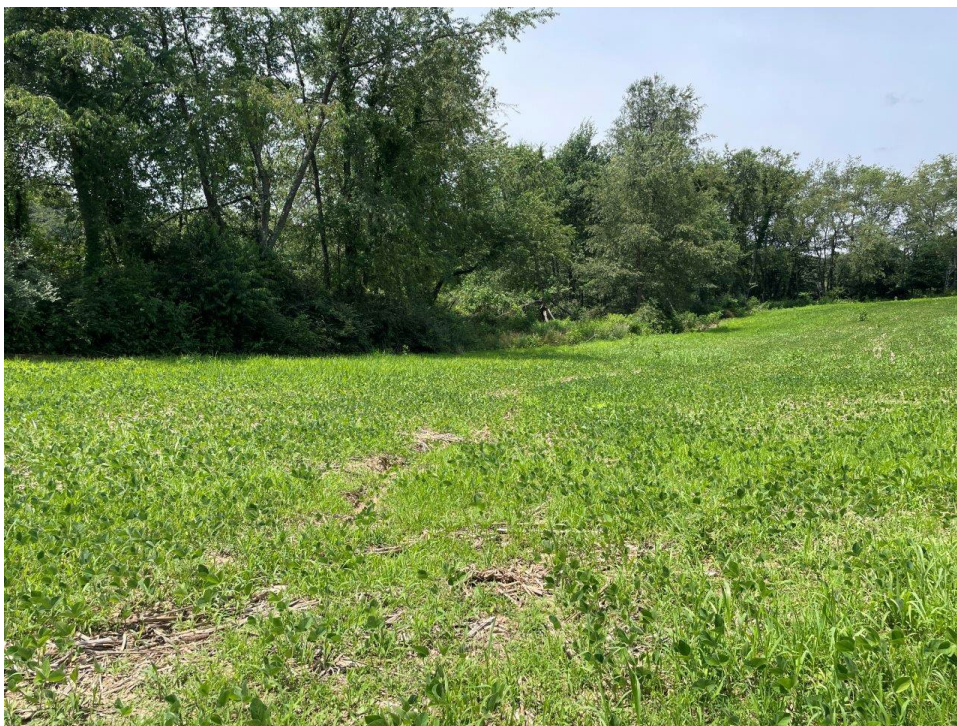
Photograph 20 – Overview of upland sample point STP 04 in the south central study area (facing northeast).

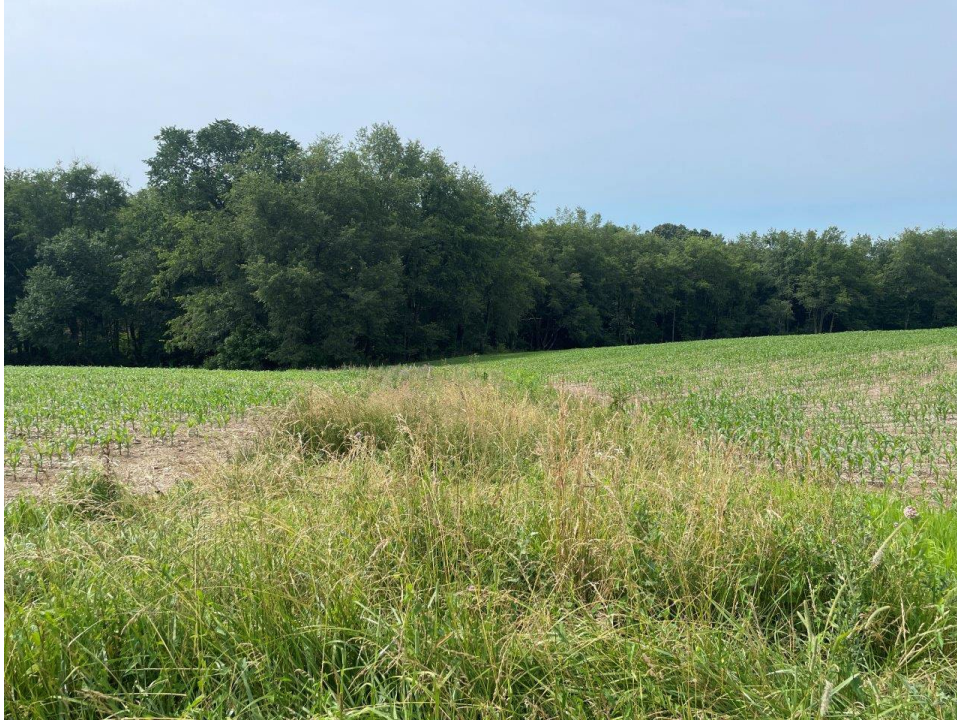
Photograph 21 – Overview of erosional feature in agricultural field (facing southeast).

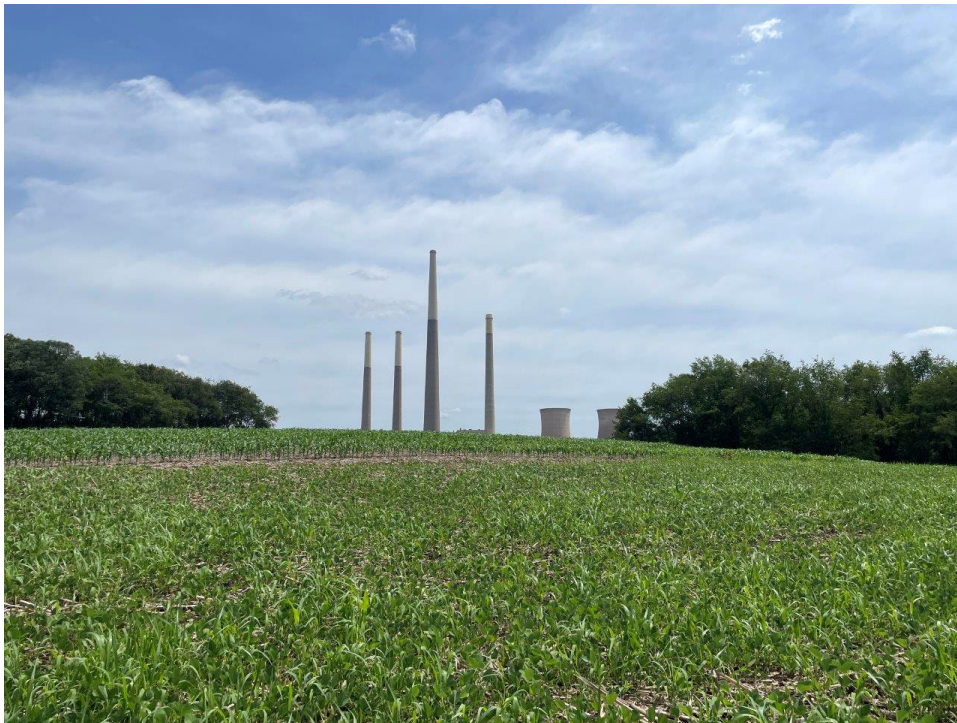
Photograph 22 – View of southern study area extent in agricultural field (facing northeast).

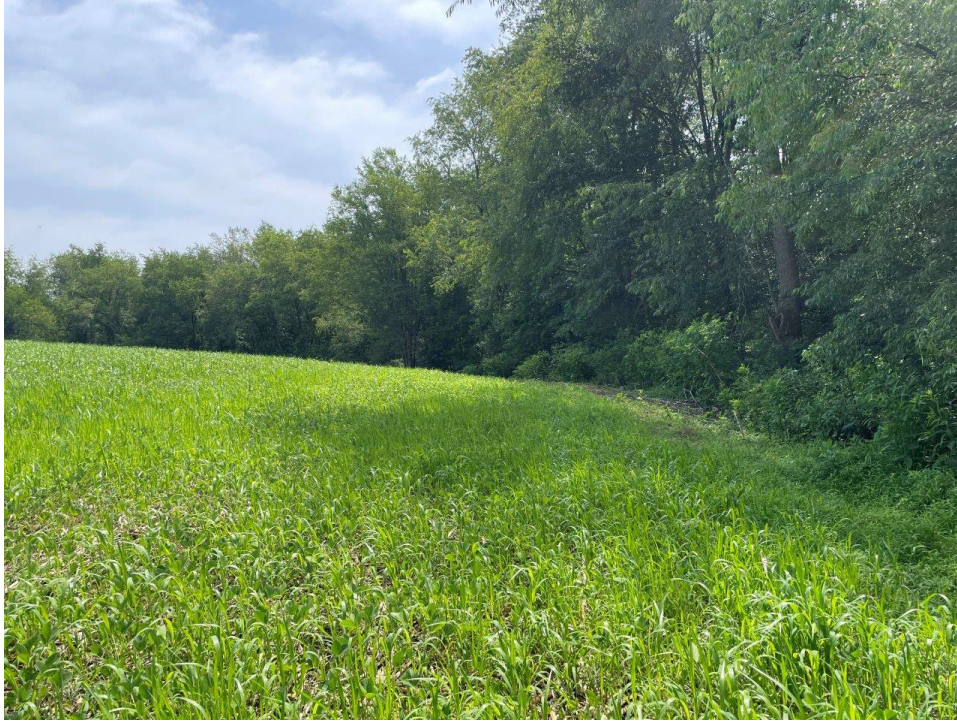
Photograph 23 – Overview of upland wooded fringe in the southeastern study area extent (facing southeast).
