## SUMMARY OF FACTS

### General Site Description

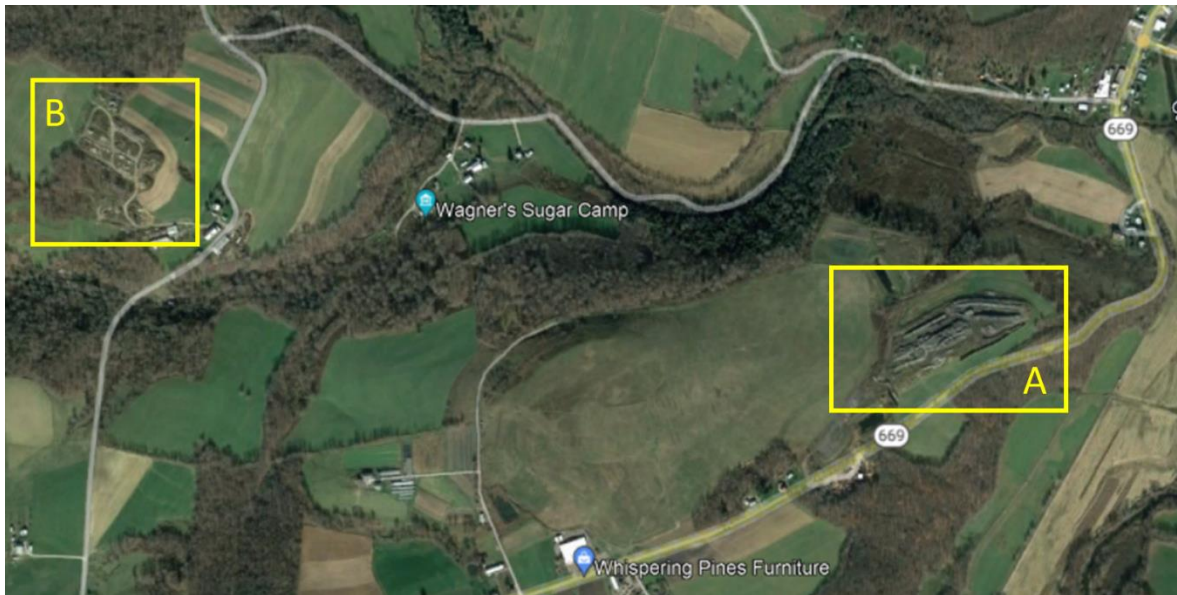
Tub Mill Farms and Clearview Farms, here in identified as the ‘Site’, is located in Elk Lick Township, Somerset County, Pennsylvania. The Site is split between two tax parcels. The first parcel, Tub Mills Farms, is Tax Parcel ID No. S14-012-009-00, here in identified as ‘Parcel A’, located off of Spring Rd (State Route 669) and is 122 acres, with approximately 11 acres containing potentially hazardous material. The second parcel, Clearview Farms, is Tax Parcel ID No. S14-007-046-00, here in identified as ‘Parcel B’, located off Oak Dale Rd and is 390 acres, with approximately 10 acres containing the potentially hazardous material. The image below identifies the areas of interest containing the potentially hazardous material.

The potentially hazardous material being stored on the Site includes, but are not limited to, chemically treated utility poles and railroad ties, estimated over several thousand. The materials at the Site are believed to have been delivered by or through Mr. Terry Brenneman, L&K Industries, Inc. (d/b/a L&K), Bridgewell Resources, LL, Nor Pac Enterprises, Inc., North Pacific Group, Inc., or Tub Mill Farms, Inc. (D/b/a Tub Mill Farms), here in collectively as the “Transferees” to the site from 2002 to present.

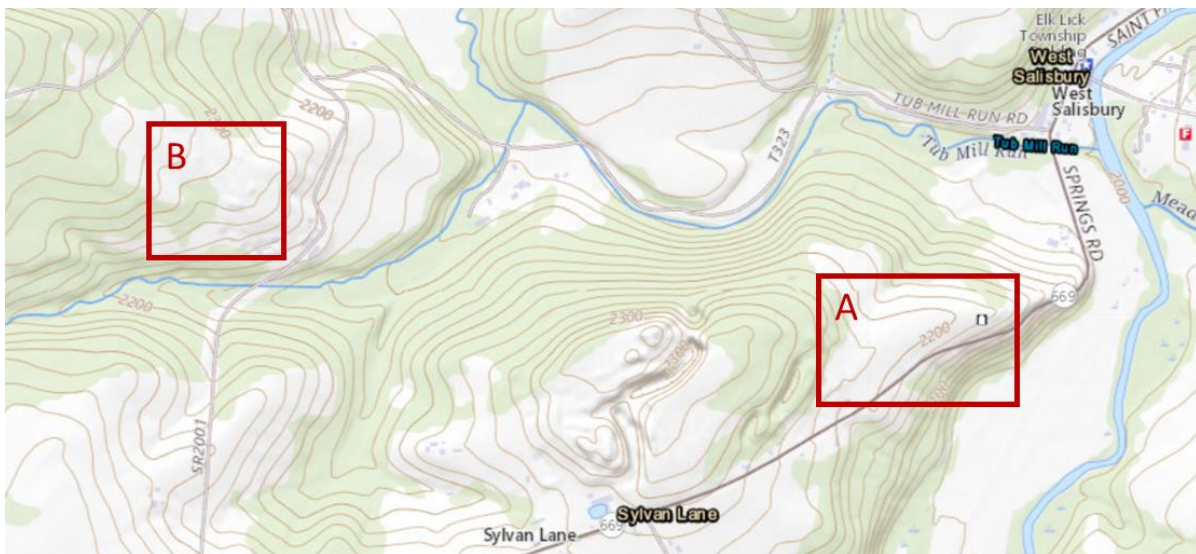
Within Parcel A, there are 2 mine drainage basins adjacent to the pile of, but not limited to, utility poles. The Old Tub Mill Mine is located on Parcel A. Coal was mined from the Elk Lick, Barton, Harlem, and Lower Bakerstown coal seams. The mine appears to have ceased operations around 2010 based on historical images.
