Wetland Delineation and Watercourse Identification Report ET-Braddock Well Pad Project Area North Braddock & East Pittsburgh Boroughs / North Versailles Township, Allegheny County, PA

> Prepared For: Merrion Oil & Gas Corporation 610 Reilly Avenue Farmington, NM

> > September 2017 Revised April 2018

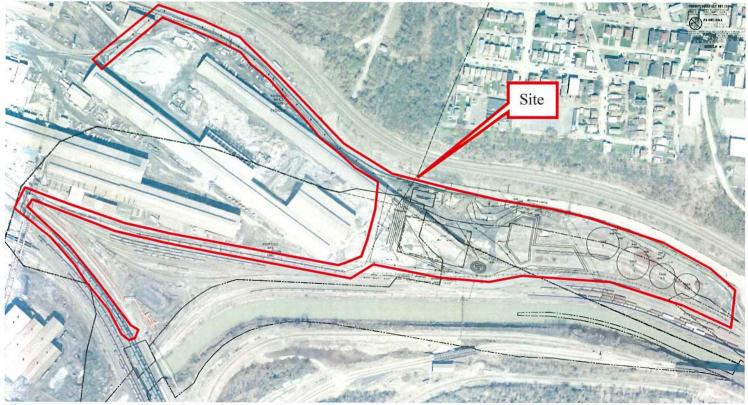
Figure 3 – Proposed Conditions Plan

Wetland Determination Data Forms were completed for each habitat type located within the Site and can be seen in Appendix A of this report. Data Forms sampling locations are indicated on Figure 3.

However, there appears to be a stream enclosure that bisects the site. The stream enclosure appears to originate north of the Site on the north side of Braddock Avenue near the terminus of O'Connell Boulevard. The stream enclosure proceeds south through the Site and terminates at an end wall along Turtle Creek south of the Site (refer to Figure 3A). It appears that both the proposed water and gas lines to be installed to the west of the pad area will cross the stream enclosure enclosure.

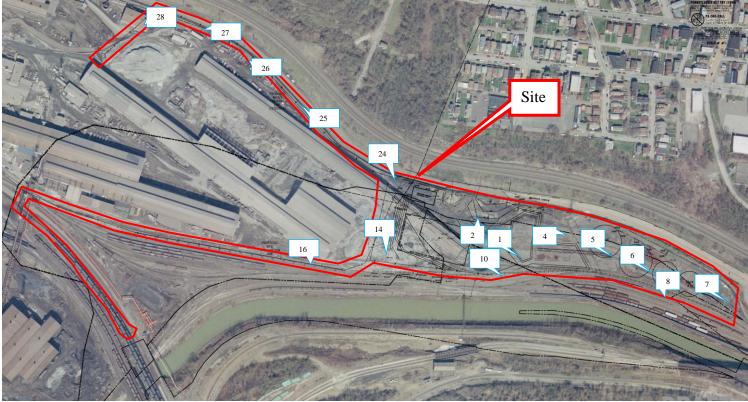
Figure 3 – Photograph Location Plan

Relevant photographs of the Site are contained in Appendix B and are keyed to Figure 3.
