ENHANCED TECHNICAL ASSISTANCE EVALUATION

Big Run Area Municipal Authority Sewage Treatment Plant

Henderson Township, Jefferson County

NPDES #PA0223107

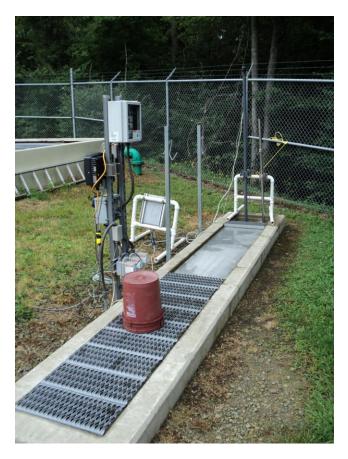
Figure C.3 Locations of Ammonia and Nitrate probes prior to the UV light in the effluent discharge
