Covered Bridge Meadow Agricultural BMPs - Grant #SW160095
Washington County Conservation District

PROJECT DESCRIPTION: The Best Management Practices (BMPs) installed during this project were streambank fencing, animal crossings, animal trail, and barn drains. The project was completed between 2016 and 2021 during multiple phases. This project is part of a larger push by WCCD to install agricultural BMPs in the Raccoon Creek Watershed.

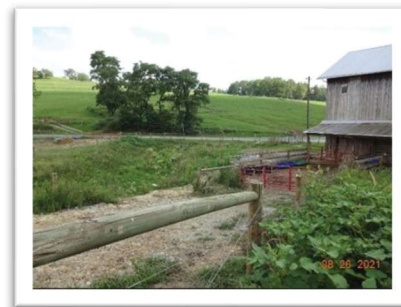
After Project

PROJECT RESULTS: The Best Management Practices (BMPs) installed for this project included 3,228 ft of streambank fencing, 2 animal crossings, 4,125 ft² of stabilized animal trail, roof gutters, dripline drain, and 2 spring development with 4 watering troughs. These BMPs resulted in a reduction in sediment, nitrogen, and phosphorus in the headwater stream.
