Tuscarora Creek Bank Stabilization Project

Growing Greener Project C90003037

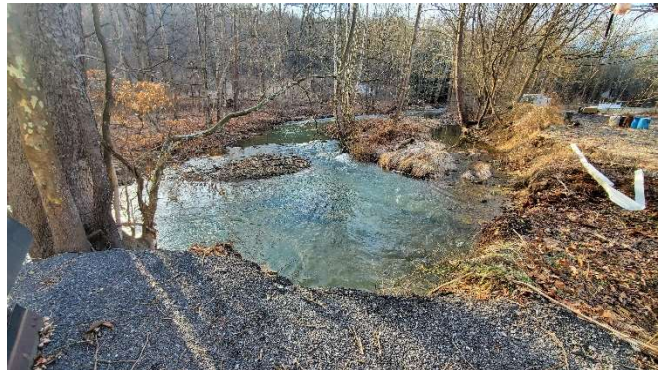
Before: A large pocket had eroded into the bank, threatening the Tell Twp. Municipal Bldg. and parking lot.

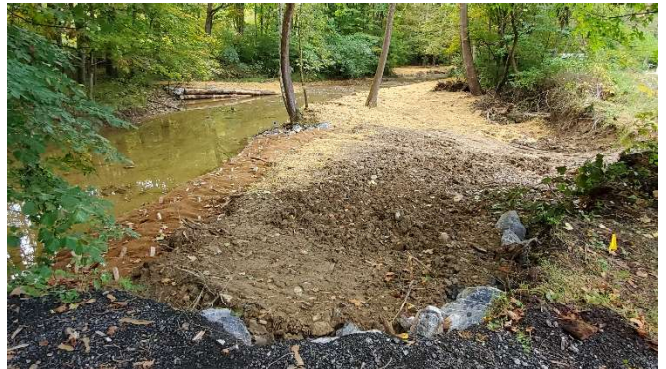
After: The pocket was filled with native material and edged with rock for stability. It was later planted with trees and shrubs. A streamlined, stable stream is the result.
