SUBJECT: Application Summary Report for Remedial Services at the Ridge Run PFAS Site

Summary Page

Client PM: Jonathan Dziekan Project Name: Ridge Run Pilot Study RRS Project Manager: Will Clogan Project Dates: 4/6/21 – 4/12/21

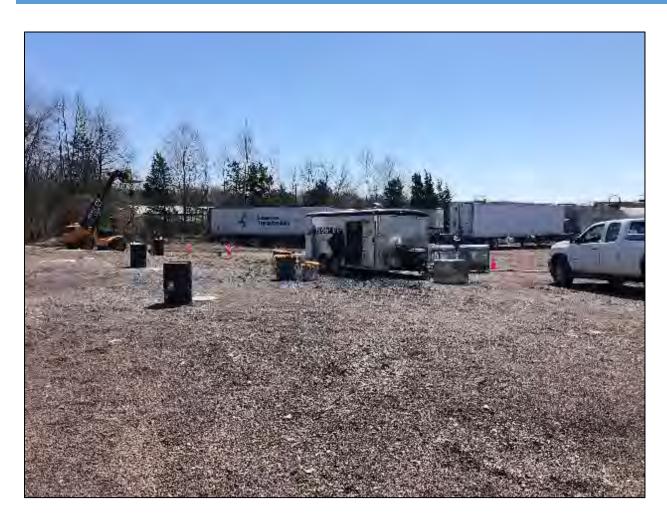
Photo 1: Injection area with RRS injection trailer. Looking South

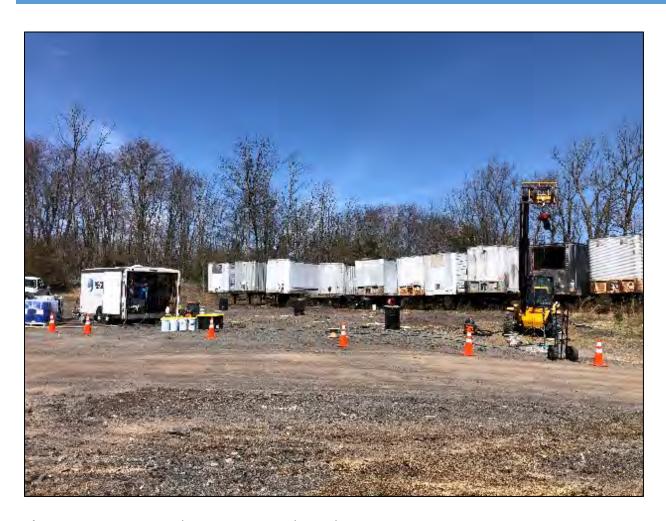
Photo 2: Injection area with RRS injection trailer Looking N

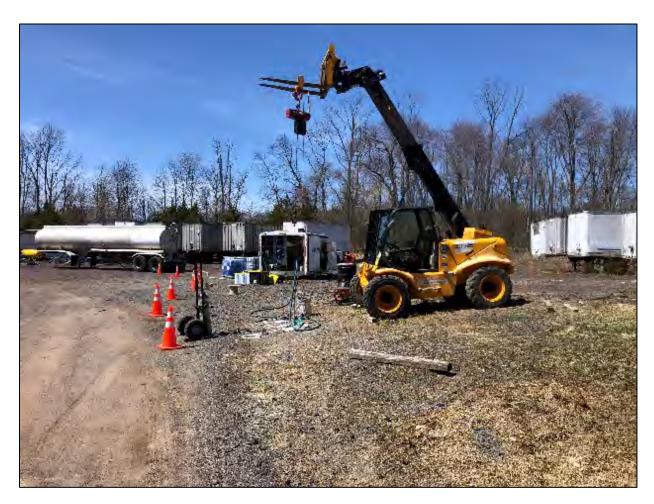
Photo 3: Injection area. Looking North
