# WASTEWATER TREATMENT EVALUATION SALISBURY TOWNSHIP'S GAP STP

LANCASTER COUNTY, PA  
NPDES #PA0081574

MARCH through MAY 2015

June 2015

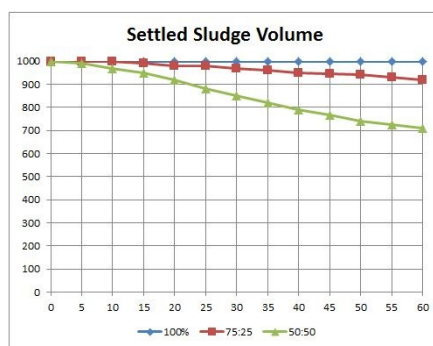
Settleability Location	Triple Settleometer Test SAR2		
	100%	75:25	50:50
0	1000	1000	1000
5	1000	1000	990
10	1000	1000	970
15	1000	990	950
20	1000	980	920
25	1000	980	880
30	1000	970	850
35	1000	960	820
40	1000	950	790
45	1000	945	765
50	1000	940	740
55	1000	930	725
60	1000	920	710

Figure 1: Triple Settleometry Test results, 3/8/15

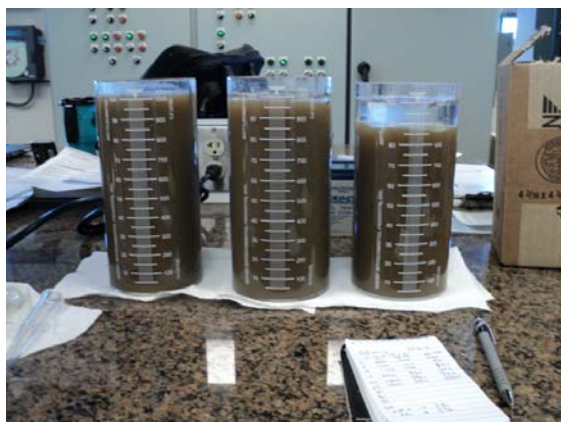
**Figure 2:** Evidence of Poor Settling due to Filamentous Organisms.

1. The facility was operating under conditions of inadequate sludge wasting, which led to dissolved oxygen deficiency that promoted the dominance of filamentous organisms.
2. Loading to the facility may be inadequate, overall, and specifically inhibiting to the proper operation of a BNR process. Supplemental electron donor carbon sources may be necessary to drive BNR, and nutrient balance or bioremediation (prepared nutrients or bacterial cultures) may be necessary to restore balance and inhibit the dominance of filamentous organisms.
3. The presence of excessive solids and filamentous organisms hinders adequate performance of the secondary clarifiers and results in both ashing of solids and occasional loss of clarifier blanket solids to downstream processes.

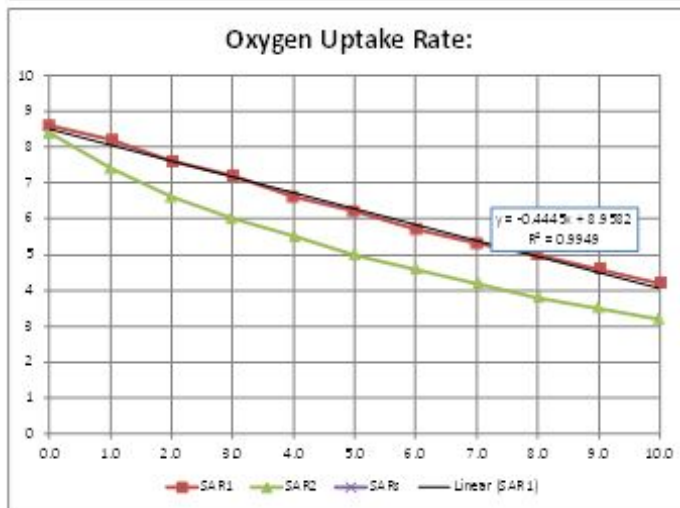
Figure C.2: Example Data from the Automated Process Monitoring Workbook

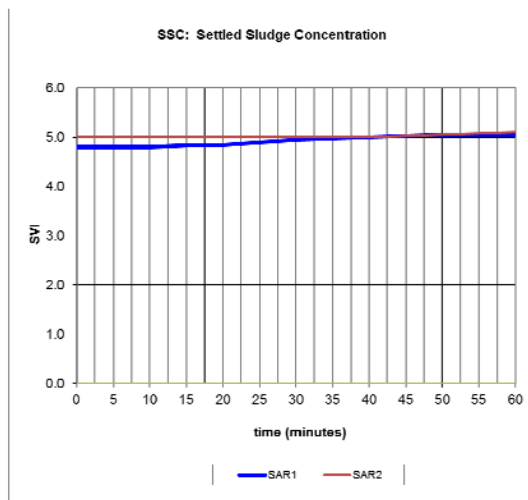
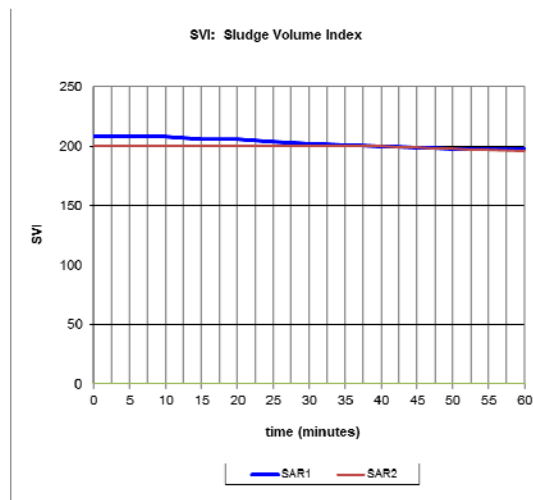
Figure C.3: Example Data from the Automated Process Monitoring Workbook

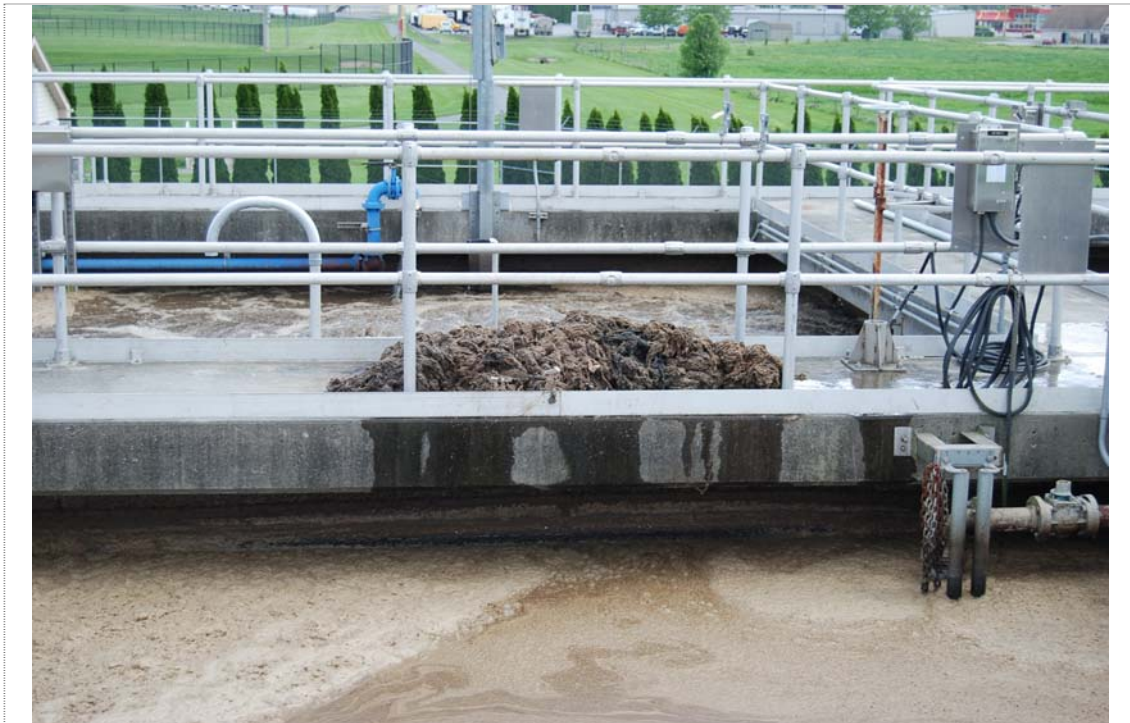
4. Further investigation noted that the lack of adequate screening in the plant headworks resulted in accumulation of rags and detritus that damaged downstream equipment and processes, including obstruction of one of the clarifier feed lines, causing imbalance in clarifier operation (and ultimately, solids loss,) and deterioration of aeration diffuser capability.

Figure 1: Large mound of rags and detritus removed from SAR

- a. Install temporary measures at the plant headworks to capture and divert much of the rags and insoluble detritus entering the plant;
  - b. Repair the existing comminutor, where teeth are either missing or where there exists insufficient clearance to assure destruction of rags and insoluble detritus;

- c. Remove rags and detritus from process equipment, including the subsurface aerators, pump impellers, anoxic mixers, clarifier rakes. This activity will be labor intensive and will require process tanks to be alternately emptied and cleaned.

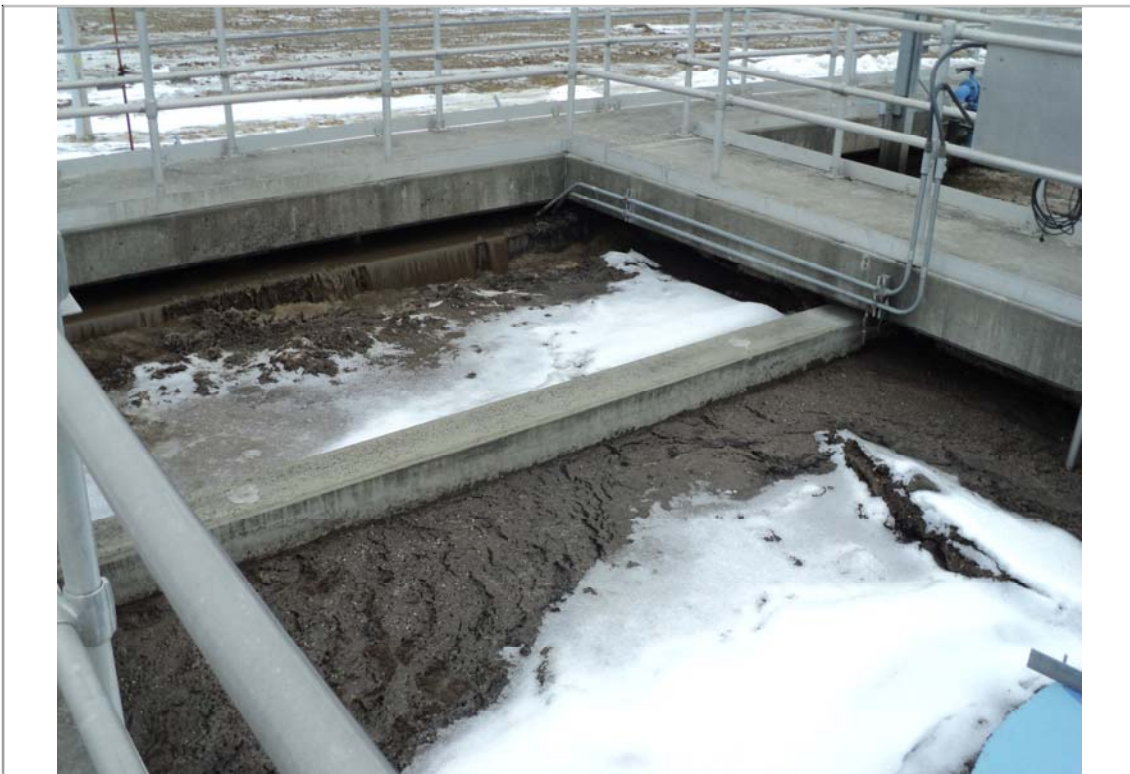
Figure 2: Scum Layer (filamentous organism reservoir) on Pre-Anoxic Tank & Phase Separator

1. Given the conditions that were present at the outset of the evaluation, and the confirmation of these issues during the field phase of the study, DEP recommended the following:
  - a. Immediately begin to reduce sludge solids concentration within the treatment process to attain the manufacturer's recommended level of solids for adequate treatment of the wastewater. Do not exceed wasting more than 10% of the solids inventory during a single day.
  - b. Immediately take measures to counteract the presence of filamentous organisms:
    - i. Chlorinate the return activated sludge (RAS) appropriately, using 12.5% Sodium hypochlorite solution while monitoring the biology to prevent overdosing.
    - ii. Remove scum layers from the anaerobic and anoxic processes upstream of the SAR tanks, in order to remove existing inoculation reservoirs of filamentous organisms.

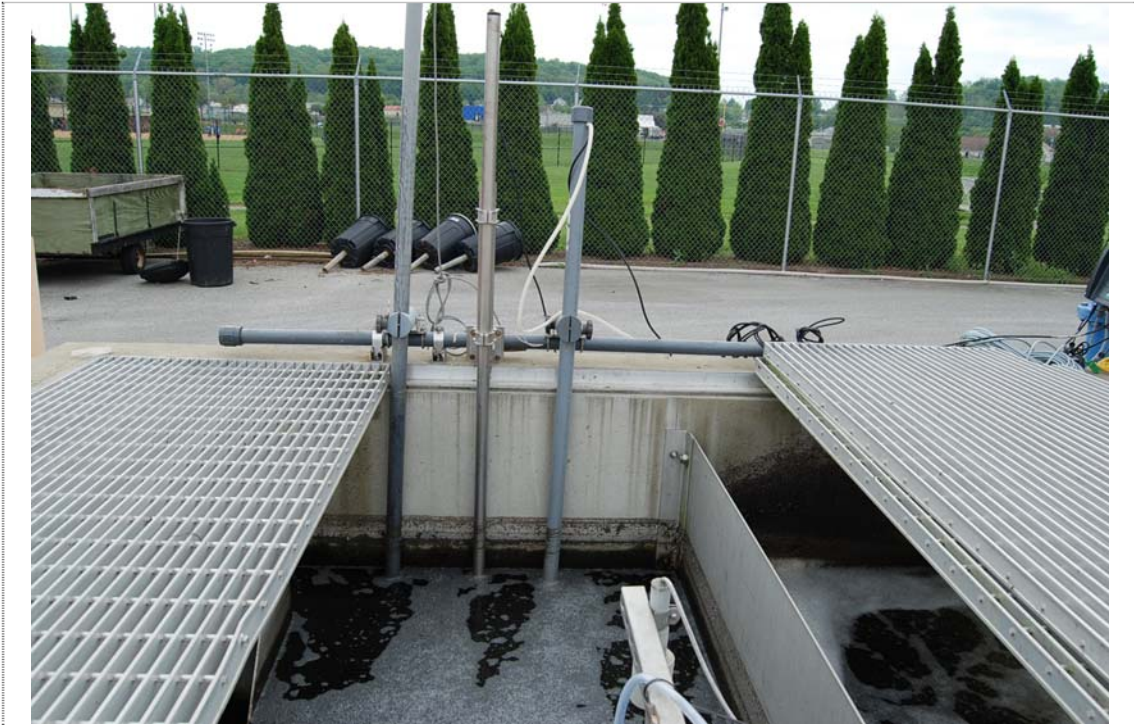
Figure 3: Probe Installation at Effluent Reaeration Tank: Nitrate, Ammonium, & DO Probes

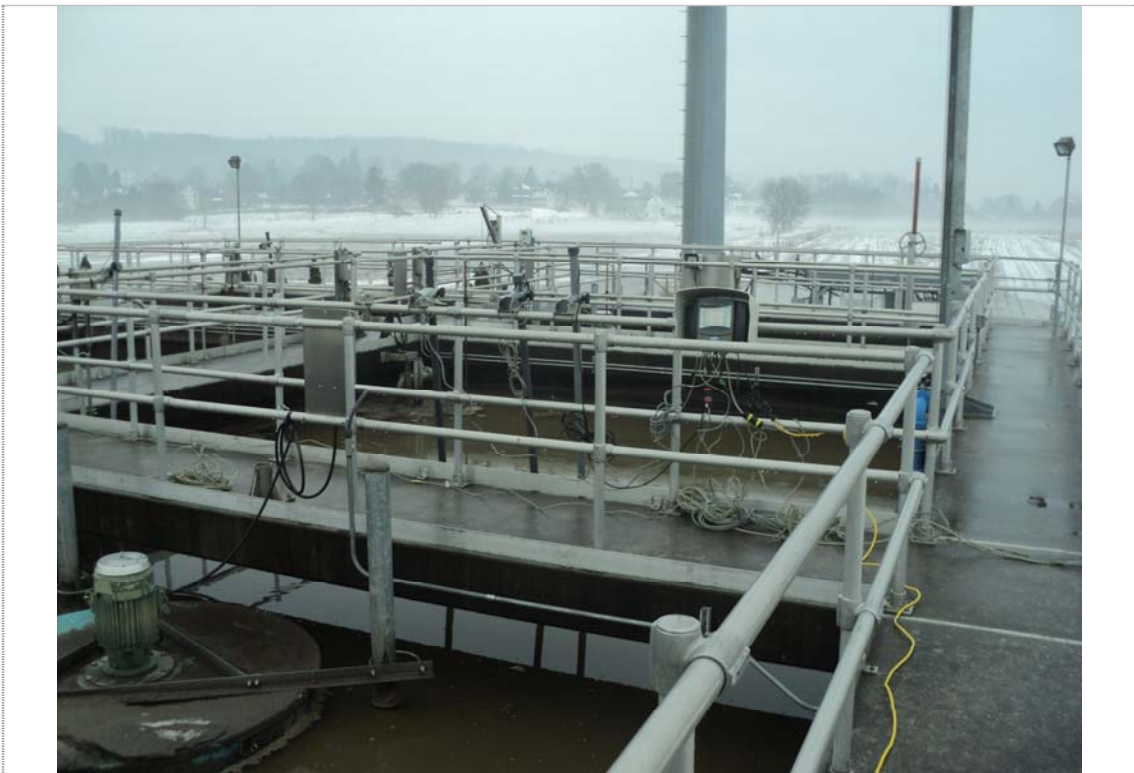
Figure 4: Probe Installation at SAR: pH, TSS, DO, and ORP; Anoxic Tank: ORP

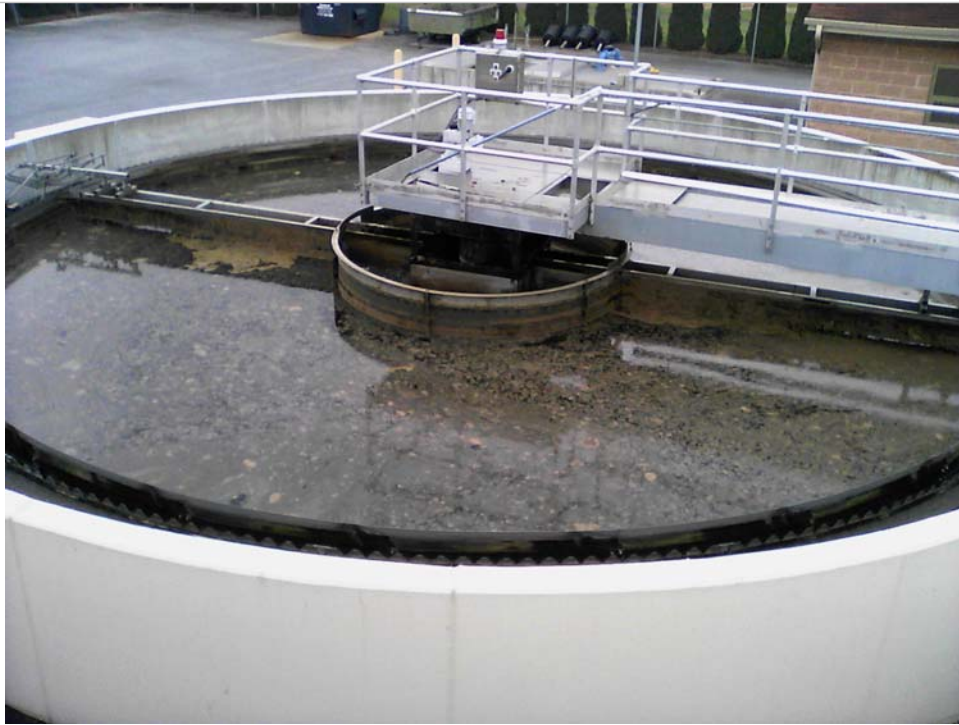
Figure 5: Secondary Clarifier inflow line was clogged by rags and taken out of service.

- b. Removal of detritus-caused obstructions to secondary clarifiers and the service-water pumps and lines; and,
  - c. Employ in their sewer billing letters public relations materials that specifically discourage the flushing of “disposable wipes” and other non-degradable solid wastes into the collection system.

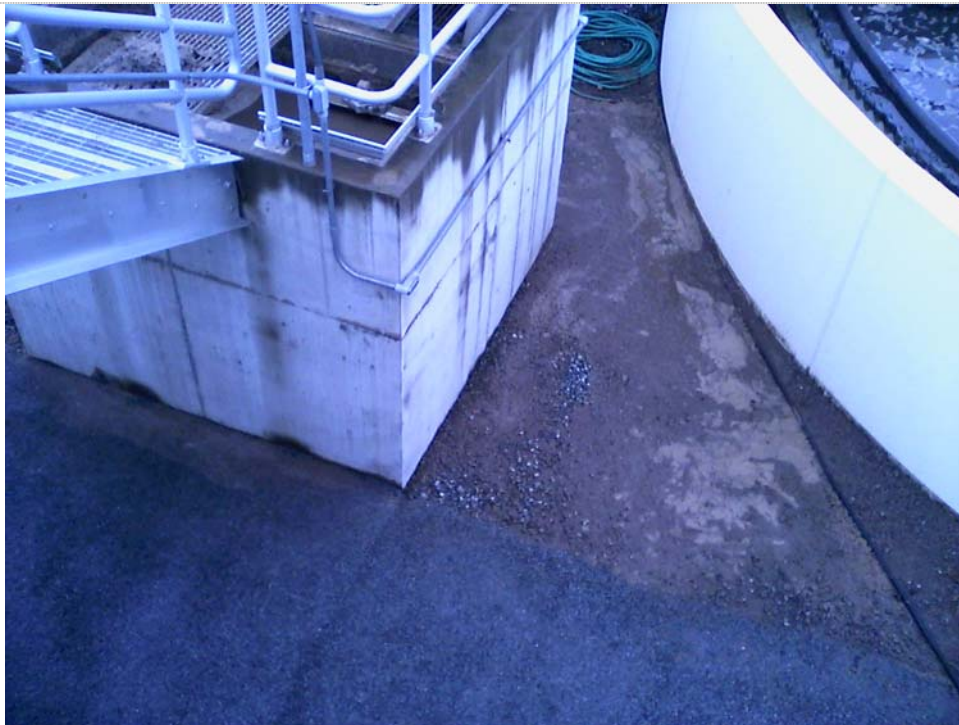
Figure 6: Evidence of line obstruction at clarifier feed splitter box.

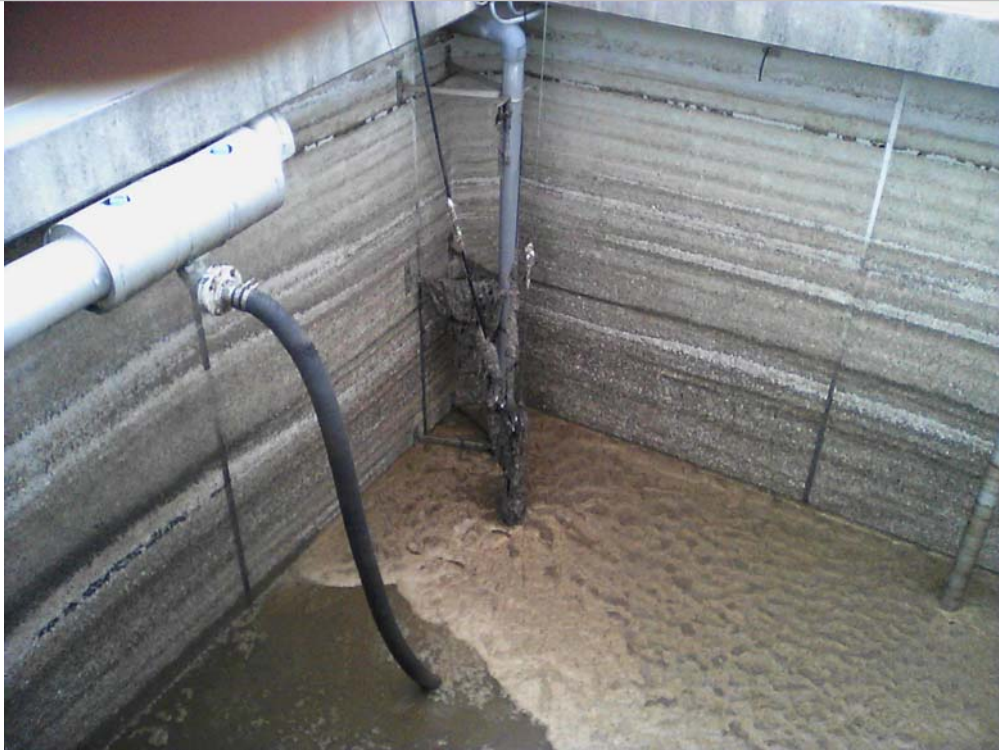
Figure 7: Example of rags accumulating in aerobic digester

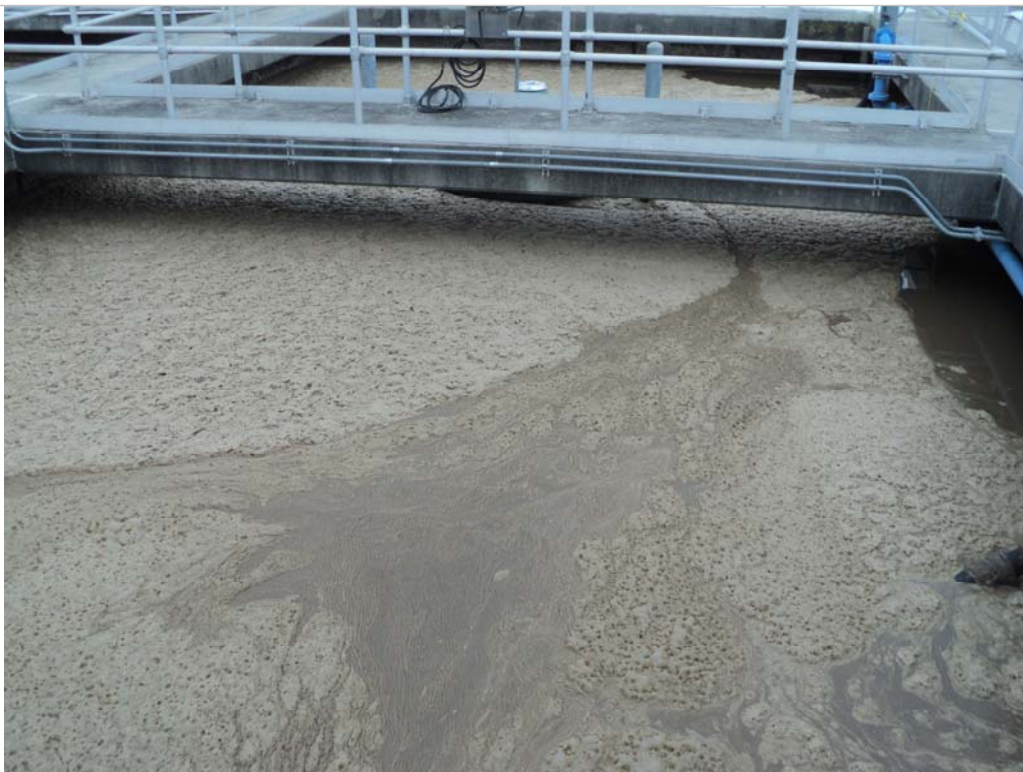
Figure 8: Foam buildup in Staged Aerobic Reactor Tank
