Hydrogeologic Study
Area A-9

Westinghouse Electric Corporation
Pittsburgh, Pennsylvania

REPORT
HYDROGEOLOGIC STUDY
AREA A-9 - BEAVER FACILITY
WESTINGHOUSE ELECTRIC CORPORATION

PROJECT NO. 88-537
MAY 11, 1989

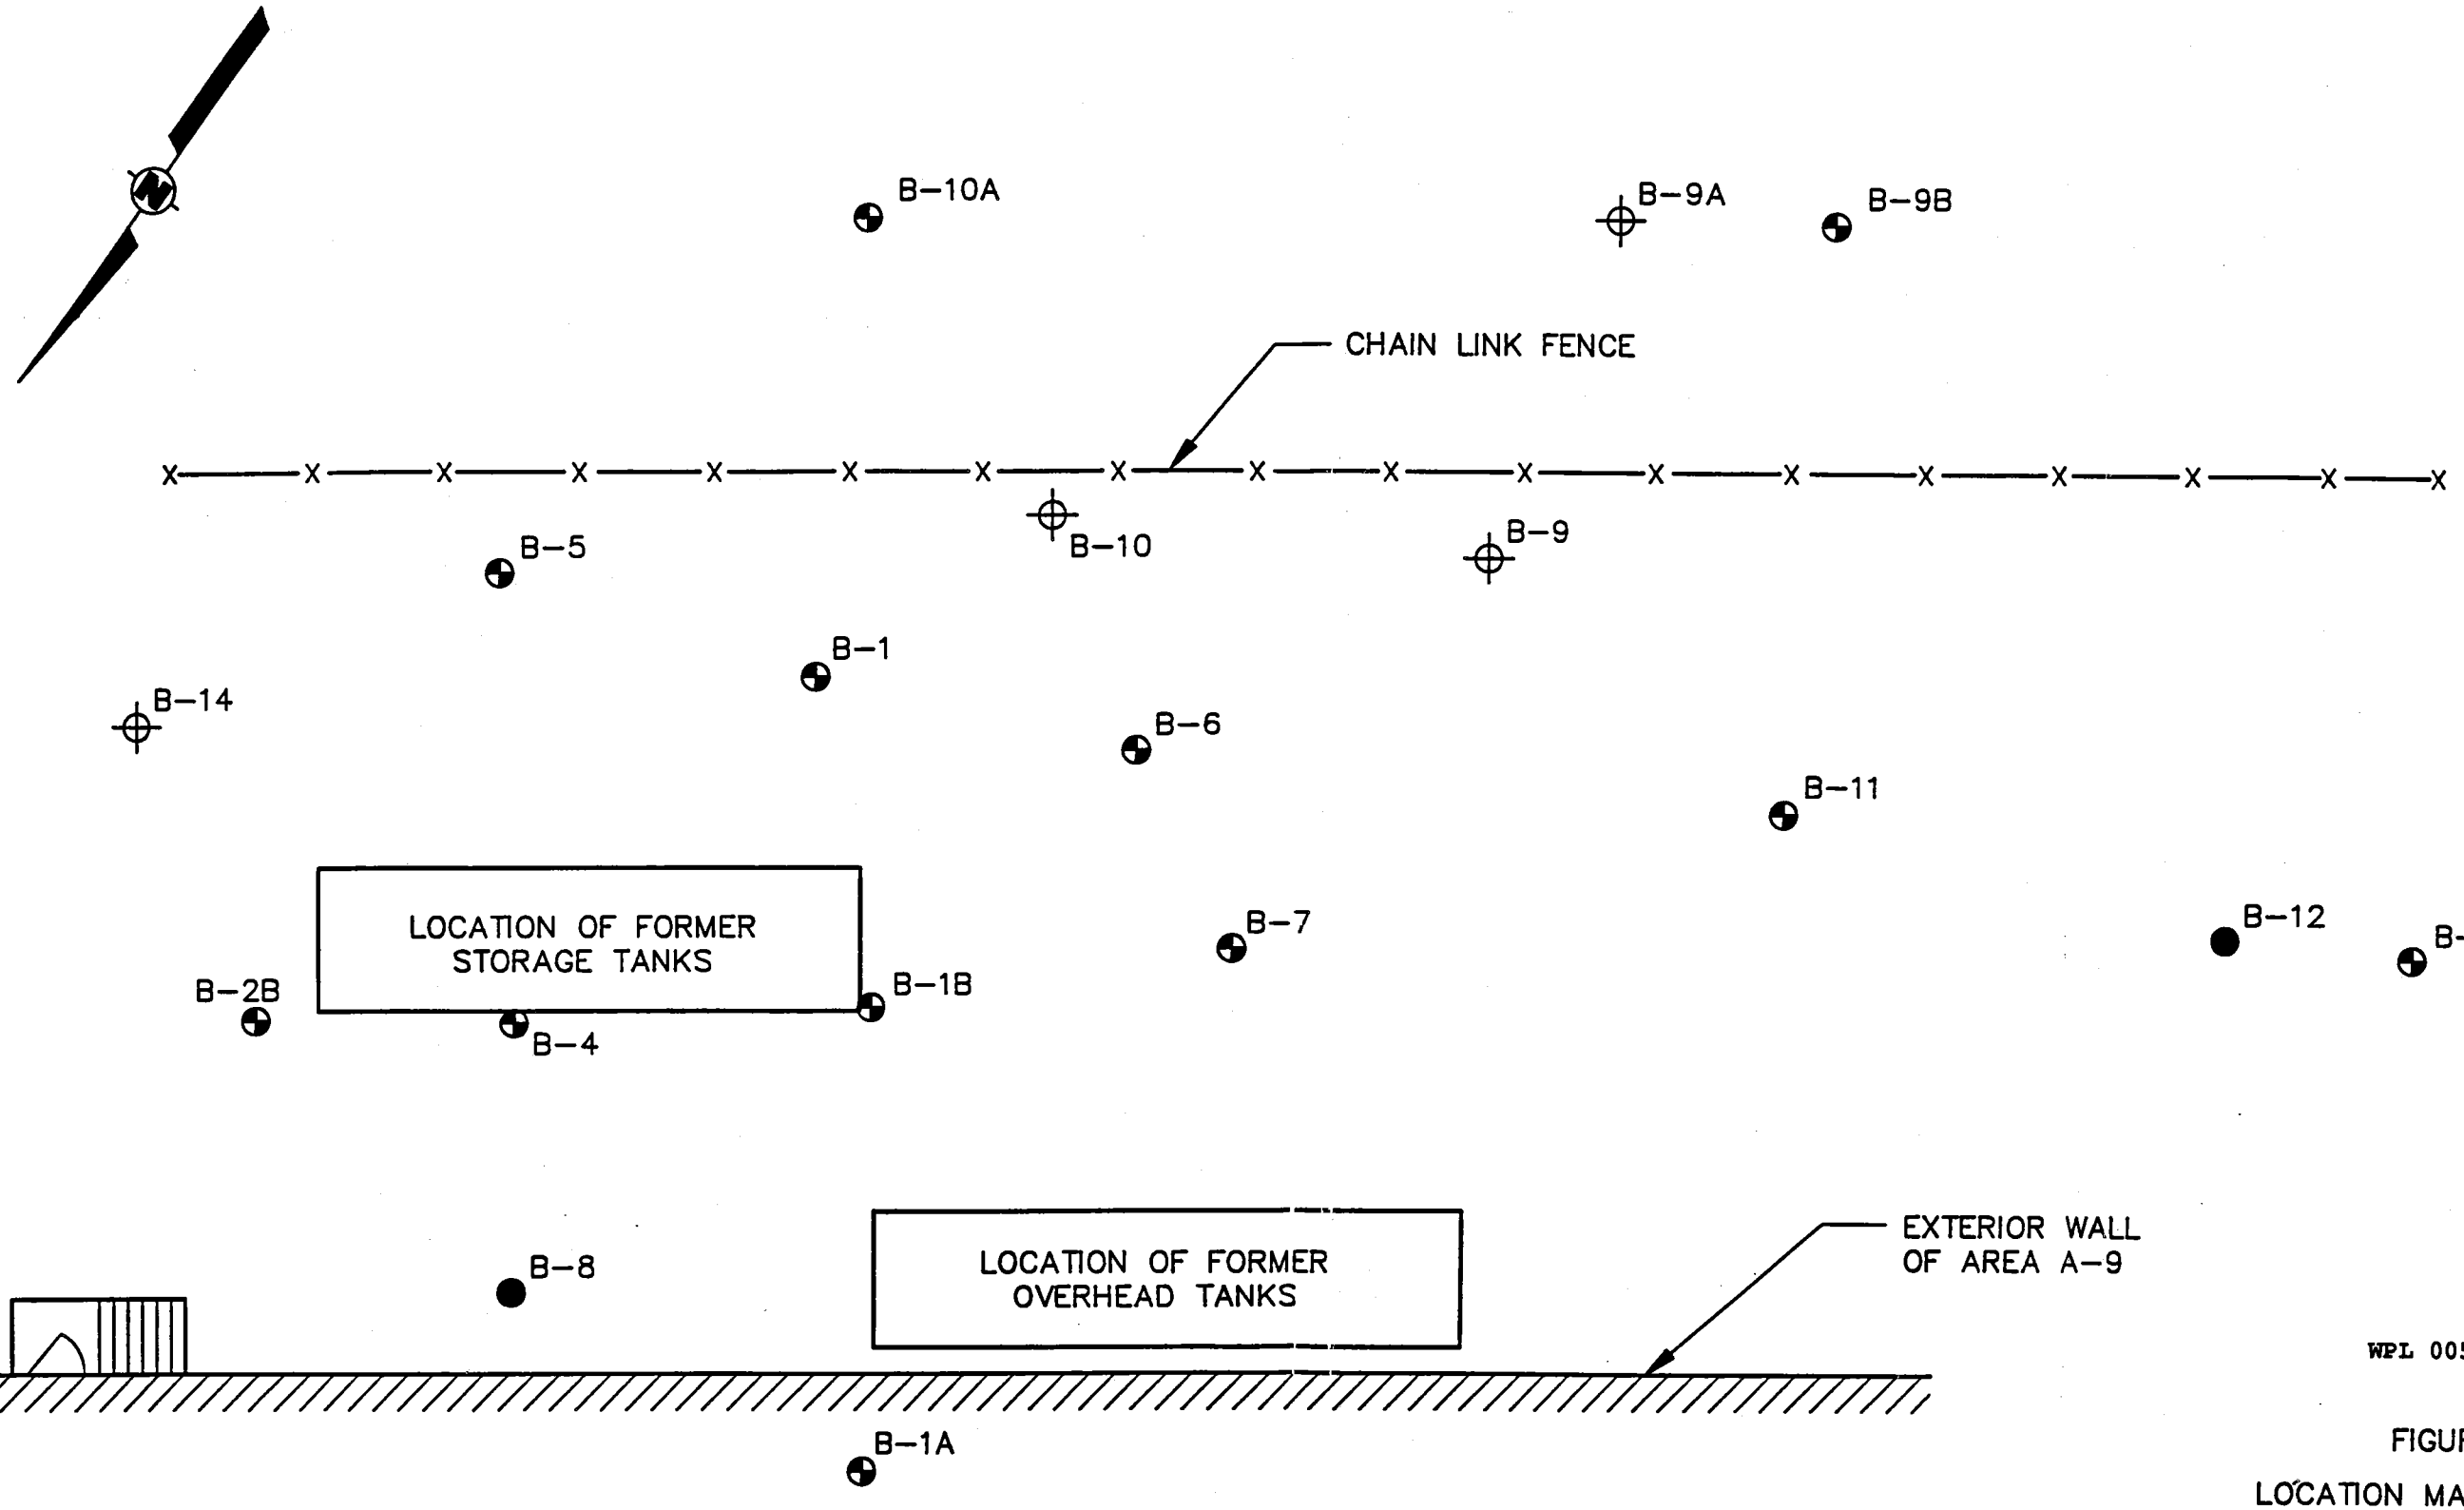
FIGURE 1

The drilling program consisted of a total of 10 soil borings. Three of these were drilled to bedrock. The remaining seven were shallow borings intended to define conditions in shallow subsurface. Boring locations are shown on Figures 1 and 2. Drilling was performed by Terra Testing and supervised by Rizzo Associates.

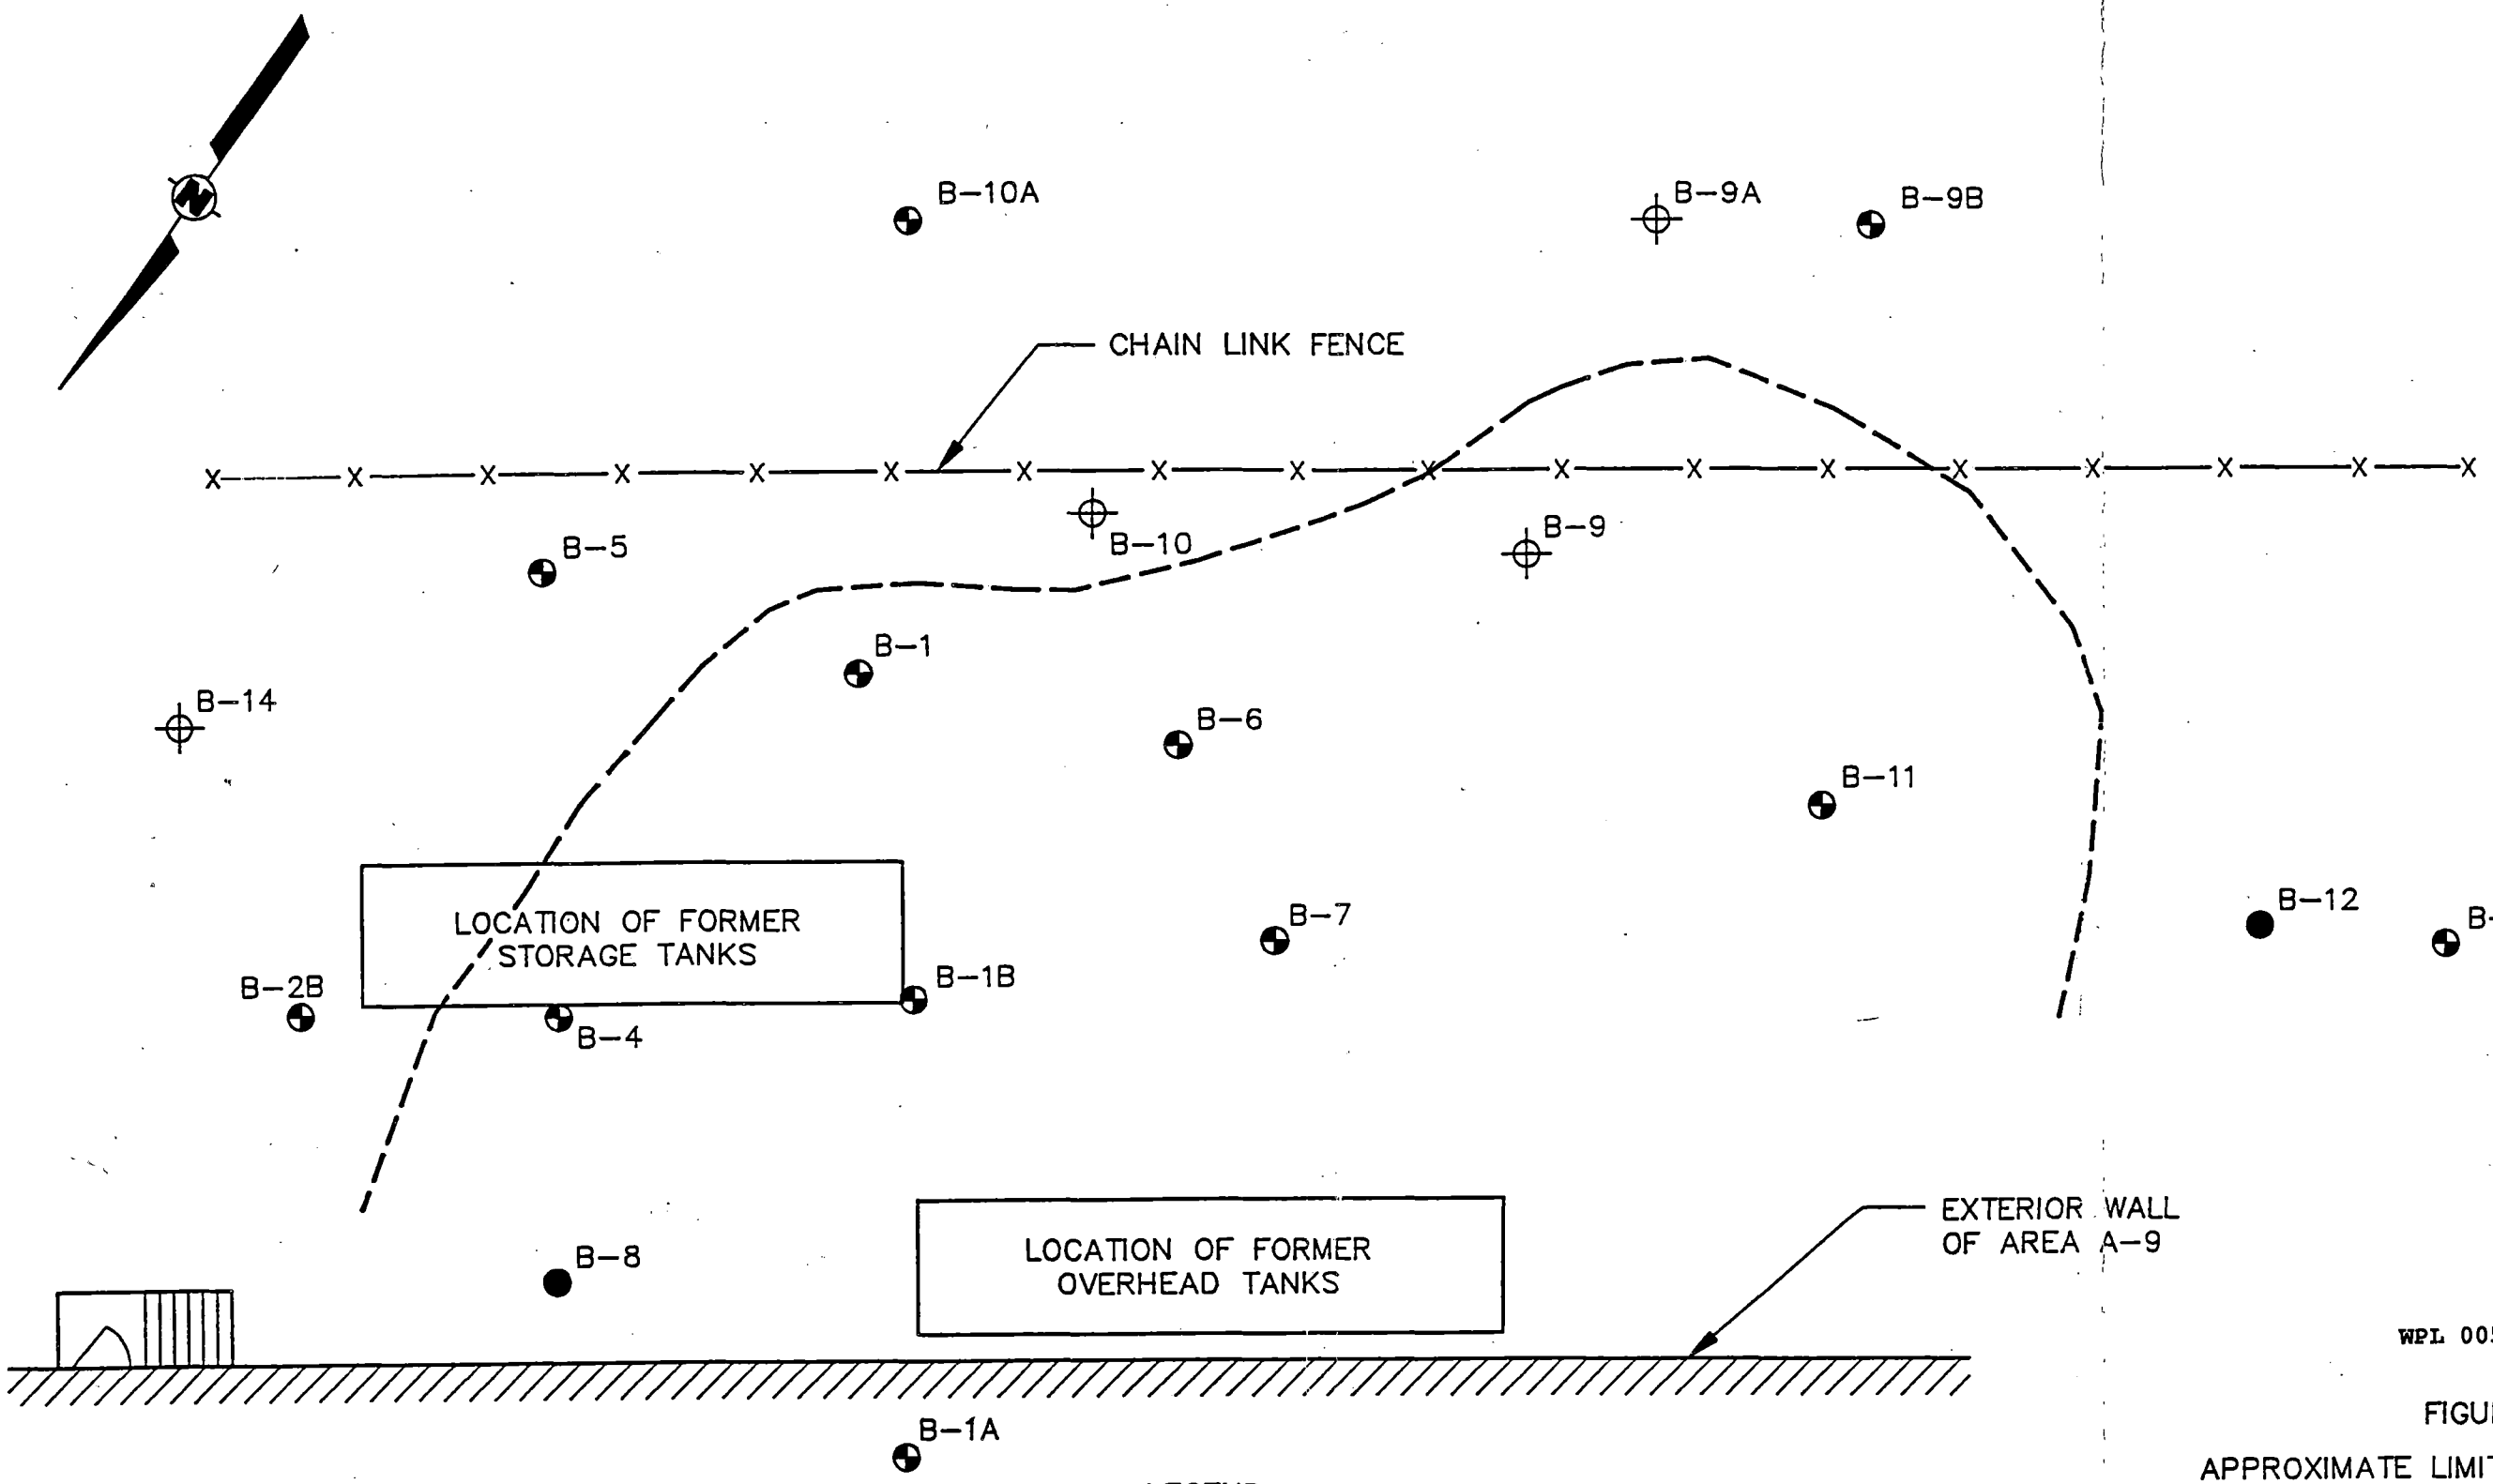
FIGURE 3

Cyanide was detected in samples from the sand fill zone of Borings B-9 and B-11. These concentrations were significantly lower than those measured in samples taken from B-6 and B-7 during the previous investigation (Rizzo Associates, 1986a). Borings on the outer fringes of the study area (B-9A, B-9B, B-10, B-10A, B-12, B-12A, and B-14) showed no evidence of cyanide contamination. Figure 3 shows the approximate limit of anomalous cyanide concentrations in the soil.

- Cyanide appears not to have migrated from the plant site. The area currently known to be contaminated is a localized perched zone surrounded by borings showing no anomalous cyanide concentrations (B-9A, B-9B, B-10A, B-12, B-12A, and B-14). The approximate limit of anomalous cyanide concentrations is shown on Figure 3. Cyanide was not detected in the zone of continuous saturation associated with the soil-bedrock interface.

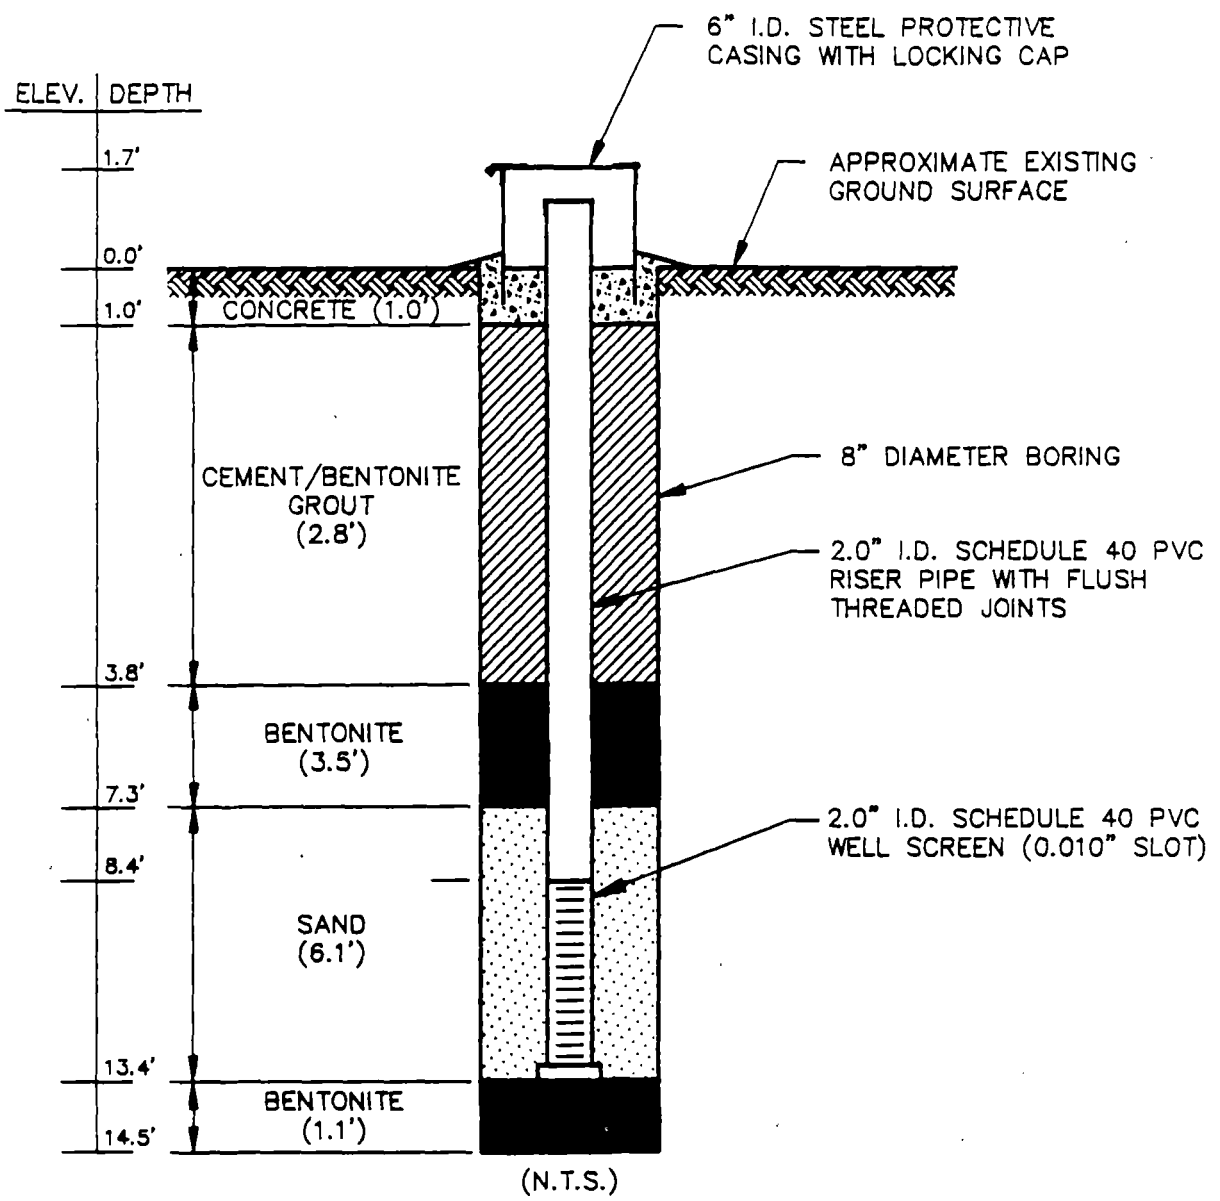
MONITORING WELL NO. B-9B
INSTALLATION DETAILS
HYDROGEOLOGIC STUDY
AREA A-9
BEAVER FACILITY

Six monitoring wells were installed as part of this investigation. Installation diagrams for these wells provided in Appendix B. Three of these (B-9B, B-10A, and B-11) were installed to monitor the perched water zone. It was recognized during drilling that these wells would be marginal in terms of yield. However, they were installed to document the limits of perched water and could yield representative samples of the perched zone in "non drought" conditions. Borings B-12 (and its replacement B-12A) and B-13 were completed as wells to monitor the groundwater zone associated with the soil-bedrock interface. No wells were installed at Borings B-9, B-9A, B-10, and B-14. Borings B-9 and B-10 were grouted because soil headspace readings indicated that they were not beyond the limits of VOC contamination. Borings B-9A and B-14 were grouted because of insufficient water to set a well.
