HORIZONTAL DIRECTIONAL DRILL ANALYSIS
I-81 ROAD CROSSING
PADEP SECTION 105 PERMIT NO.: E21-449
PA-CU-0136.0003-RD-16
(SPLP HDD No. S2-0220-16)

This reanalysis of the horizontal directional drill (HDD) installation of a 16-inch diameter pipeline that traverses Interstate Highway 81 (I-81), Middlesex Road, Wetland W-I30, and Stream S-I47 in Middlesex Township, Cumberland County, Pennsylvania, is in accordance with the Stipulated Order issued under Environmental Hearing Board Docket No. 2017-009-L for HDDs listed on Exhibit 3 of the Stipulated Order. This HDD is number 9 on the list of HDDs included on Exhibit 3 of the Order.

The 16-inch pipeline HDD is referred to herein as HDD S2-0220-16.

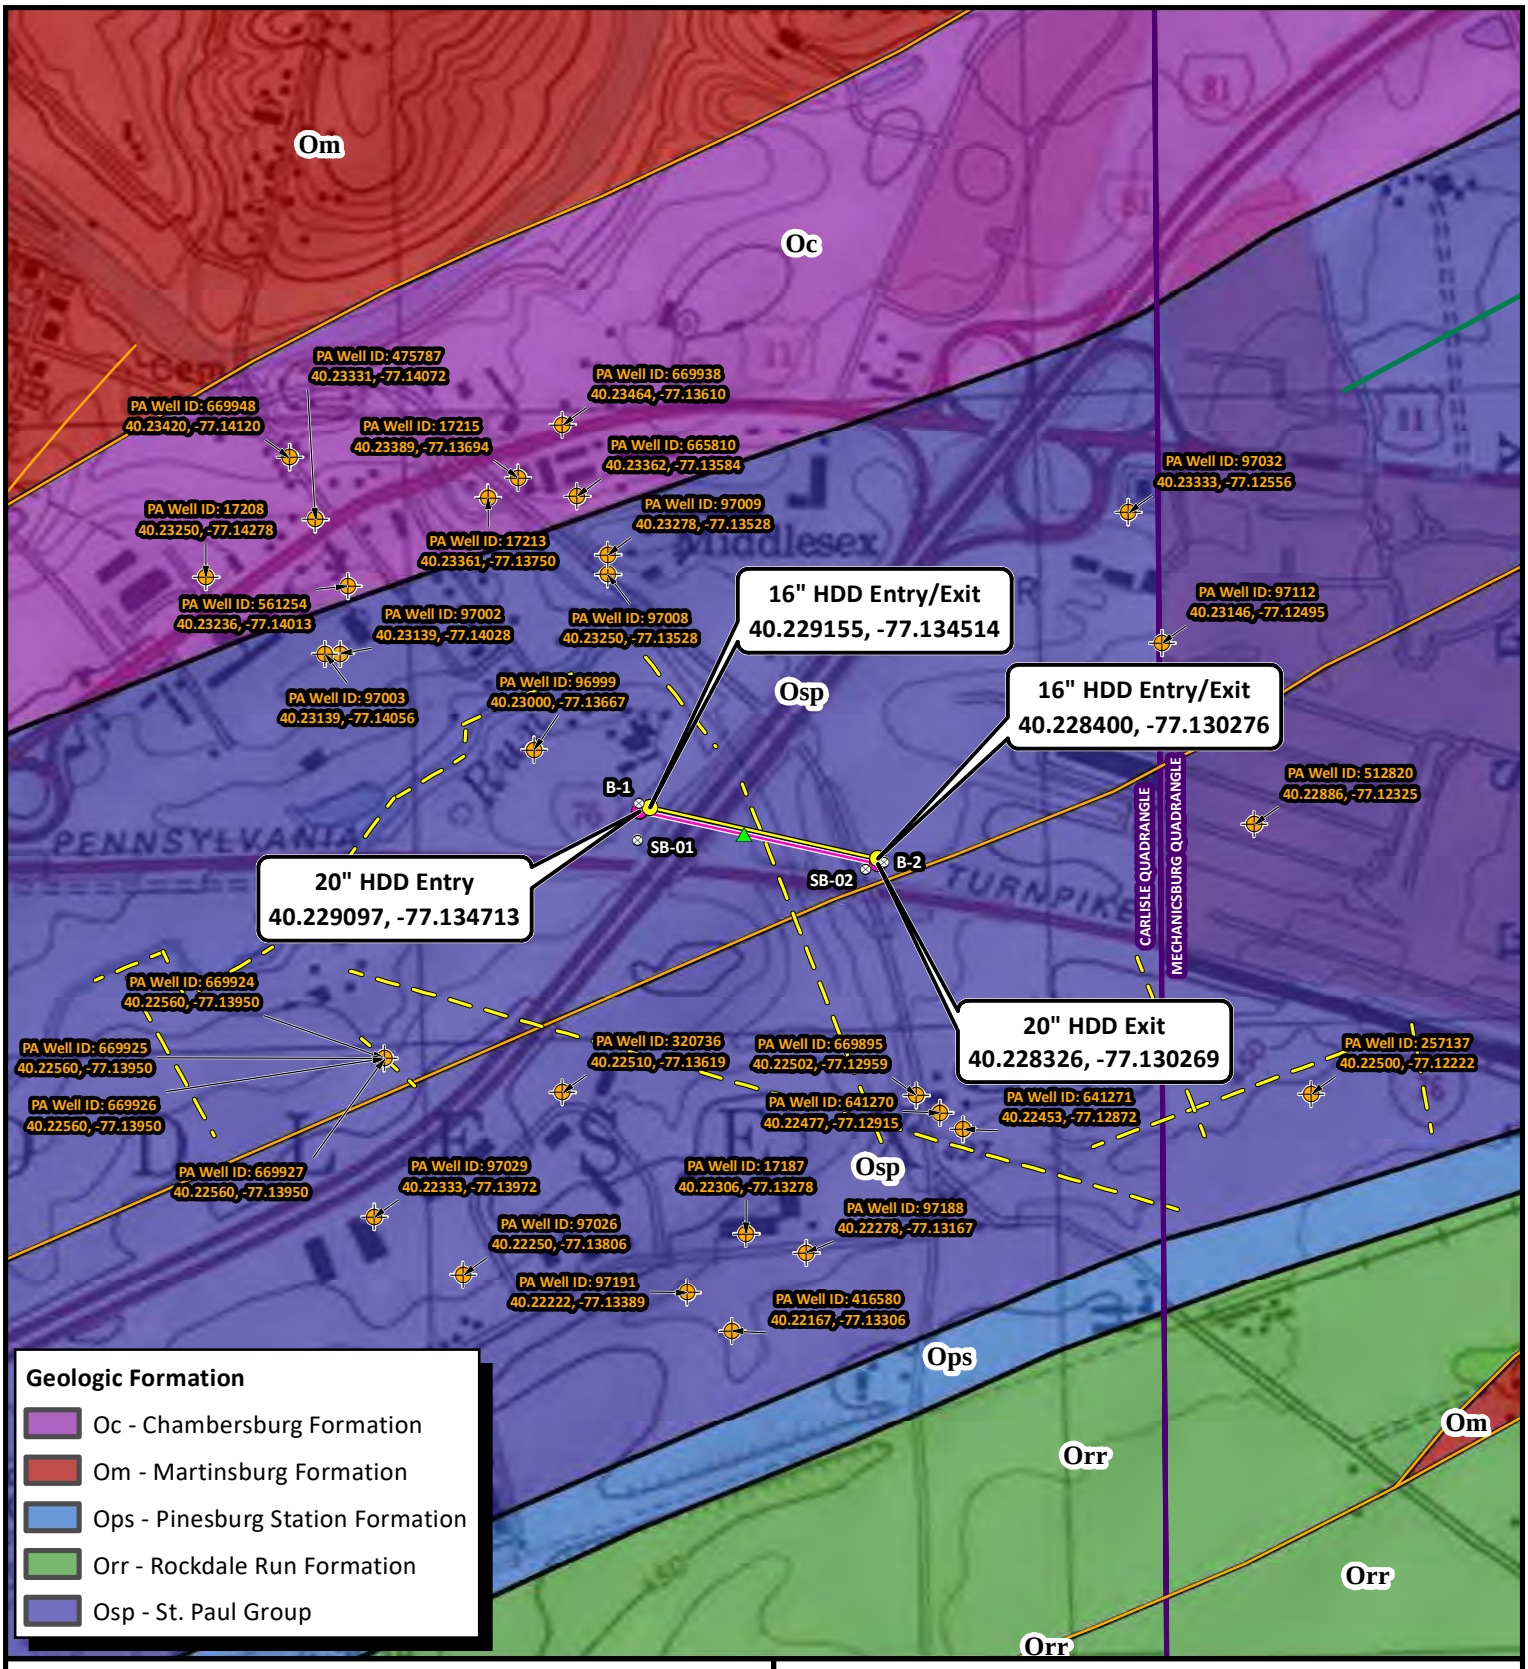
Figures 2 and **3** show the results of the fracture trace analysis overlain on the geologic map and aerial base map, respectively. Fourteen fracture traces were identified in close proximity to the proposed I-81 HDD. Five of the fracture traces trend approximately northeast-southwest (NE-SW), parallel to geologic strike. Nine of the fracture traces trend approximately northwest-southeast (NW-SE) and may represent joint sets perpendicular to geologic strike. Nine of the fracture traces correspond with straight stream segments of LeTort Spring Run and unnamed tributary S-I47 and are likely associated with local

geologic structure. It is important to note that one of the NW-SE trending fracture traces crosses the HDD near the location of the reported IRs.
