SUPPLEMENTAL SITE CHARACTERIZATION REPORT

BISHOP TUBE SITE

EAST WHITELAND TOWNSHIP
CHESTER COUNTY, PENNSYLVANIA

FEBRUARY 2008

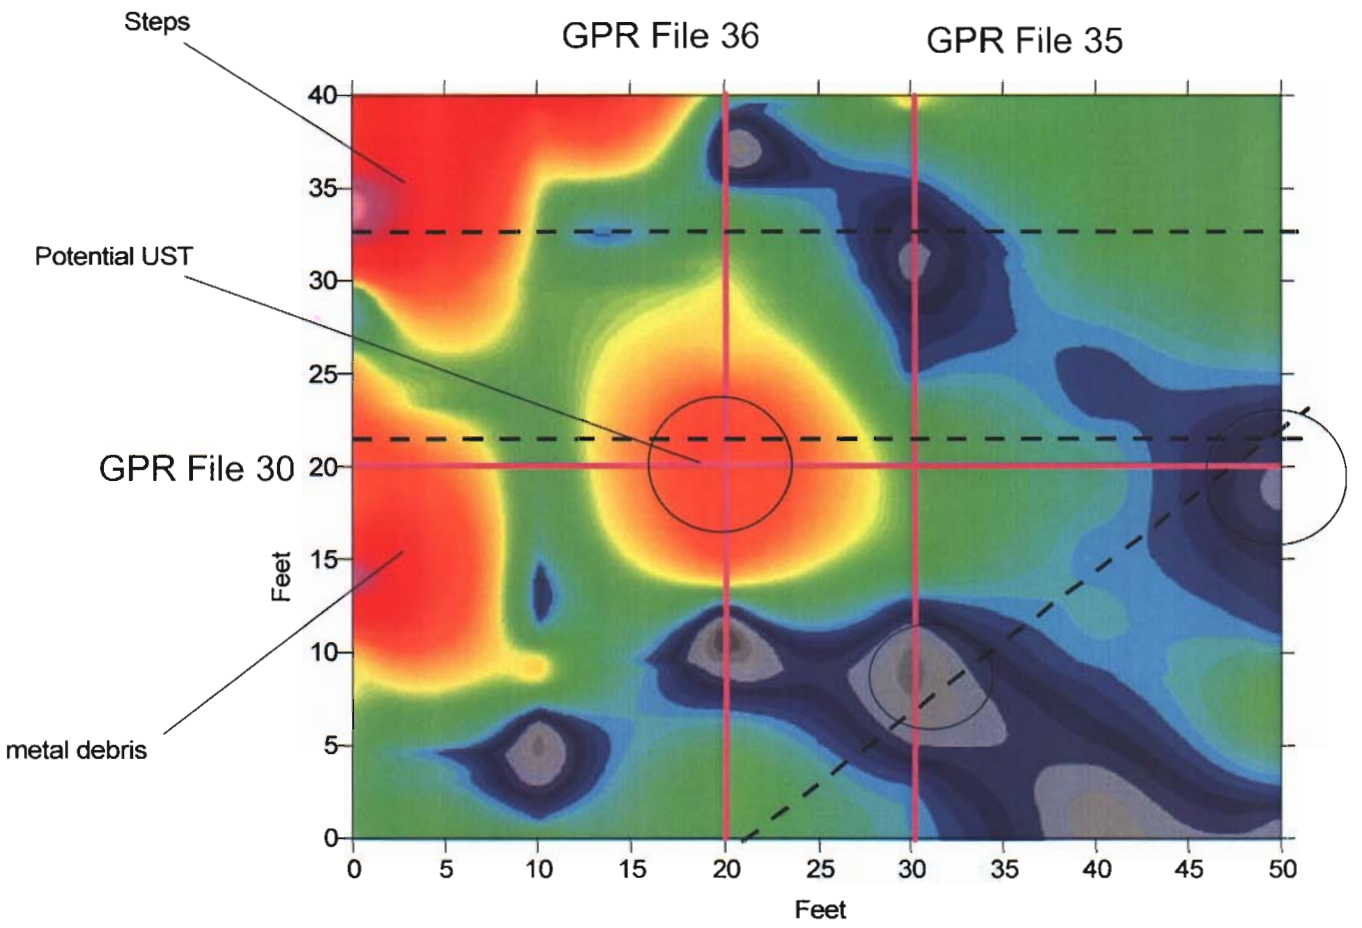
EM61 Contour Map-Area A		
Michael Baker, Jr., Inc. Bishop Tube Site East Whiteland Township, Chester County, PA		
June 2007		07248
ARM GEOPHYSICS *Surface & Borehole Geophysics*		Figure 1

Unknown Anomaly

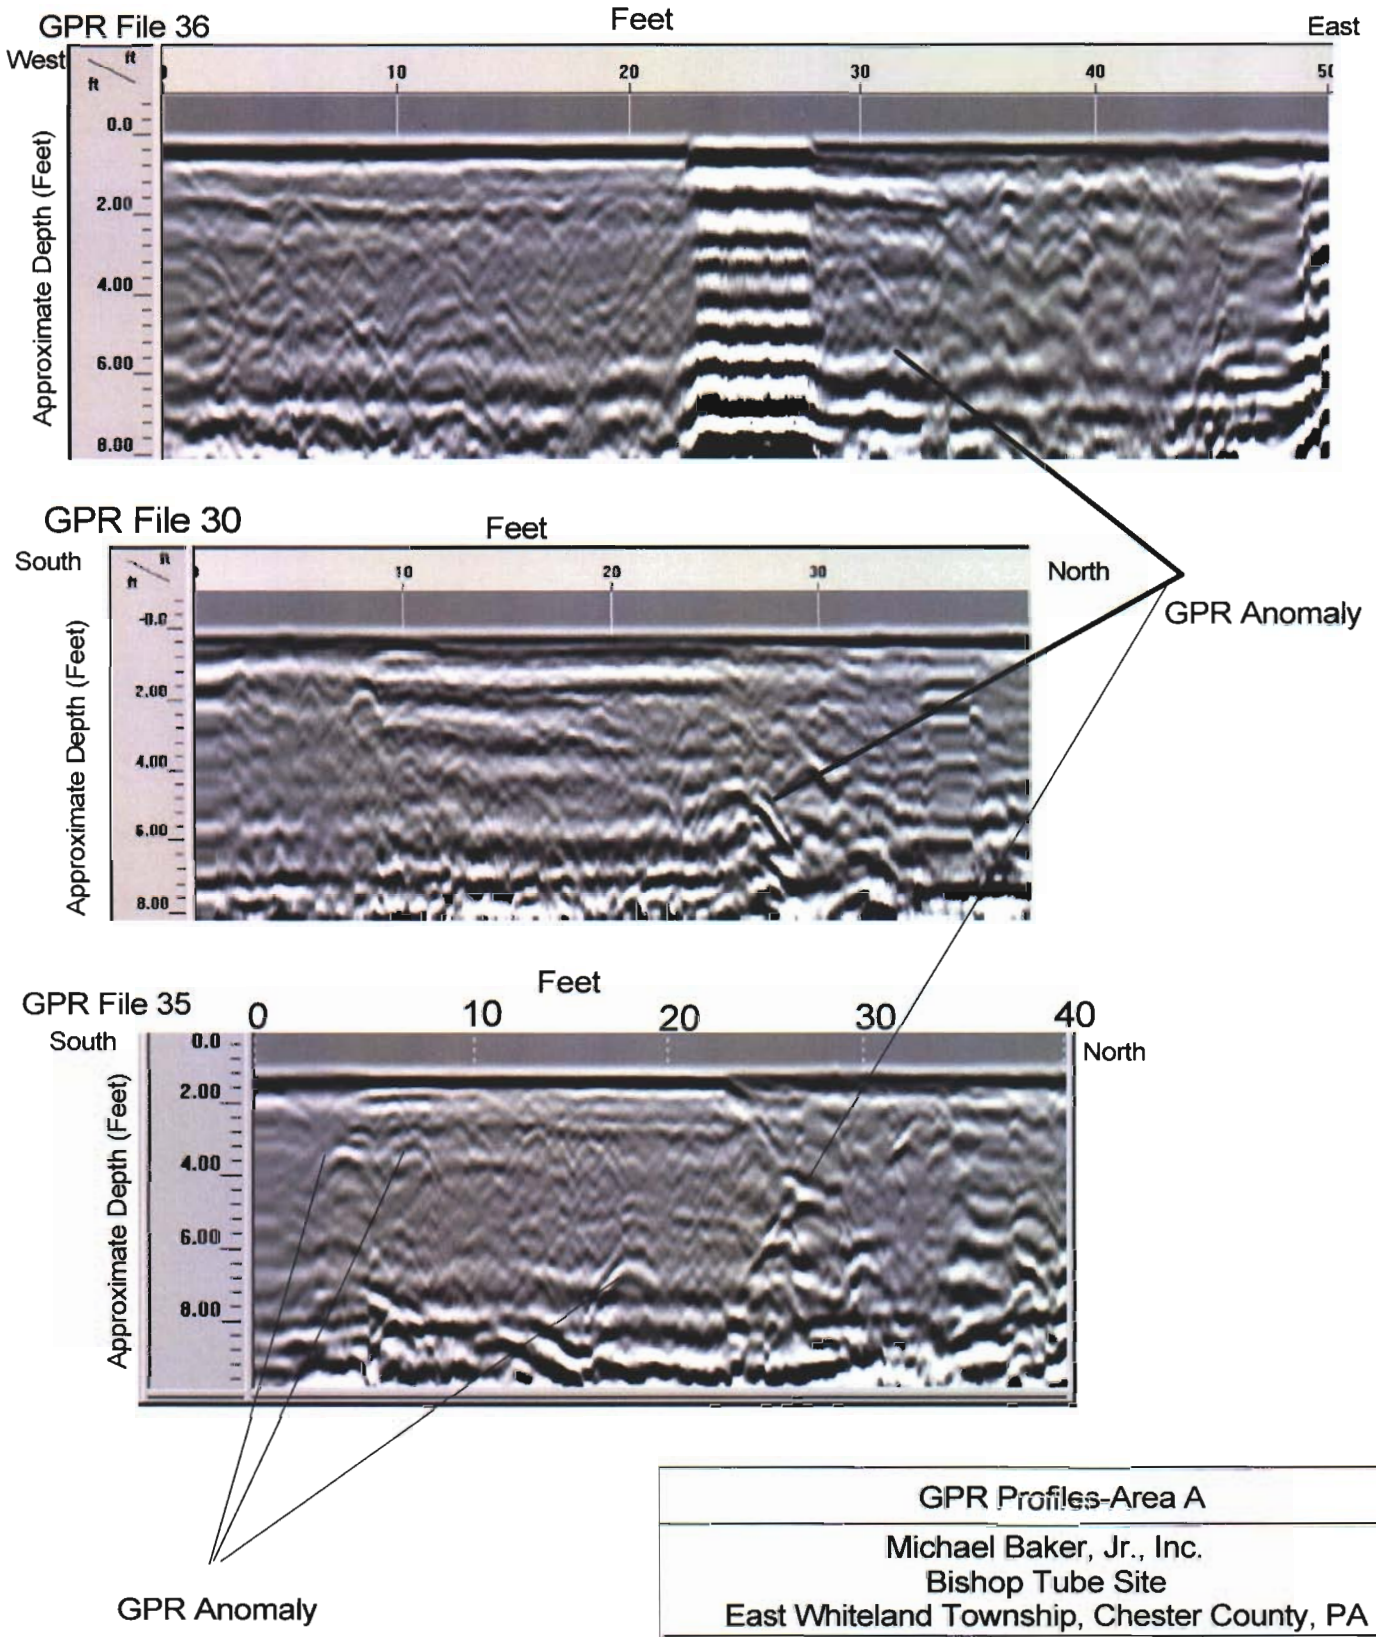
Figure 1 presents an EM61 contour map. The survey area measured 50 feet by 40 feet. EM61 and GPR data were collected along bidirectional transects (north to south and east to west) at 10-foot spacings. Anomalies outlined along the western boundary are the result of surface metallic debris in the survey area. There is no metal source of the anomaly located in the central portion of the survey area. This anomaly appears to be the result of subsurface metal content. The GPR profiles collected over this EM anomaly are presented on Figure 2. The anomaly has characteristics similar to a potential vault or associated piping. Based on the EM61 data, the dimensions of the anomaly are approximately 4 feet by 3 feet. Other anomalies (shown as blue and gray) in the EM61 data may represent isolated metallic debris within the subsurface.

Several potential utilities were marked within this AOC. These are shown as dashed lines on Figure 1. The utility that is oriented from the southwest to the northeast trends toward a manhole cover that is located approximately 20 feet to the south of the survey grid.

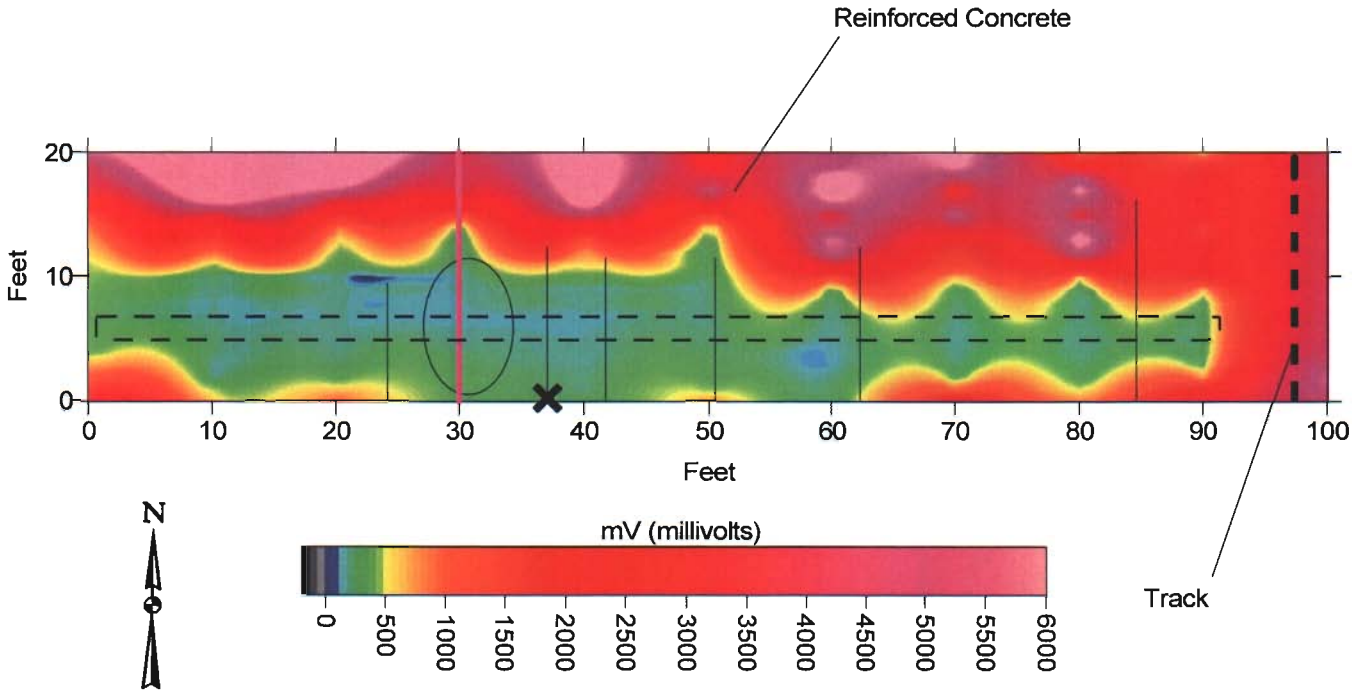
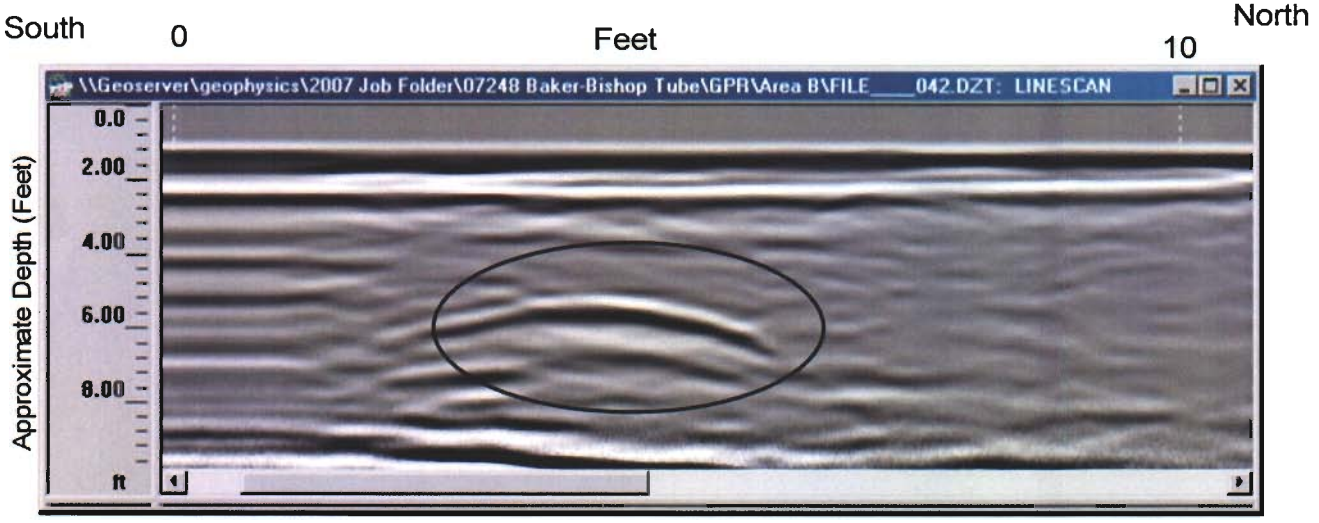
GPR Profiles-Area A		
Michael Baker, Jr., Inc. Bishop Tube Site East Whiteland Township, Chester County, PA		
June 2007		07248
ARM GEOPHYSICS *Surface & Borehole Geophysics*		Figure 2

Water Pipe

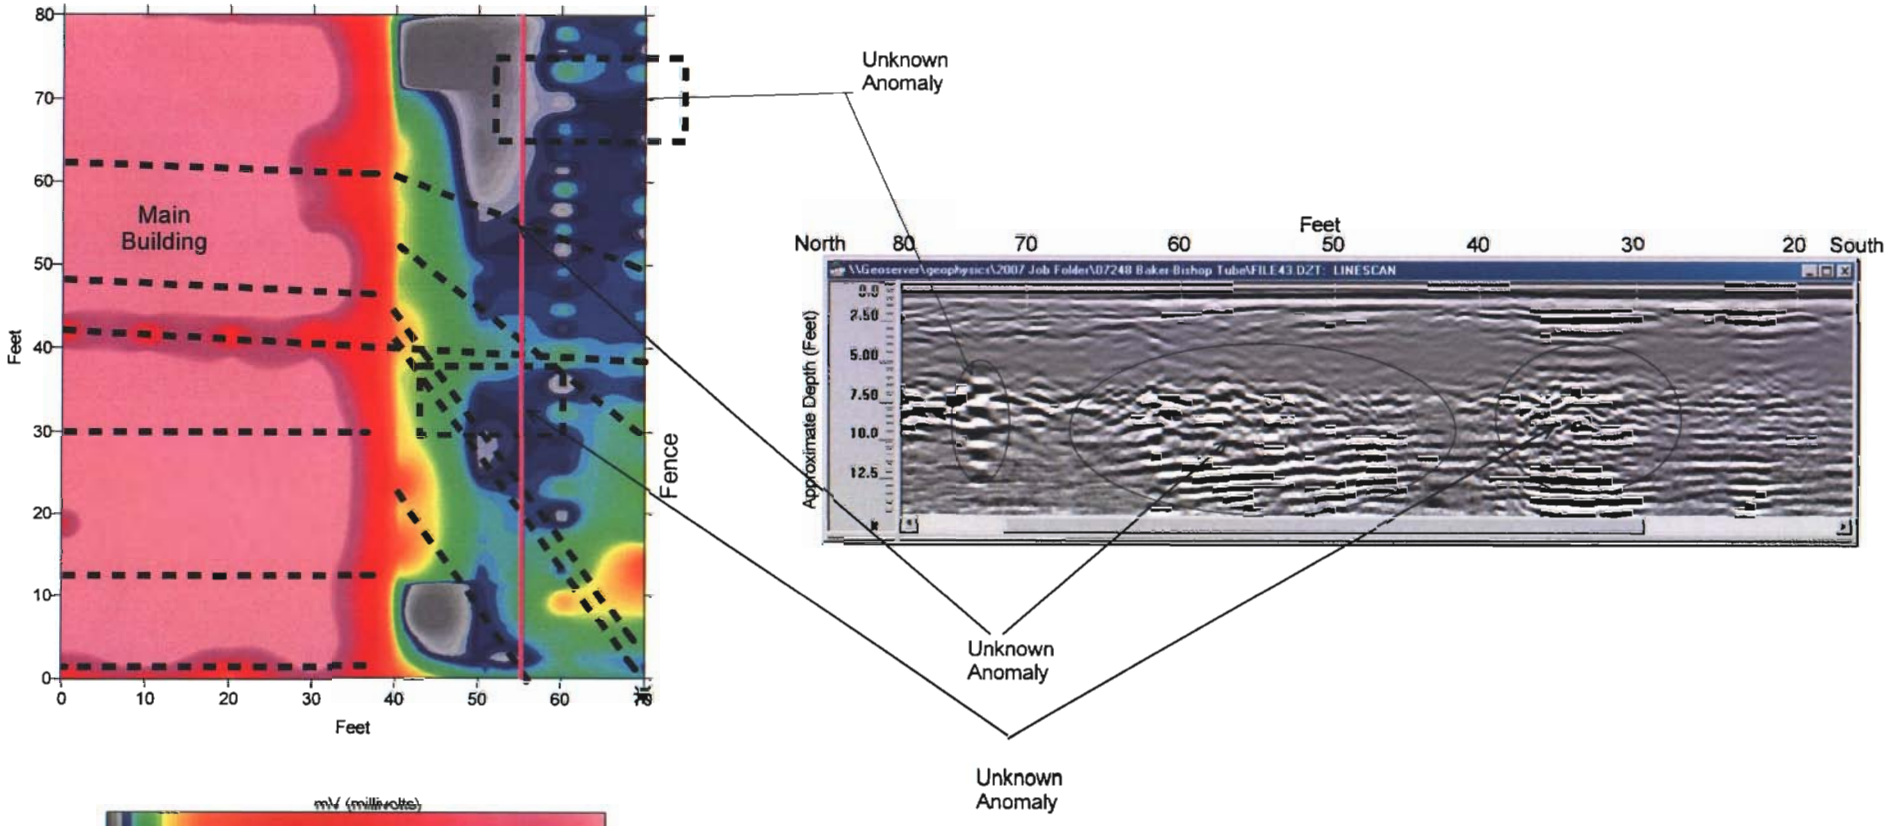
EM61 Contour Map-Area B		
Michael Baker, Jr., Inc. Bishop Tube Site East Whiteland Township, Chester County, PA		
June 2007		07248
ARM GEOPHYSICS *Surface & Borehole Geophysics*		Figure 3

Figure 3 presents an EM61 contour map. The survey area measured 100 feet by 20 feet and is located inside of the main building along the south wall. Data were collected along bidirectional transects (north to south and east to west) with spacing of 10 feet between each transect. Anomalies seen in the northern portion of the contour map are most likely the result of reinforcing steel embedded in the concrete. The green areas outlined along 5-8 feet inline distance along the Y-axis correspond to a utility or trench that was detected by the utility locator. Several smaller utilities were also detected trending from south to north and were marked on the ground surface and included on Figure 3. An example of a GPR profile collected over this unknown anomaly has been included on Figure 3.

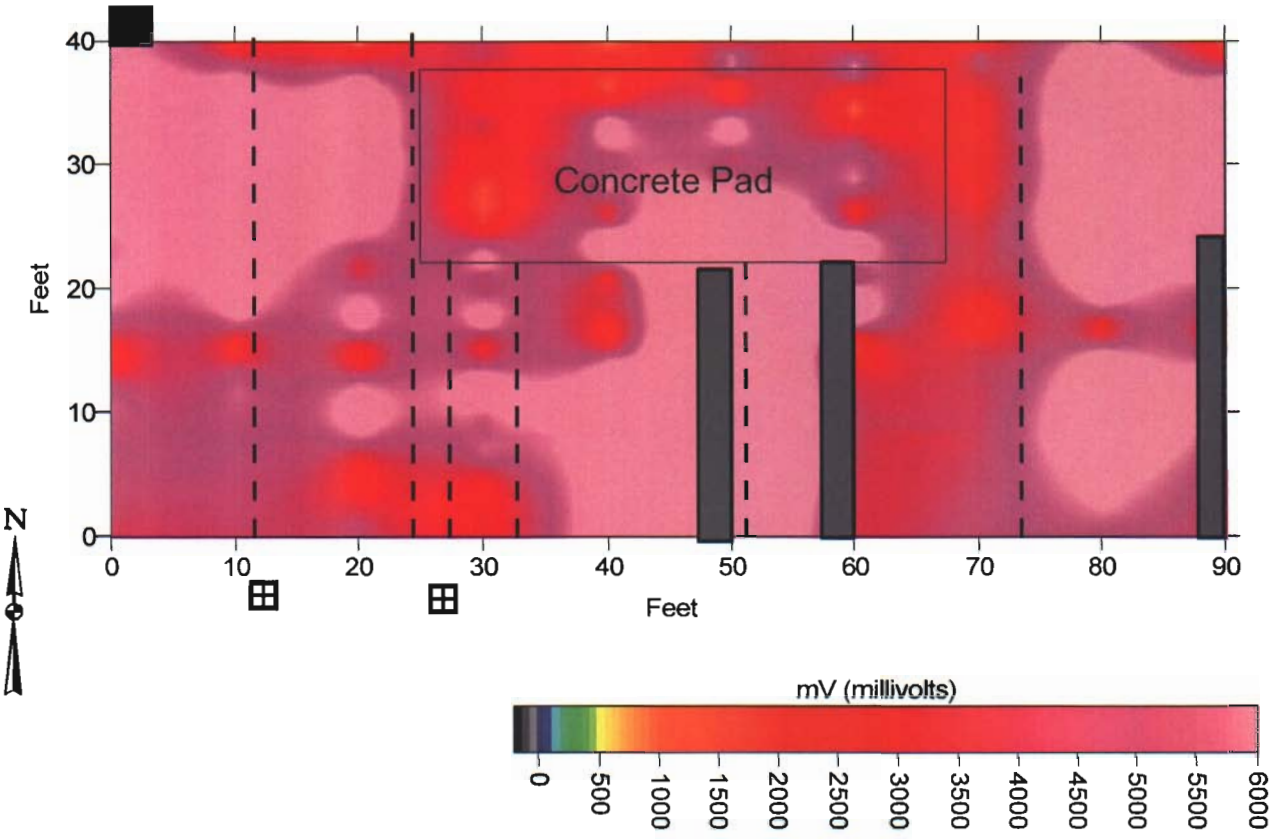
EM61 Contour Map-Area C		
Michael Baker, Jr., Inc. Bishop Tube Site East Whiteland Township, Chester County, PA		
June 2007		07248
ARM GEOPHYSICS *Surface & Borehole Geophysics*		Figure 4

Figure 4 presents an EM61 contour map. The survey area measured 70 feet by 80 feet and includes the inside and outside portion of the northeast corner of the building. Data were collected along bidirectional transects (north to south and east to west) with spacing of 10 feet between each transect. Anomalies seen in the western portion of the contour map are the result

of reinforcing steel embedded in the concrete inside of the building. Several utilities were detected by the utility locator and marked on the ground surface and included on Figure 4. Several anomalies were detected by the EM61 and also recorded on the GPR profiles collected in this area on the outside of the building. These anomalies have been highlighted on the provided GPR profile presented on Figure 4. The anomalies do not have the typical characteristics of possible underground storage tanks. Generally, USTs have a parabolic shaped reflection on GPR profiles. These anomalies appear to rectangular or flat toped.

Several utilities were detected and marked using the utility locator. These utilities have been marked on the ground surface and included on Figure 4.

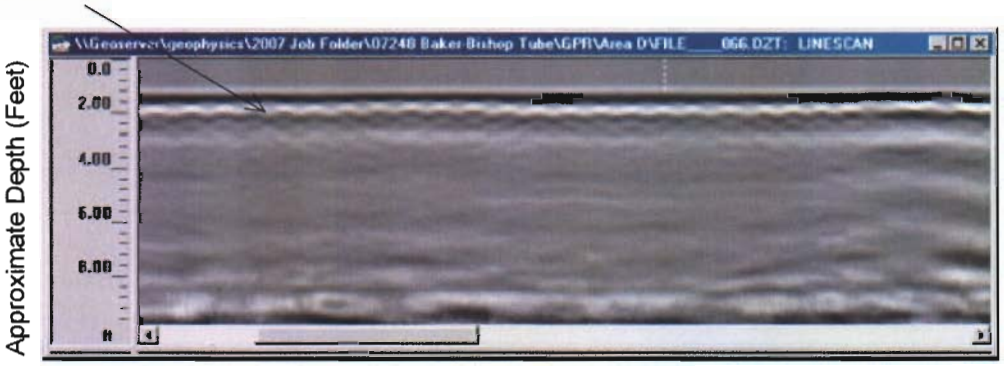
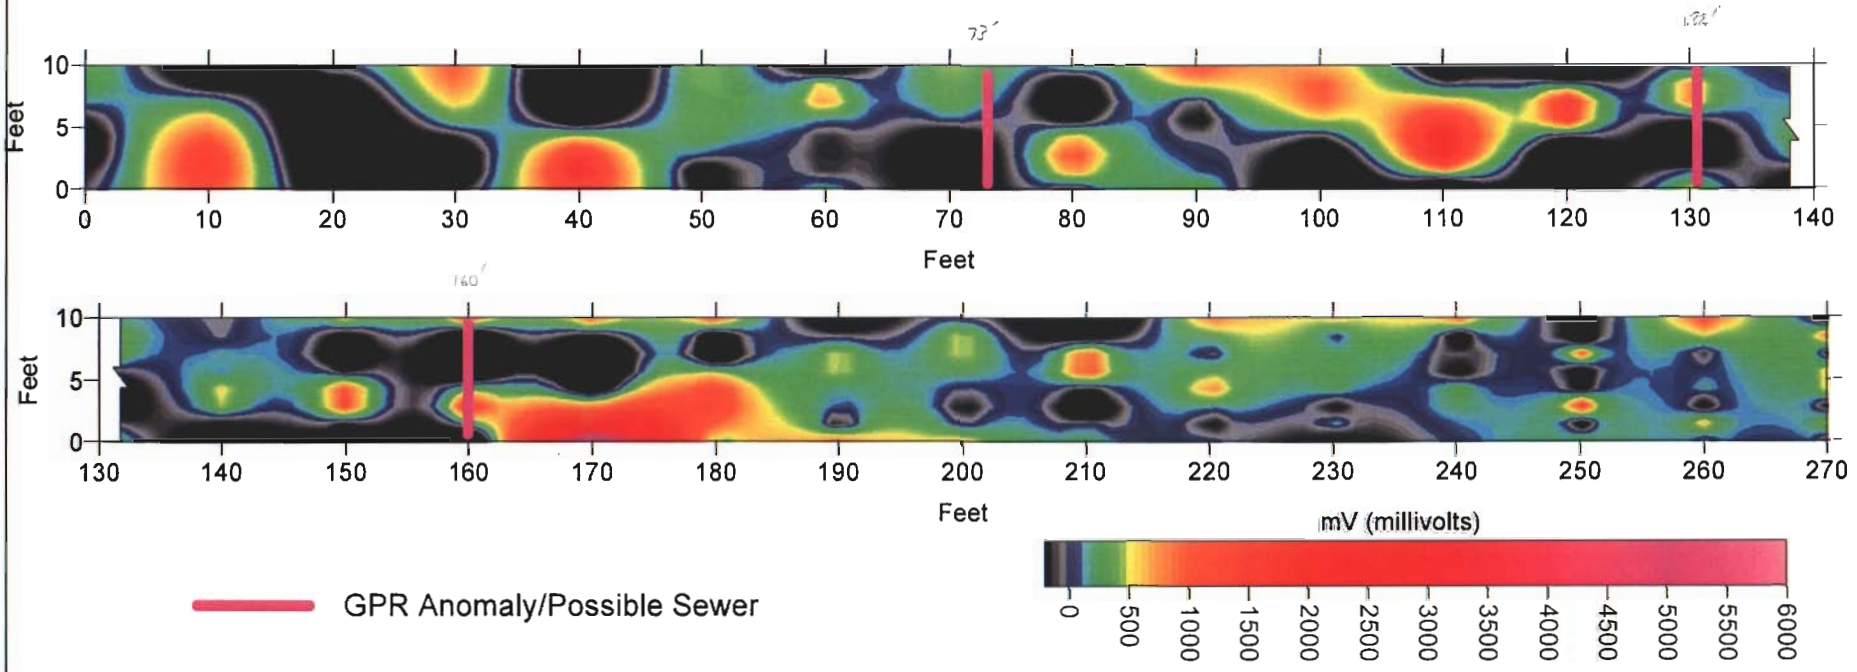
EM61 Contour Map-Area D		
Michael Baker, Jr., Inc. Bishop Tube Site East Whiteland Township, Chester County, PA		
June 2007		07248
ARM GEOPHYSICS *Surface & Borehole Geophysics*		Figure 5

Figure 5 presents an EM61 contour map. The survey area measured 90 feet by 40 feet. Data were collected along bidirectional transects (north to south and east to west) with spacings of 10 feet between each transect. Anomalies seen in the contour map are the result of reinforcing steel embedded in the concrete. The GPR profile provided on Figure 5 shows the characteristic pattern typical for rebar.

Several utilities and trenches were detected with the utility locator and the GPR. These locations were marked on the surface with spray paint and have been included on Figure 5.

Typical Rebar pattern
