If Interim report, Subject to Change as Additional Information Becomes Available
If Interim Report, this Report is cumulative, containing information from previous reports in addition to new information and may change
SPLP PENNSYLVANIA PIPELINE PROJECT
HORIZONTAL DIRECTIONAL DRILLING – INADVERTENT RETURN REPORT FORM

REPORT DATE:	Current as of 8/31/2020		**HDD ALIGNMENT #**	PA-CH-100.0000-RD	
PROJECT SITE:	PPP 6 - S3-0290 - Milford Rd./Little Conestoga Rd		**HDD COMPANY:**	Michels Directional Crossing	
DATE AND TIME WHEN IR WAS INITIALLY DISCOVERED			**DATE:**	8/10/2020	**TIME:** 1530
LOCATION: STREET	427-423 Green Valley Rd, Downingtown, PA 19335		**MUNICIPALITY:**	Upper Uwchlan	**COUNTY:** Chester
LATITUDE:	40.0794	**LONGITUDE:** -75.7104	**FROM STATION:**	14824+00	**TO STATION** 14824+00
STREAM NAME:	S-H10 (UNT to Marsh Creek), S-H11 (UNT to Marsh Creek)		**POND / LAKE NAME:**	Pond H3 (Marsh Creek Reservoir)	**WETLAND NAME:** WL-H17 (PEM, PFO)
DEP PERMIT Nos. (102 AND 105)	E&S Permit # ESG0100015001, Water Obstruction Permit E15-862				
CORPS PERMIT NO.	PASPGP-5 (issued April 12, 2017)				
IR TRACKING ID:	PPP6_PA-CH-0100.0000-RD_MilfordRd_IRInterim_03_090120				
IS AUGUST 8, 201

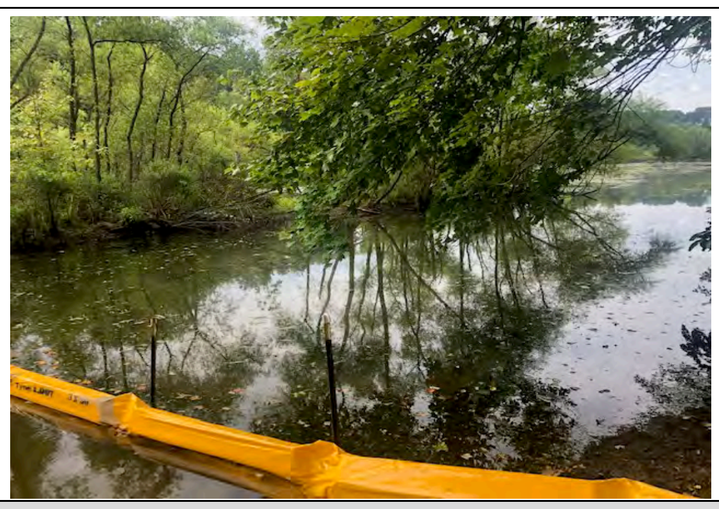
View of IR release location within WL-H17.

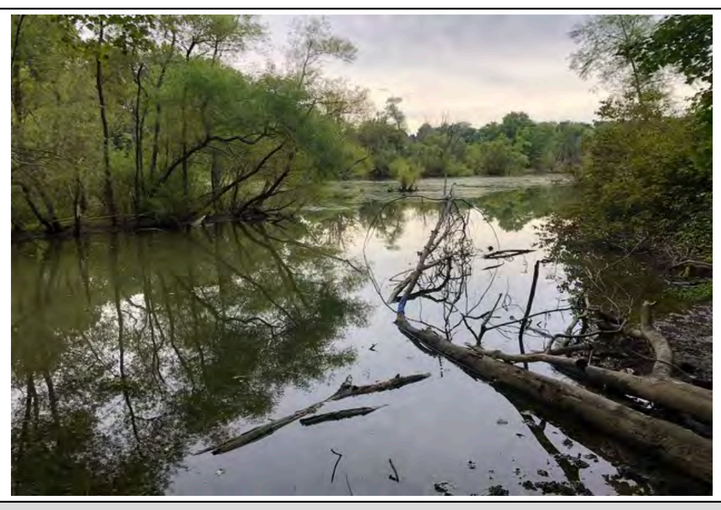
View of stream S-H10 (UNT to Marsh Creek)
