BLAST VIBRATION DAMAGE ASSESSMENT STUDY AND REPORT

**PREPARED FOR:
THE MIAMI-DADE COUNTY BLASTING TASK FORCE**

ASSESSMENT OF BLAST VIBRATION IMPACTS FROM QUARRY BLASTING IN DADE COUNTY

David E. Siskind & Mark S. Stagg

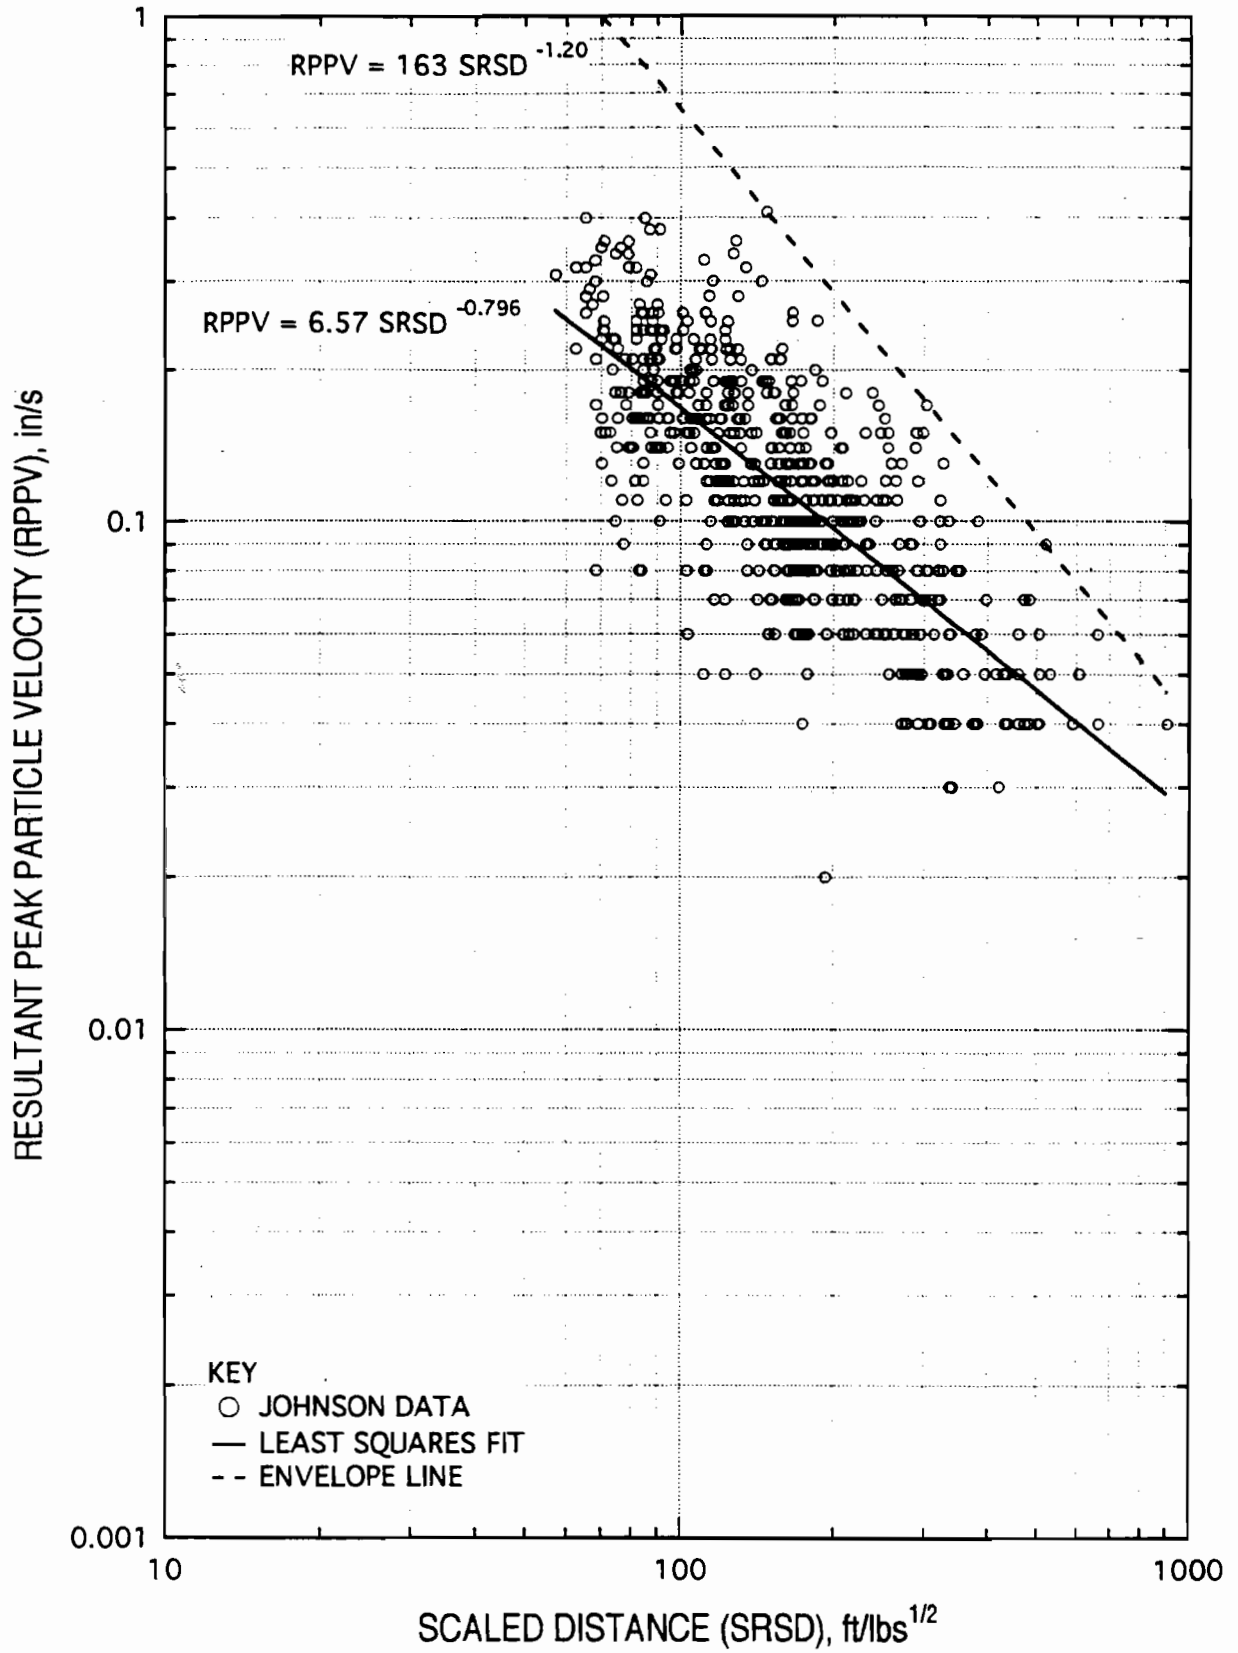
Figure 5 shows the Johnson's summary plot of vibrations from 609 Broward County blasts. These are resultant values (vector sums) and not single-component amplitudes (PPV's), plotted by Johnson in accordance with Broward County regulations. There is great variability in this data, partly because measurements from four different sites are combined. However, even single sites were found to have much variability. For example, at a scaled distance of 300 ft/lb^{1/2}, the mean vibration amplitude was 0.07 in/s with a measurement range of about .035 to 0.17 in/s. This variability is from geologic differences at the measuring sites and in the vibration transmission paths and also possibly from differing blasting practices. Many quarries studied by the U.S. Bureau of Mines and others have had far less scatter (Siskind, 1997 and 2000).

Figure 5.- Propagation plot, vibration amplitude versus distance from 609 blasts in Broward County, from Johnson, et al., 2000. Values plotted are resultants (vector sums).

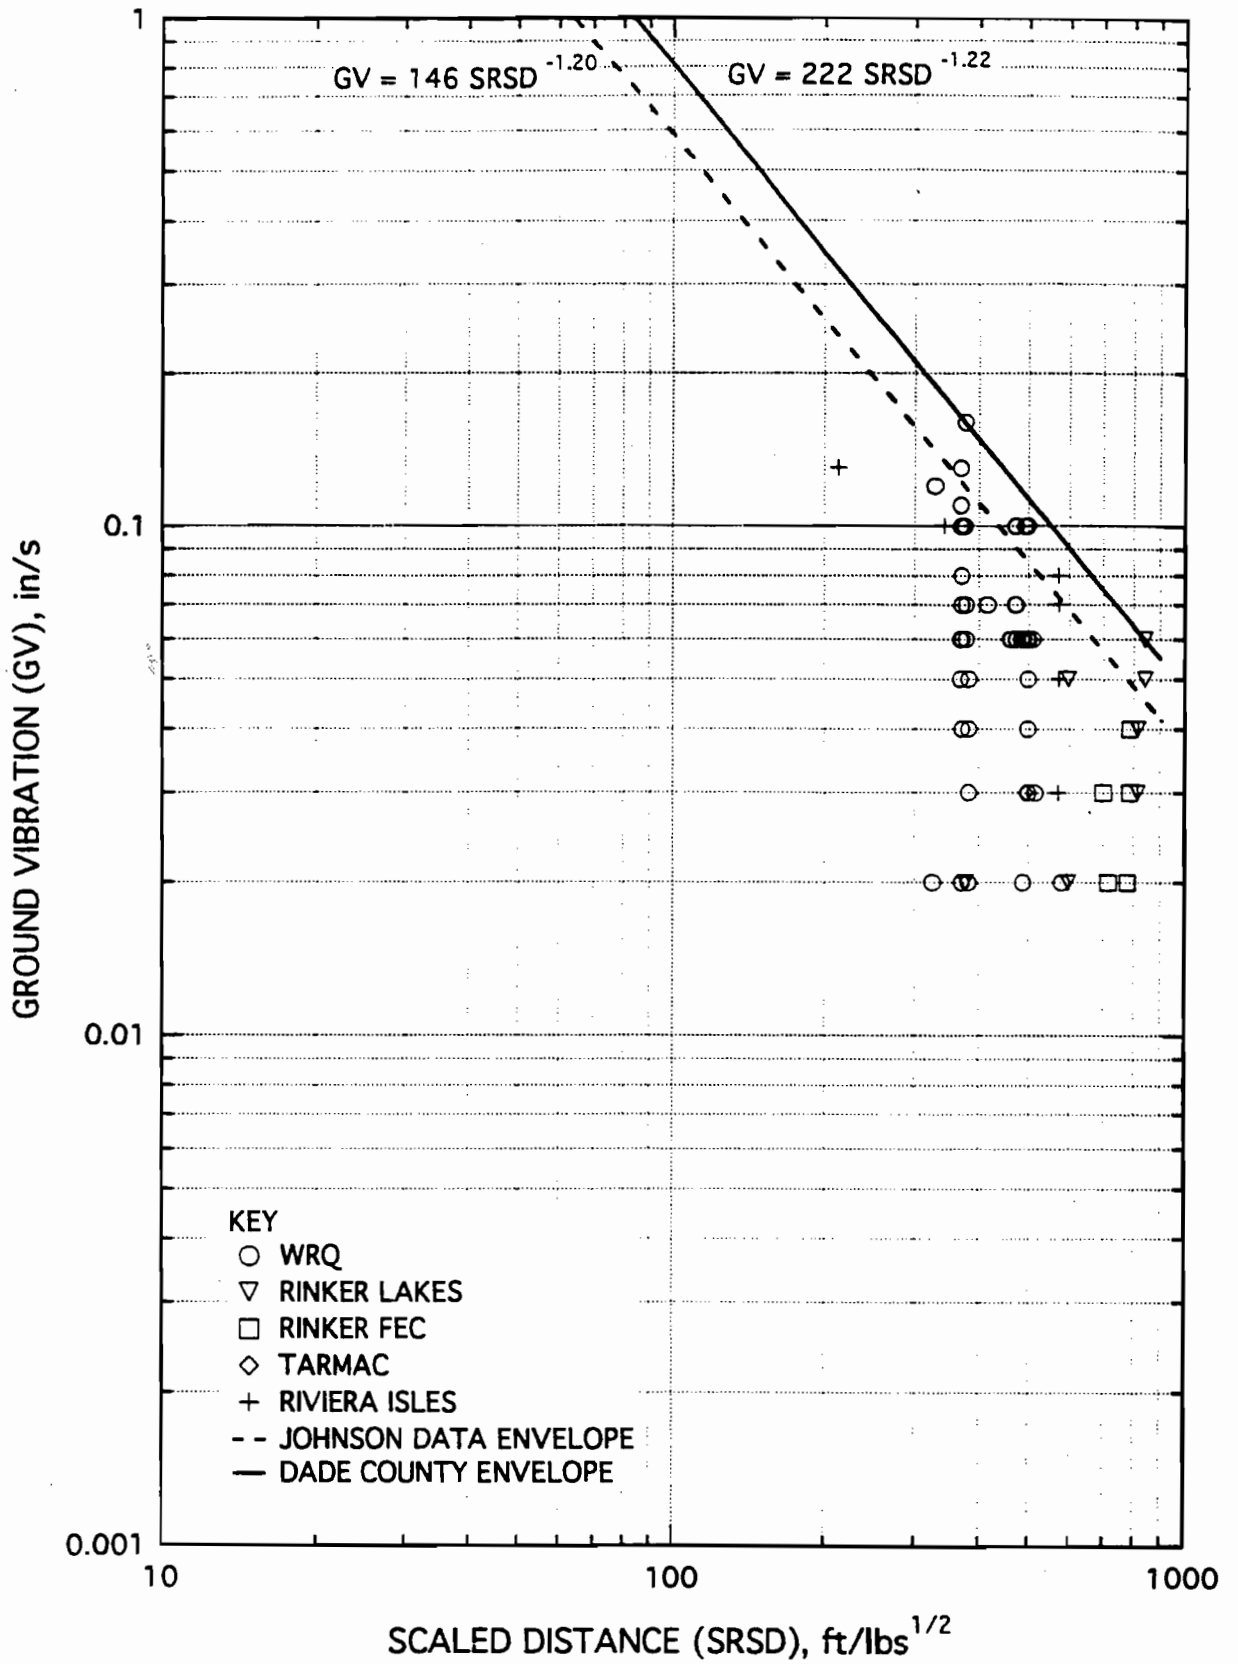
Figure 6 is a summary of quarry blast vibrations collected by Dade County in the year 1999. This represent all the 1999 blasts in the NW Miami area where the seismograph triggers settings of 0.02 in/s were exceeded. Even with no values recorded for blasts below 0.02 in/s, there is still a large range of amplitudes for any given scaled distance. An envelope line was also derived from this data and is shown on the plots as the "Dade County Envelope." This line is close to, but slightly higher than, the Johnson Envelope.

Figure 6.- Propagation plot, vibration amplitude versus distance from 1999 Dade County monitoring of quarry blasts in NW Miami areas of Miami Lakes and Palm Springs North.

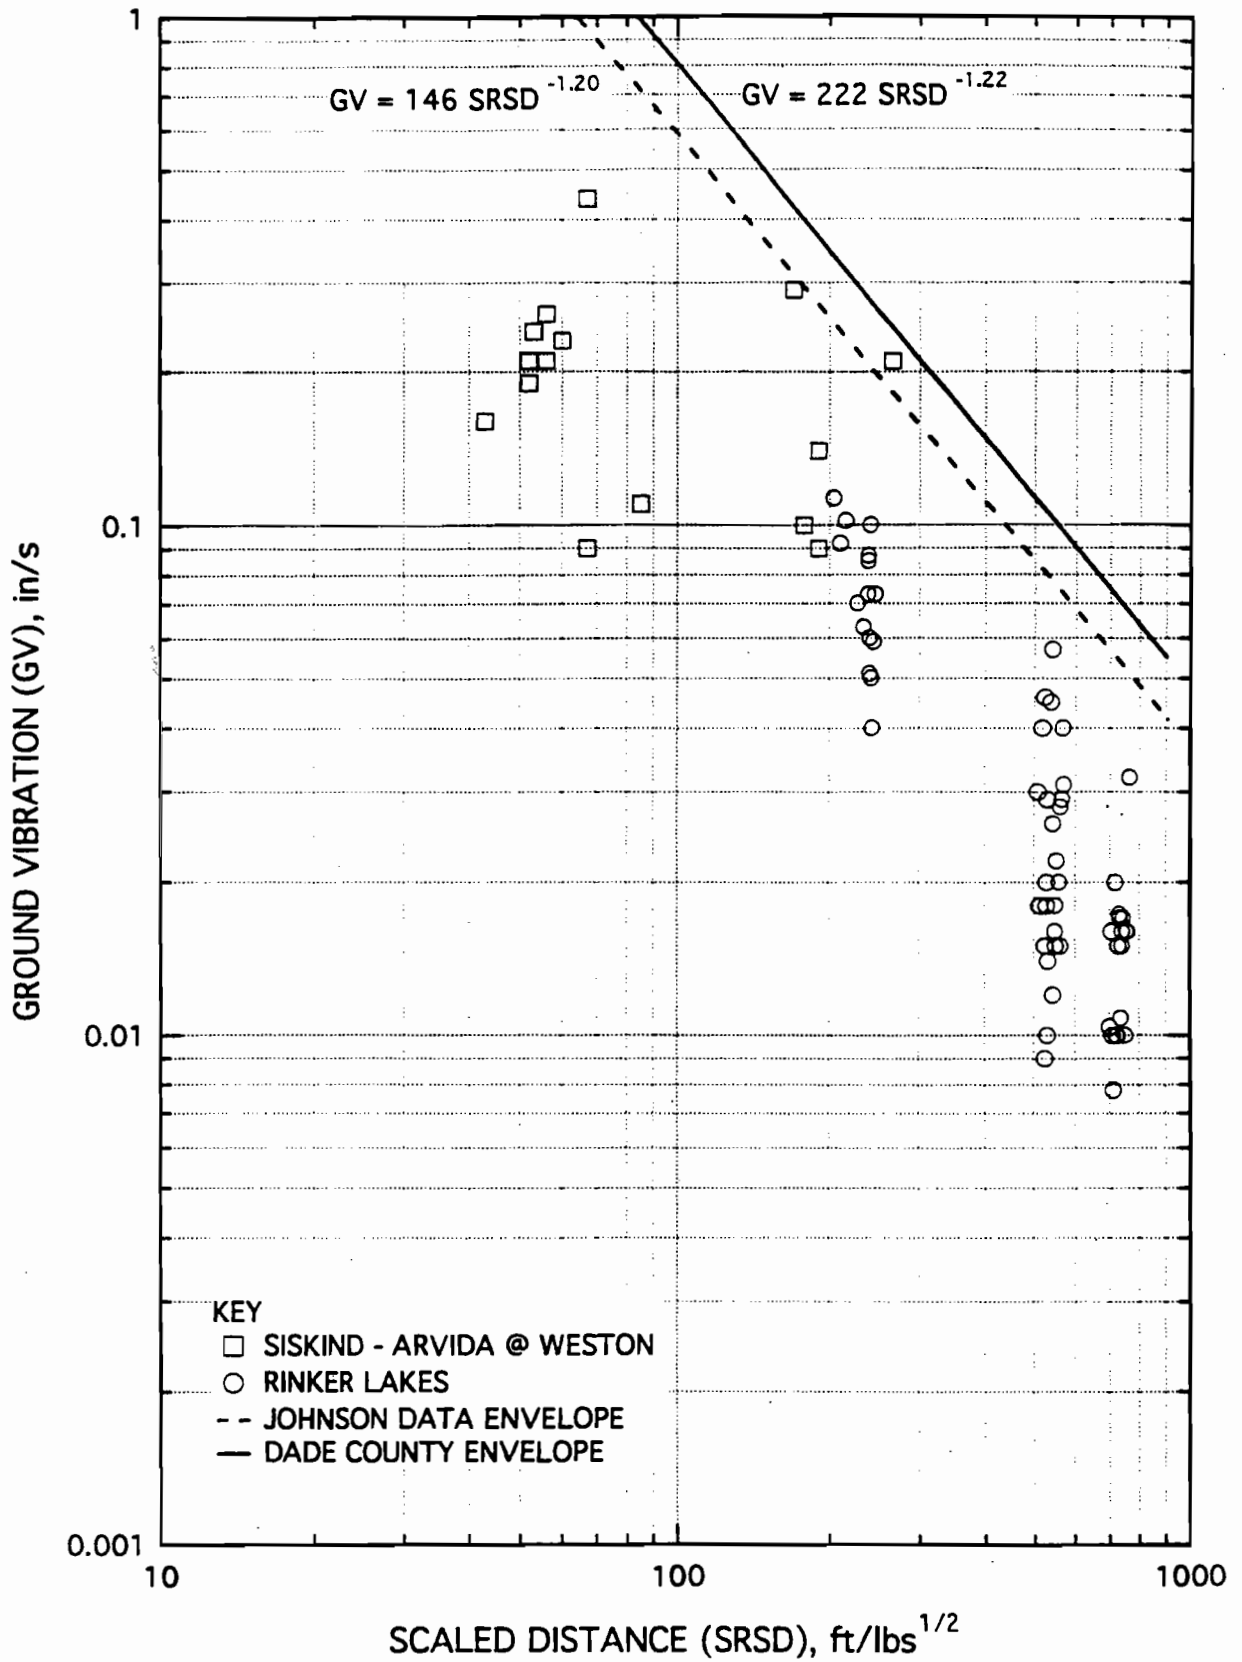
Figure 7 shows the Weston data (Siskind, et al., 1996) and the 1979 Rinker Lake measurements (Andrews, 1979). The Weston data have extreme scatter, in part, because some monitoring was done on unconsolidated granular soil. The two high points, for example, would be absent if data measured on the foundation slabs were used. All the Weston and the Rinker Lake measurements fall below the Dade County Envelope and, except for the two high points, also below the envelope from Johnson's data set.

Figure 7.- Propagation plot, vibration amplitude versus distance from USBM's Weston Arvida site study (Siskind, et al., 1996) and the Andrews Rinker Lake study of 1979.

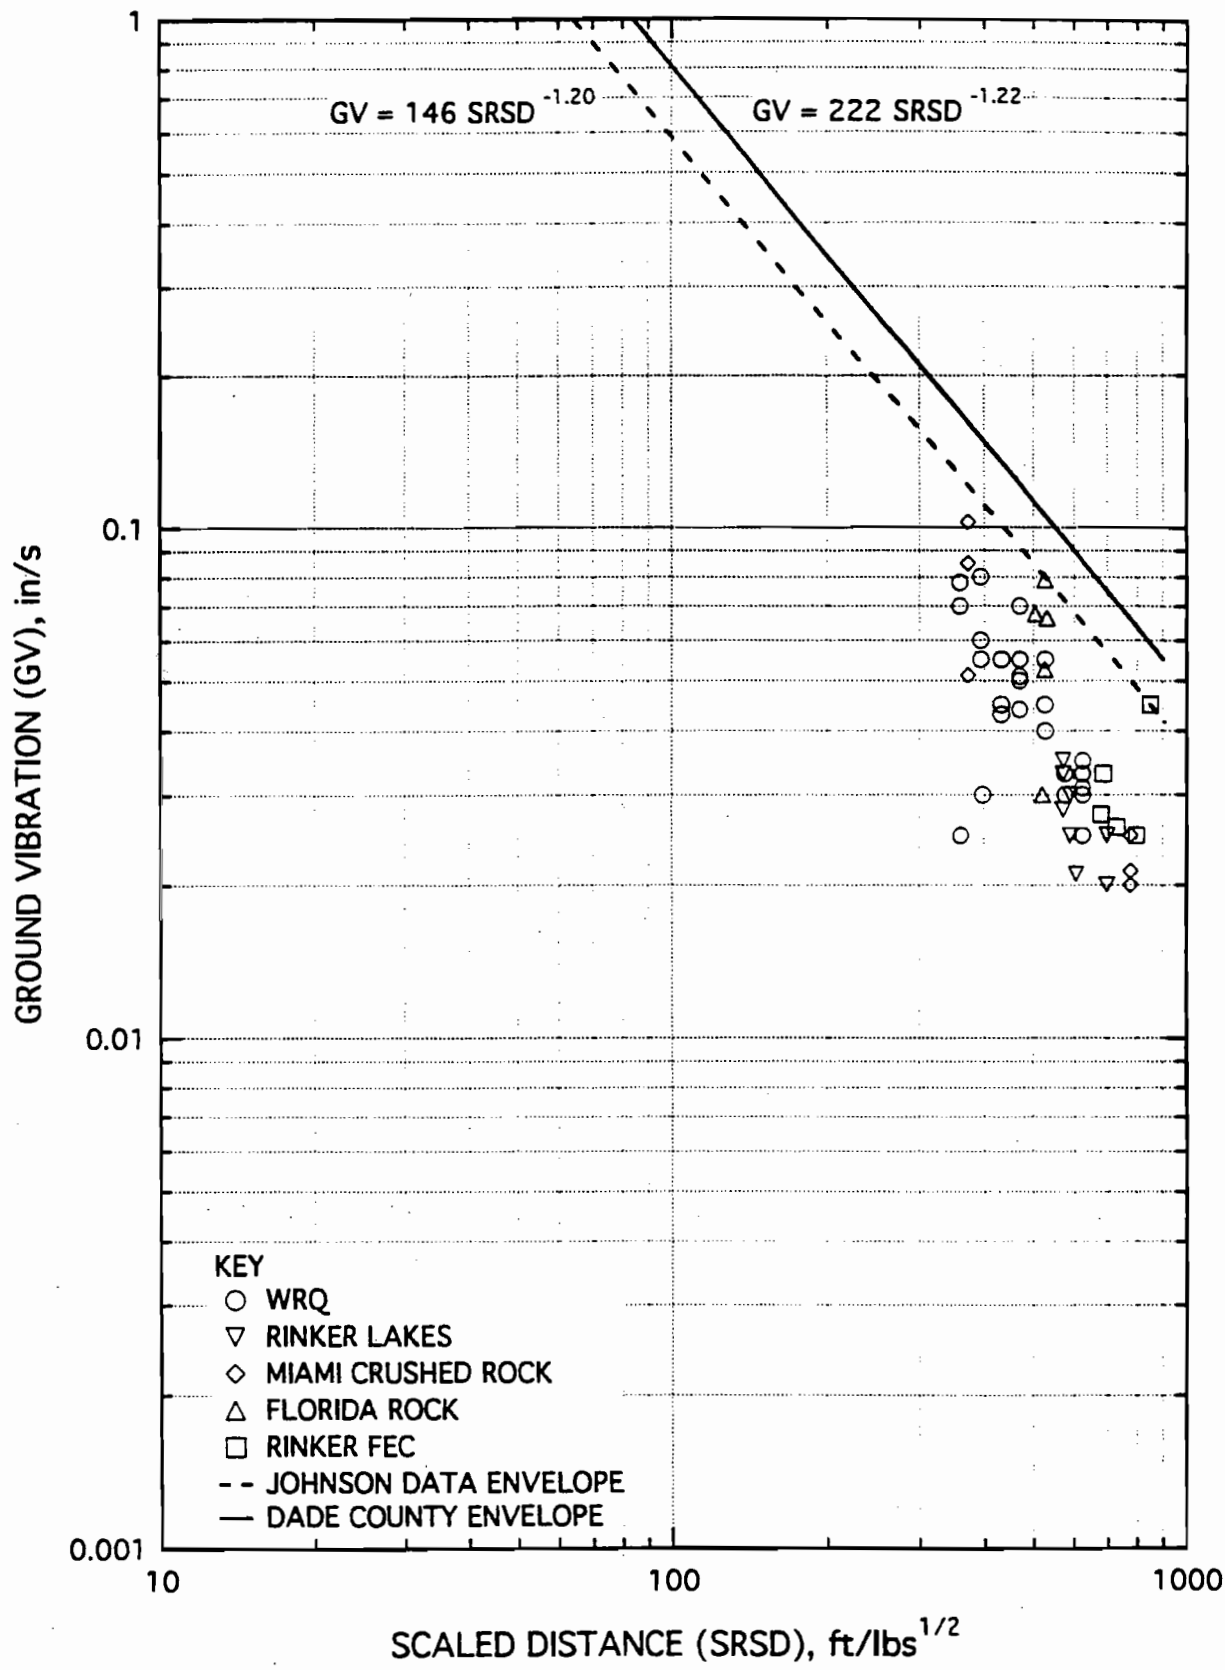
Figure 8 summarizes data collected by DESA for this study with the measurements from the 41 blasts listed in Appendix A. The scatter here is far less than the County's 1999 data, although it is only two months of monitoring compared to one year for the County. These amplitudes are, on the average, similar to those obtained by the County in 1999 and all are below the worst-case Dade County data envelope.

Some individual vibration amplitudes appear high. This and the high scatter or variability suggest the question is: did the blast detonated properly or was the effective charge weight per delay somehow not as designed or reported? The causes of the relatively high vibration are beyond the scope of this study, however, some ideas come to mind. The water filled pits likely provide additional confinement during the critical and short explosive detonation process when the vibrations are generated. This would lead to higher vibrations at the source: The geology and structure greatly influence the vibration decay with distance. The low attenuation is almost certainly from the highly permeable layer over more competent rock. This favors the generation of surface waves, particular vibration frequencies, and especially low frequencies (discussed in the next section).

Figure 8.- Propagation plot, vibration amplitude versus distance from DESA monitoring of Dade County quarry blasts, February to April 2000.

The U.S. Bureau of Mines had found generally high vibration amplitudes at other low-frequency sites and correlated these to the use of two-short delays (Siskind et al., 1989). The usual practice of using 8-ms intervals to define charge weight per delay may not work effectively at sites where the wave periods are 100 ms and longer (vibrations of less than 10 Hz) and longer time intervals may be needed there to provide the destructive wave interference for multi-delayed blast rounds. Experimenting with delays is a possible tool for the quarries to reduce vibration amplitudes and possible impacts to neighbors.

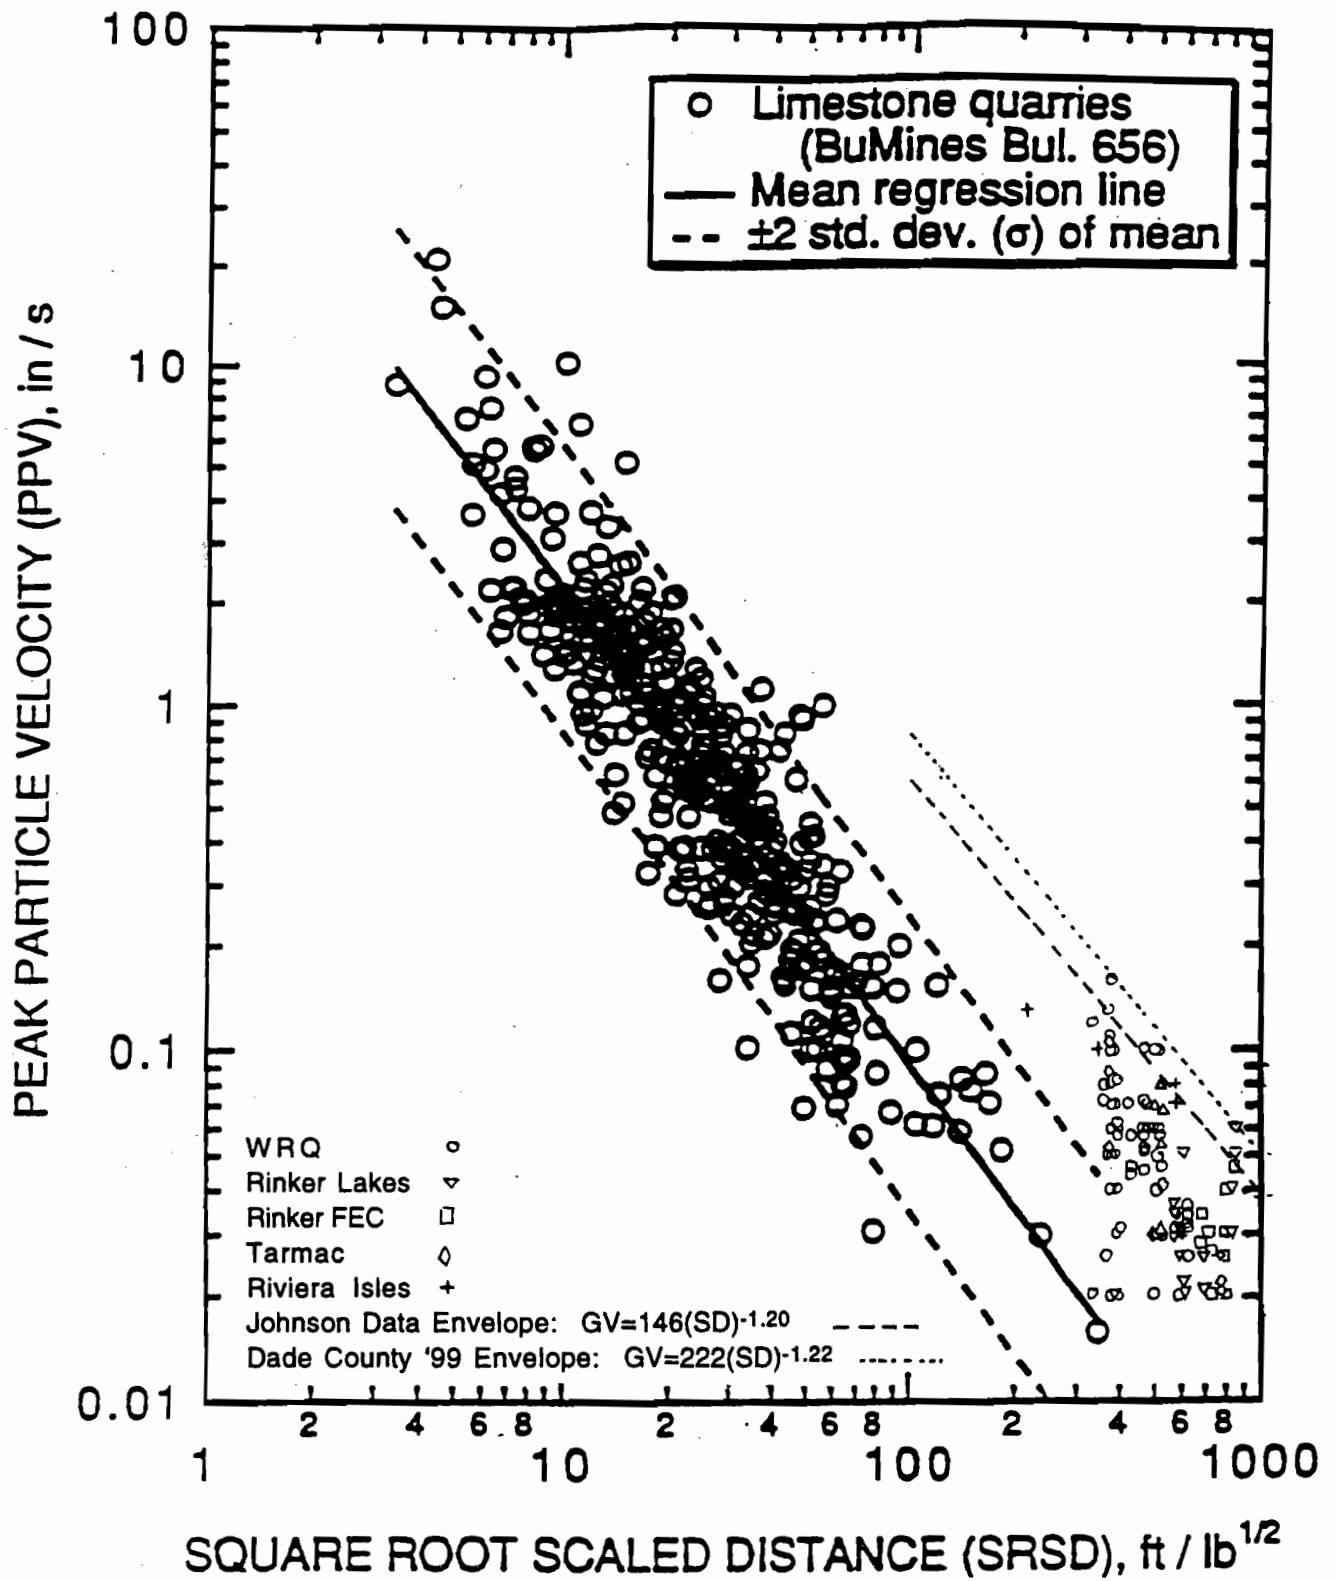
Figure 9 shows the Dade County measurements superimposed on the eleven-limestone quarry summary and their relatively high vibration amplitudes at large scaled distances.

Figure 9.- Summary of 11 northern limestone quarries plus Dade County quarry vibration values. From, Crum, et al., 1995.
