CHAPTER 102 INSPECTION REPORT

Permit No.: PAD510225

Report No.: 20

GENERAL INFORM	ATION		
Project/Site Name:	Alliance 51 st Street, Philadelphia	Permit Issuance Date:	9/5/2023	
Site Address:	1656 S. 51 st St.	Permit Expiration Date:	9/4/2028	
Site City, State, ZIP:	Philadelphia, PA 19143	Permit Type:	NPDES IP	
RP/Permittee Name:	Eric Carlson	Site Municipality(ies):	Philadelphia	
RP/Permittee Address:	40 Morris Ave., Suite 230	Site County(ies):	Philadelphia	
RP/Permittee City, State, Z	ZIP: Bryn Mawr, PA 19010	Earth Disturbance:	11.54	acres
RP/Permittee Email:	ecarlson@alliancehp.com	Site Latitude:	39.935278	
Surface Water(s):	Schuylkill River	Site Longitude: -	75.209236	
Special Protection?	🗌 Yes 🖾 No	Complaint Inspection?	🛛 Yes	🗌 No
Construction Stage:	Inactive	Activity:	Construction	⊧ <u>></u> 1 ac.
Operator Name	Operator Company	Operator E	mail	Approved
n/a				
		IATION		
Inspection Date:	4/2/25	Inspection Time:	11:45	АМ 🗌 РМ
Lead Inspector Name:	Robert Page	Inspector Email:	ropage@pa.ge	vc

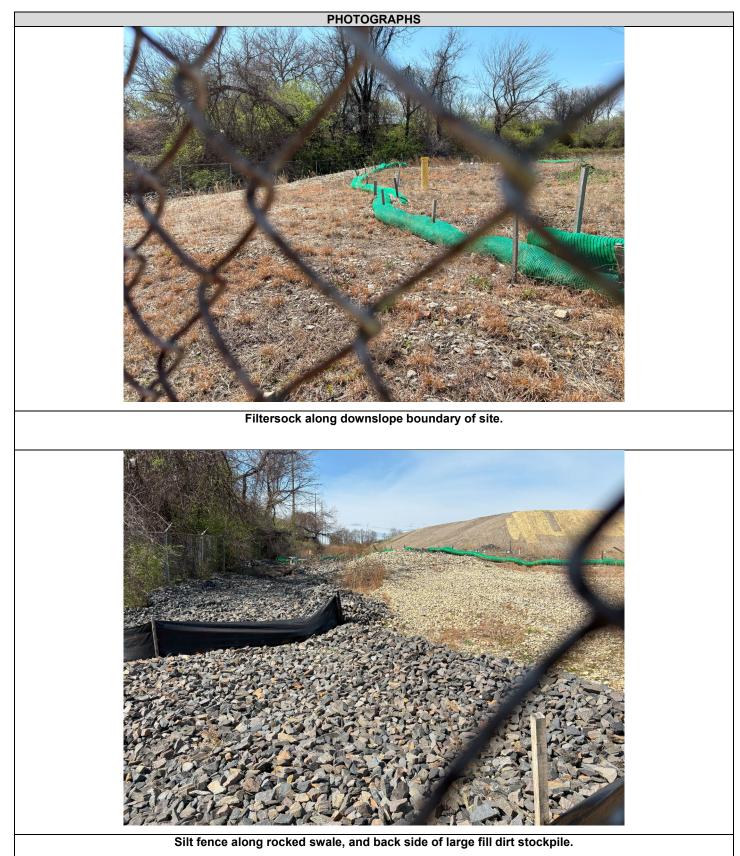
Downslope filtersock (foreground); contaminated fill dirt stockpile without tarp (at center); downslope end of large fill dirt stockpile with erosion matting (background).
