HORIZONTAL DIRECTIONAL DRILL RE-ANALYSIS  
JOANNA ROAD CROSSING  
PADEP SECTION 105 PERMIT NO: E06-701  
PA-BR-0181.0000-RD-16  
(SPLP HDD No. S3-0250-16)

Comments prepared by Mr. David W. Anspach III  
Resident 609 Joanna Road, Morgantown, Pa 19543  
324 Feet from HDD Western Entry Point

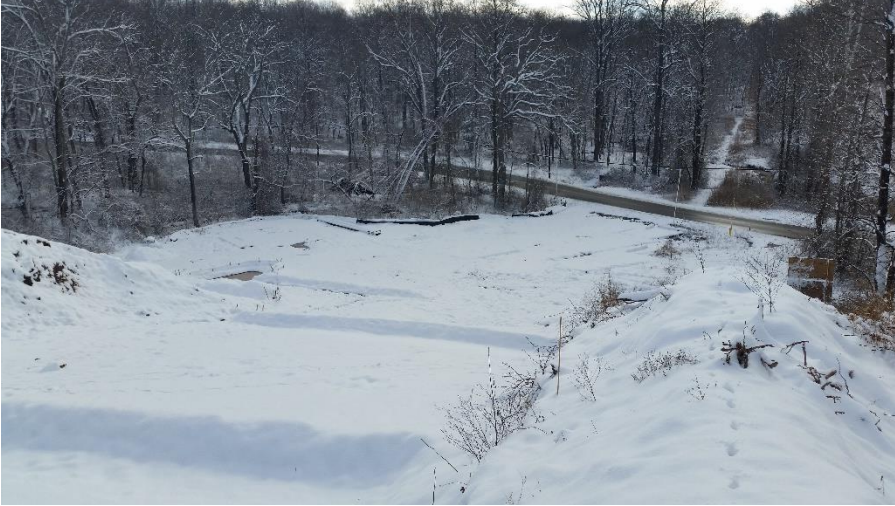
*February 18, 2018 Looking East along the HDD route.*

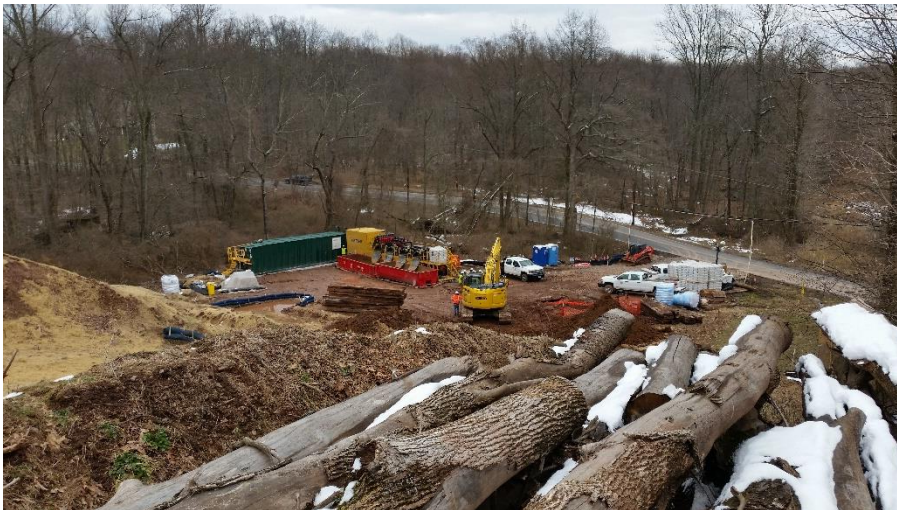
*UPI mobilization*

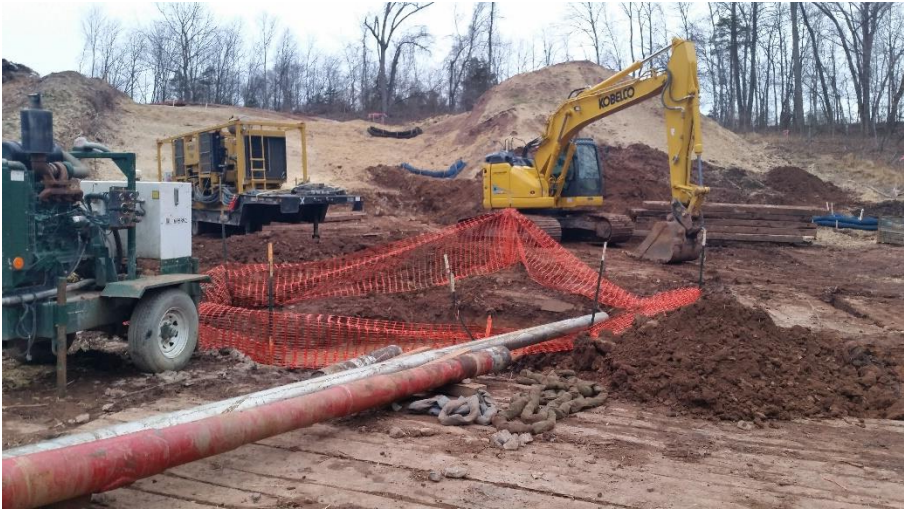
*Excavation West Side of HDD alignment.*

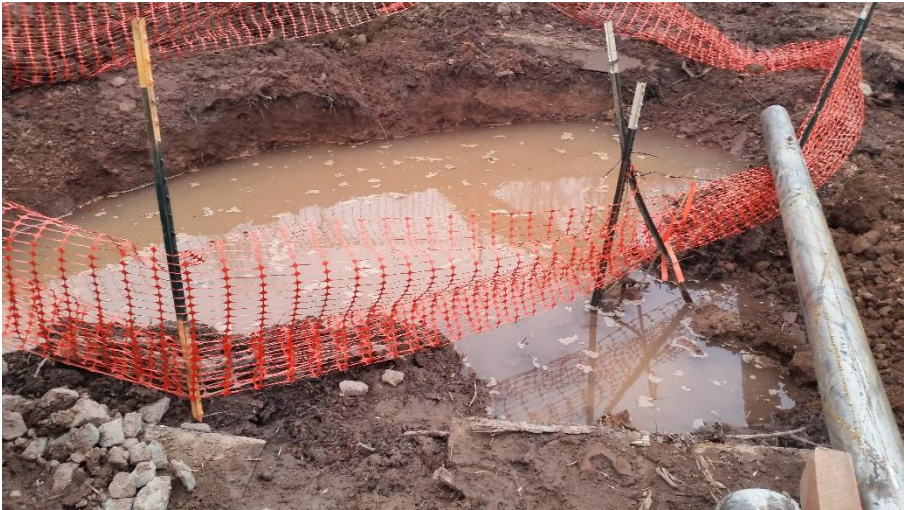
*Drill pit constantly fills with ground water, West side of HDD alignment.*

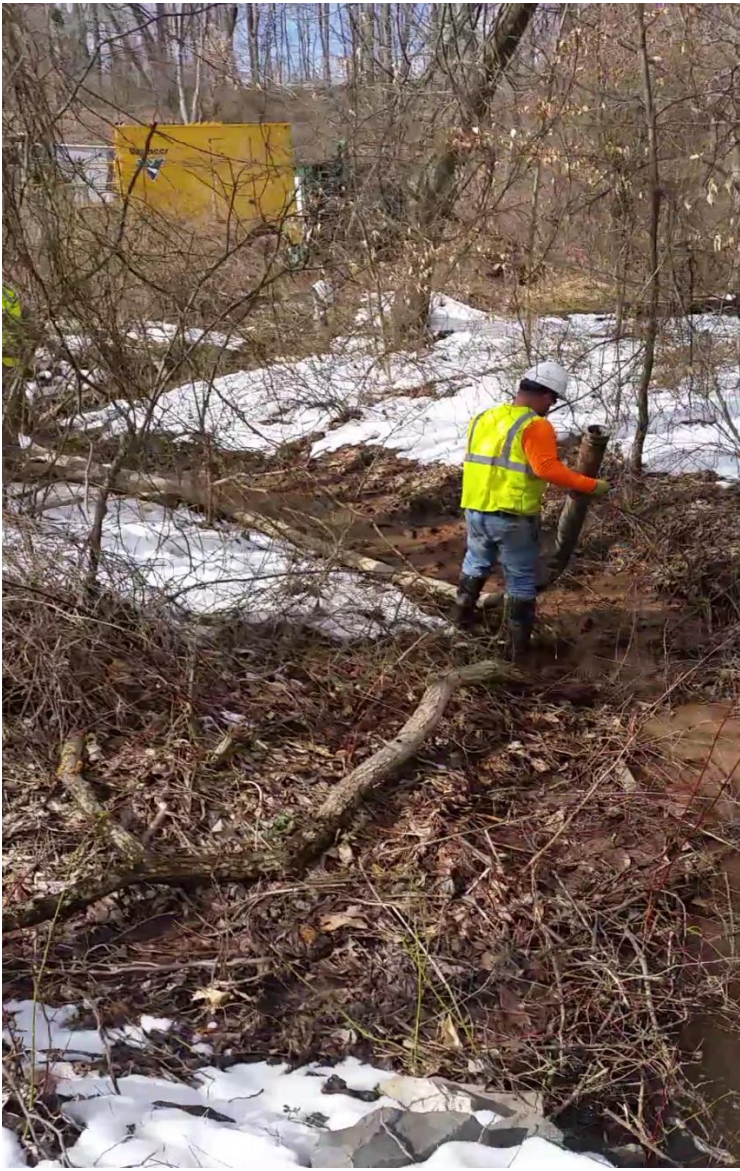
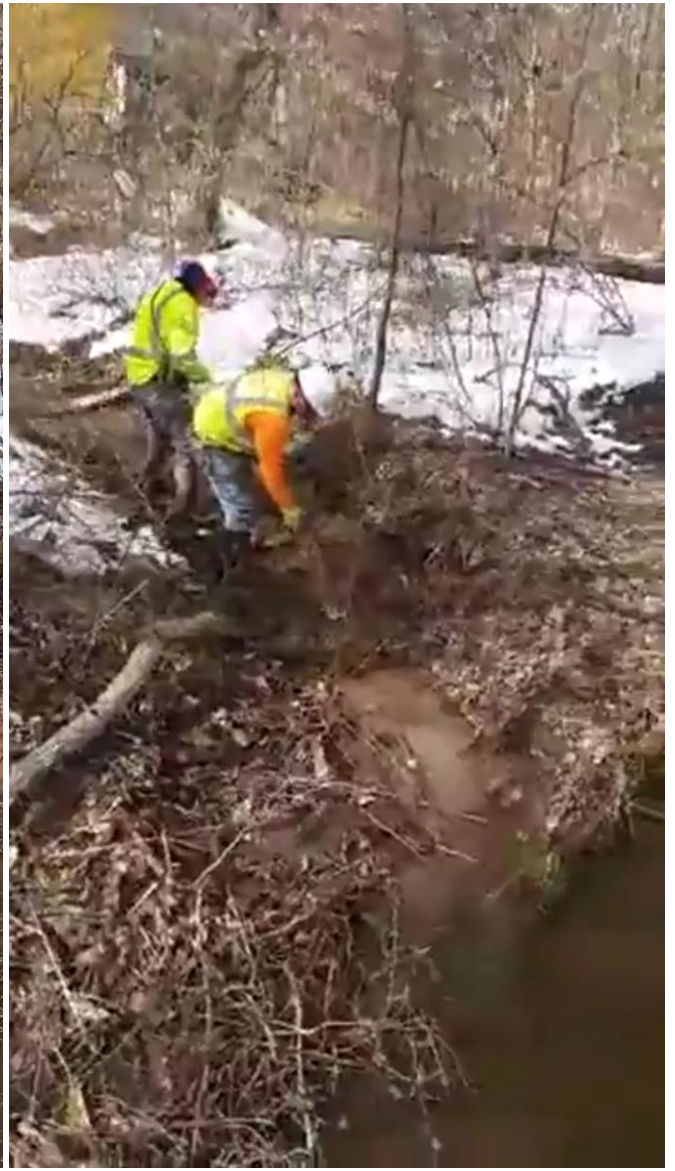
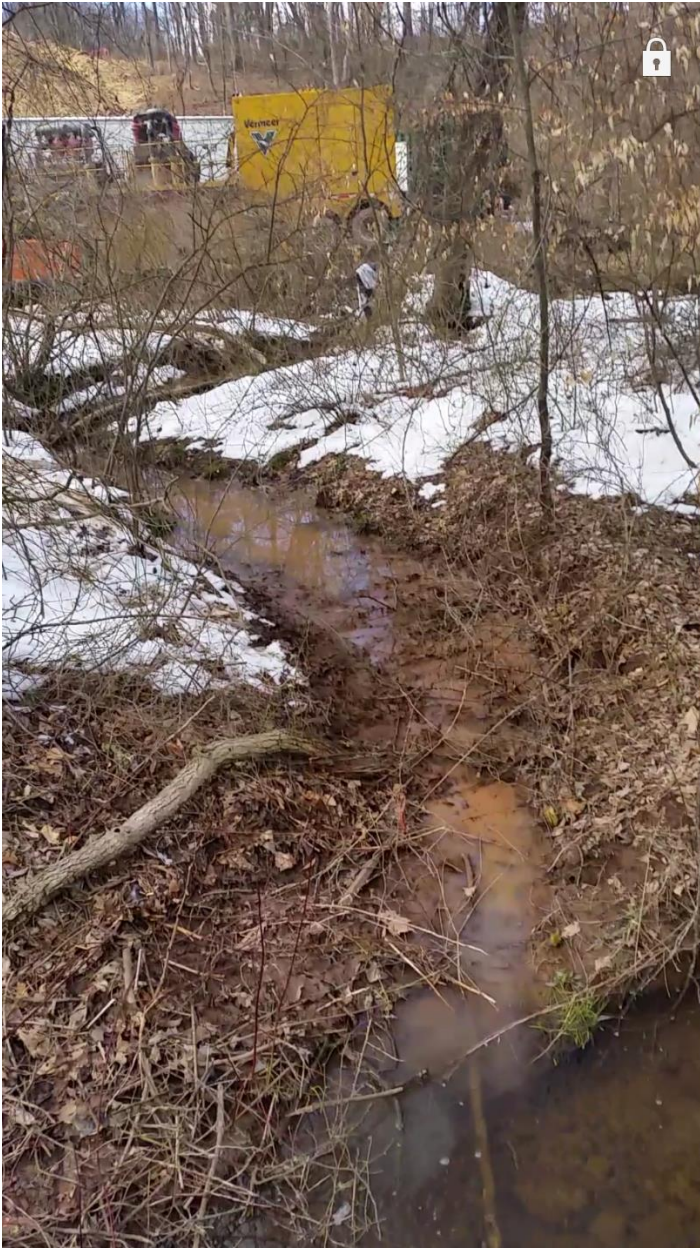
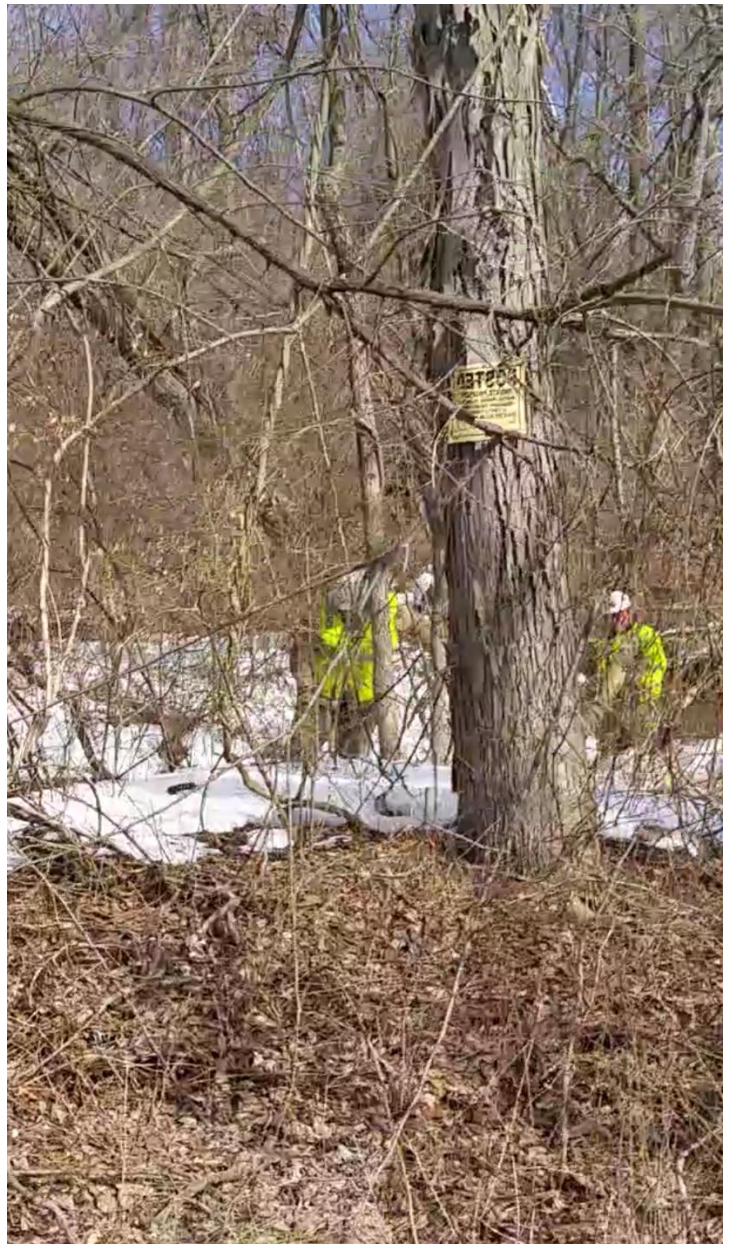
**March 25, 2018** Drilling mud exits the Limit of Disturbance and is cleaned up utilizing a Hydraulic Vacuum (vac) truck (red truck in the rear of left photo) without notification to the Landowner or the PADEP. Turbid conditions are noted in the unnamed tributary (right photo). No note of this cleanup is noted in provided drilling activity log. All staff ignored No trespassing signs and accessed property not granted, Police report filled.

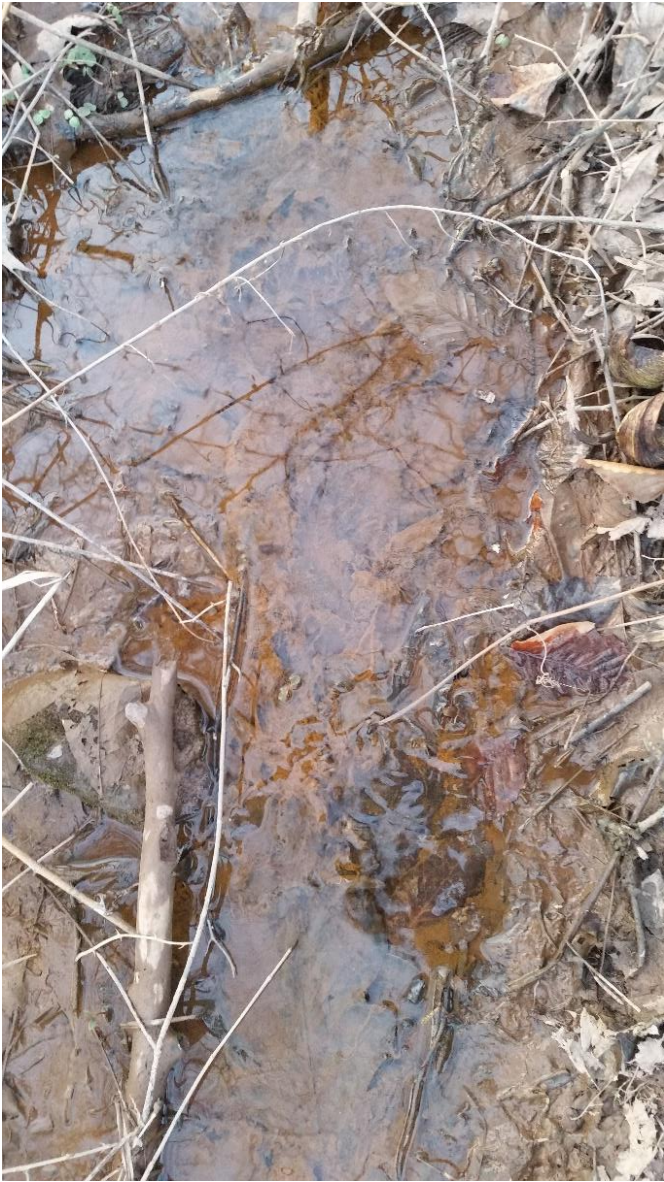
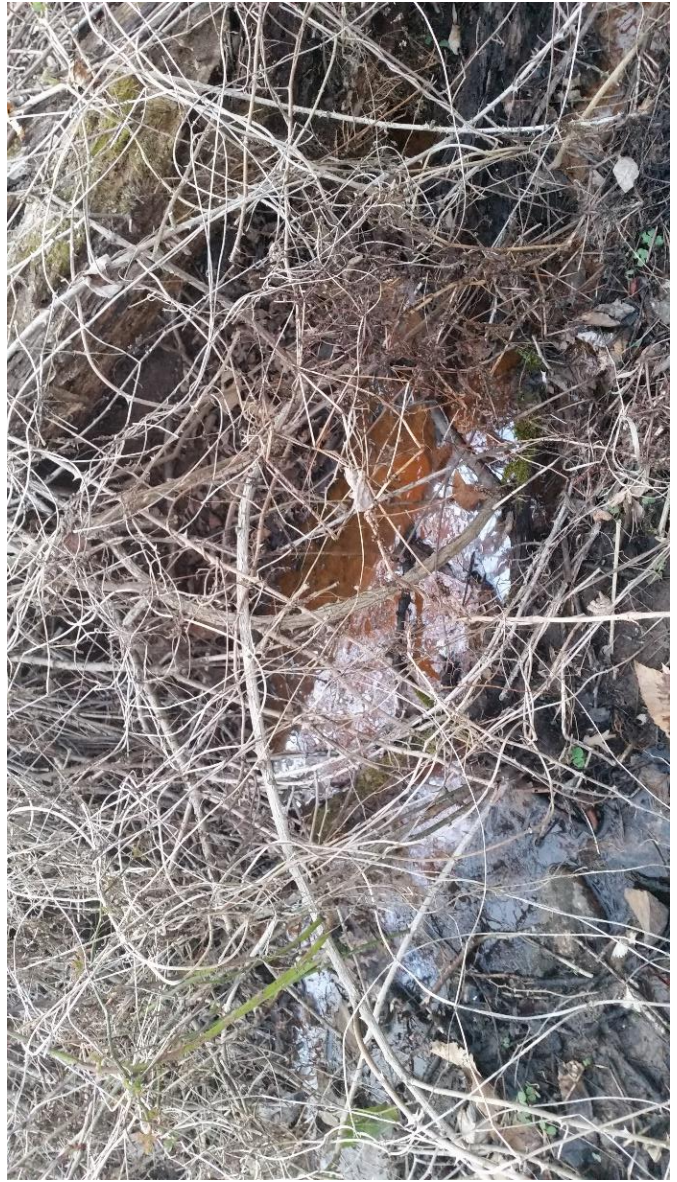
**April 12, 2018** Presence of oil and grease sheen as well as billowy orange growth noted in the unnamed tributary to the East branch of the Conestoga River, Thick orange billowy growth noted as well.

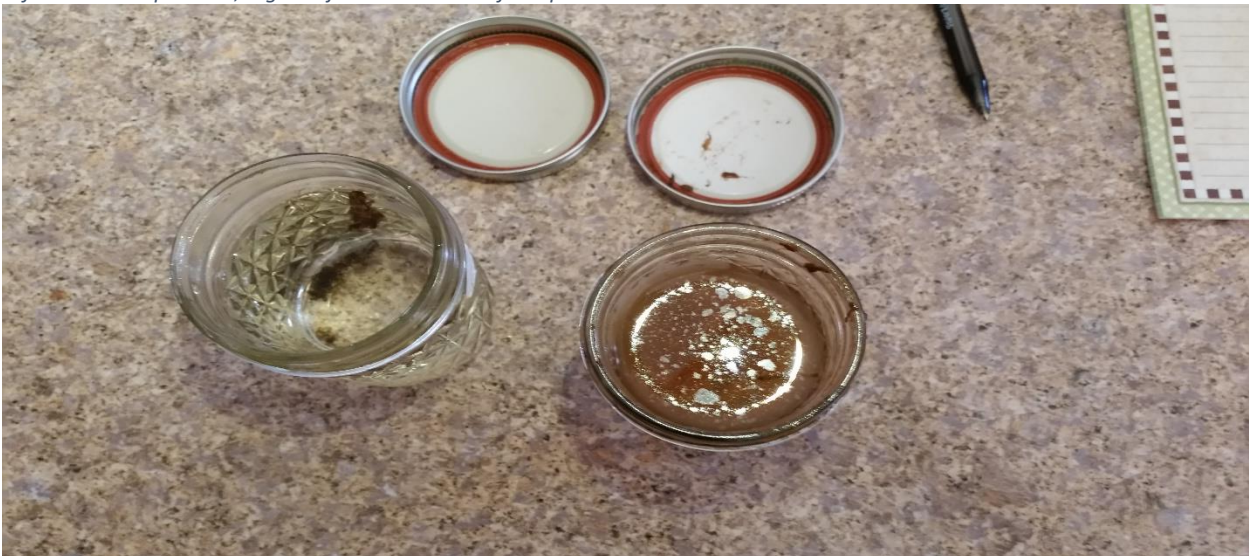
**April 13, 2018** Samples drawn and photographed depicting condition of the unnamed tributary above the influence of the HDD rig and filter plant.

*Left container upstream, Right adjacent to the drill filter plant.*

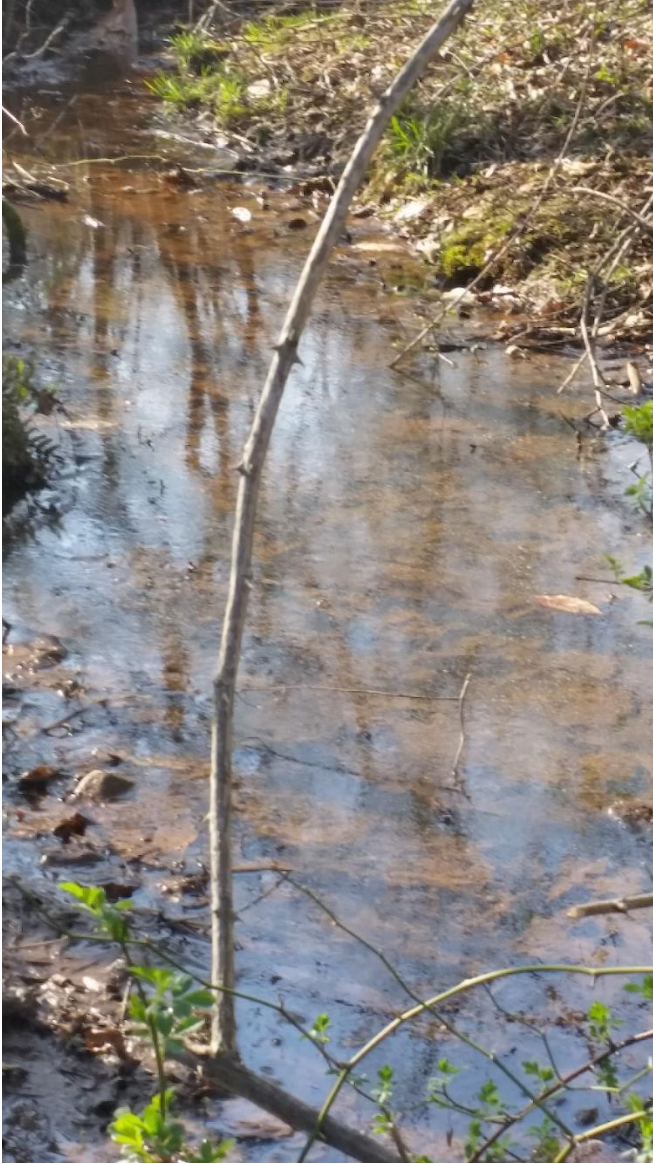
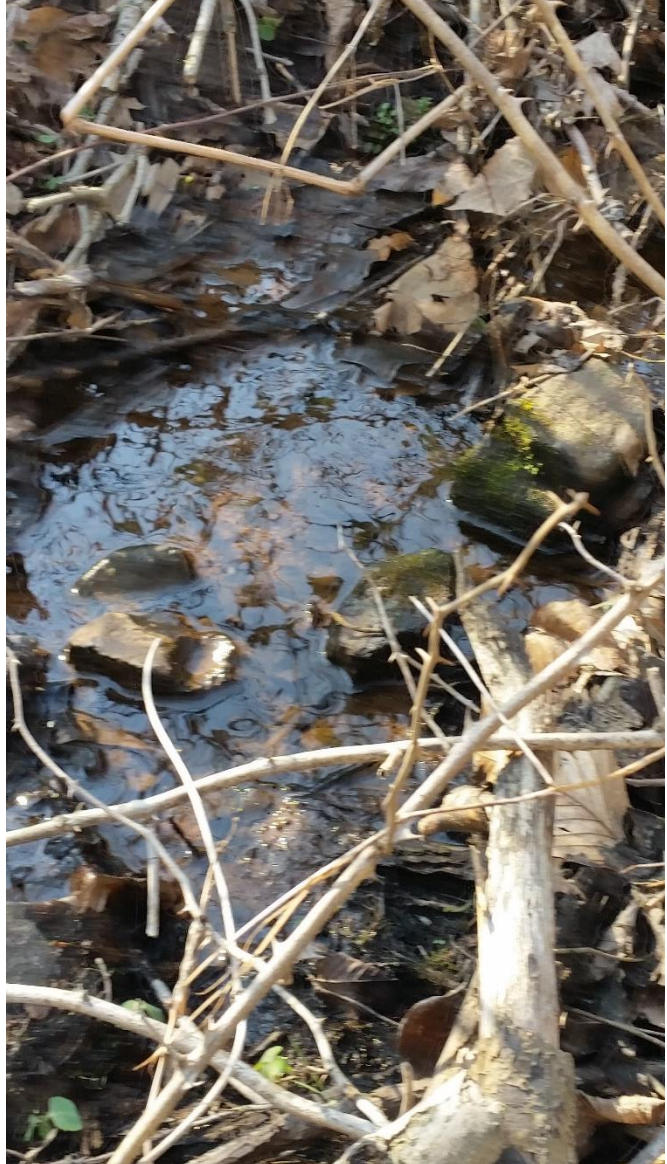
**April 18, 2018** Oil and Grease sheen continues to present on the surface of the unnamed tributary. Tributary is turbid and ash like substance is on the surface. No reports to the PADEP nor any mention on the timeline.

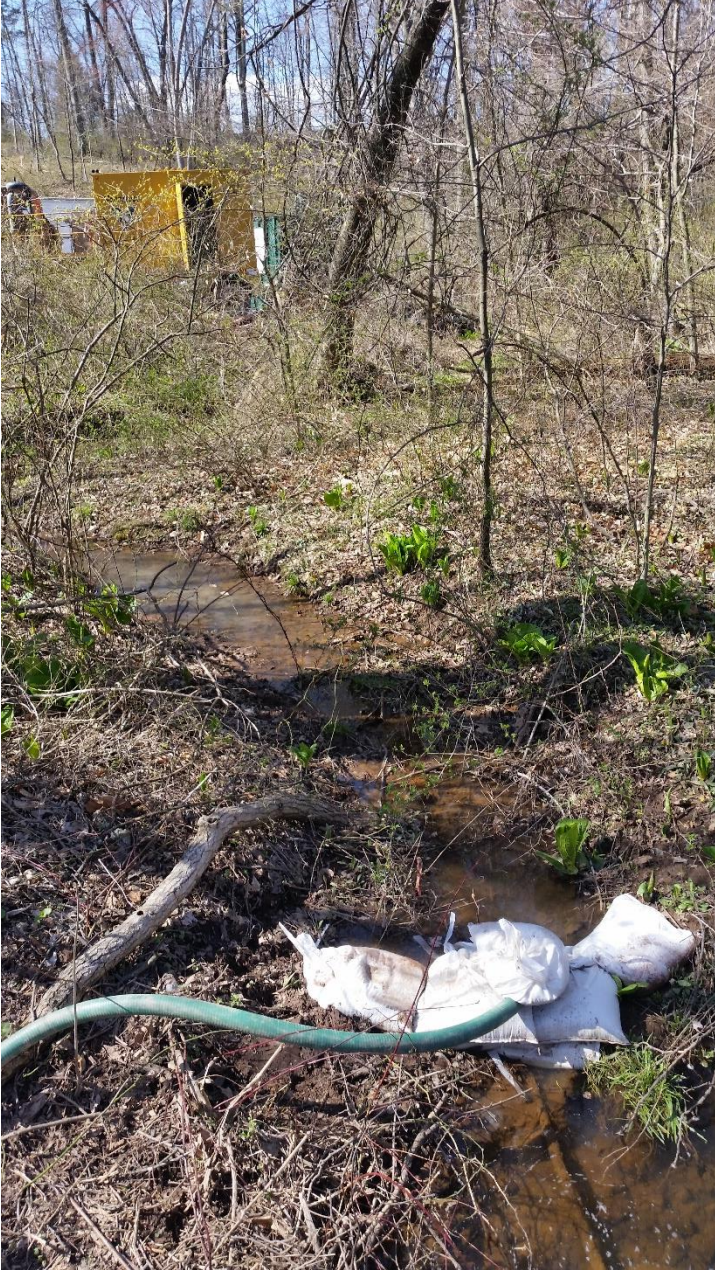
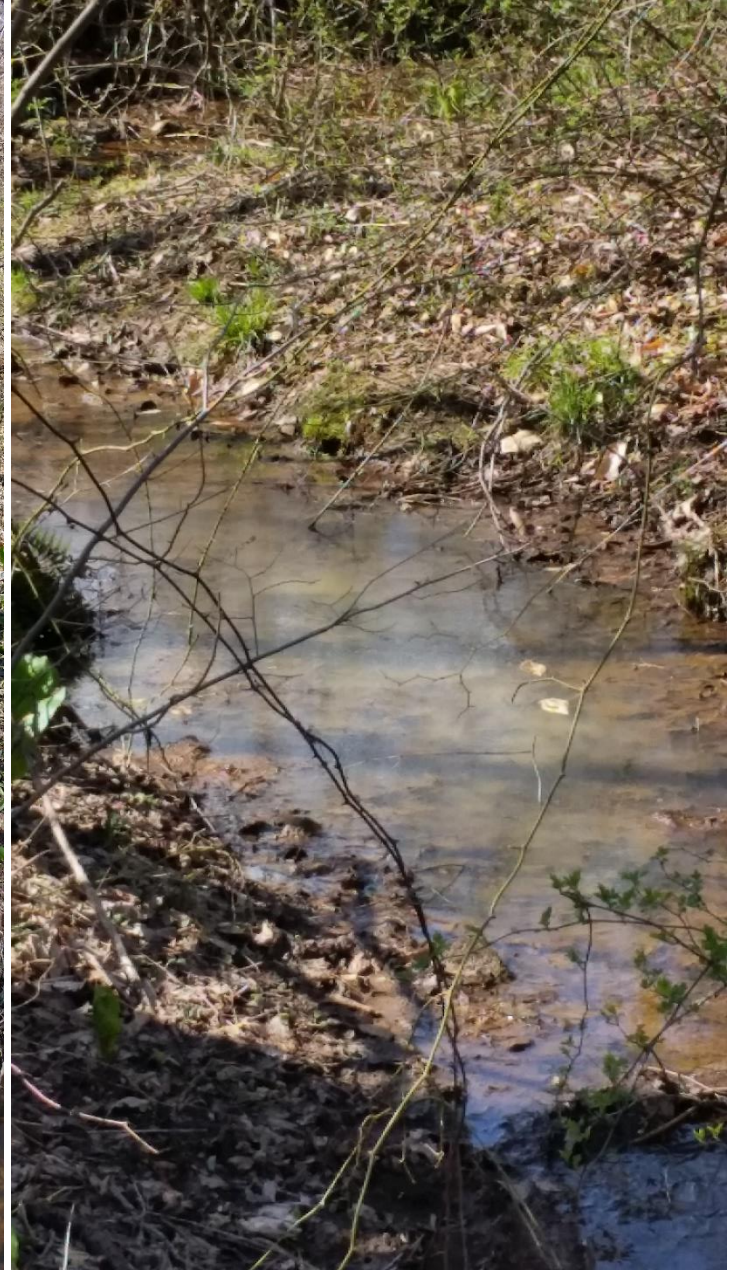
**April 20, 2018** Workers dam the unnamed tributary and again vac truck contamination out of the tributary. Tributary shows signs of turbid cloudy water. No report is made to PADEP nor is any mention of this made in timeline.

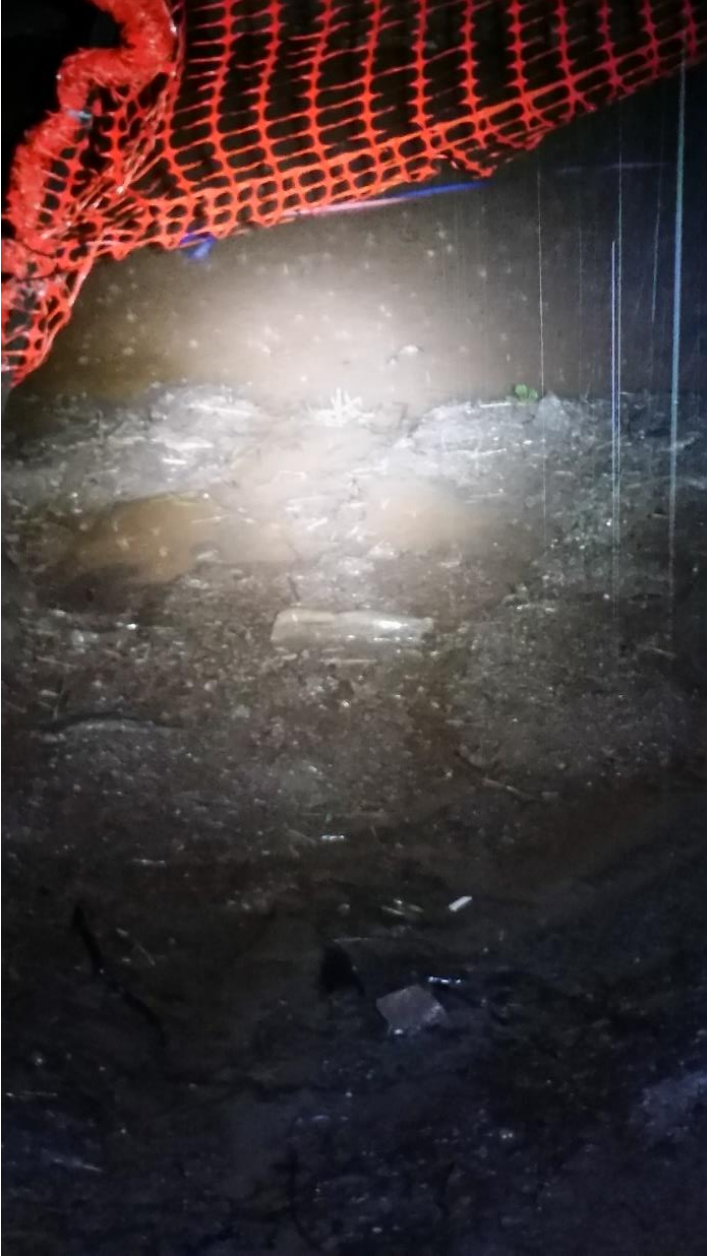
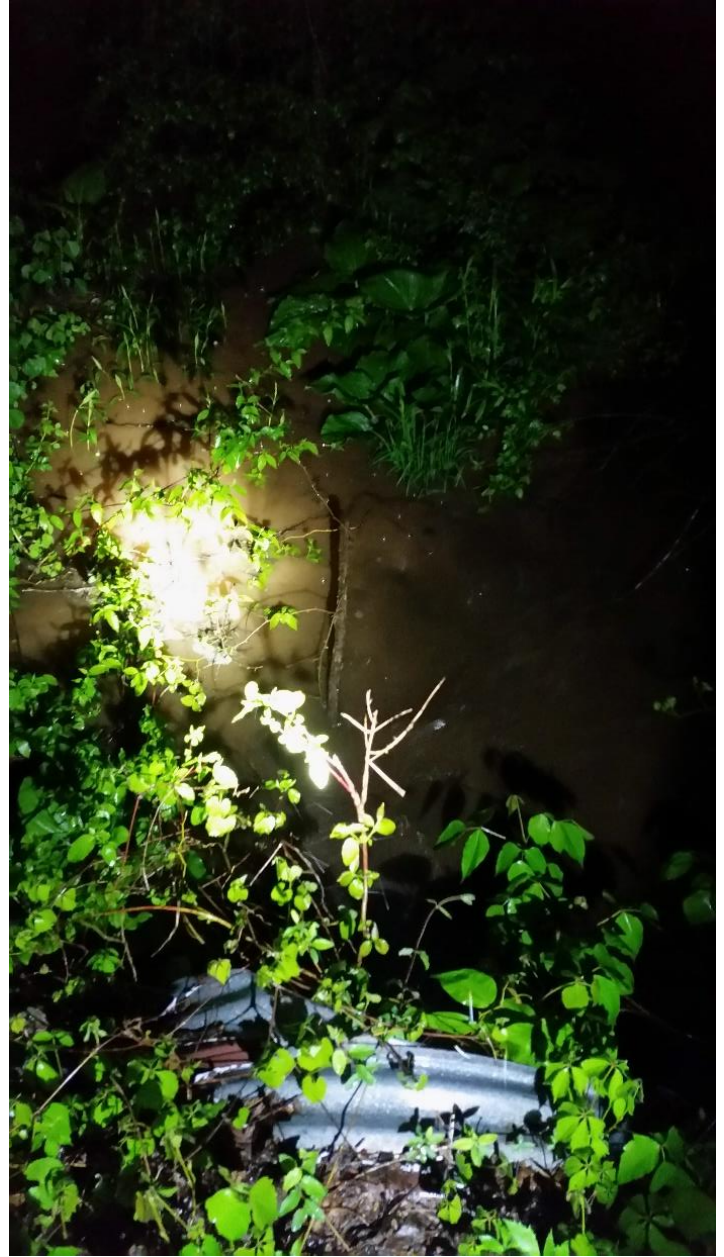
**May 13, 2018** Heavy rain fall washes drilling mud out of the pit and into the surrounding emergent wetlands and the unnamed tributary. No event was reported to PADEP nor mentioned in the reanalysis report.

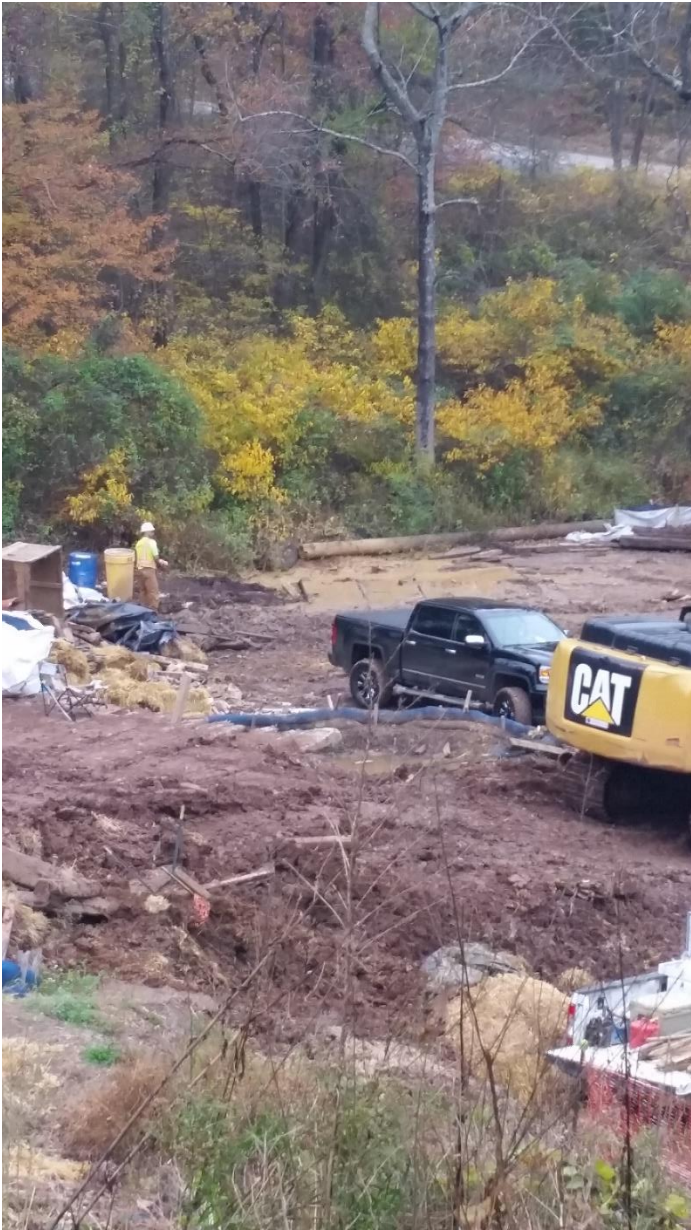
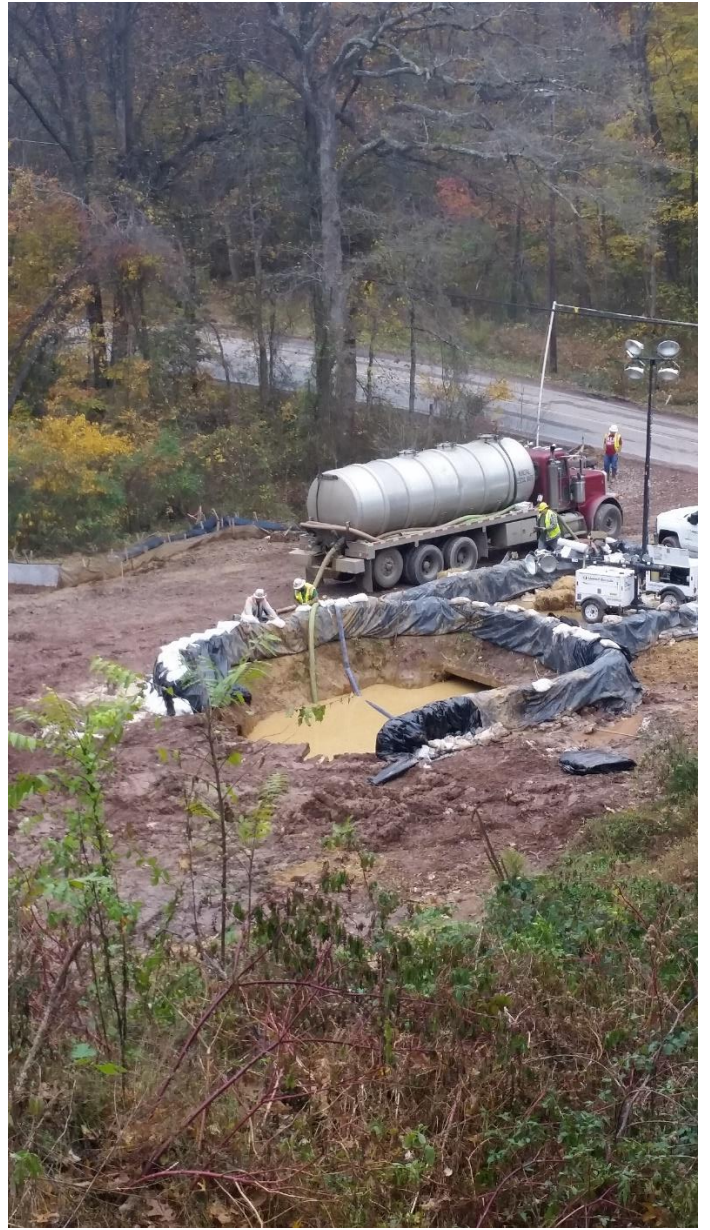
**November 1, 2018** Driller UPI was relieved of duty and the drill was removed. Drill pit continues to be pumped continually and turbidity is again observed in the creek. Drilling fluid is observed throughout the site due to equipment spills during work and careless removal.

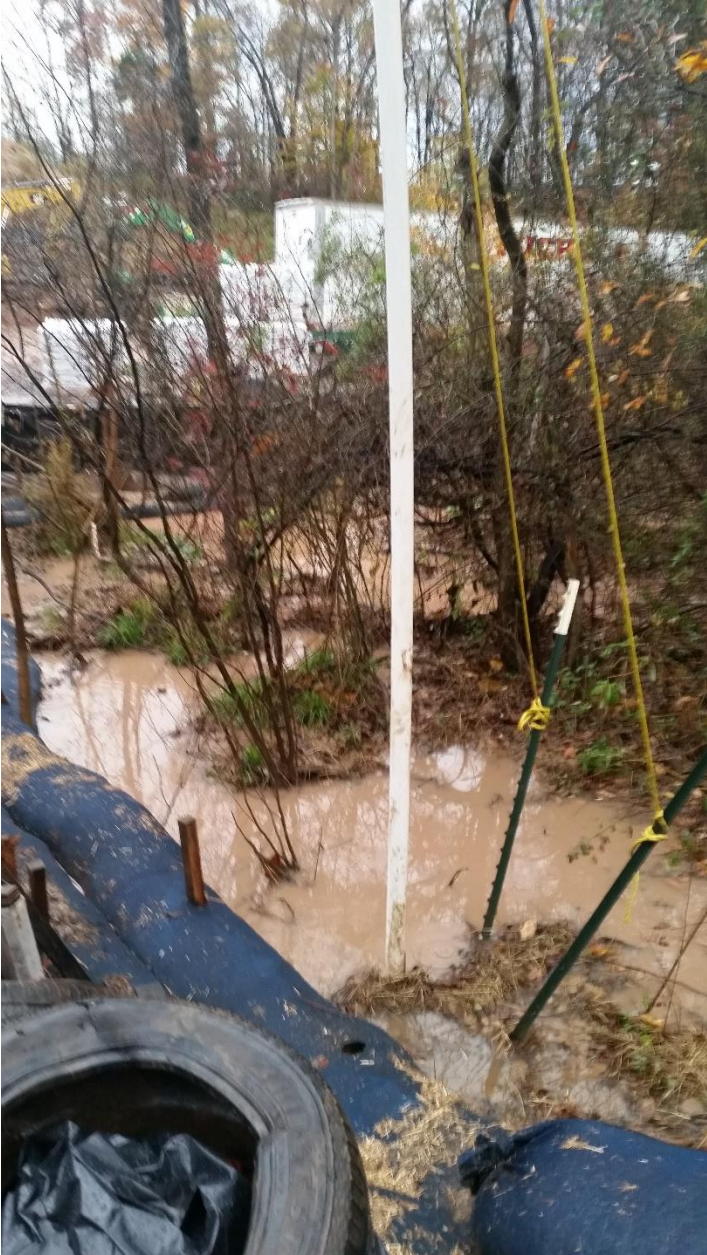
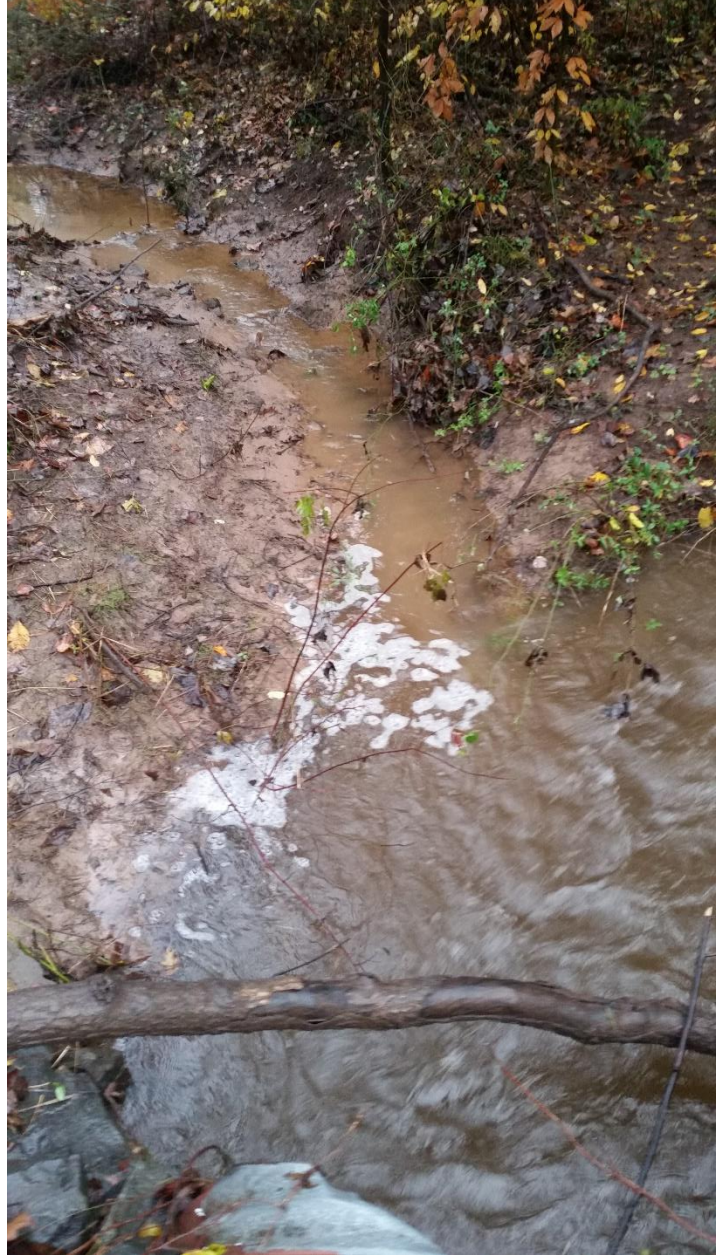
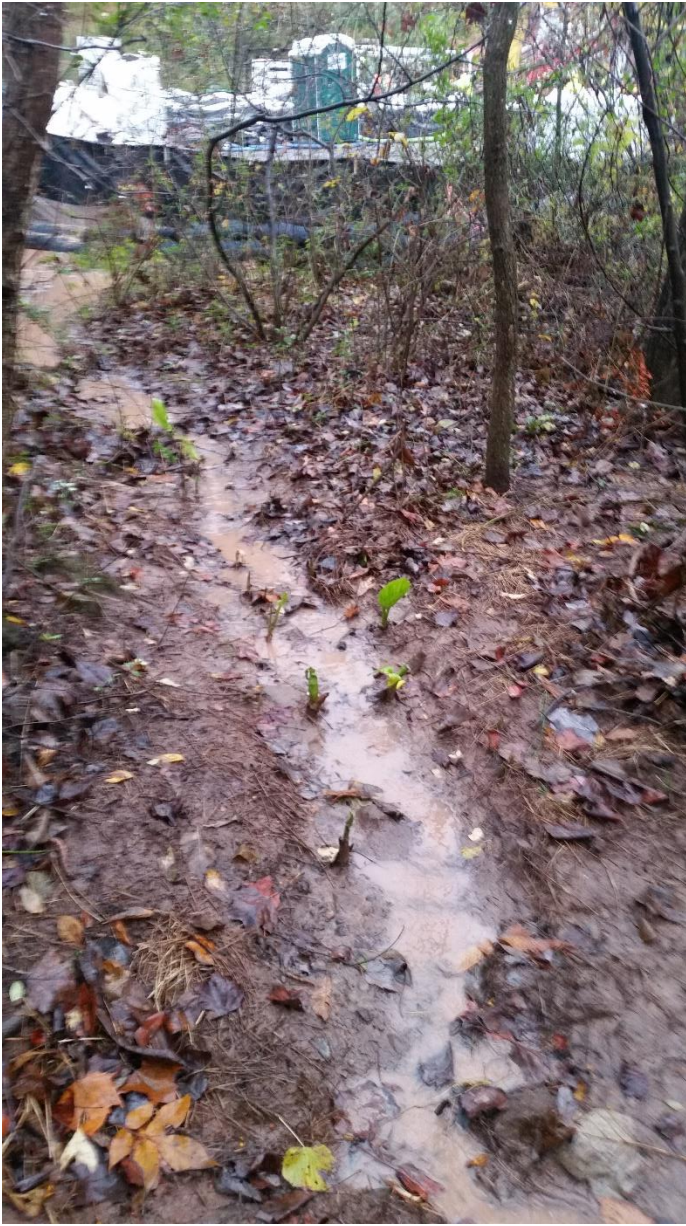
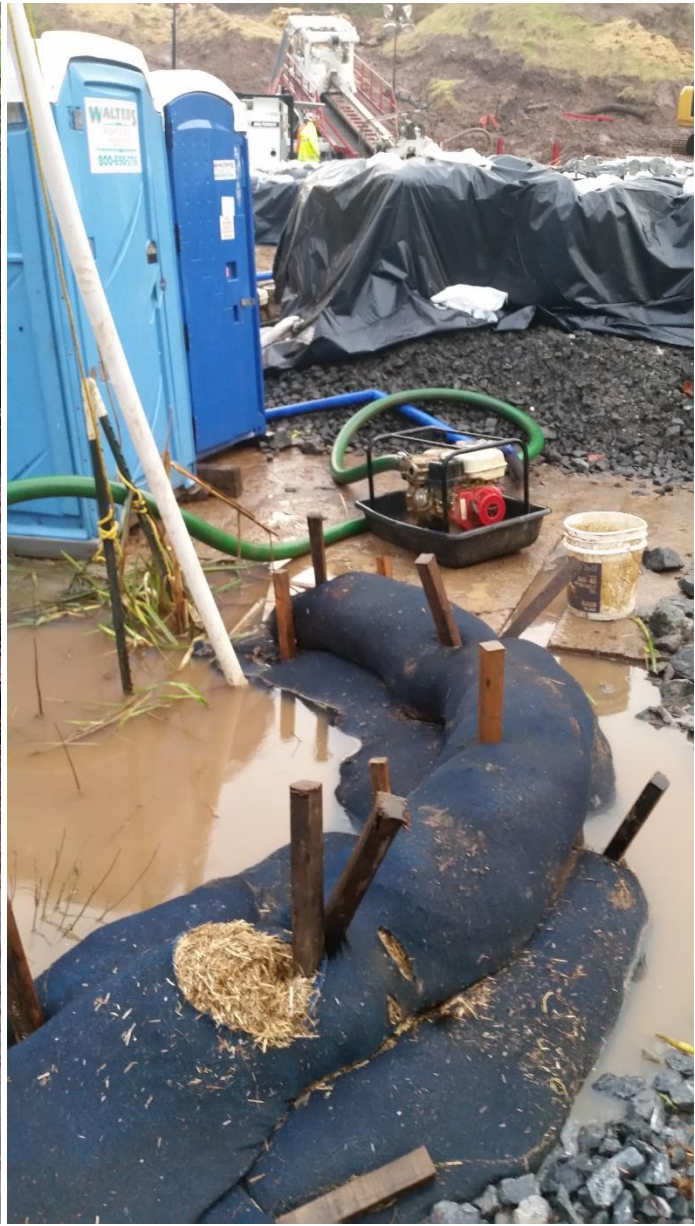
**November 6, 2018** Drill team #3, Michael's, mobilized to the site and afterwards the drill pit again washes out during storm event into unnamed tributary.

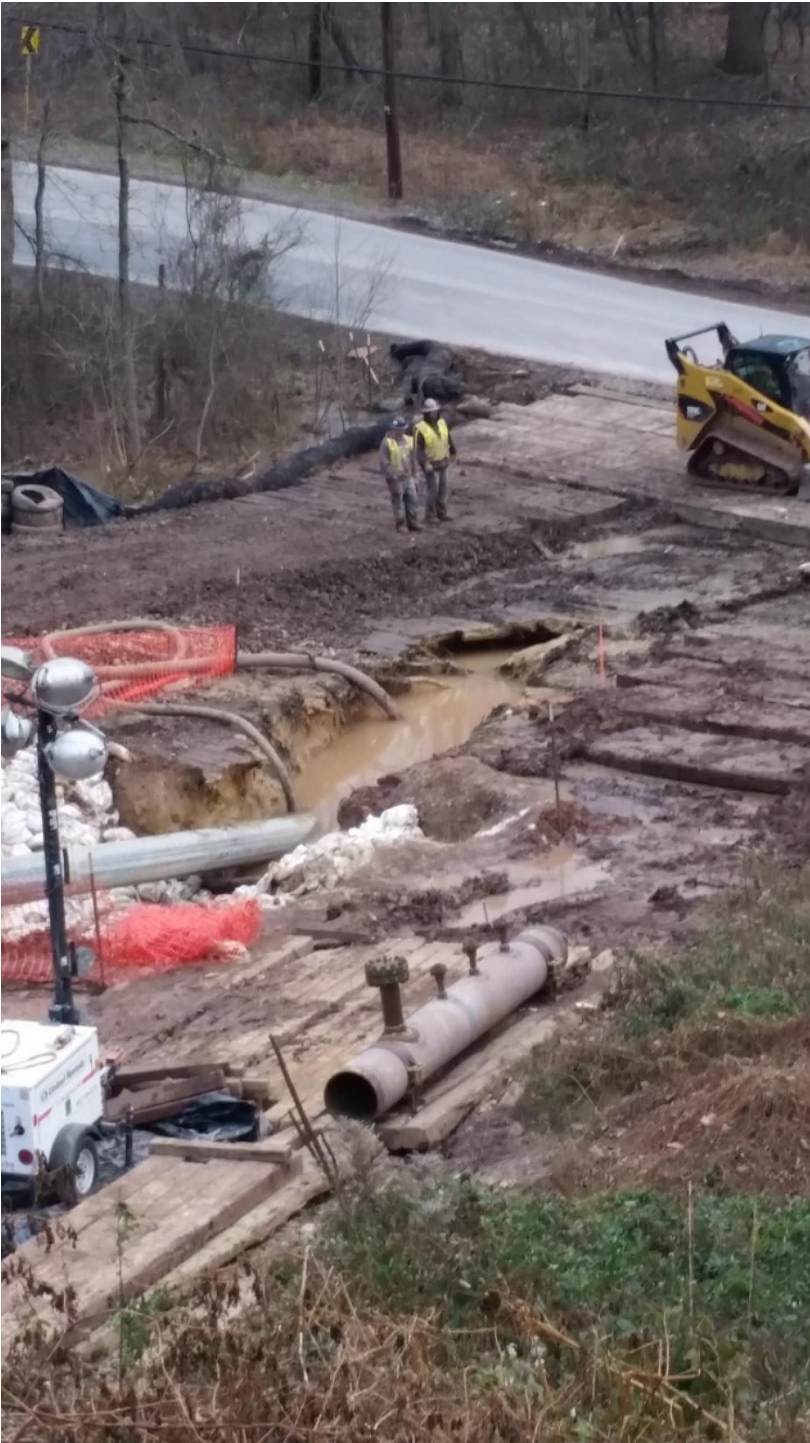
**November 20, 2018** Timber mats removed revealing undermined top soils which landowner warned Land Agent about. Pull through pipe shows extensive damages to coatings. Ground water continues to fill drilling pit, sand bag E&S structure is pushed into soils and presumed buried.

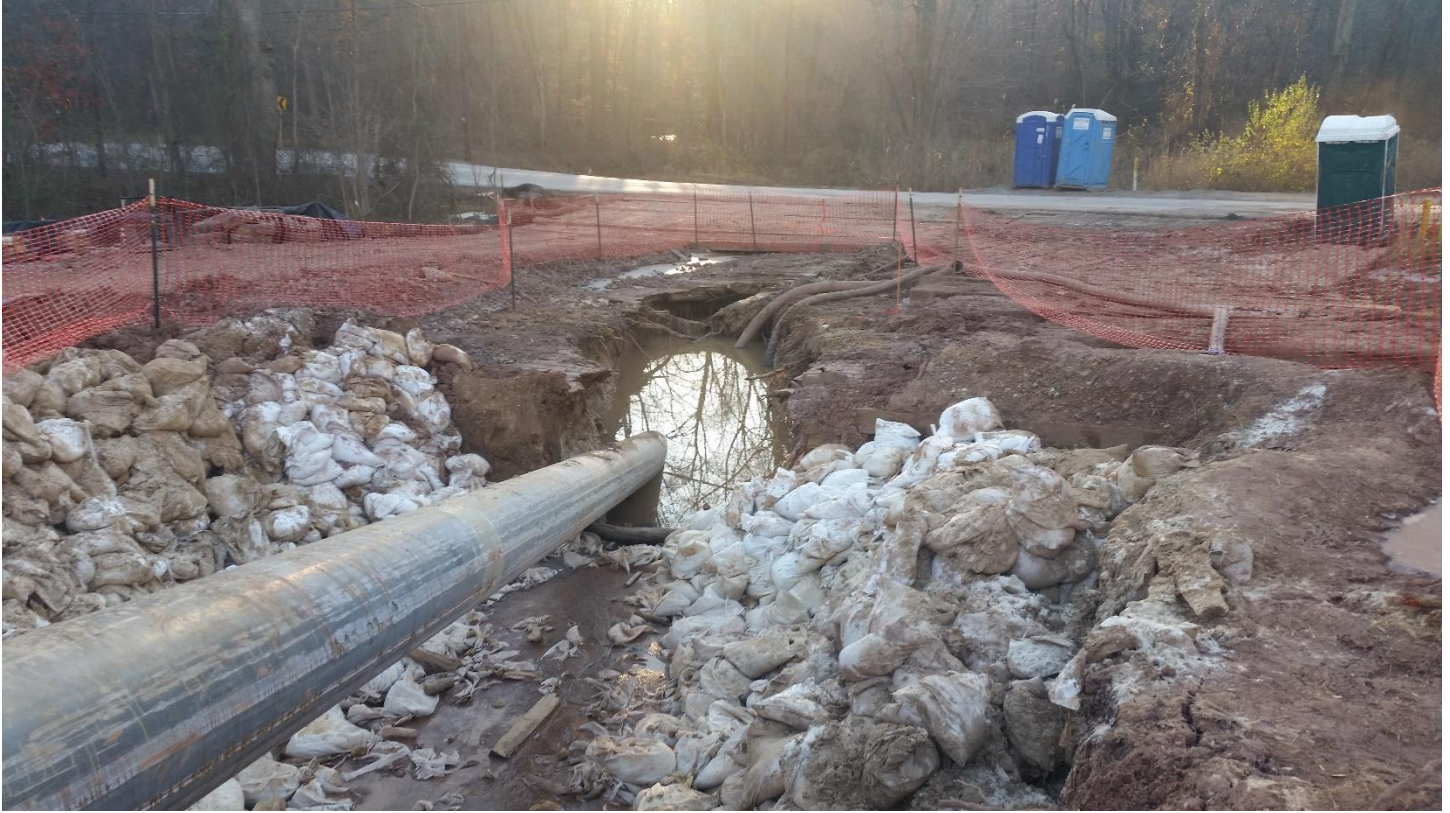
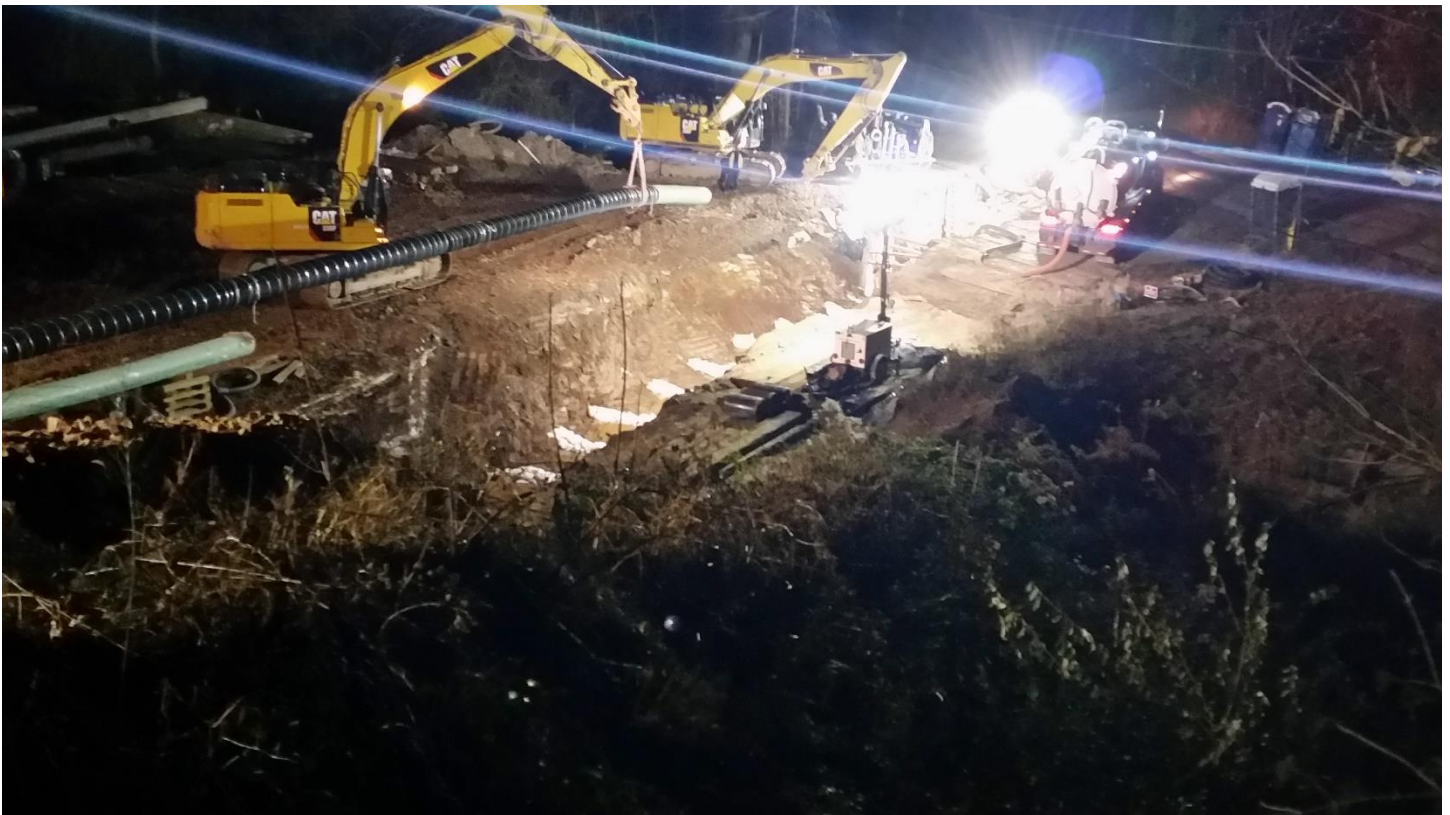
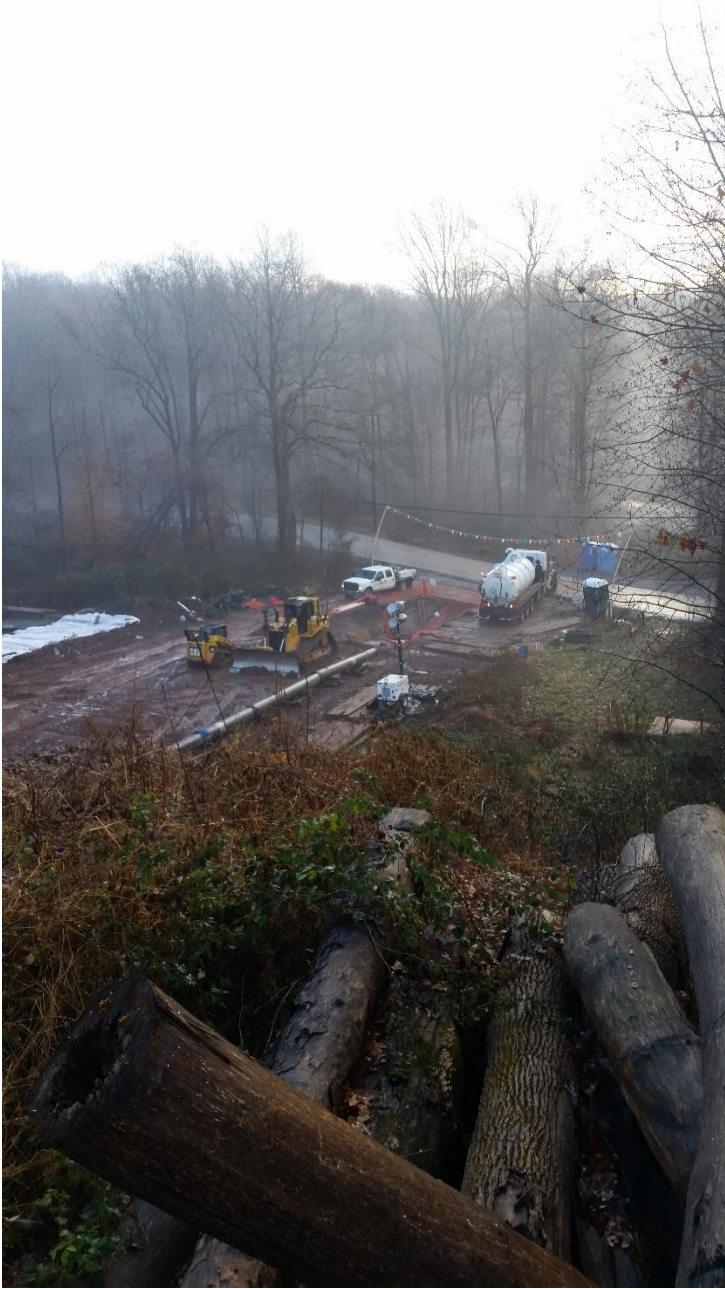
**November 24-24, 2018** Additional removal of timber mats is conducted revealing the extent of undermined soils. Drill pit extends nearly to the road, vac truck runs continually to keep pit dry for welding.
