HORIZONTAL DIRECTIONAL DRILL RE-ANALYSIS  
JOANNA ROAD CROSSING  
PADEP SECTION 105 PERMIT NO: E06-701  
PA-BR-0181.0000-RD-16  
(SPLP HDD No. S3-0250-16)

Comments prepared by Mr. David W. Anspach III  
Resident 609 Joanna Road, Morgantown, Pa 19543  
324 Feet from HDD Western Entry Point

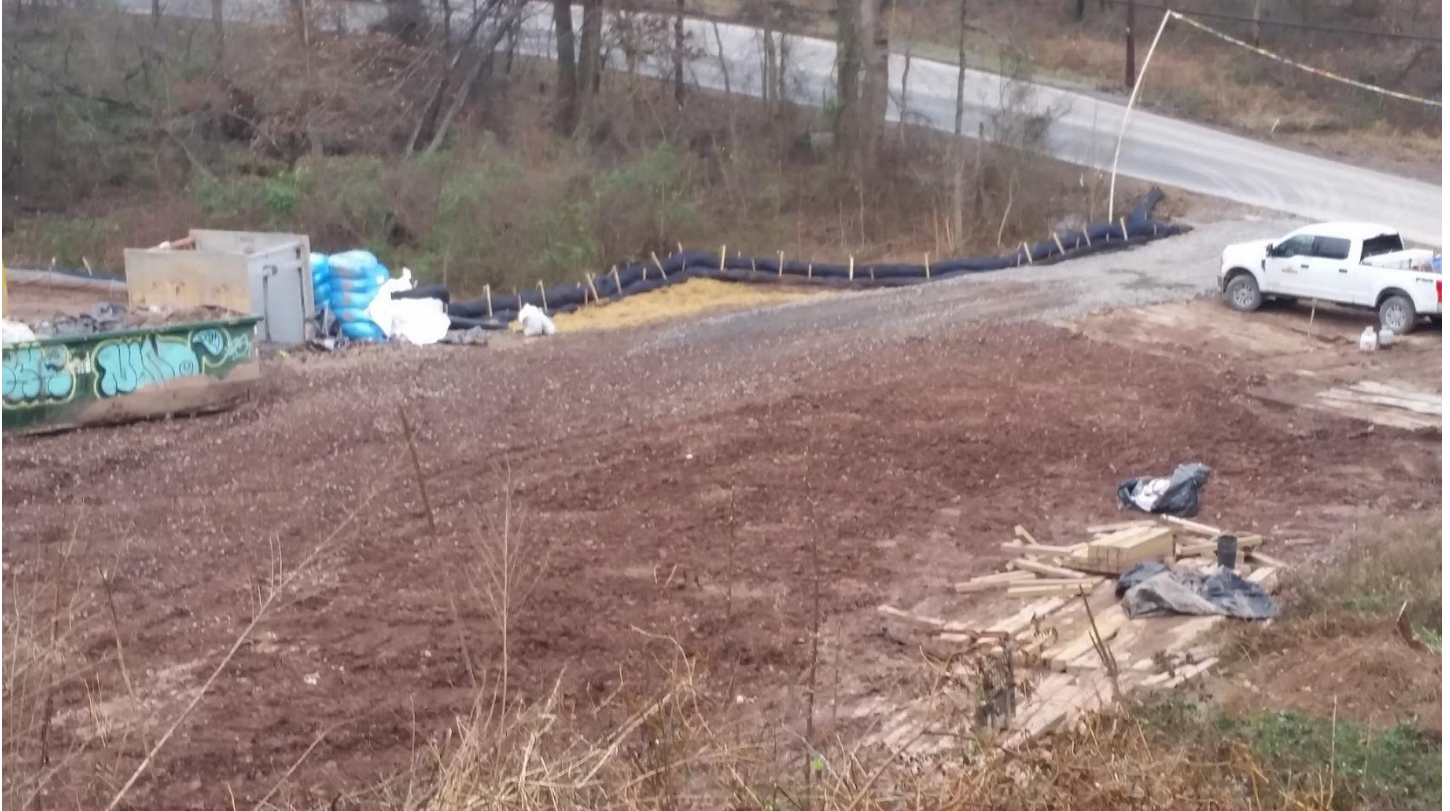
**November 28, 2018** The pipe is buried. Michael's demobilizes all equipment stabilizes site to company standards and leave the area.
