# Report of Findings (As-built Information)

Toboyne Township, Perry County  
Schaeffer Run  
Back Hollow Bridge TBT-3 Inspection  
Bridge Key: 29744

Project #212IC-BF-00037  
January 11, 2018

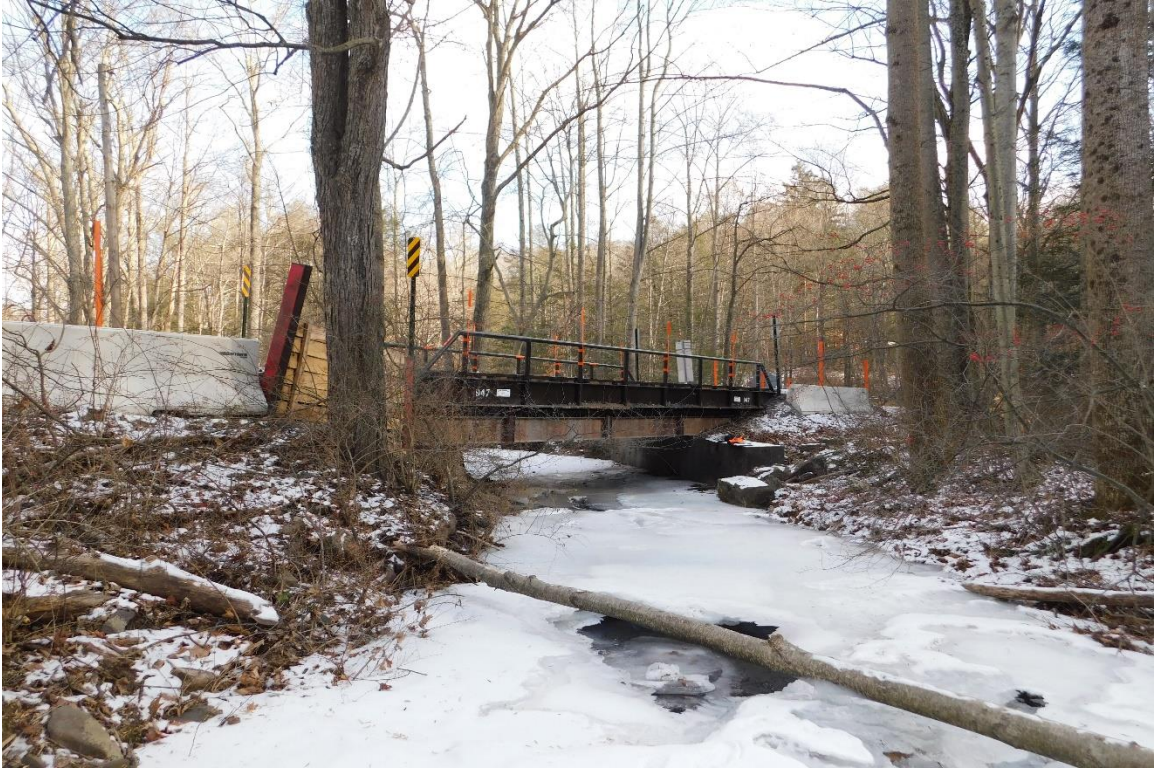
Photograph 1.

1. The Back Hollow Bridge is oriented in a Northwest to Southeast direction, and spans Schaeffer Run Creek (See Tt Dwg. S-001 and Photographs 1 to 4).
2. The recently installed "Air Bridge" matched the ADM Welding and Fabrication drawings, and was in good condition. The bridge consisted of six (6) 40'-0" long W18x50 longitudinal beams spaced at 2'-6" on center. The running surface consisted of two (2) sections 3 ½" H x 6" W x 5'-0" white oak planks positioned on the outer 5'-0" on each side of the bridge. The center 2'-6" section of the bridge is cover by ¼" checkered plates. The guide rails on each side consisted of 3 ½" O.D. pipe. See ADM drawings (Sheets 1 of 2 and 2 of 2) and Sections A-A, B-B and Detail No. 3 on Tt Dwg. S-002.

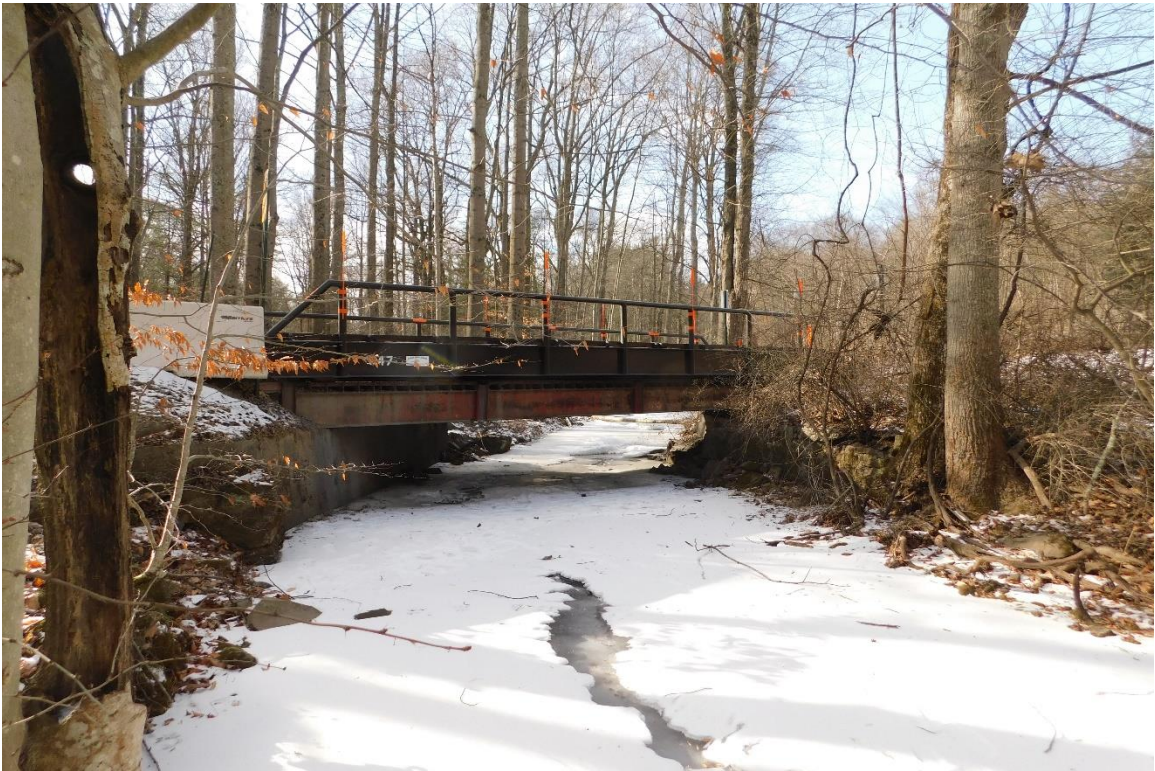
Photograph 2.

11. The concrete barrier placed on the downstream side of the approach on the southeastern end is undermined and without full support on the northwestern end of the northwestern most barrier (See Photographs 2 and 14).

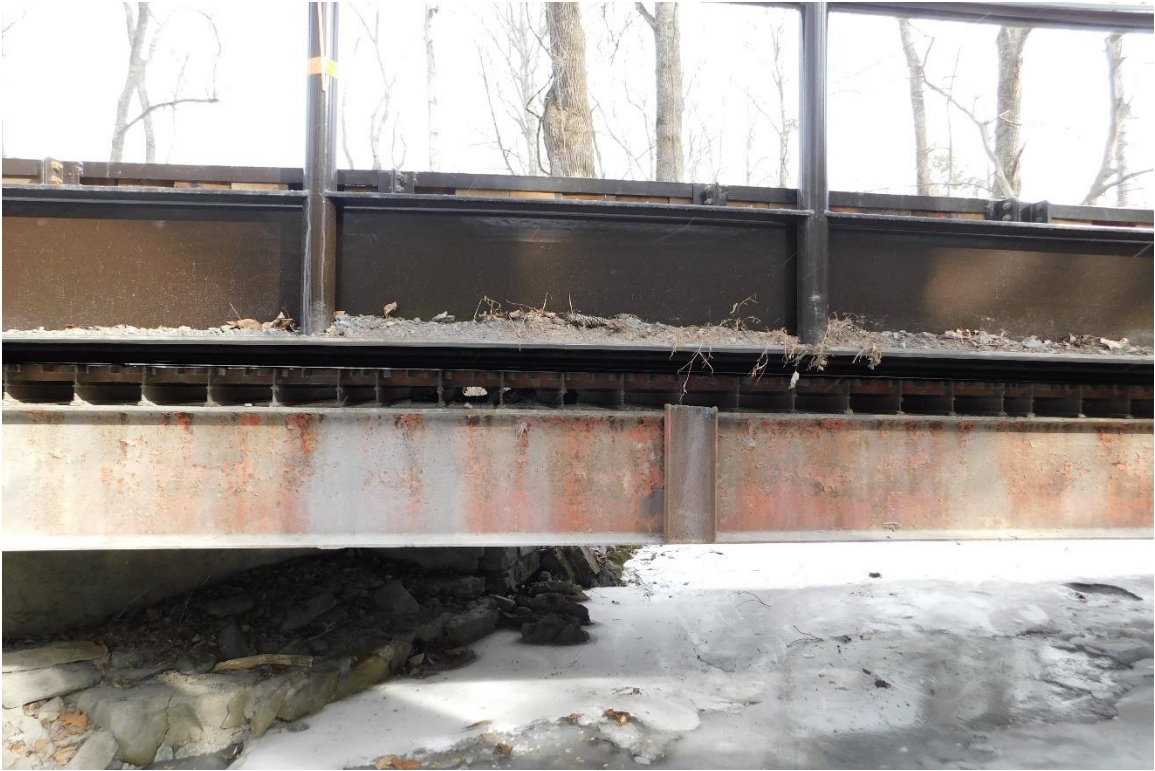
Photograph 5.

Bridge” was 1’-11 ½” above the deck of the existing bridge (See Section B-B on Tt Dwg. S-002 and Photograph 5).

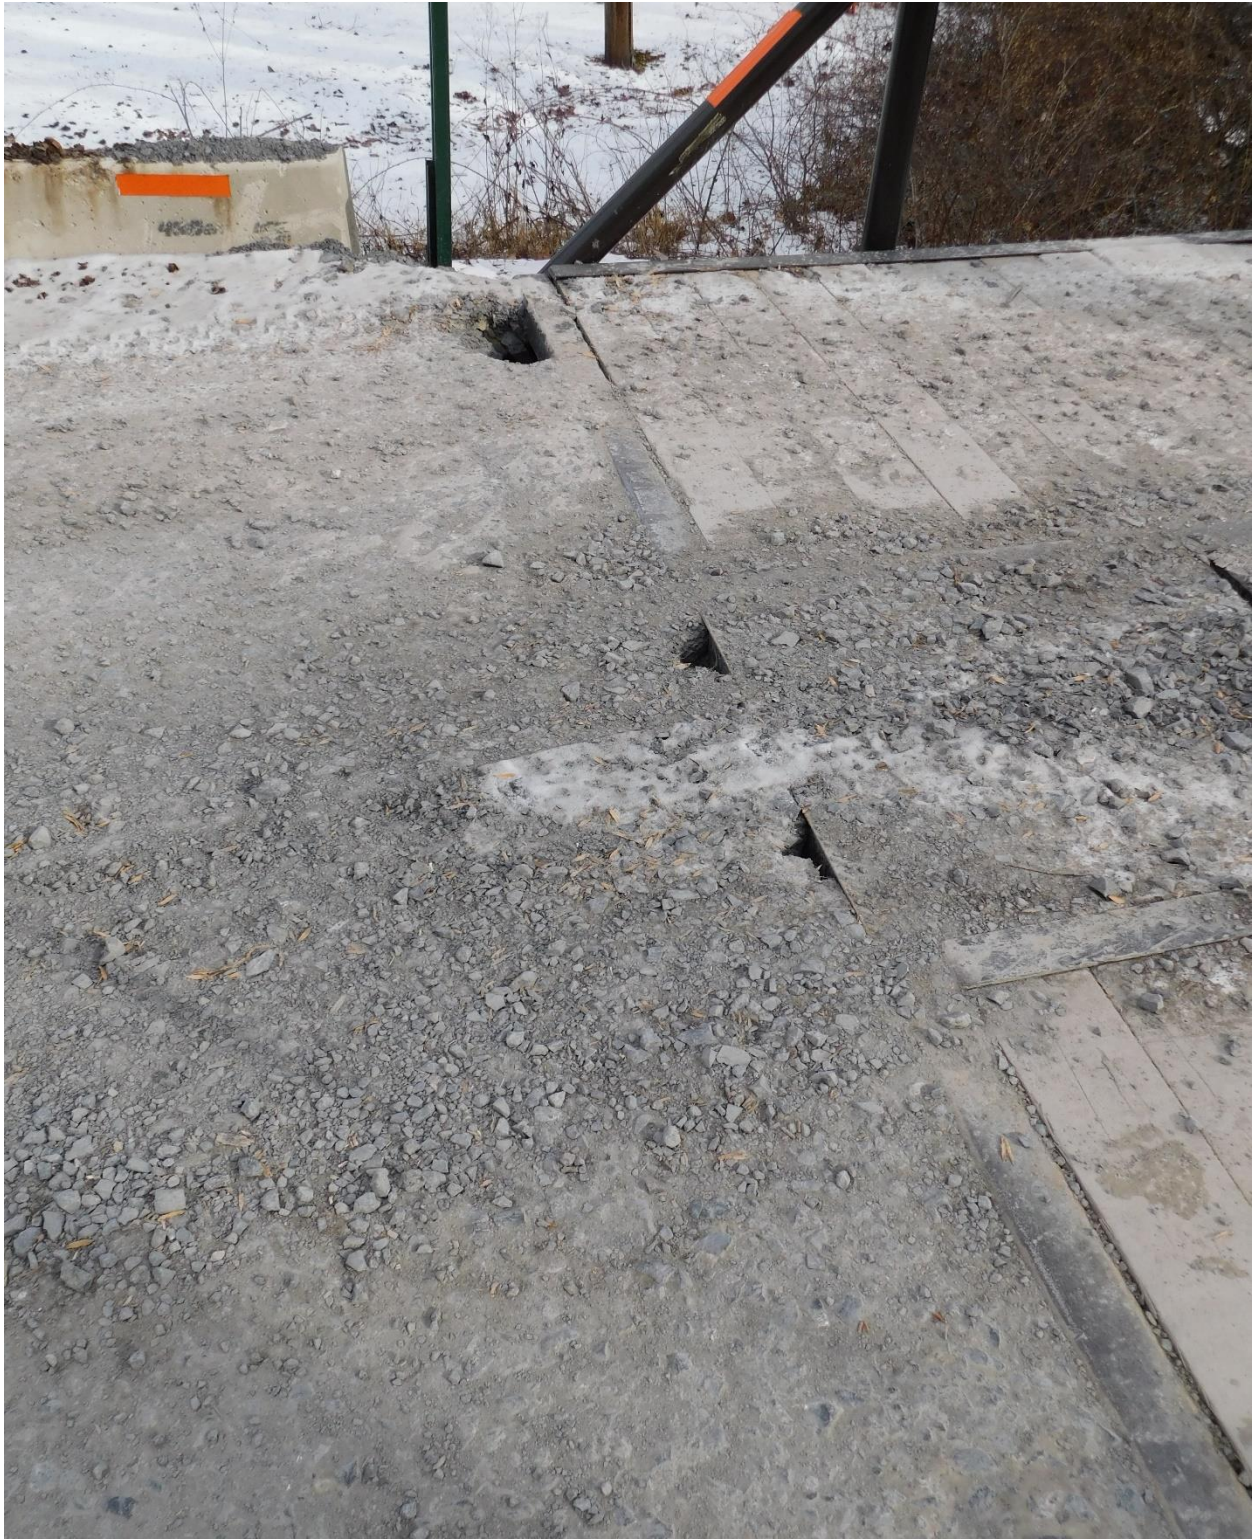
Photograph 9.

7. Soil and gravel put in place for the new roadway approach at the northwestern end of the bridge have begun to sluff under the bridge in three (3) locations (See Section E-E on Tt Dwgs. S-002 and S-003 and Photograph 9).

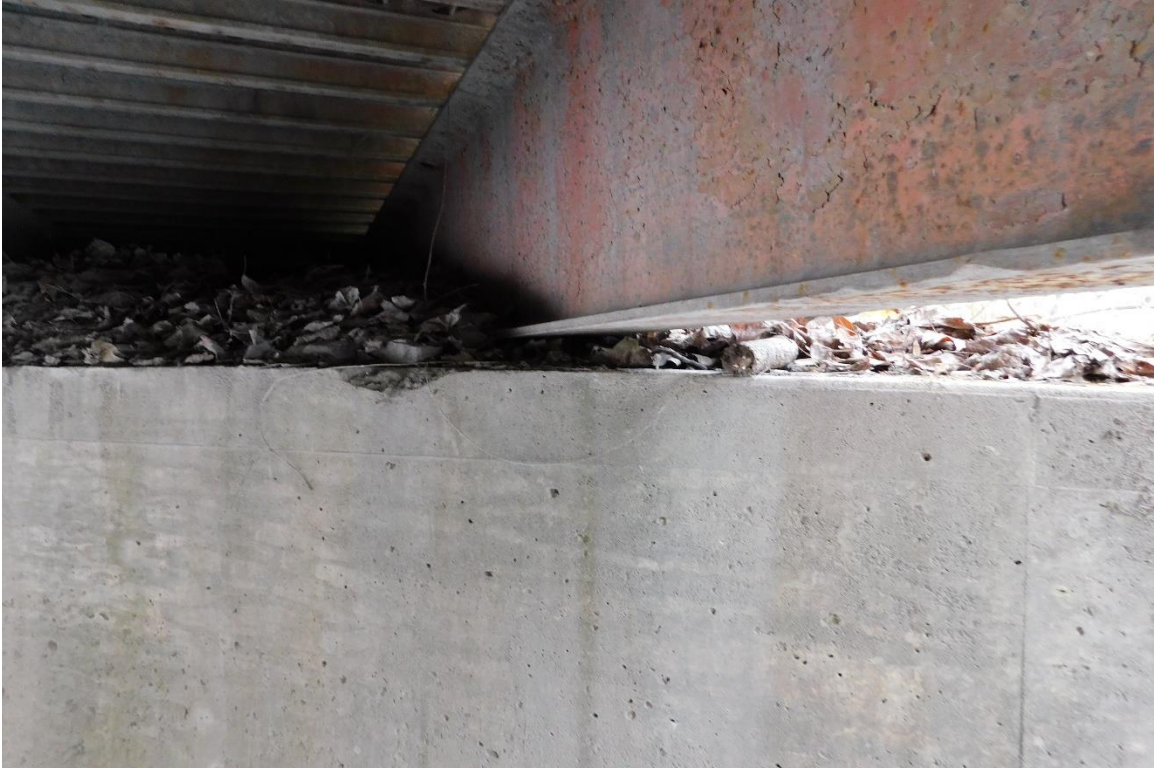
Photograph 10.

8. The W18 girders for the existing bridge are not supported on the concrete baffle wall on the southeastern end (See Photographs 10 and 11), nor on the stone wall on the northwestern end (See Photographs 12 and 13).

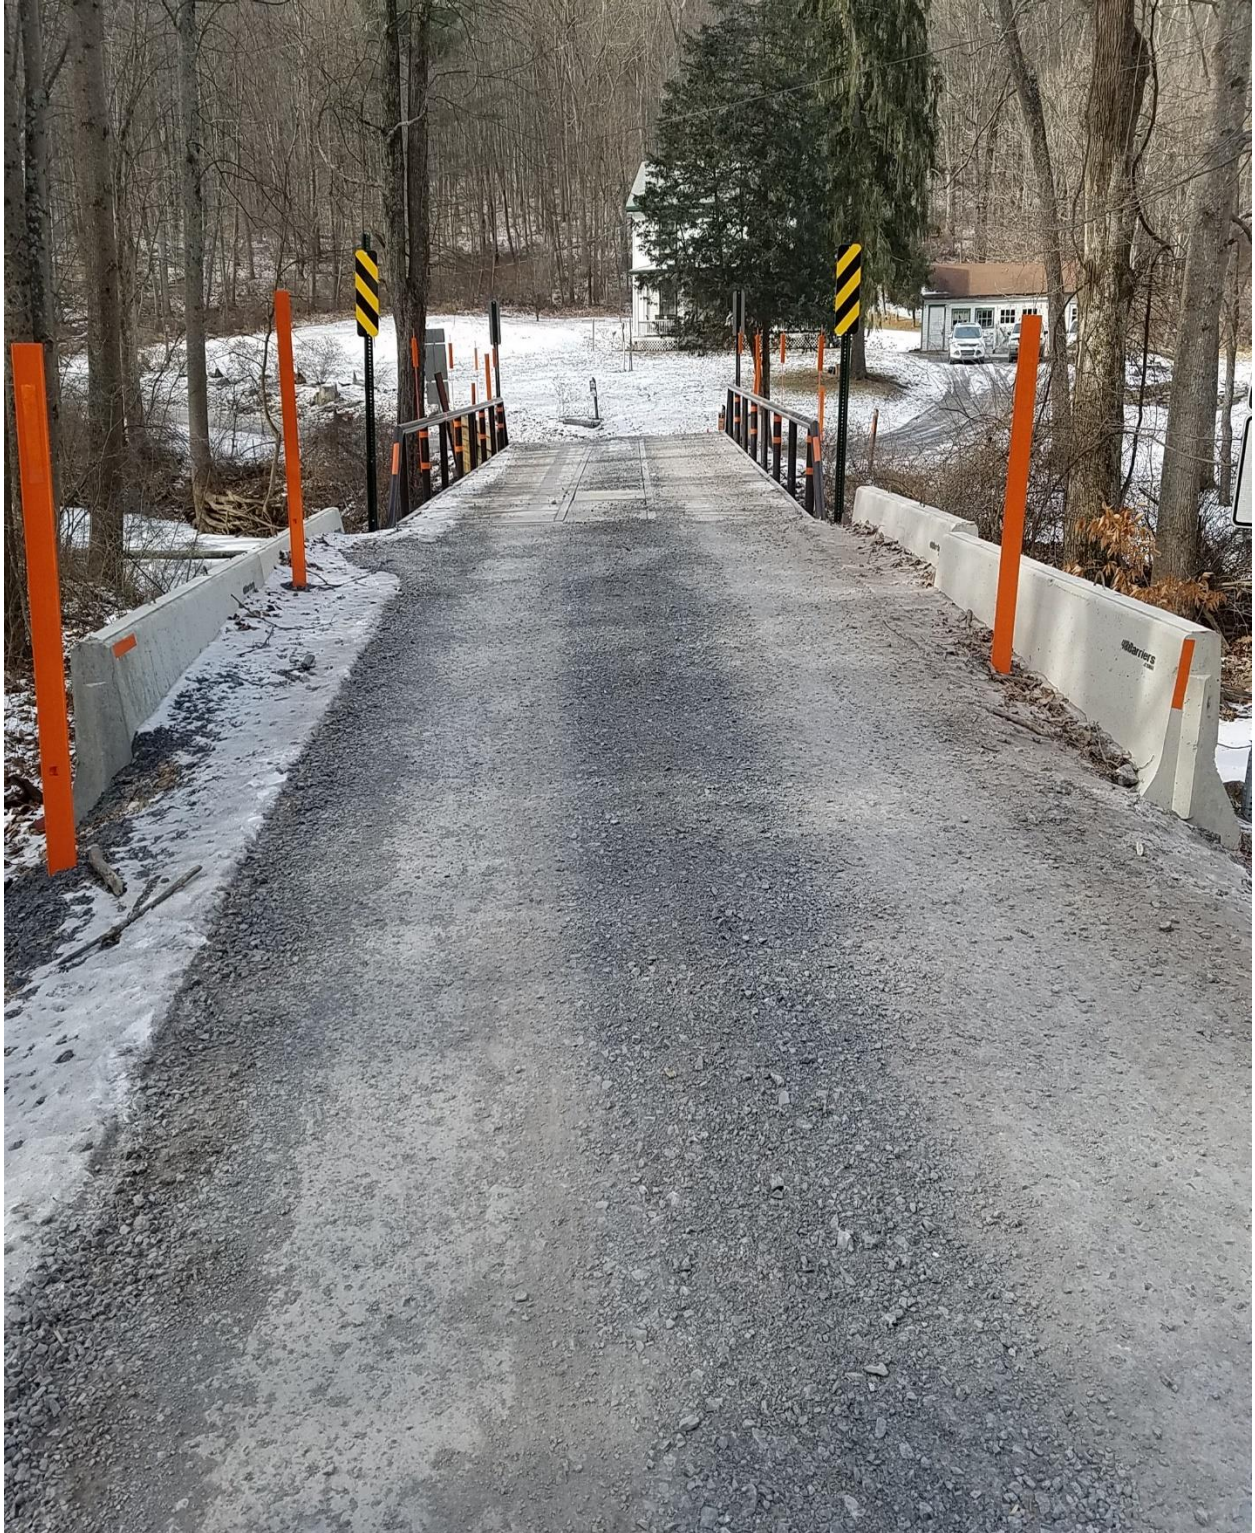
Photograph 14.

10. Concrete barriers were placed on the upstream side of the approach on the southeastern end to act as a retaining wall for when the approach was built-up (0’-0” to 1’-11 ½” max.). These barriers are leaning outward as though they are being pushed over by the soil (See Photograph 14). It is possible that these barriers were installed with the observed slant, and not being pushed over.

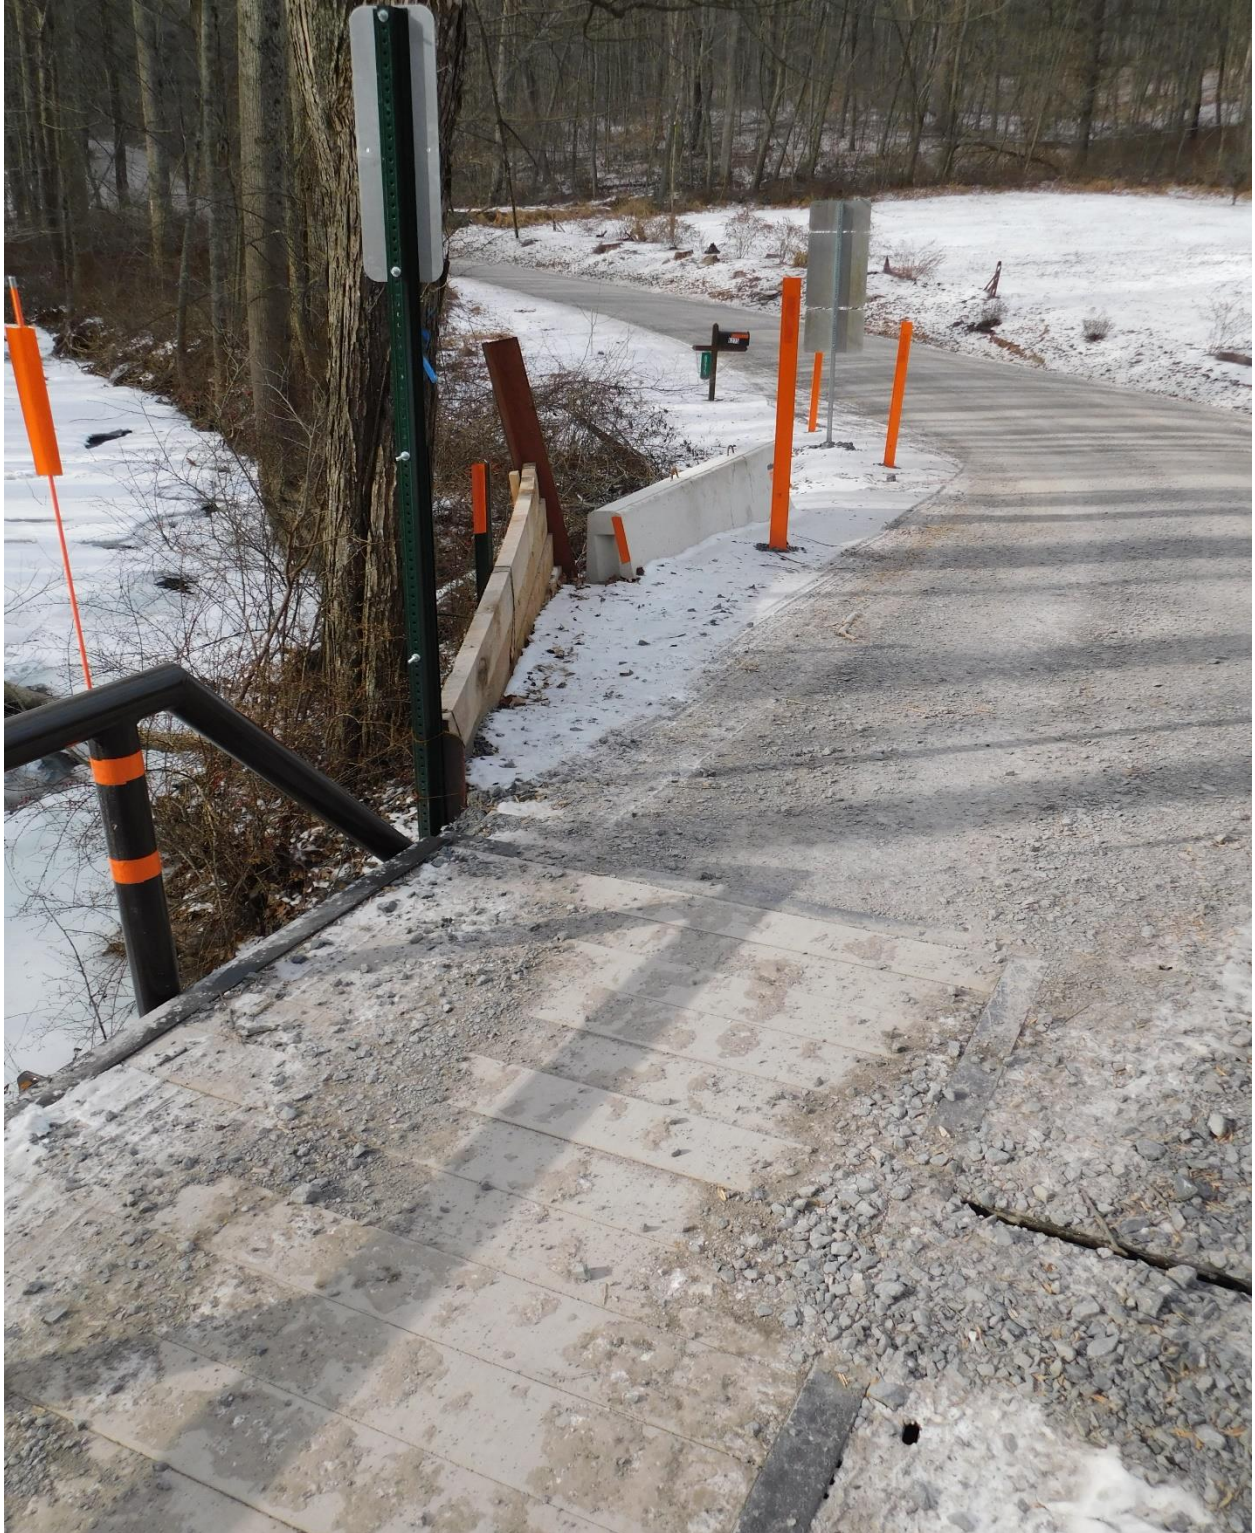
Photograph 15.

12. A wood plank retaining wall on the upstream side at the northwestern end appears to be twisting / bowing (See Photographs 15 and 17). However, it is my opinion that there has been no movement and the planks are in the shape they are in because they were installed between two (2) existing posts. Photograph 16 shows the concrete barrier on the downstream side of the northwestern end of the bridge.

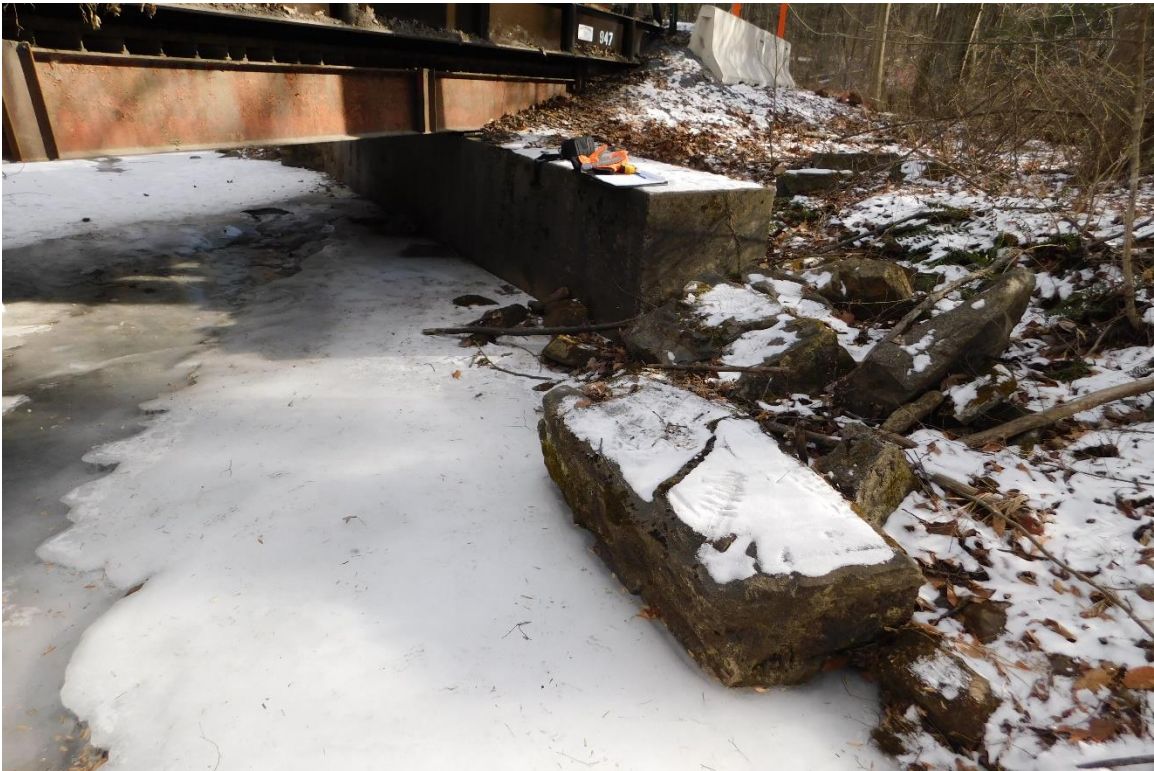
Photograph 18.

13. A piece of stone approximately 3’-10” L x 1’-10” W x 1’-6” H has fallen into the stream bed (southeastern side of stream – See Photograph 18).
14. A bridge weight limit sign on the southeastern end states that the bridge has a 13 tons weight limit, except combinations 28 tons (See Photograph 19).

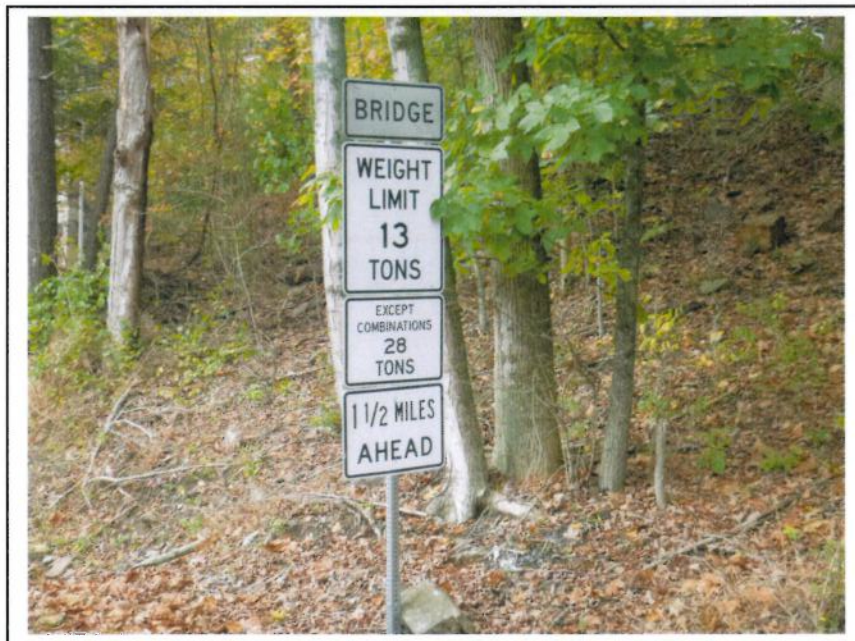
Photo No. 9: Near Advanced Weight Posting Sign

The bridge is posted for 13 Tons, Except Combinations 28 Tons. The approach weight posting signs are >25' from bridge but provide visibility across structure due to road alignment. All weight posting signs are in satisfactory condition. Weathering noted on several of the advance sign panels (See Photo Nos. 9 & 10). The far advanced supplemental weight posting sign at the township line is missing due to construction of a pipeline, however this sign is not required, the far advanced sign is in place. One lane bridge signs are in place, the far post is slightly loose, stable. Both one lane bridge signs are dirty, the far sign is very dirty (See Photo Nos. 13 & 14). Additionally, there are hazard clearance signs present, the near left post and panel are bent with scrapes, stable, need repaired. The post at the near right is very loose and leans (See Photo No. 15). All four are placed at improper height.

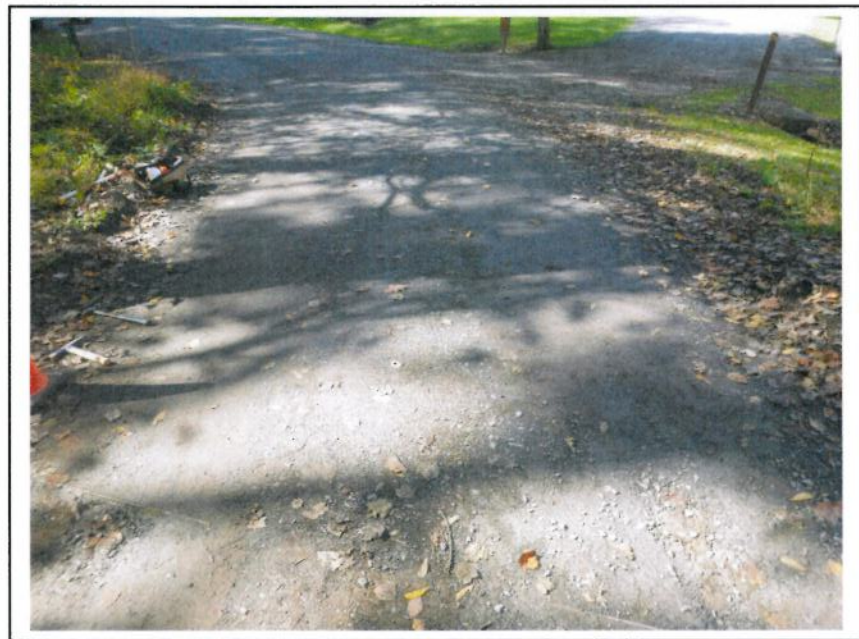
Photo No. 17: Near Right Railing Damage

- Moderate damage at far left, three bent posts, end post bent out 5", all secure.
- Painted on top and inside face with freckled corrosion, remainder exhibits corrosion and minor pitting. A few scrape marks and minor isolated paint peel on inside face.
- Right railing exhibits outward lean at top (outward lean 2" max. to 1/4" min., old condition)
- Severe impact damage at the near right. The top channel is no longer connected to the first post and the turndown is no longer present. The post is no longer connected to the beam at the top and is barely attached at the bottom of the beam. (See Photo No. 17)

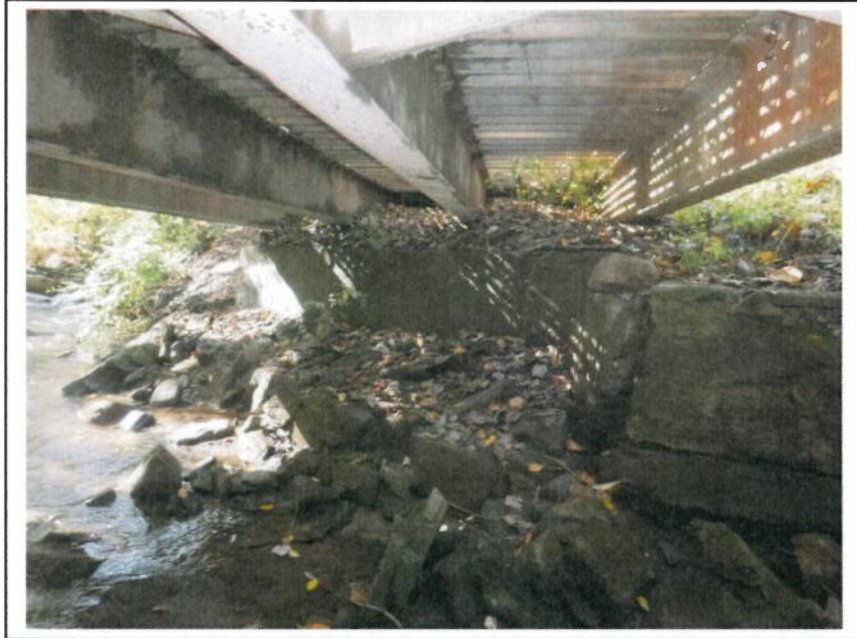
Photo No. 30: Bay 3 Intermediate Diaphragm Gap in Connection

- Four cracked welds noted at connection to beam web locations.
  - o Beam 1 bottom angle connection, 3/8" long fine crack in weld (right face of web) (See Photo No. 28).
  - o Beam 2 (center bay) bottom angle connection of beam 2 web 4" long (full height) crack in weld on near side (right face of web) (See Photo No. 29).
  - o Beam 3 bottom angle connection, 3/8" long fine crack in weld (left face of web).
  - o Beam 4 (upstream. fascia) top & bottom angle connection 11/16" gap at bottom connection, 1/8" gap at top with slight misalignment (left face of web) (See Photo No. 30).

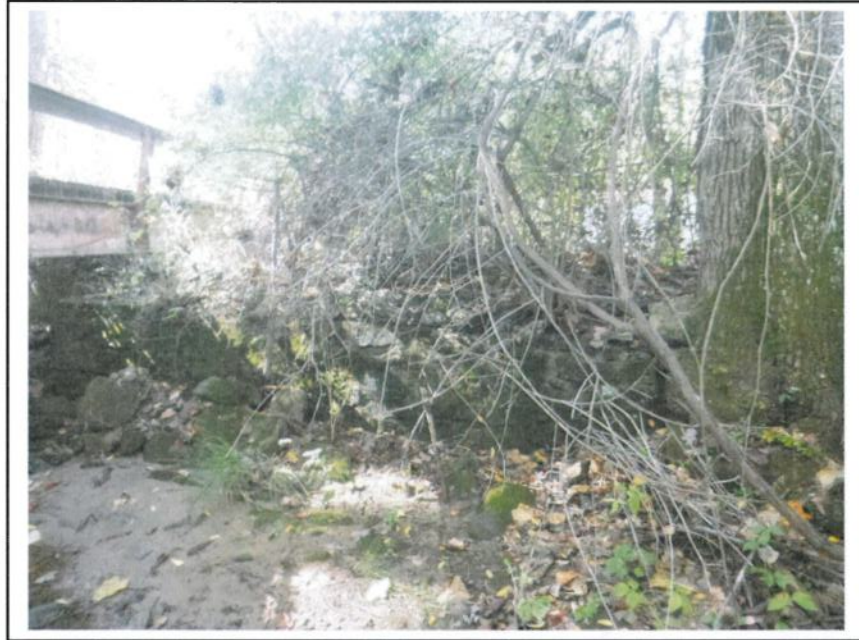
Photo No. 32: Near Left Abutment Voids

- Old masonry abutment no longer provides support for superstructure and retains fill where beams bear.
- No formal substructure visible to support beams.
- Parget and joints mostly sound at center.
- Movement & separation of stones 3' long x 3' high area with voids probed to 3' penetration, 3' long x 0.5' vertical x 0.5' under void at base below 3' long x 1.5" wide crack above. (See Photo No. 32)
- Somewhat stable.
- 1 1/2" to 2 1/2" wide x 2' long diagonal crack between stone and abutment corner at near right end of masonry, 1 s.f. deterioration above.
- Loose stones in fill below beam 1, end 3'. Beam supported beyond.
- Loss of bearing stones under beam 4 at the near abutment, see superstructure for more information.

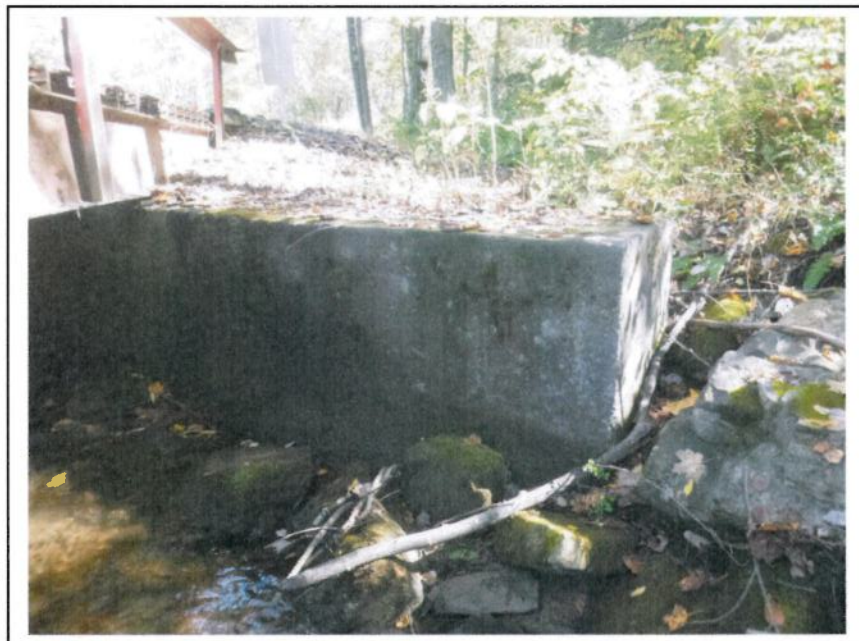
Photo No. 37: Far Left Wing Void

- Far left masonry some minor deterioration at end 1' long x 0.5' vertical x 2' under void (See Photo No. 37).
- Joints mostly sound.
- Concrete sound, similar to abutment.

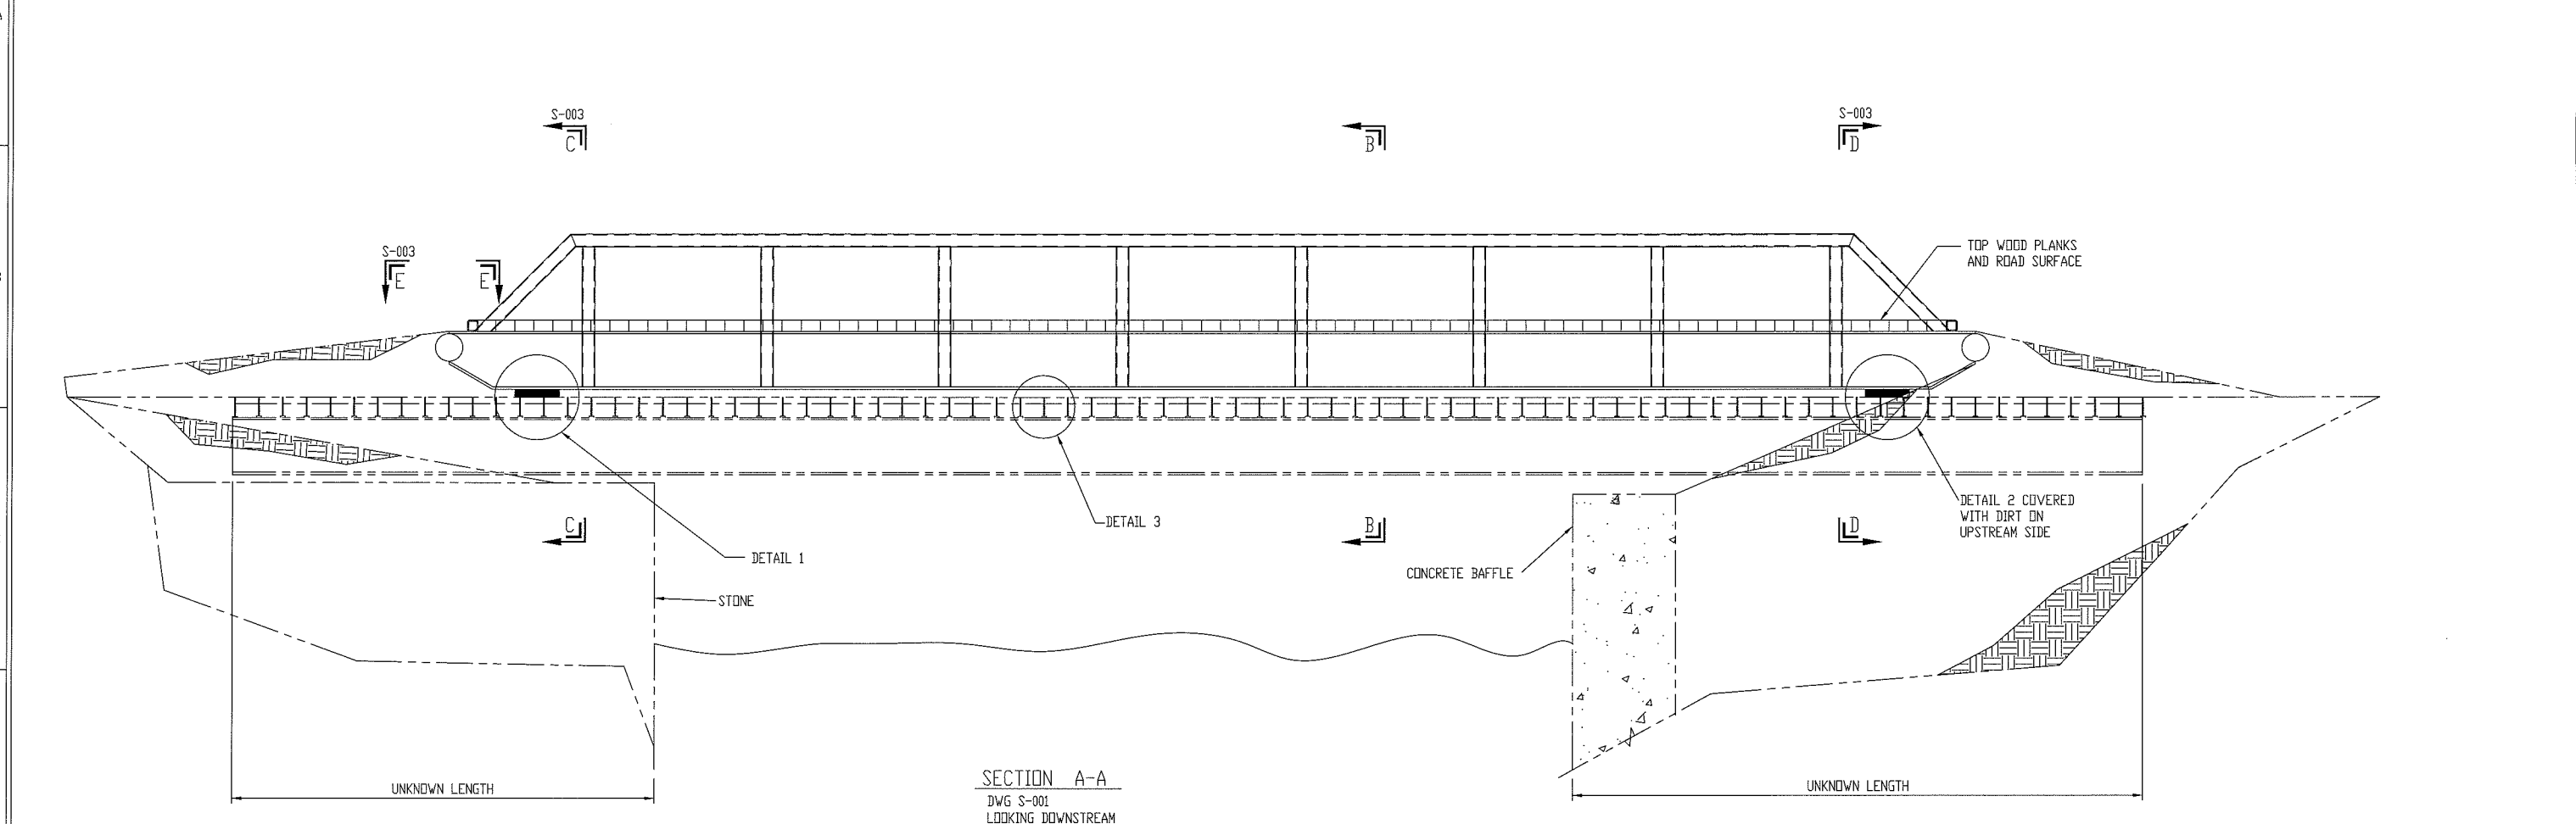
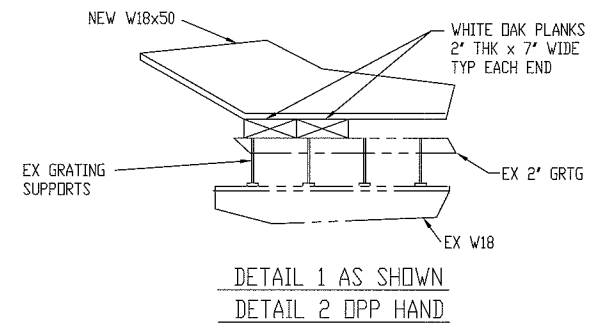
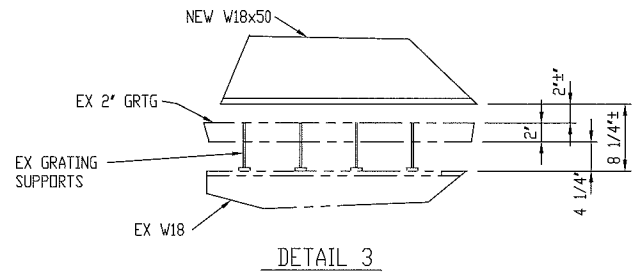
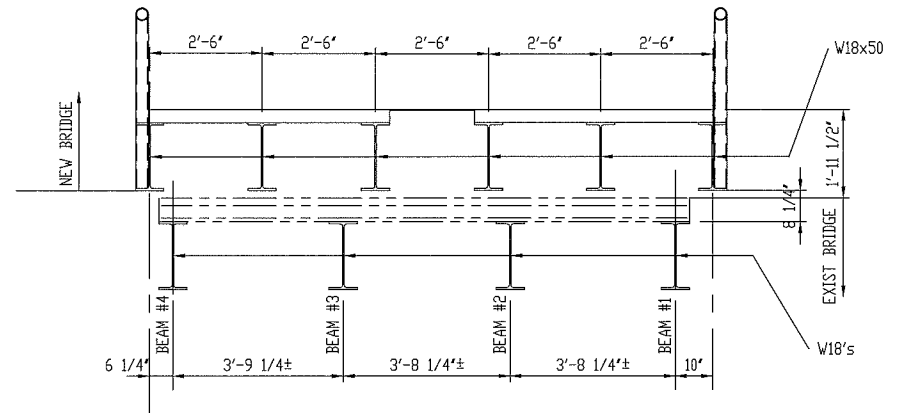
SECTION B-B

4. The “Air Bridge” was supported on the existing bridge at each end by two (2) 7” W x 2” H white oak planks (See Section A-A and Detail 1 on Tt Dwg. S-002). These planks spanned across the width of the bridges as described next. On the upstream and downstream sides on the northwestern end of the bridge the oak planks extend to the centerlines of the outermost W18x50’s of the “Air Bridge” (See Section A-A and Detail 1 on Tt Dwg. S-002, Section C-C on Tt Dwg. S-003 and Photograph 6). On the downstream side on the southeastern end of the bridge the oak planks did not extend to the outermost W18x50 of the “Air Bridge” (See Section A-A and Detail 2 on Tt Dwg. S-002, Section D-D on Tt Dwg. S-003 and Photographs 7 and 8), leaving the downstream, southeastern outermost W18x15 unsupported. The interior four (4) W18x50 beams appear to be supported by the oak planks. It could not be determined if the oak planks support the outermost upstream side W18x50 as that section was buried.
