Historic Resource Survey Form

HISTORIC NAME Duffy Farm; Greenawalt Farm

CURRENT/COMMON NAME Lower Farm Ruin (Site 36Da235)

Organization/Company Heberling Associates, Inc.

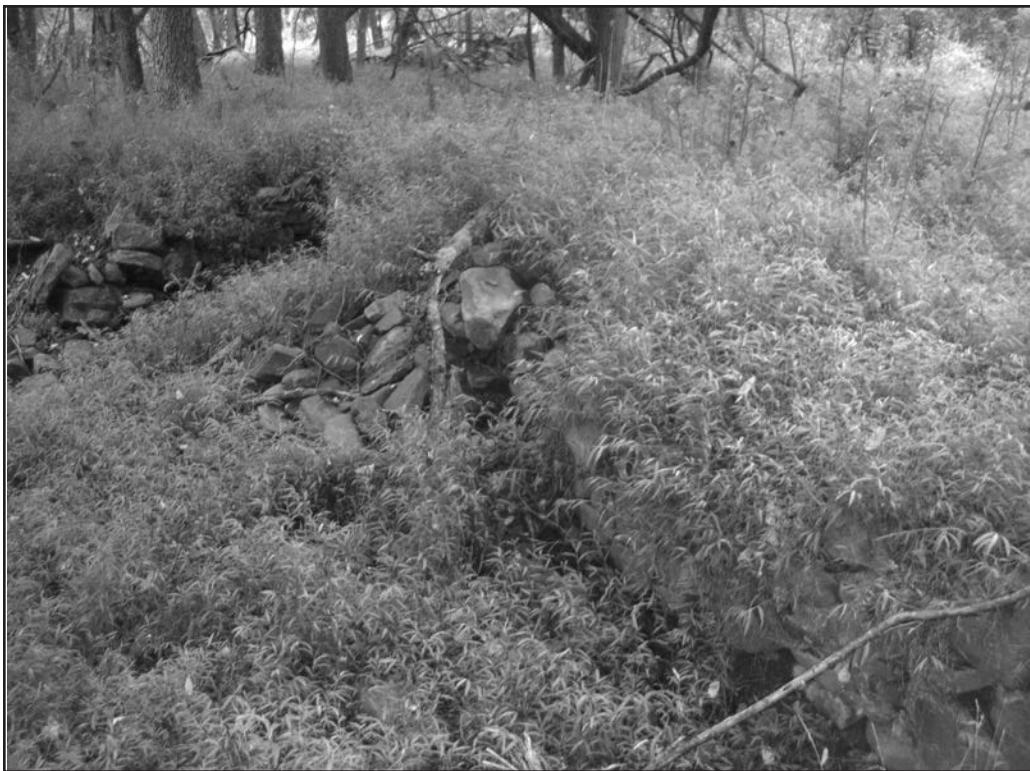
Although part of an integrated farming system, the house yard, located north of the barnyard, is a distinct cluster of resources. Although initially serving a domestic function, the elements in this cluster reflect its conversion and use as an office and bunkhouse, supporting the workers who operated the labor-intensive tobacco farm. The fully excavated foundation, a mix of larger filler stones and dressed dry laid horizontal stone, is between 3 and 5.7 ft deep (Photos 1-2). The cellar is now filled with dirt, rubble, and other fill (Photo 3). The extant foundation, 32 ft wide and 26 ft deep, outlines what was the core of the original mansion house. Collapsed in the southeastern corner and compromised elsewhere, it is pierced on the southern side of the western elevation by a cellar door, a broken lintel stone being one of the only intact architectural elements aside from a poured concrete porch stair that once served a shed porch, found amid the ruins (Photo 4-5). A rubble pile at the northern end of the cellar may have served as a hearth foundation. There is no trace of a rear wing foundation.

Photo 3: Duffy Farm; Greenawalt Farm, Middletown, Londonderry Twp., Dauphin County. Detailed view of the house foundation, facing northwest.

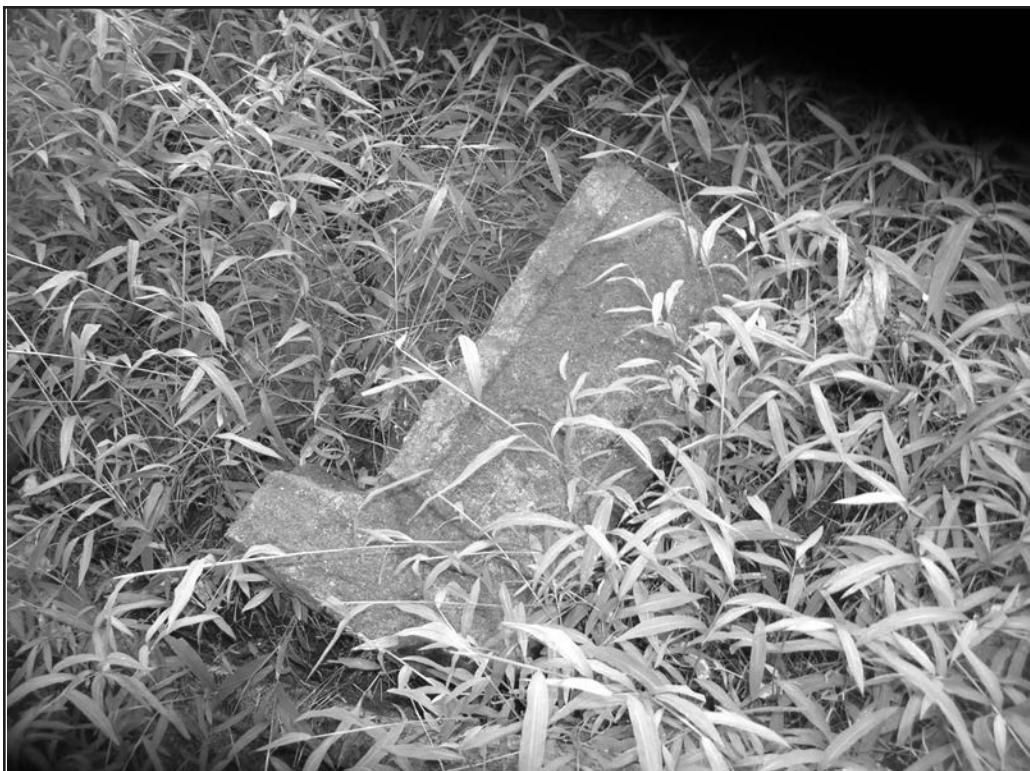
Photo 4: Duffy Farm; Greenawalt Farm, Middletown, Londonderry Twp., Dauphin County. Detailed view of the stone lintel, facing west.

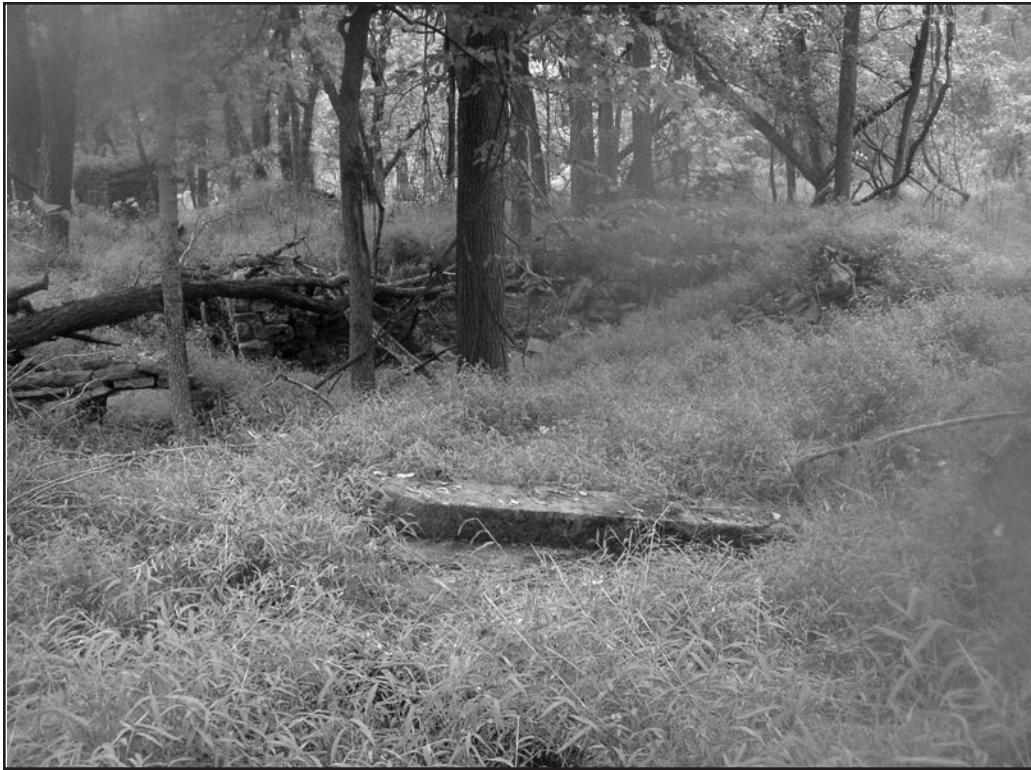
Photo 5: Duffy Farm; Greenawalt Farm, Middletown, Londonderry Twp., Dauphin County. View of the porch step and house foundation, facing northwest.

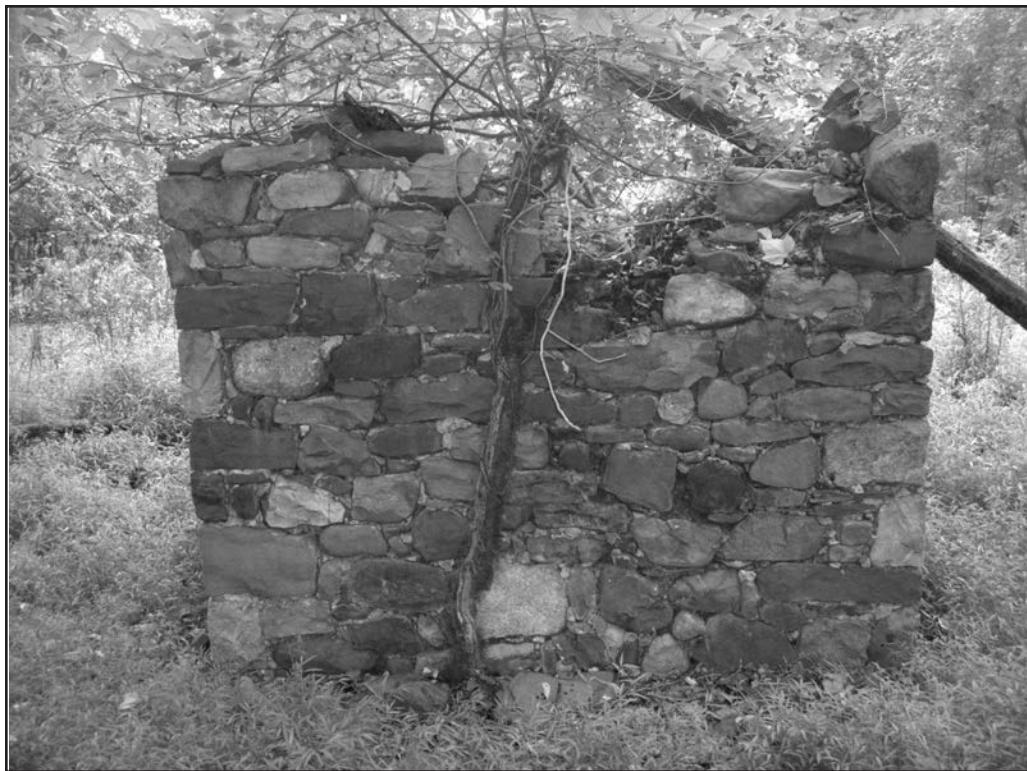
The ruins of a stone smokehouse are located at the western edge of what was the house yard (Photo 6). The 9.3 ft square structure was, like the other buildings, constructed of an array of cobblestone, with cut stone lining the 3 ft wide central portal and small flue portal on the rear (western) elevation (Photo 7). The walls, 1.5 ft thick, extend approximately 7 ft from ground level. Decayed and collapsed roof joists that once supported a gable front roof rest on the top of the extant walls. A second major element, the ruins of a washhouse, is located at the northern edge of the house yard (Photo 8). The ruined structure, filled with rubble, features a 1.5 ft wide stone foundation that is 10.5 ft long, 7.4 ft deep, and opens on the south side (Photo 9). A ruin of undetermined function is located in the center of the house yard. The roughly 6 ft square pile of stone, soil, and other fill is located between the ruins of the smokehouse, well, and washhouse.

Photo 7: Duffy Farm; Greenawalt Farm, Middletown, Londonderry Twp., Dauphin County. View of the smokehouse, facing south.

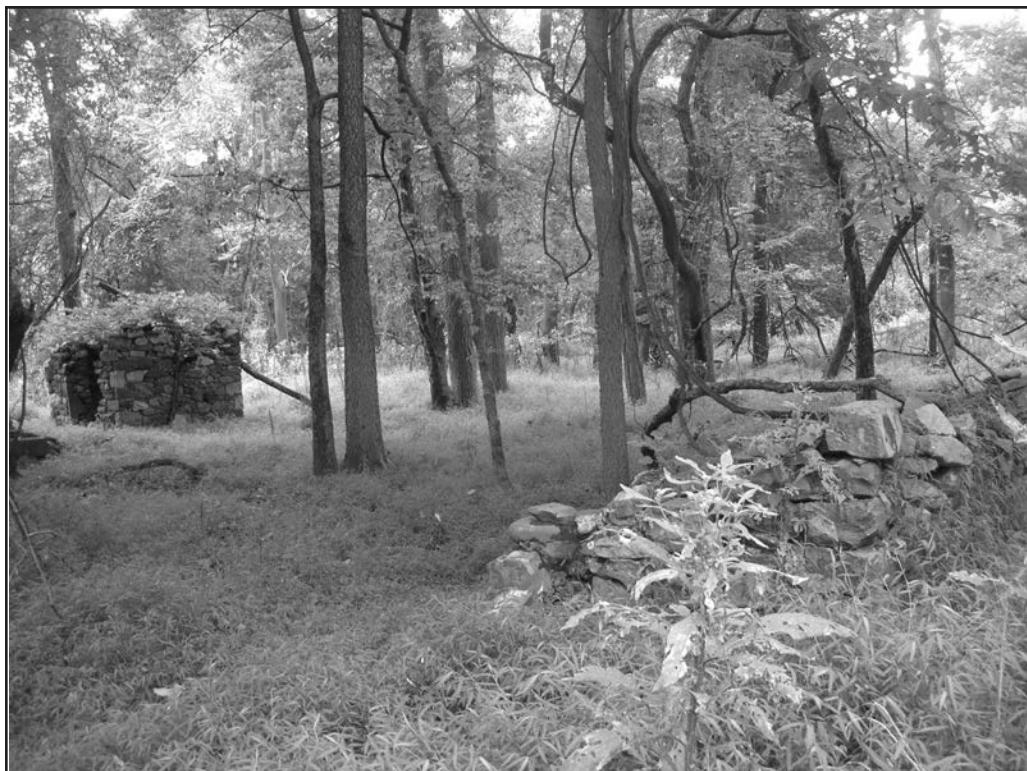
Photo 8: Duffy Farm; Greenawalt Farm, Middletown, Londonderry Twp., Dauphin County. View of the washhouse and smokehouse, facing southwest.

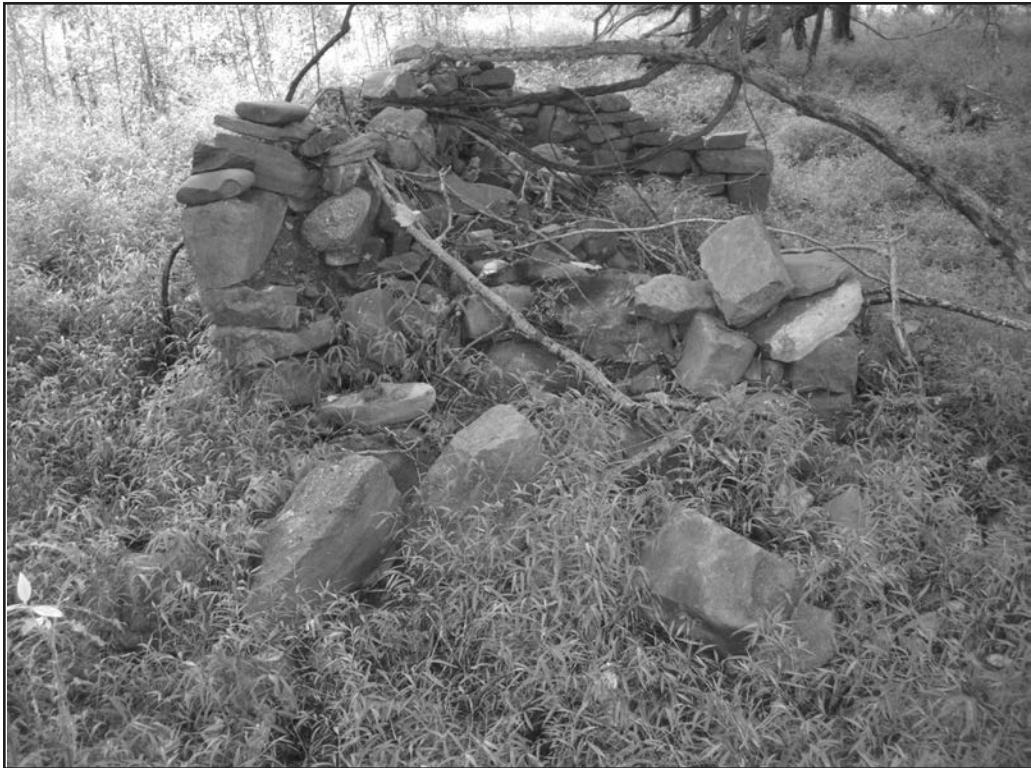
Photo 9: Duffy Farm; Greenawalt Farm, Middletown, Londonderry Twp., Dauphin County. View of the washhouse, facing southeast.

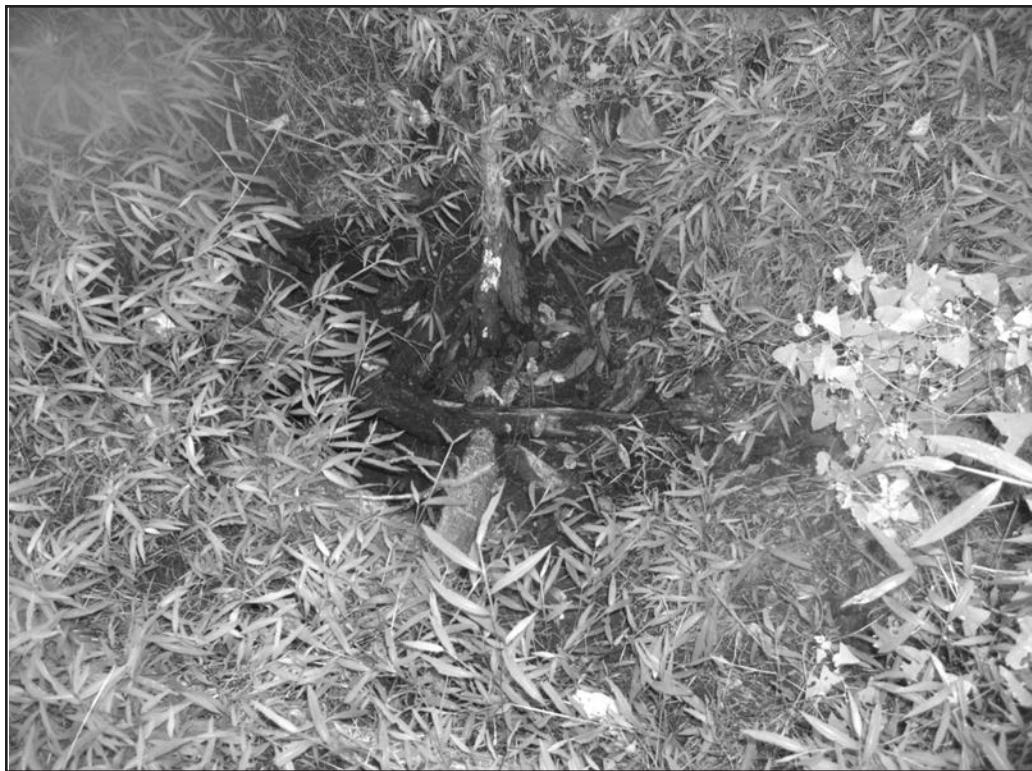
A collapsed well depression is located immediately (10 ft) to the north of the smokehouse (Photo 10). This well is 8 ft in diameter and lined with 8 courses of flat stone. The depression is 3.8 inches deep at its center, and inset with a single 1-inch metal pipe, entering into the well from the northeast. A second well is located to the southeast of the house yard. Smaller than the other wells on the site, the depression is 4.5 ft in diameter and 4 ft deep (Photo 11). This well site is not lined with stone or brick, and there is no evidence of piping.

Photo 11: Duffy Farm; Greenawalt Farm, Middletown, Londonderry Twp., Dauphin County. View of the front yard well, facing east.

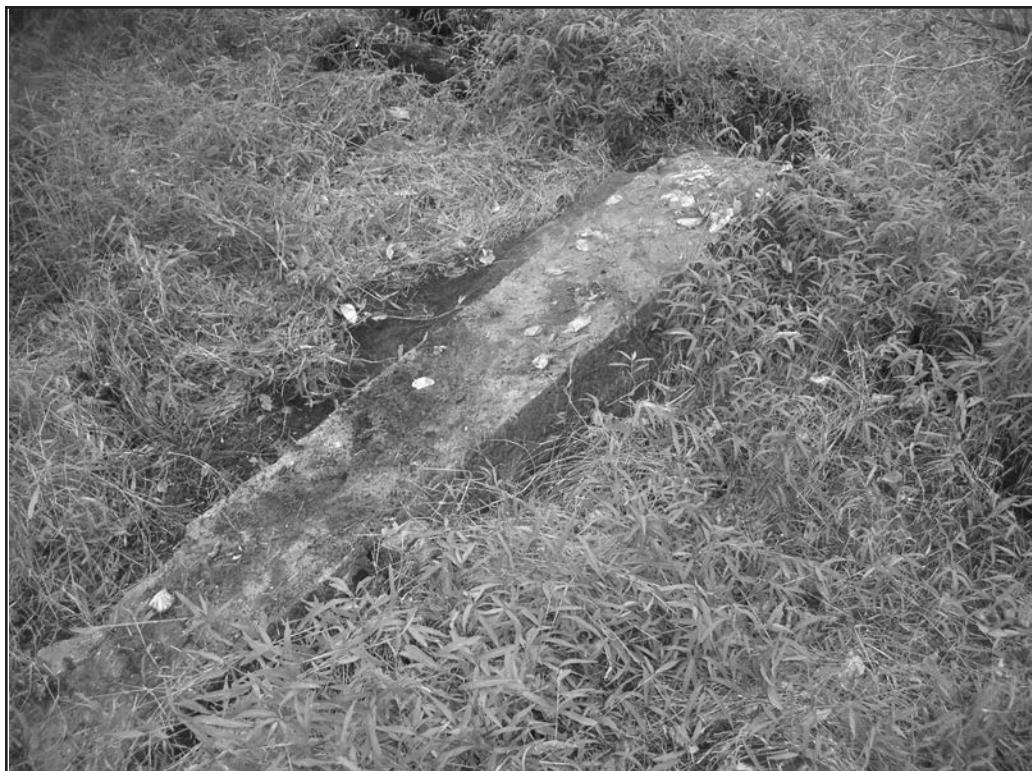
A low foundation ruin is located to the north of the house, retaining only three of its foundation walls. The 6.5 ft wide and 10 ft deep footprint was constructed out of dressed and coursed stone, with some heavy bricks and poured concrete (Photo 12), and may have been a remnant of one of the tobacco barns. Several other low brick foundations, typically 1.5 ft wide and exposed to a depth of 8-10 inches, are found on both the north and south sides of the house yard. An 8 ft long low brick retaining wall, constructed of five courses of brick, was built parallel to a large trough in the ground to its south, serving as a shed foundation, loading platform, or walkway (Photo 13). A pair of large rectangular low brick and concrete foundations are located south the southern elevation of the house foundation. The first, a low wall (20 ft x 60 ft), likely contained the garden (Photo 14), the second, slightly offset and wider (10 ft x 35 ft), may have supported a structure (Photo 15). Neither appears to have been excavated or displays any elements of a superstructure.

Photo 12: Duffy Farm; Greenawalt Farm, Middletown, Londonderry Twp., Dauphin County. View of a concrete foundation, facing north.

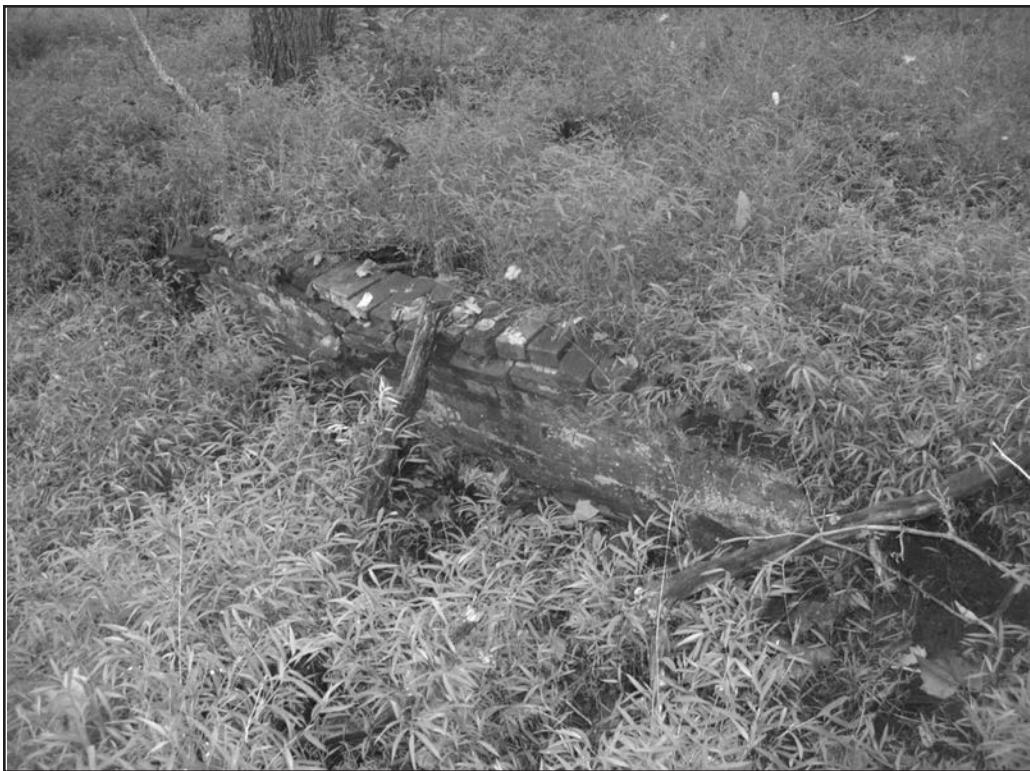
Photo 13: Duffy Farm; Greenawalt Farm, Middletown, Londonderry Twp., Dauphin County. View of a retaining wall, facing southwest.

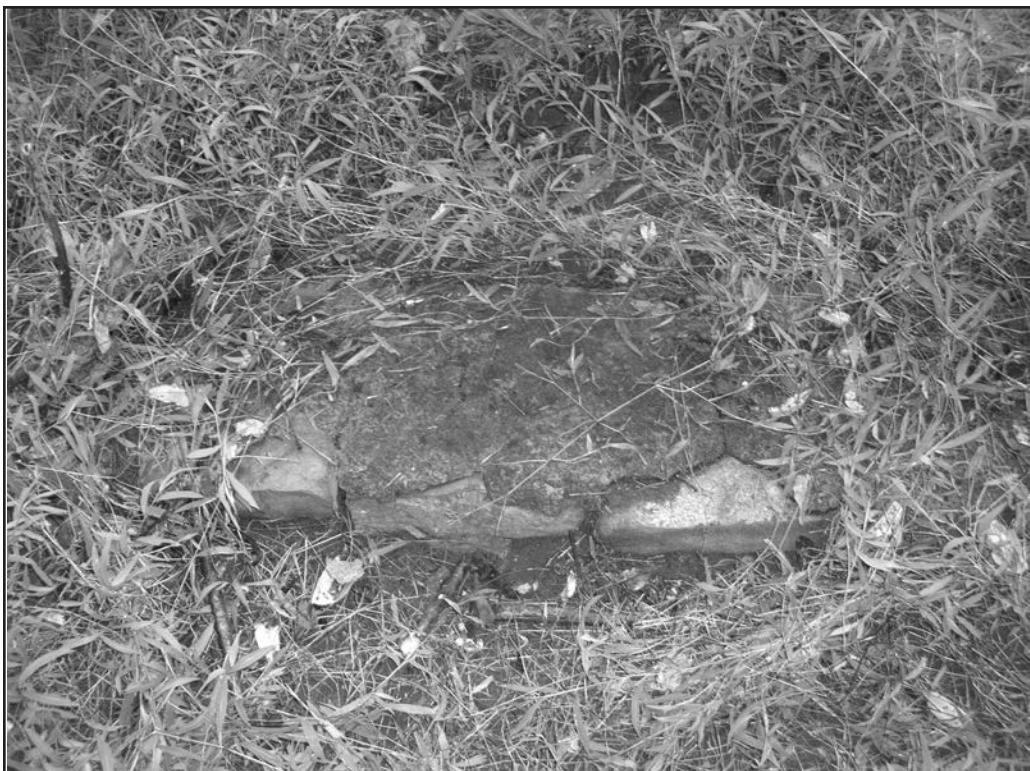
Photo 14: Duffy Farm; Greenawalt Farm, Middletown, Londonderry Twp., Dauphin County. View of a foundation, facing west.

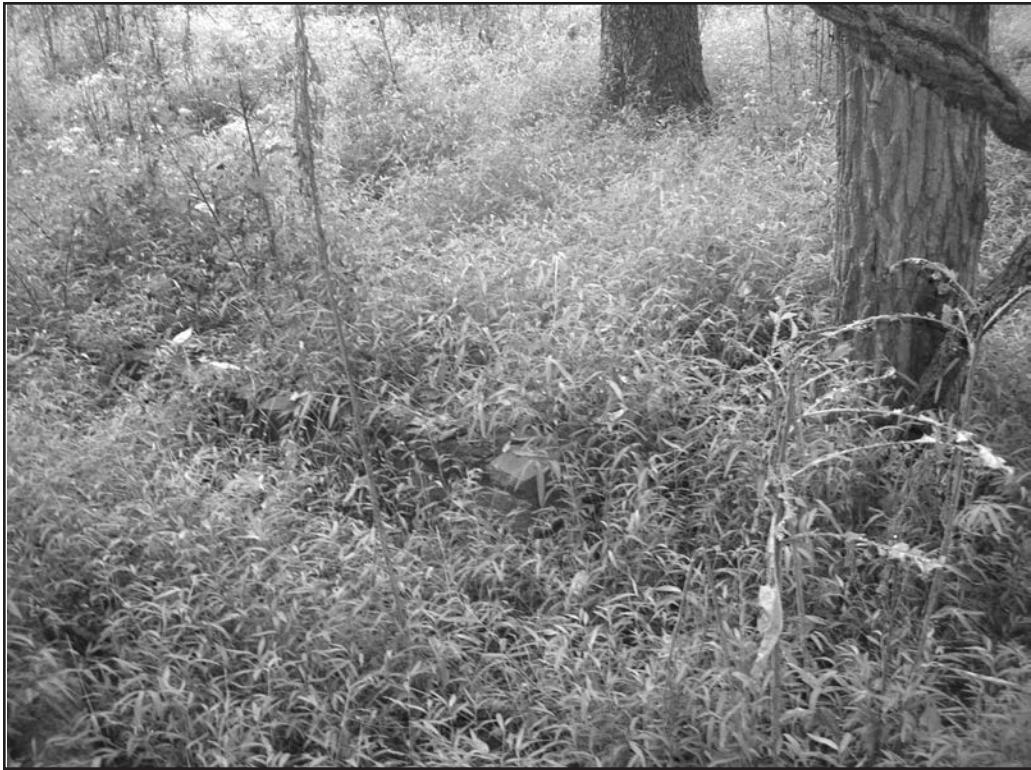
Photo 15: Duffy Farm; Greenawalt Farm, Middletown, Londonderry Twp., Dauphin County. View of a foundation, facing northwest.

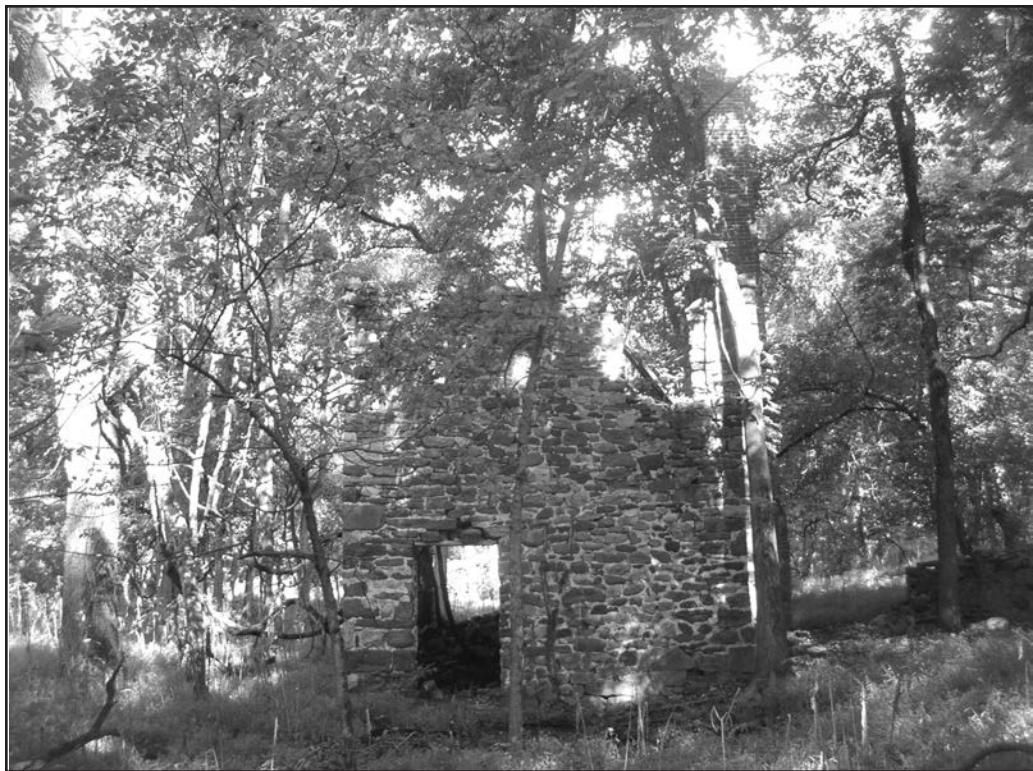
The one and a half story tall engine house structure is roughly 17 ft square. The building ruin rests on an excavated foundation. Like most of the structures on the property, the engine house and mill was constructed of a mix of rounded cobble and cut sandstone, built to a depth of 20 inches (Photo 24 and 25). The stone is set in an irregular arrangement between the heavier dressed cornerstones. The building is pierced on the south side by a large (6.3 ft x 3.5 ft) doorway topped with a heavy wooden lintel. There are two extant window bays, a bay on the first story of the west elevation, retaining a now decayed lintel, and a bay on the south elevation on the second floor (Photo 26). The west side of the second floor retains the outline of a door entry. The interior of the structure reveals something of its use: the interior is ringed by three bands of wood and small shelves built into the wall and the anchors for 11 joists that once ran from east to west. The northern corner of the eastern elevation is pierced by a brick lined portal that vented what may have been a boiler used to power a steam engine on the ground floor. Only the first floor of the interior was finished with cement stucco. Notably, piping built into a brick lined portal into a now collapsed cellar is located at the base of the southern elevation, in a relationship with a nearby well.

Photo 24: Duffy Farm; Greenawalt Farm, Middletown, Londonderry Twp., Dauphin County. View of the engine house, facing north.

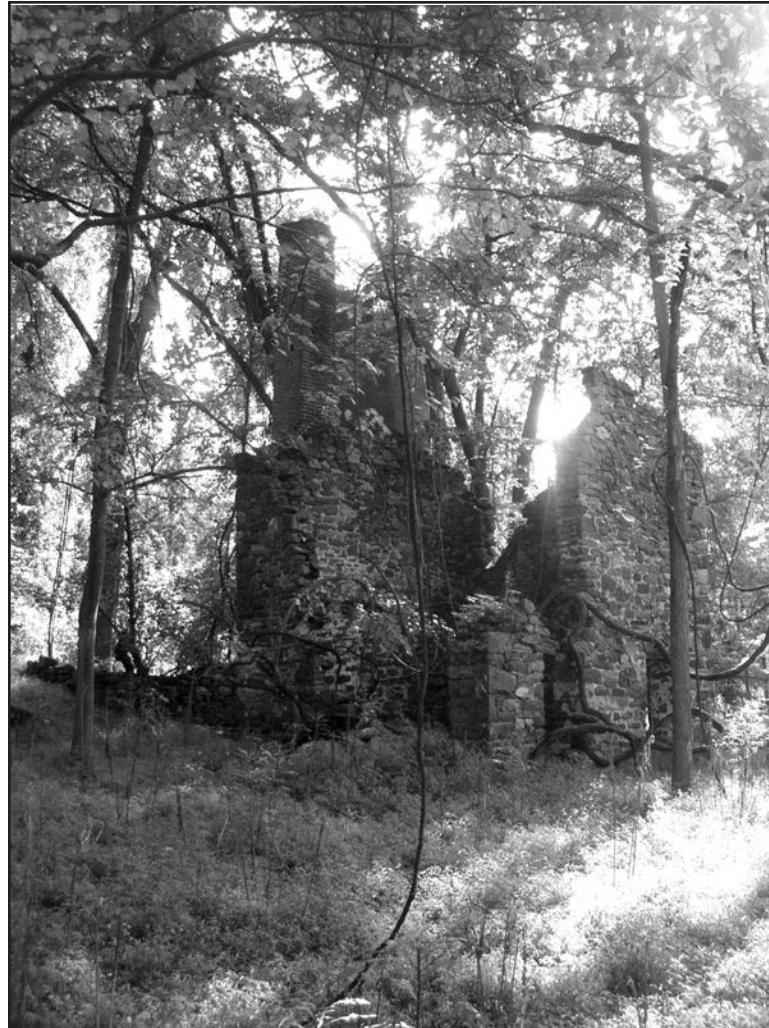
Photo 25: Duffy Farm; Greenawalt Farm, Middletown, Londonderry Twp., Dauphin County. View of the engine house, facing south.

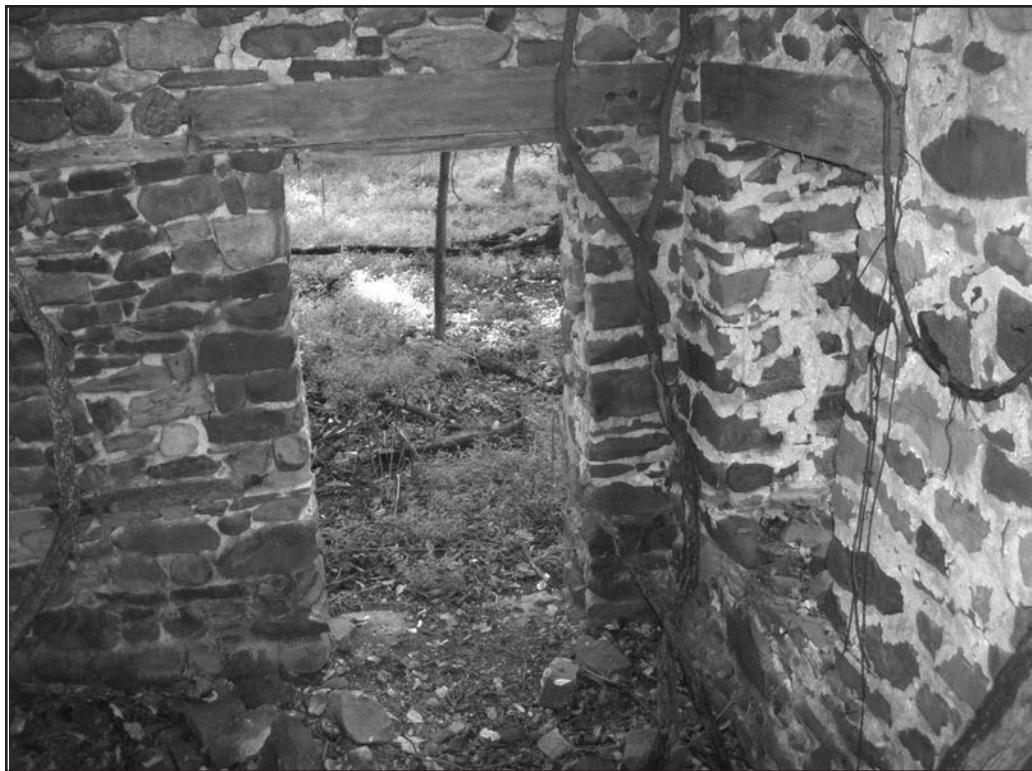
Photo 26: Duffy Farm; Greenawalt Farm, Middletown, Londonderry Twp., Dauphin County. Detail view of the engine house interior, facing south.

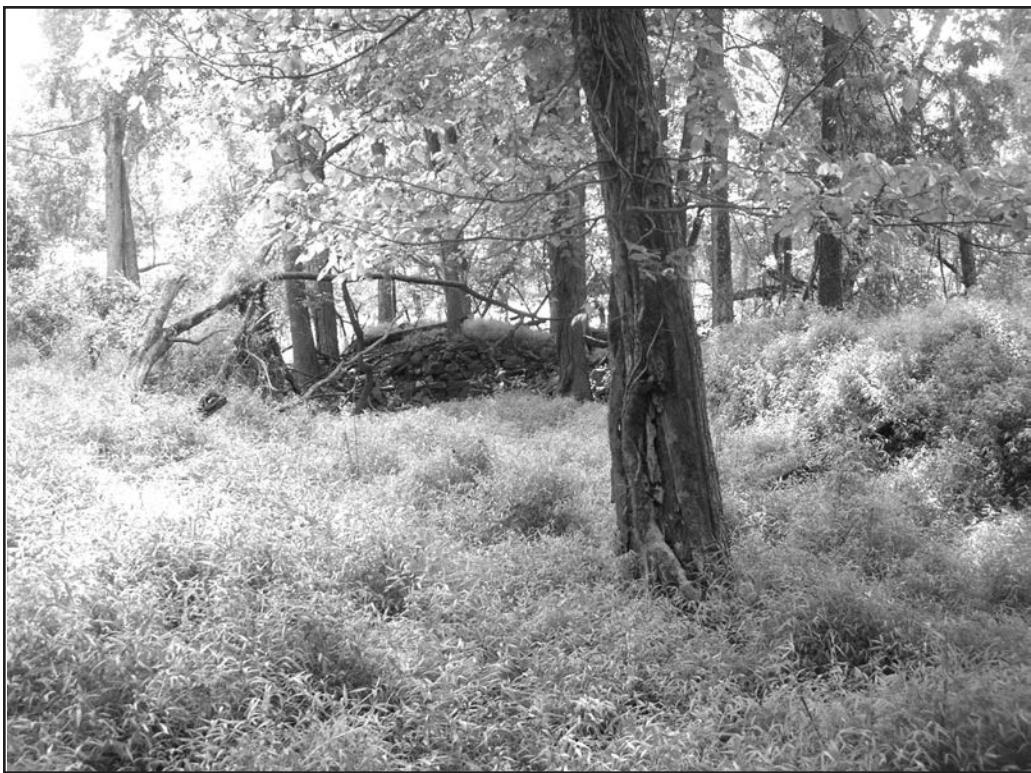
the cut stone and cobble mix (Photo 30). The outline of the structure is truly massive, 106 ft in overall length with southern and northern wing walls extending east for 17 ft and 16 ft respectively (Photo 31). A wall extends at a right angle from the southern wing wall for 13 ft to the south. The wall is 6 ft tall at its greatest depth in the southwestern corner, although stone, earth, and debris have filled much of the cellar.

Photo 31: Duffy Farm; Greenawalt Farm, Middletown, Londonderry Twp., Dauphin County. View of the cellar tobacco barn, facing south.

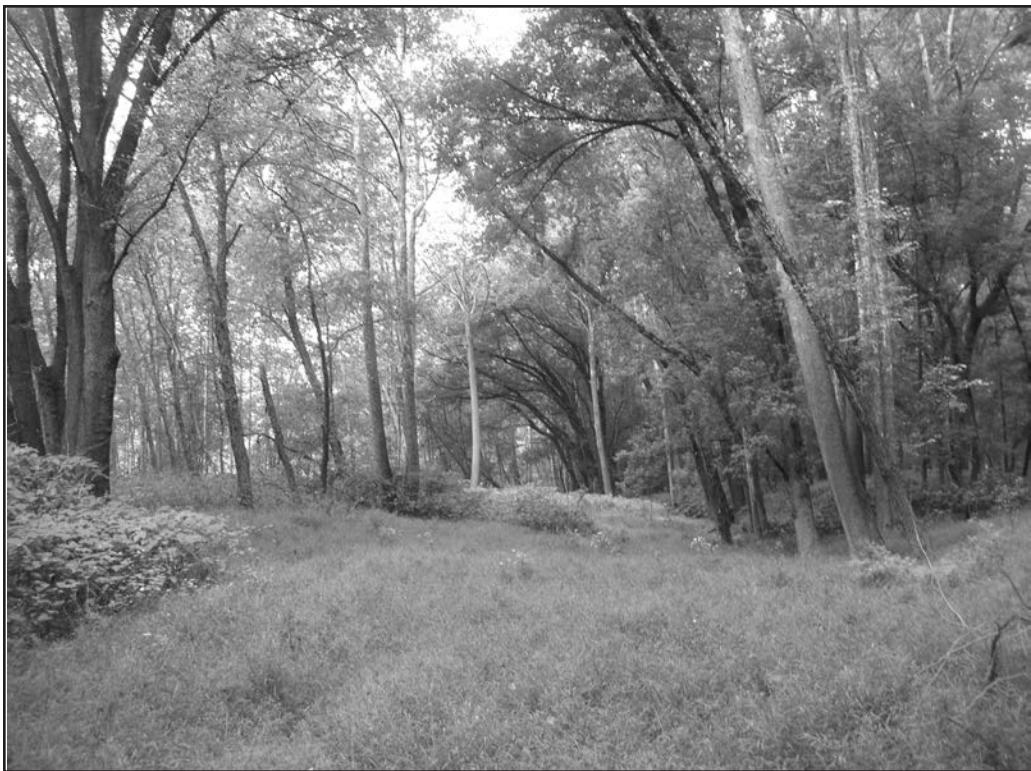
Photo 32: Duffy Farm; Greenawalt Farm, Middletown, Londonderry Twp., Dauphin County. View of the levee and roadway, facing south.
