Date(s) of Inspection: **10/11/22** TV  PA  SM  GP  NM  MEGA  Permit #(s): \_\_\_\_\_ Expiration Date: \_\_\_\_\_ Case #: \_\_\_\_\_ PF ID #: **851121**

Company Name: **Hanson Aggregates LLC** Municipality: **East Rockhill Twp** County: **Bucks**

Plant Name: **East Rockhill Quarry** Physical Location: **2105 N. Rockhill Rd, Sellersville, PA 18960** Federal ID - Plant Code #: \_\_\_\_\_

**10/11/22 Hanson East Rockhill Quarry AQ Sampling Photos**

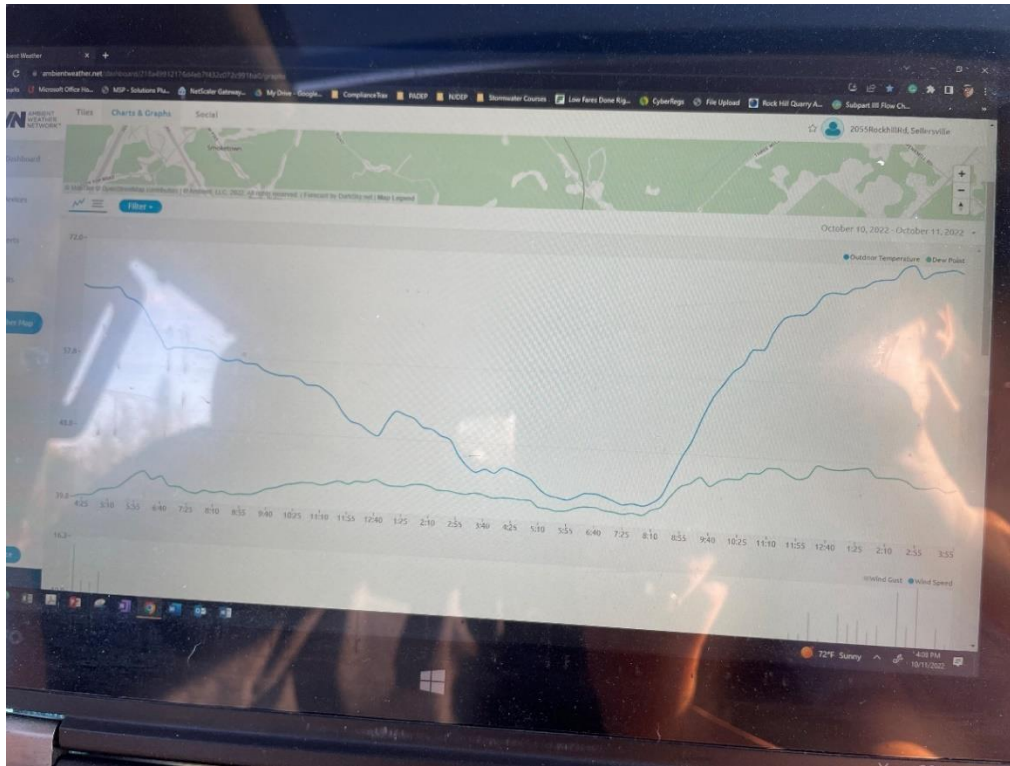
Computer screenshot of autonomous weather recording station onsite displaying temperature and dew point for the past 24 hours - 10/11/22, 4:08 PM

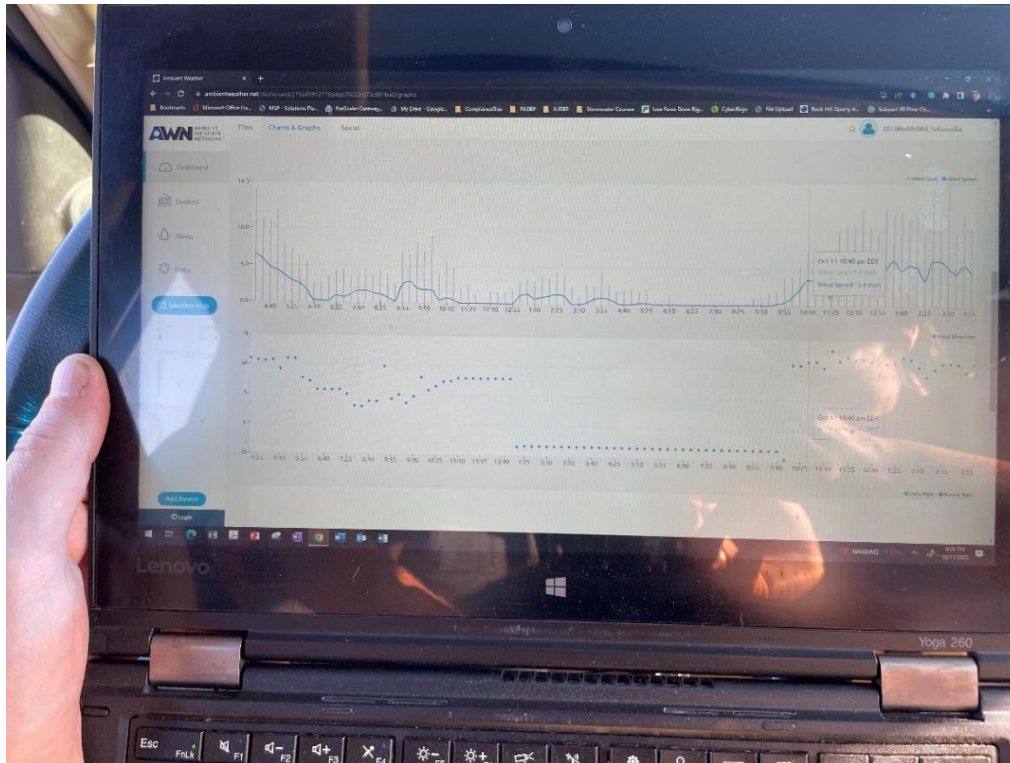
Computer screenshot of autonomous weather recording station onsite displaying wind gust, wind speed, and wind direction for the past 24 hours - 10/11/22, 4:09 PM

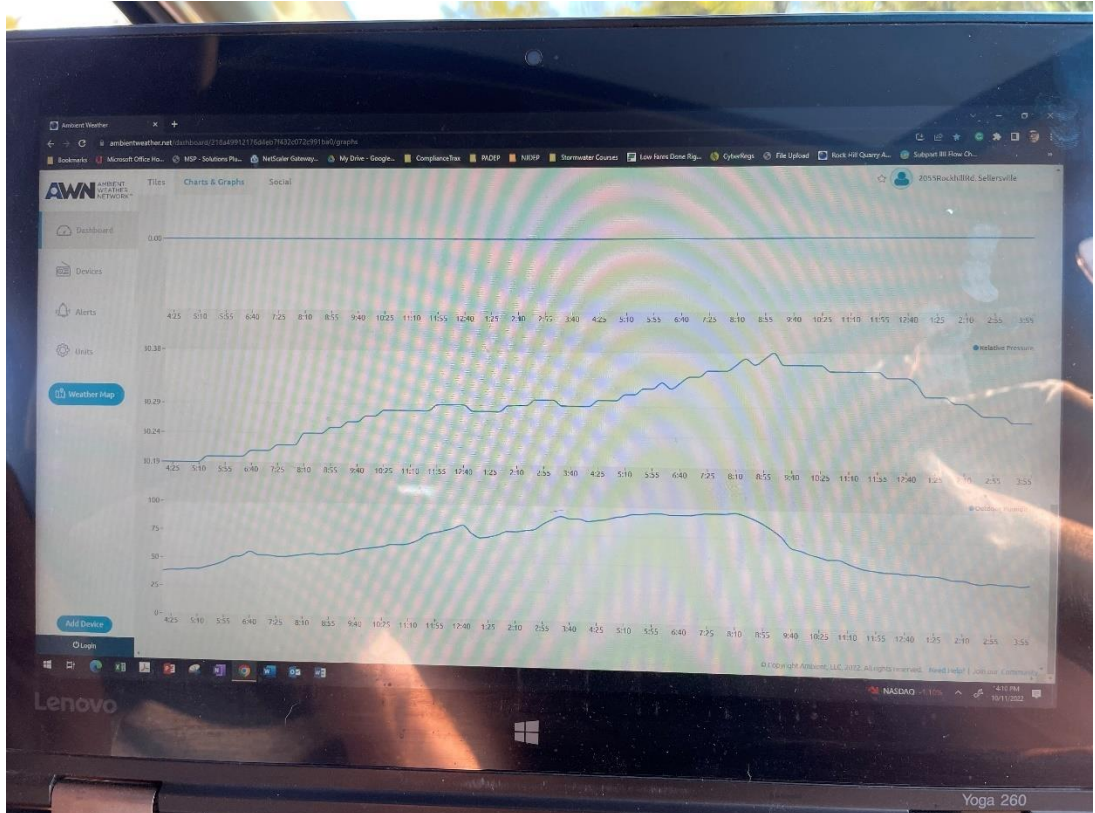
Computer screenshot of autonomous weather recording station onsite displaying hourly rain, relative pressure, and humidity for the past 24 hours - 10/11/22, 4:10 PM
