Building Inspection Results

Client: Environmental Assurance Co., Inc.
 Project: Homer City Power Plant – Coal Silos
 Job Number: EACI-25-27

Date: June 2, 2025
 Inspector: Edgar King
 License Number: **030716**

LIMITED ASBESTOS-CONTAINING BUILDING MATERIALS INSPECTION
HOMER CITY GENERATING STATION SILOS ROOFING

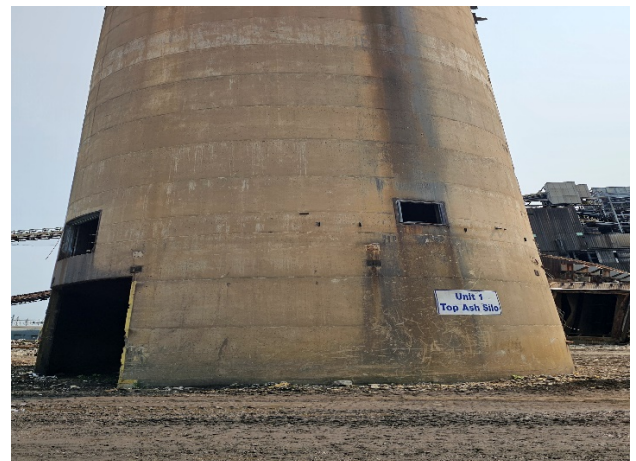
Photo 18: UNIT #1 TOP ASH SILO

SAMPLE	LOCATION	DESCRIPTION	APPROX QUANTITY	CONDITION	POTENTIAL FOR DAMAGE	ASBESTOS CONTENT
RF-01	Silo #1 – Around Old Column Areas	Clear Caulking	60 Ln Ft (A)	Poor	High	None
RF-02	Silo #1 – Around Old Column Areas	Clear Caulking	(A)	Poor	High	None
RF-03	NID 1A / 1B / 2A / 2B Lime Silos	Silver / Yellow Rubber Coating on Concrete	Not Quantified	Poor	High	None
RF-04	NID 1A / 1B / 2A / 2B Lime Silos	Silver / Yellow Rubber Coating on Concrete	Not Quantified	Poor	High	None
RF-05	NID 1A / 1B / 2A / 2B Lime Silos	Silver / Yellow Rubber Coating on Concrete	Not Quantified	Poor	High	None
RF-06	By Product Silos 1 and 2	Silver / Yellow Rubber Coating on Concrete	Not Quantified	Poor	High	None
RF-07	By Product Silos 1 and 2	Silver / Yellow Rubber Coating on Concrete	Not Quantified	Poor	High	None
RF-08A	Unit 1 – Top Ash Silo	Black Rolled Roofing	Not Quantified	Poor	High	None
RF-08B	Unit 1 – Top Ash Silo	Beige / Grey Insulation	Not Quantified	Poor	High	None

RF-09	Unit 1 – Top Ash Silo Around Sides	Grey / Brown Flashing	Not Quantified	Poor	High	None

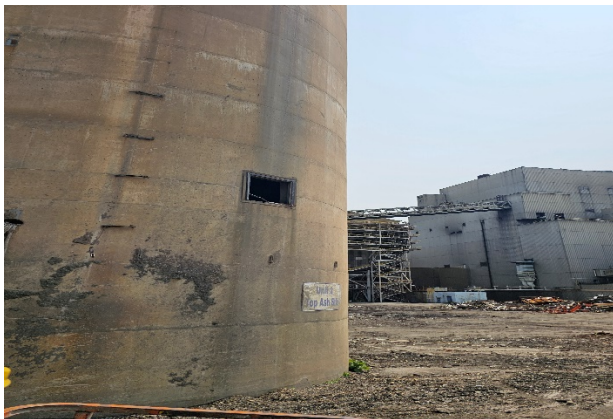
Photo 23: UNIT #2 TOP ASH SILO

SAMPLE	LOCATION	DESCRIPTION	APPROX QUANTITY	CONDITION	POTENTIAL FOR DAMAGE	ASBESTOS CONTENT
RF-10A	Unit 1 – Top Ash Silo	Grey Rubber	Not Quantified	Poor	High	None
RF-10B	Unit 1 – Top Ash Silo	Black Rolled Roofing	Not Quantified	Poor	High	None
RF-11A	Unit 1 – Top Ash Silo Around Sides	Grey Caulking Flashing	Not Quantified	Poor	High	None
RF-11B	Unit 1 – Top Ash Silo Around Sides	Tan Caulking Flashing	Not Quantified	Poor	High	None
RF-12A	Unit 2 – Top Ash Silo	White Rubber	Not Quantified	Poor	High	None
RF-12B	Unit 2 – Top Ash Silo	Black Rolled Roofing	Not Quantified	Poor	High	None
RF-13	Unit 2 – Top Ash Silo	Black Rolled Roofing	Not Quantified	Poor	High	None
RF-14	Unit 2 – Top Ash Silo Around Sides	Black Flashing	Not Quantified	Poor	High	None
RF-15	Unit 2 – Top Ash Silo Around Sides	Black Flashing	Not Quantified	Poor	High	None
