# Effects of Underground Mining in Pennsylvania 6<sup>th</sup> Report 2018-2022

PA Department of Environmental Protection

Bureau of Mining Programs

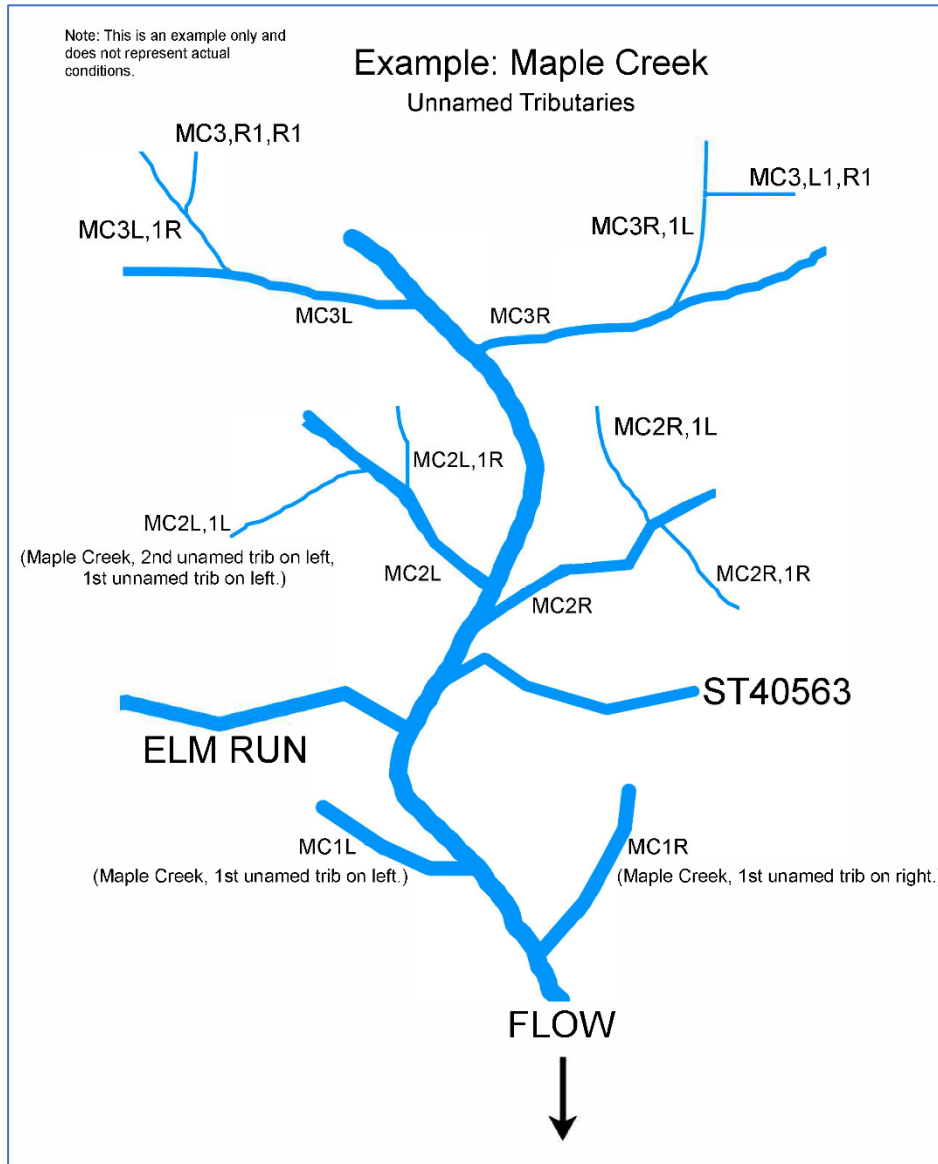
**Figure 1.** Example of stream location designations.

Where the streams/tributaries have no local name, a number designation is given (ST-ID number). The letters “L” and “R” are designations for left and right in navigating the tributaries to the affected area when moving upstream. For example, “LngR-2L, 1L” means Long Run 2nd tributary on the left, then 1st tributary on the left. See Figure 1 as an example of locating the stream segment affected.
