Re: Comments on Report for HDD PA-CH-0127.0000-RD (HDD# S3-0320)

Pursuant to the Corrected Stipulated Order entered on EHB Docket No. 2017-009-L on August 10, 2017 ("Order"), and on behalf of Clean Air Council, Mountain Watershed Association, Inc., and the Delaware Riverkeeper Network ("Appellants"), please accept these comments on Sunoco Pipeline L.P.'s ("Sunoco") re-evaluation report ("Report") for the horizontal directional drilling ("HDD") indicated by drawing number PA-CH-0127.0000-RD (the "HDD Site").

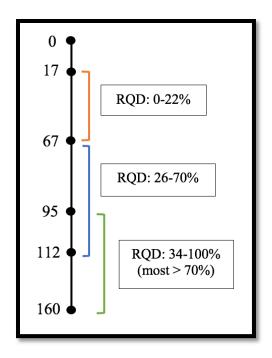
Figure 1 Graph of RQD Results by Depth (bgs) (higher RQD appears to correlate with depth at this site)

Although Sunoco's redesign of for the Site includes deepening the drilling profile, Sunoco has not explained why it has chosen the specific depth it proposes to pass through, or why that depth is preferable to any other depth. At this Site, deeper depths appear to correlate with higher rock integrity with some variability. See Figure 1 Graph of RQD Results by Depth (below). Drilling deeper to access the higher quality and more granite-like material could be a good strategy to avoid inadvertent returns, LOC, and another abandoned pilot hole so long as the appropriate depth is chosen. The Department should require Sunoco to justify the depth of its redesigned profile by contrasting it with the possibility of drilling at other depths.
