## **TRIP REPORT**

### **HOPELAND ROAD VALVE SITE – INFILTRATION TESTING**

**Table 1**  
**Summary of Infiltration Test Results**  
**Hopeland Road Valve**  
**Heidelberg Township, Lebanon County, PA**  
**Sunoco PPP**

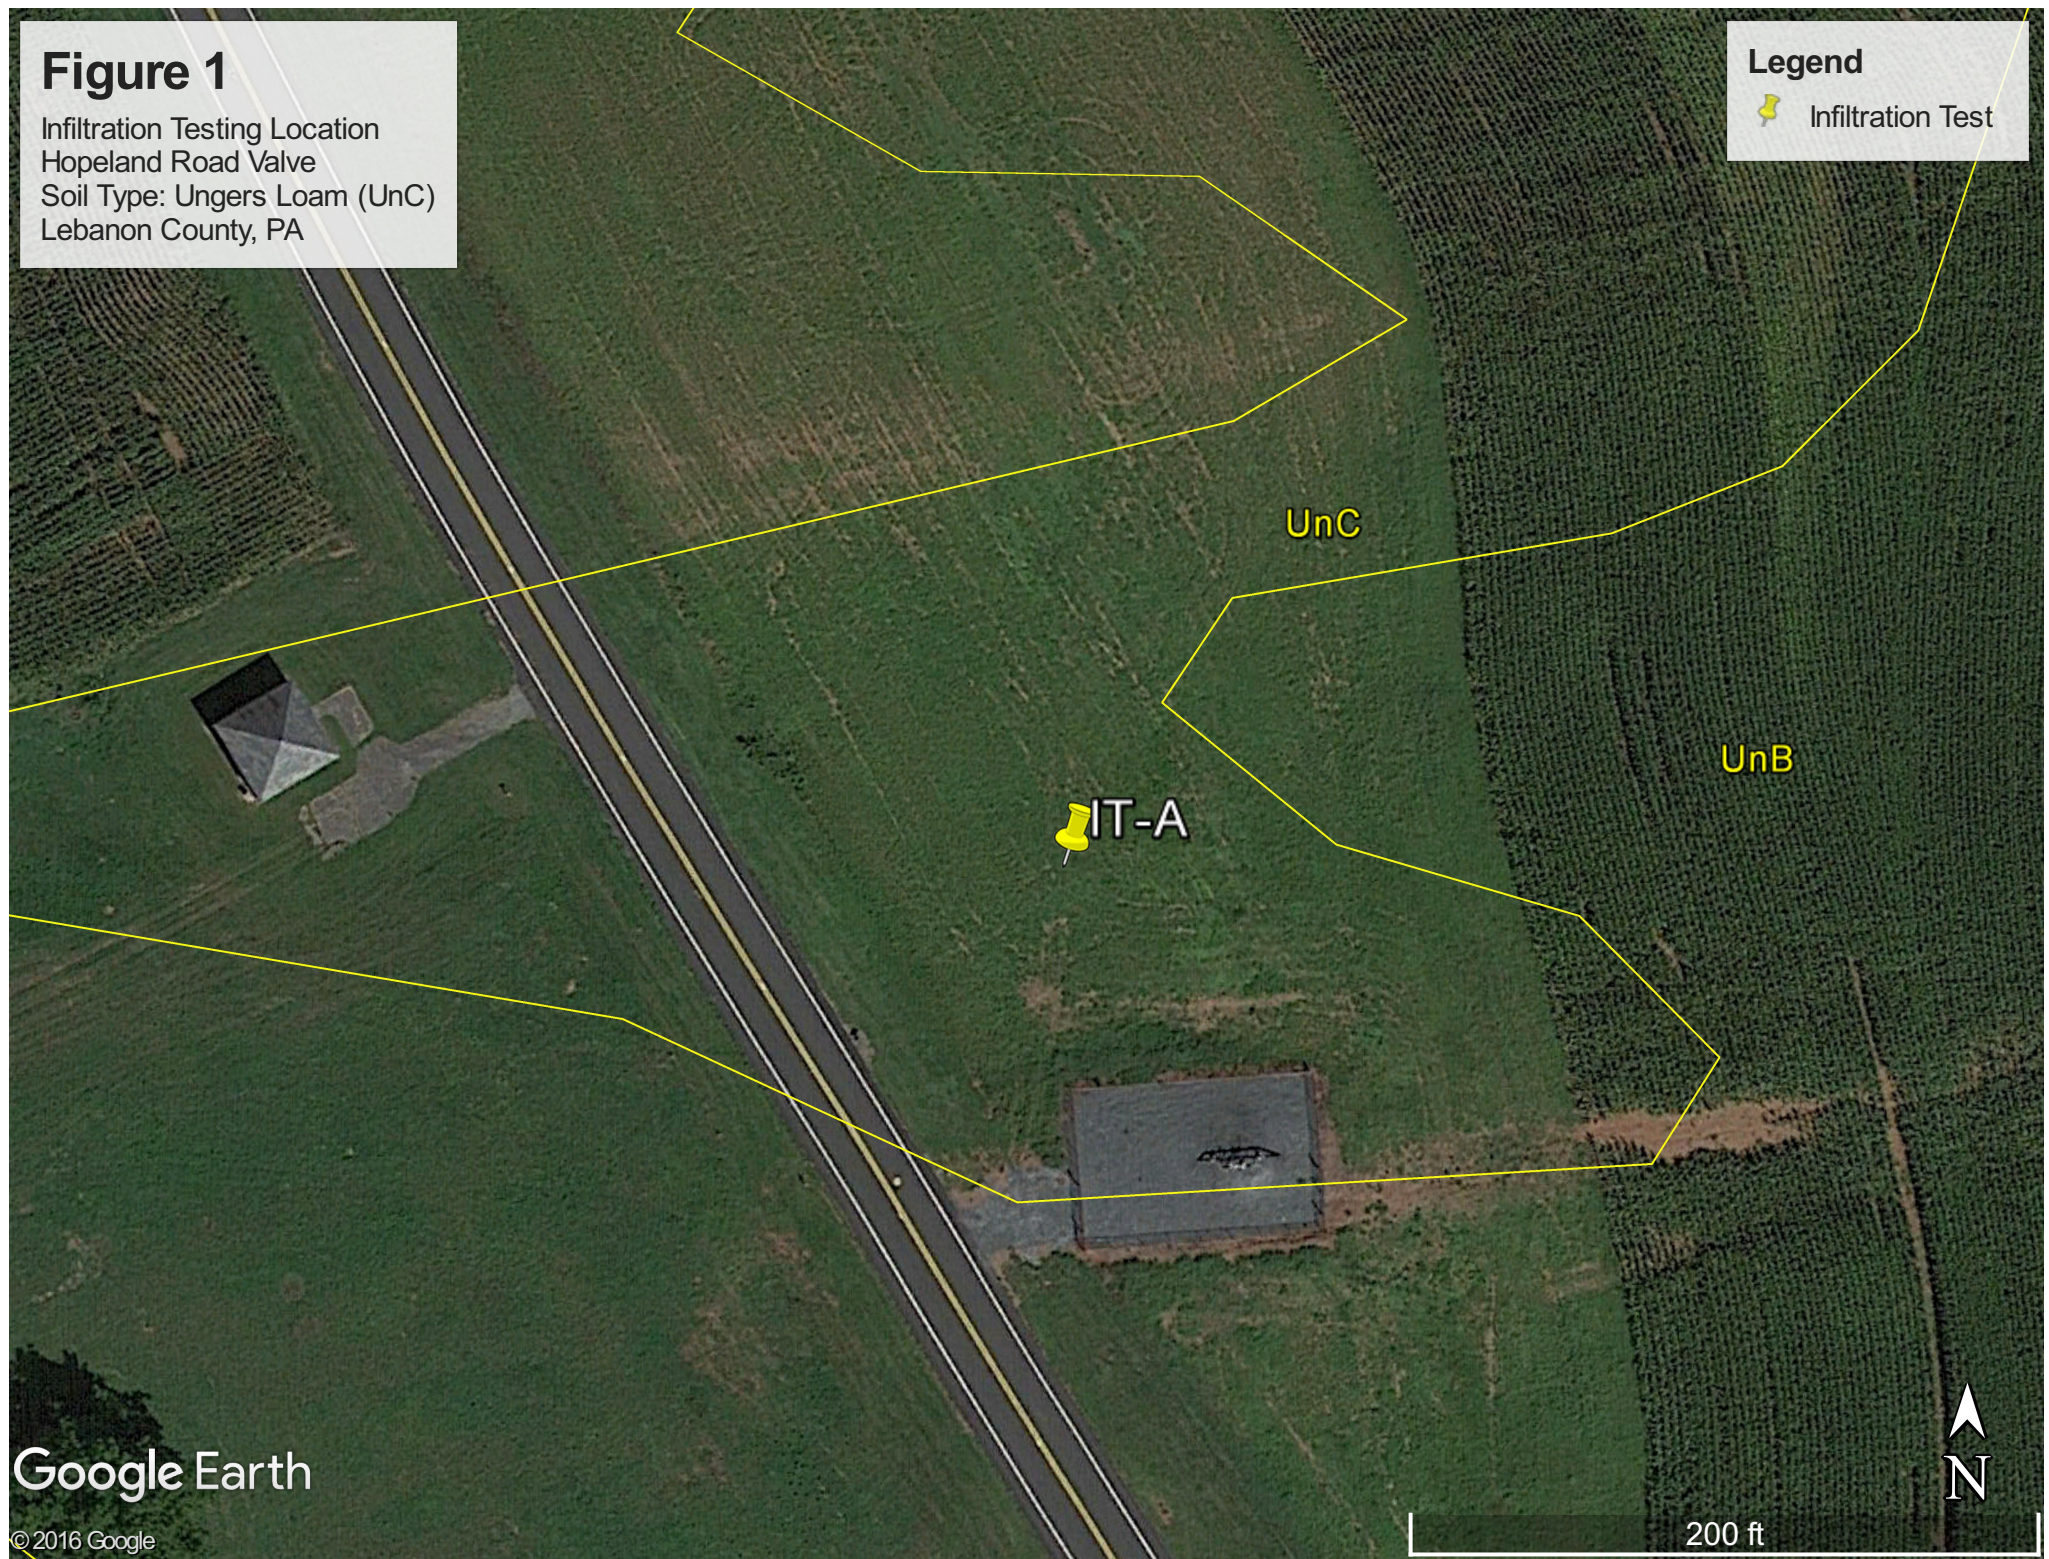
Infiltration Test

Infiltration Testing Location  
Hopeland Road Valve  
Soil Type: Ungers Loam (UnC)  
Lebanon County, PA

This Trip Report presents the field data and results of double-ring soil infiltration tests conducted to support the design of a stormwater management system at the Hopeland Road Valve site located in Heidelberg Township, Lebanon County, Pennsylvania, as part of the Pennsylvania Pipeline Project (PPP) for Sunoco Pipeline, LP. One shallow test (IT-A) was performed at the site. The test location is listed by coordinates (latitude and longitude) in Table 1 and shown on the attached figure.
