Please accept the following comments in response to the HDD Reevaluation Report submitted by Sunoco Pipeline, L.P. for DEP Permit number E15-862, HDD Reference number PA-CH-0199.0000 filed on October 9, 2020.

Figure 7: Geophysical Survey Results Summary

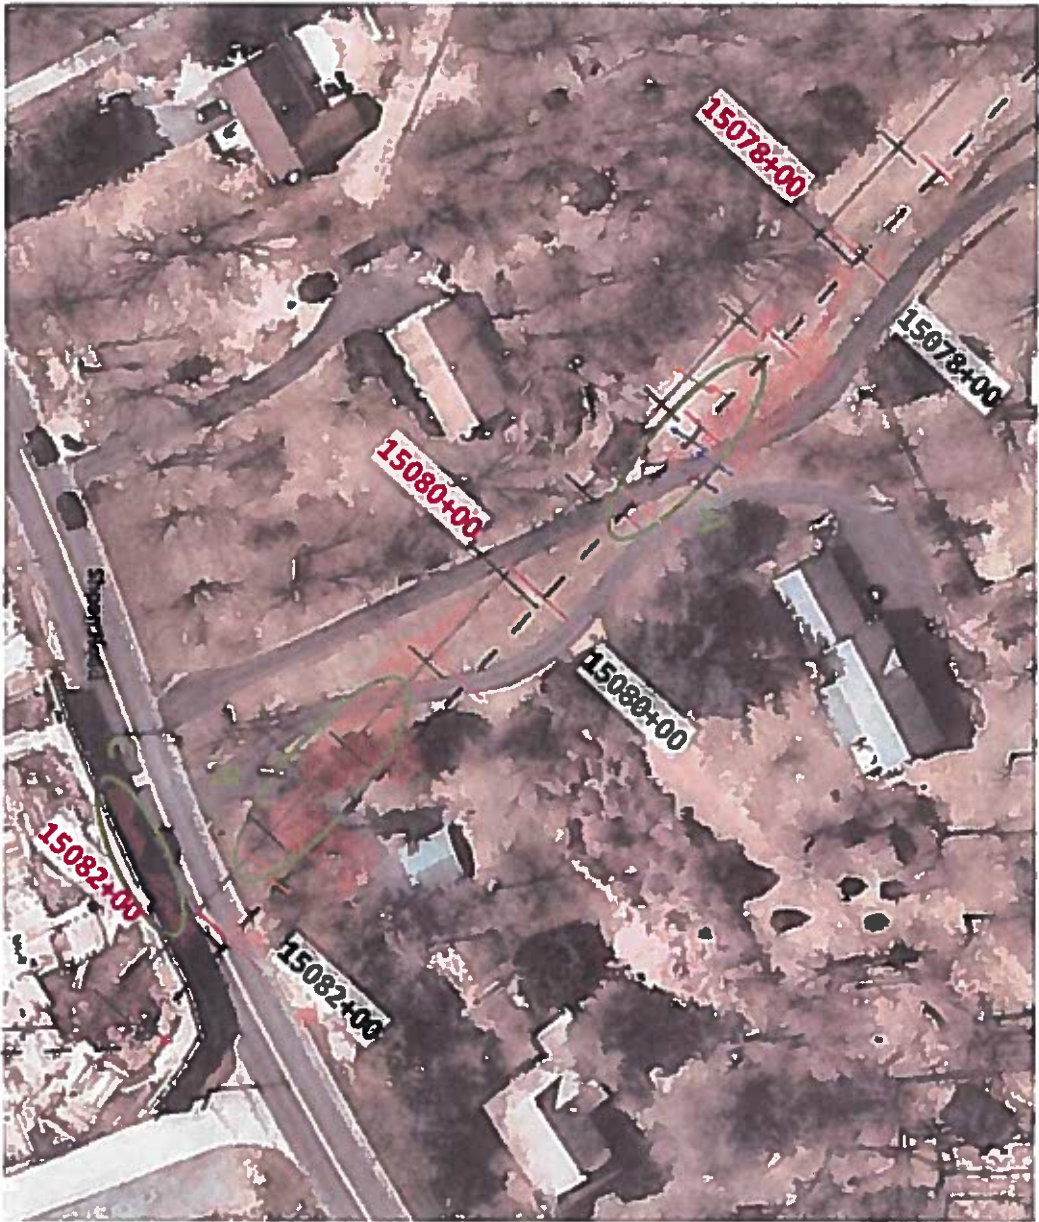
Notes:
 Basemap from Mapmap, January 2020.
 Survey profiles/stations from DGPS survey by RETTEW.

- 2D Proposed Pipeline
- 16-inch Pipeline & Station Number
- Microgravity Mass Deficiencies
- Possible Fracture Zone Detected By:
- Electrical Imaging
- Seismic MASW
- Seismic Refraction
- Recommended Geotechnical Follow-up

"The geophysical survey results display anomalies along the alignment indicative of fractures that are possible locations for slightly-elevated subsidence hazards. RETTEW recommends further geo-technical investigations in the three areas labeled "A" through "C" as well as continued monitoring of all the anomalous locations as further drilling is conducted in the area. Area "C" is cited for further investigation due to its location beneath the road and proximity to the exit/entry"

In general, the geophysical survey results display anomalies along the alignment indicative of fractures that are possible locations for slightly-elevated subsidence hazards. Figure 7 summarizes the anomalous areas with various colored double-arrows. Overlapping and/or adjacent arrows, and the gravity mass deficiency anomalies (red hachures) indicate the highest risk of subsidence and possible enhanced water migration. The location of these anomalies at the bottom of the hill increase the possibility of water seepage out of the ground rather than increased infiltration into the ground. RETTEW recommends further geo-technical investigations in the three areas labeled "A" through "C" as well as continued monitoring of all the anomalous locations as further drilling is conducted in the area. Area "C" is cited for further investigation due to its location beneath the road and proximity to the exit/entry. The resistivity profiles are consistent with water emerging from the HDD in rock and saturating the soils. The elevated topography (and presumably water table) could provide the hydraulic head that is driving this emergence and seepage.
