Re: Reevaluation Report  
Norfolk Southern Railroad Crossing (S1B-0250)  
Permit No. E65-973  
Penn Borough, Jeanette, and Hempfield Townships, Westmoreland County

**ATTACHMENT 2**  
**WATER SUPPLY ILLUSTRATION**

**Well Location Map**  
**HDD# PA-WM1-0088.0000-RR**  
**Westmoreland County, PA.**

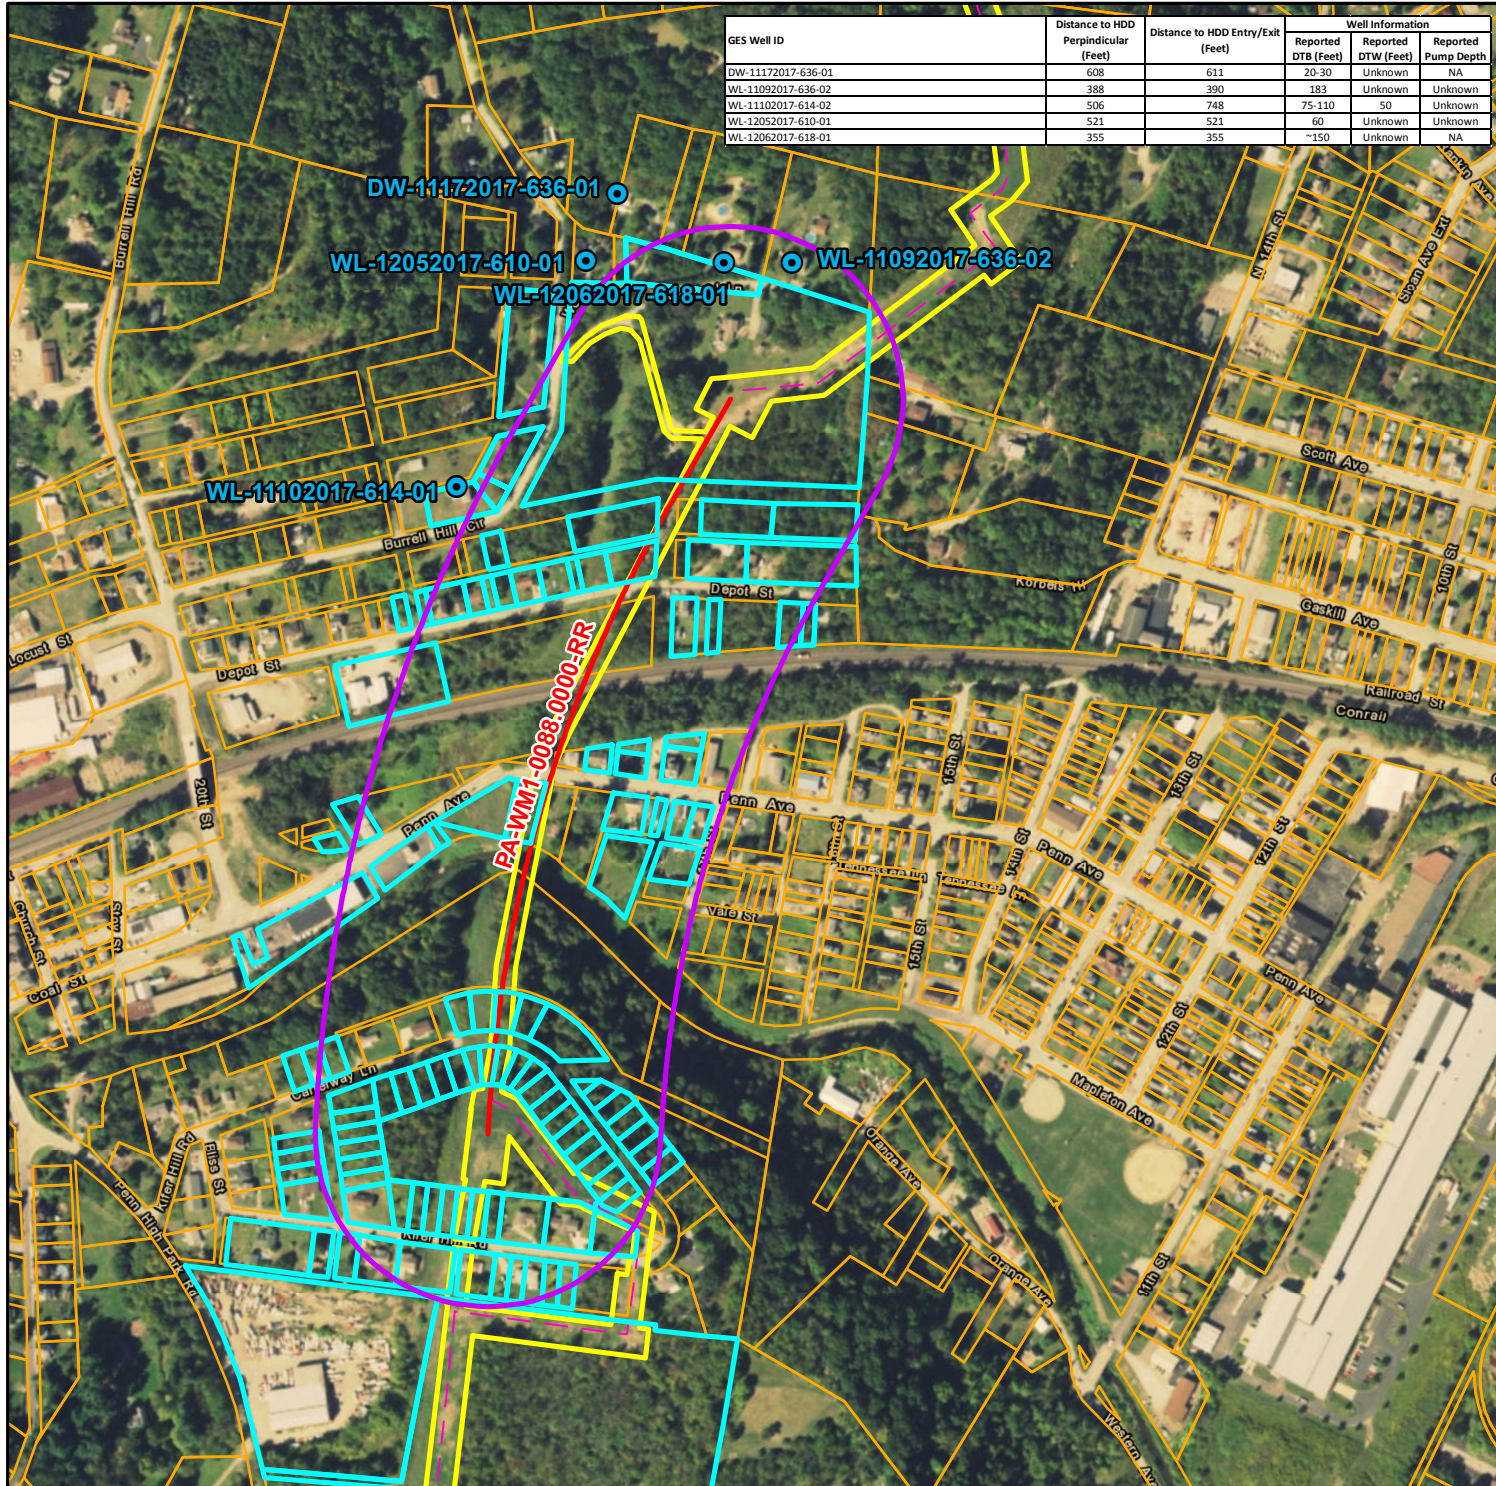
GES Well ID	Distance to HDD Perpendicular (Feet)	Distance to HDD Entry/Exit (Feet)	Well Information		
			Reported DTB (Feet)	Reported DTW (Feet)	Reported Pump Depth
DW-11172017-636-01	608	611	20-30	Unknown	NA
WL-11092017-636-02	388	390	183	Unknown	Unknown
WL-11102017-614-02	506	748	75-110	50	Unknown
WL-12052017-610-01	521	521	60	Unknown	Unknown
WL-12062017-618-01	355	355	~150	Unknown	NA

- LOD
- Parcel
- PPP Centerline
- HDD
- 450 foot buffer of HDD alignment
- Public Water Supply/Landowner Confirmed No Well

**\*\*Testing locations current as of 12/08/2017**
