**Re: SPLP Response to Comments
Hydrogeological Reevaluation Report
Strasburg Road/Bow Tree Drive HDD (S3-0520)
DEP Permit Nos. E15-862
East Goshen Township
Chester County, Pennsylvania**

ATTACHMENT 1
WATER SUPPLY ILLUSTRATION

ATTACHMENT 2
HDD PLAN AND PROFILES, WITH FRACTURE TRACE LINES, AND WELL/WATER
DATA

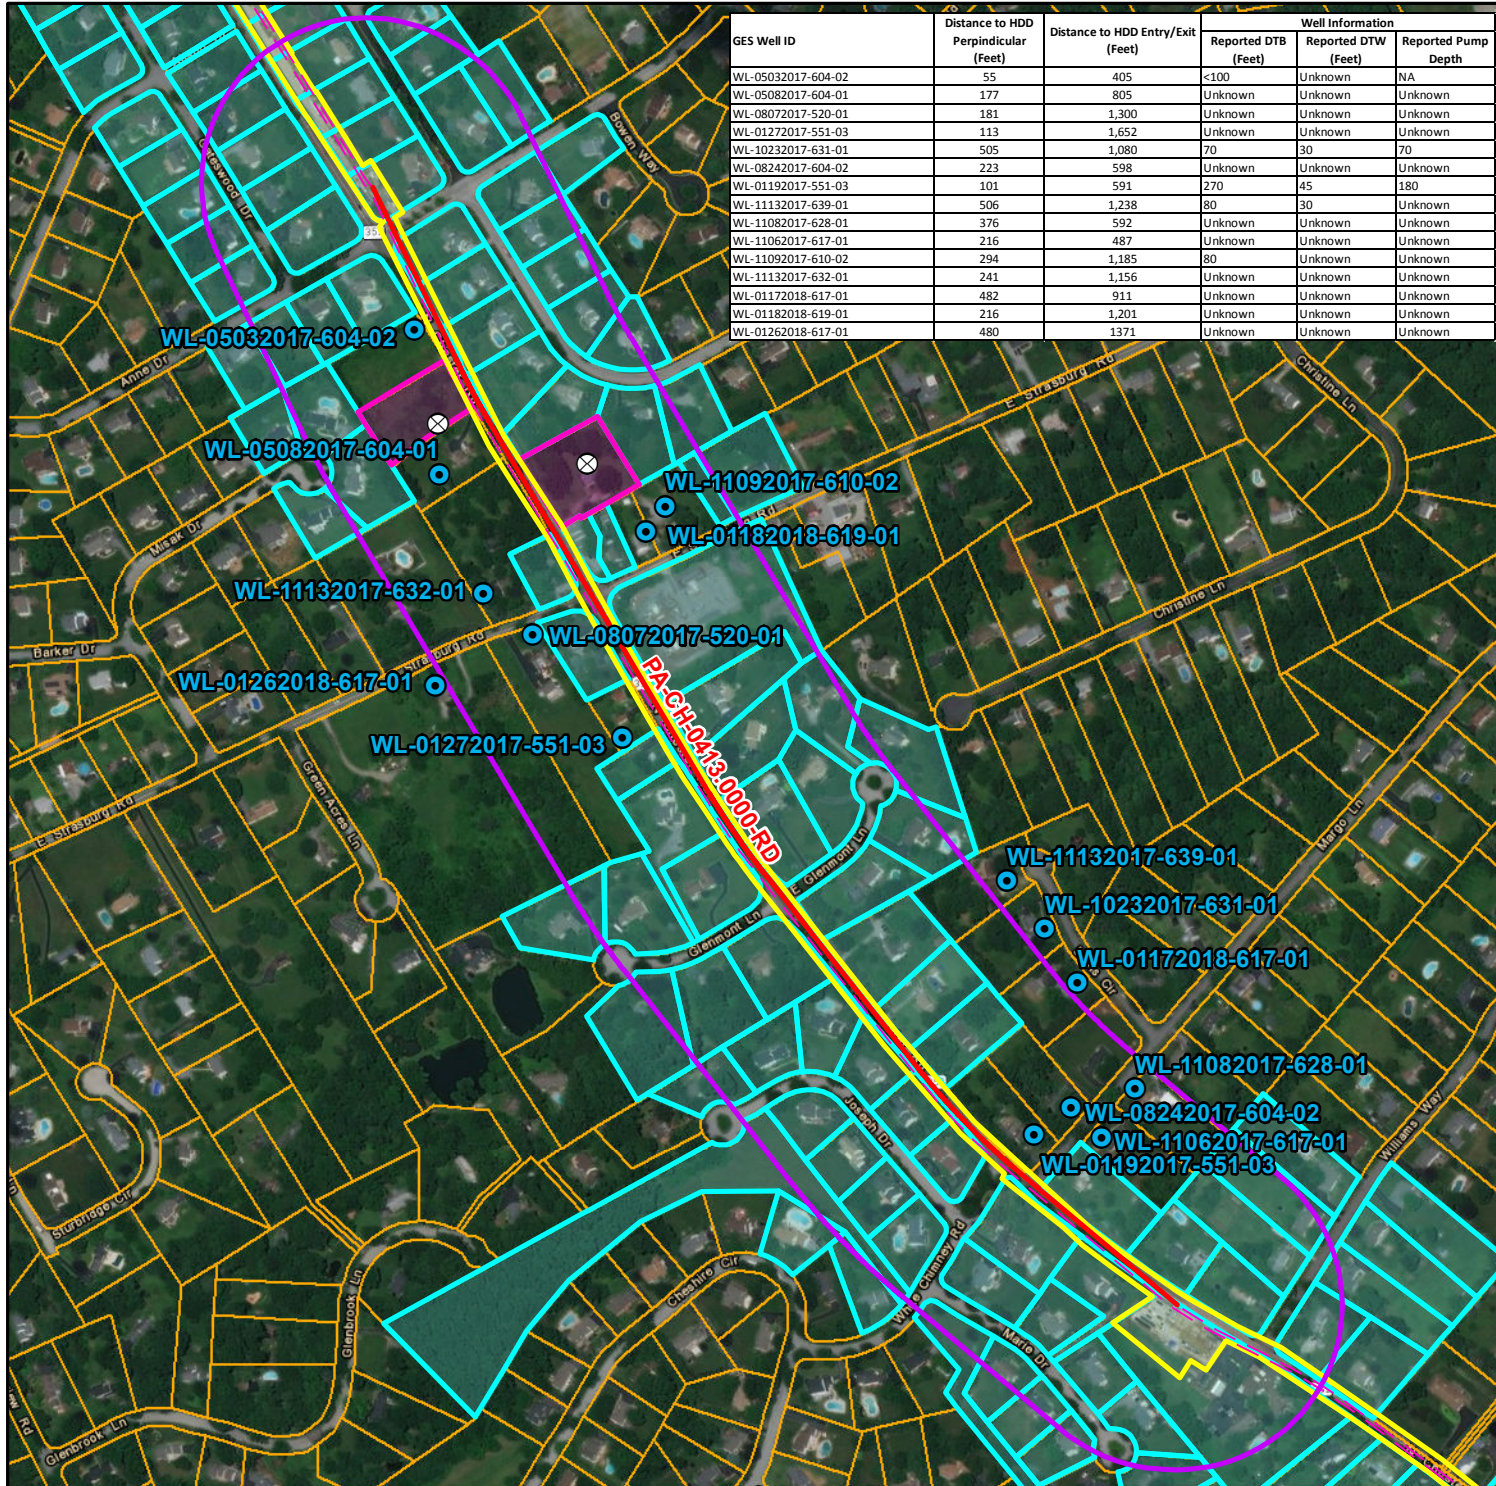
As stated in paragraph 2 on page 3 in Reevaluation report for this HDD, “*The production zone for waters wells in this formation is from the well bottom to highest point of water inflow from the water bearing overburden above competent bedrock, and seams, joints, and fractures in the upper bedrock of the formation*”. Water wells in bedrock can only pump water from inside the surface casing within overburden if it is screened and open rock interval within the bore annulus, and water volume from the top water elevation down to the pump intake.

Use of this water and the resulting draw upon adjacent groundwater within the fractured bedrock is cyclic throughout the day, with the greatest demand occurring during morning and evening hours and on weekend days and holidays when residents are generally home.

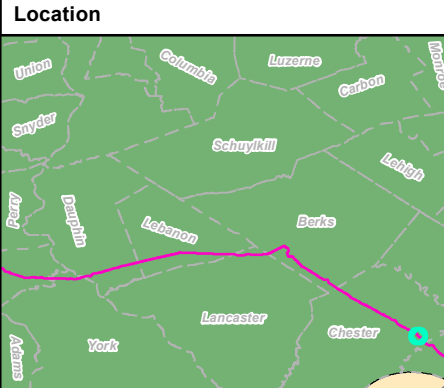
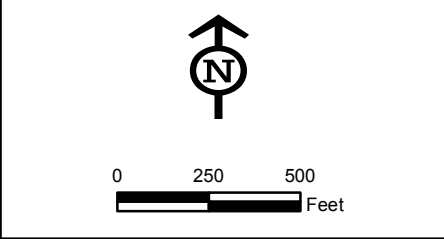
Well Location Map
 HDD# PA-CH-0413.0000-RD
 Chester County, PA.

GES Well ID	Distance to HDD Perpendicular (Feet)	Distance to HDD Entry/Exit (Feet)	Well Information		
			Reported DTB (Feet)	Reported DTW (Feet)	Reported Pump Depth
WL-05032017-604-02	55	405	<100	Unknown	NA
WL-05082017-604-01	177	805	Unknown	Unknown	Unknown
WL-08072017-520-01	181	1,300	Unknown	Unknown	Unknown
WL-01272017-551-03	113	1,652	Unknown	Unknown	Unknown
WL-10232017-631-01	505	1,080	70	30	70
WL-08242017-604-02	223	598	Unknown	Unknown	Unknown
WL-01192017-551-03	101	591	270	45	180
WL-11132017-639-01	506	1,238	80	30	Unknown
WL-11082017-628-01	376	592	Unknown	Unknown	Unknown
WL-11062017-617-01	216	487	Unknown	Unknown	Unknown
WL-11092017-610-02	294	1,185	80	Unknown	Unknown
WL-11132017-632-01	241	1,156	Unknown	Unknown	Unknown
WL-01172018-617-01	482	911	Unknown	Unknown	Unknown
WL-01182018-619-01	216	1,201	Unknown	Unknown	Unknown
WL-01262018-617-01	480	1,371	Unknown	Unknown	Unknown

- GES Testing Location
- Known Well, Testing Refused (Location Approximate)

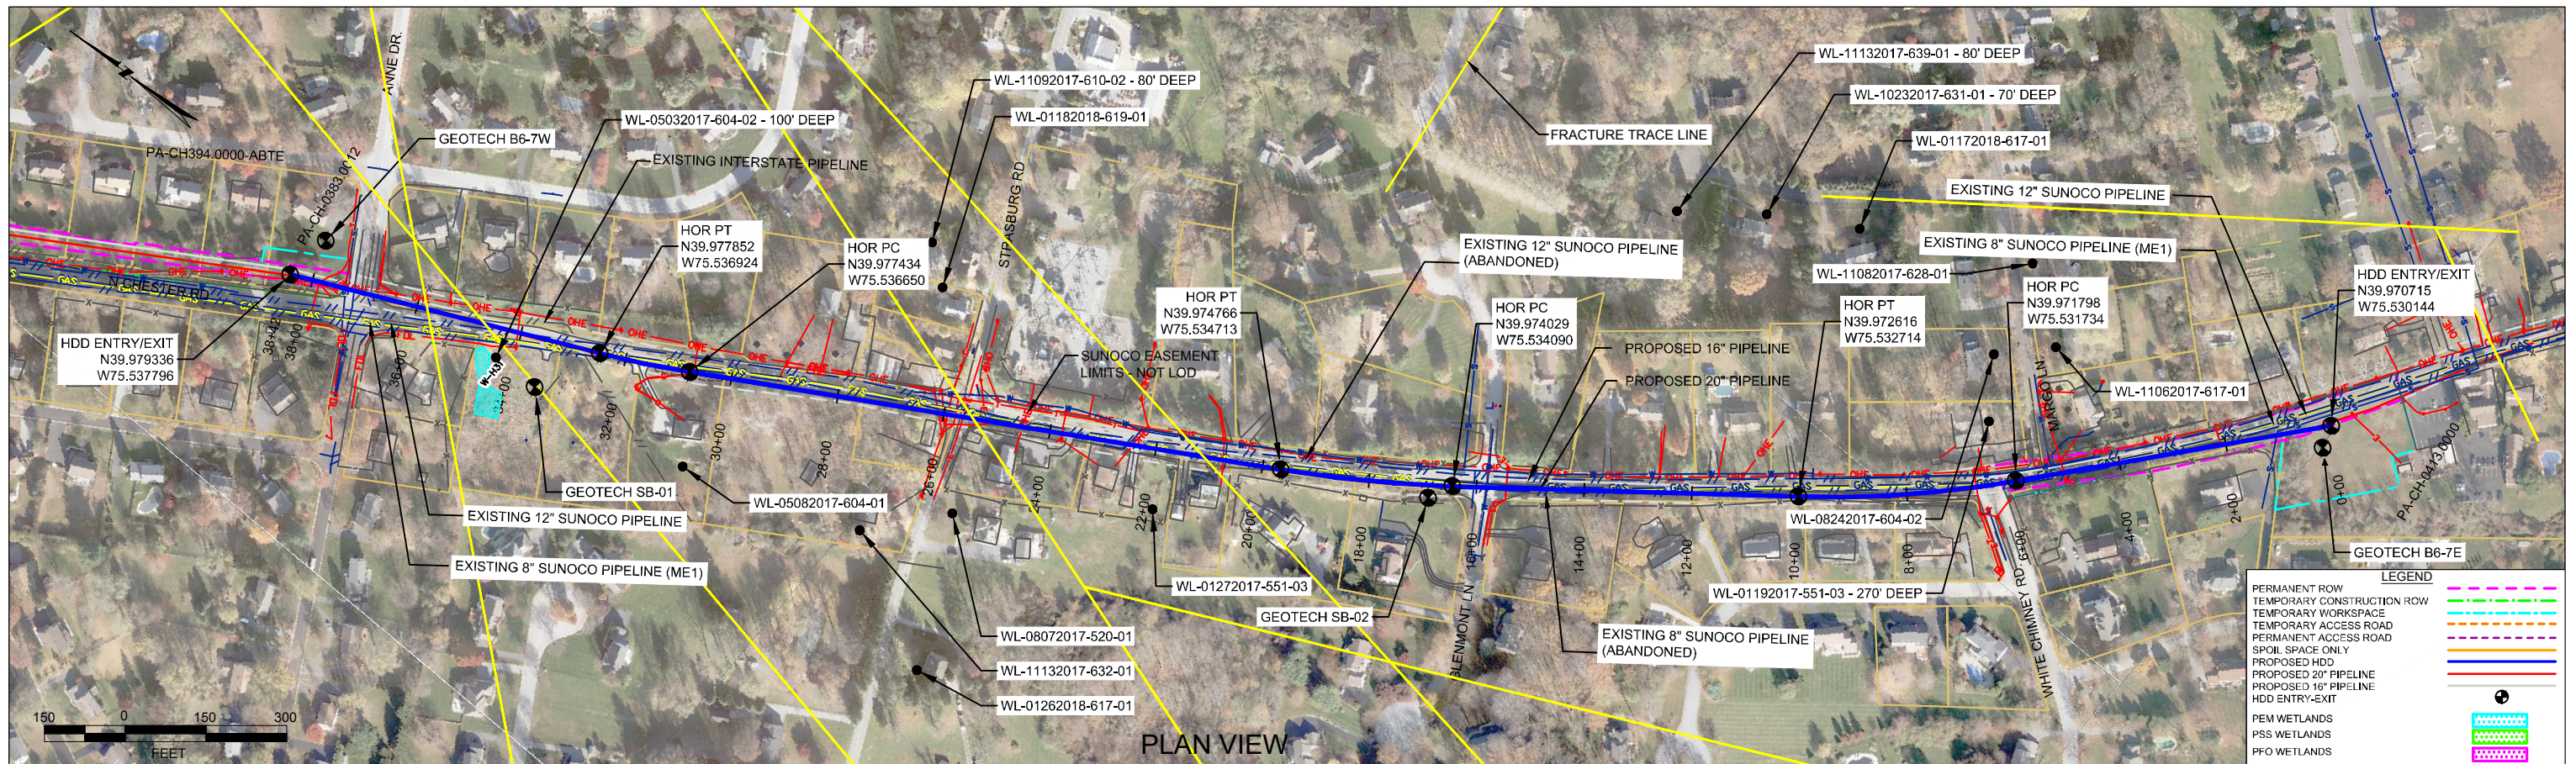
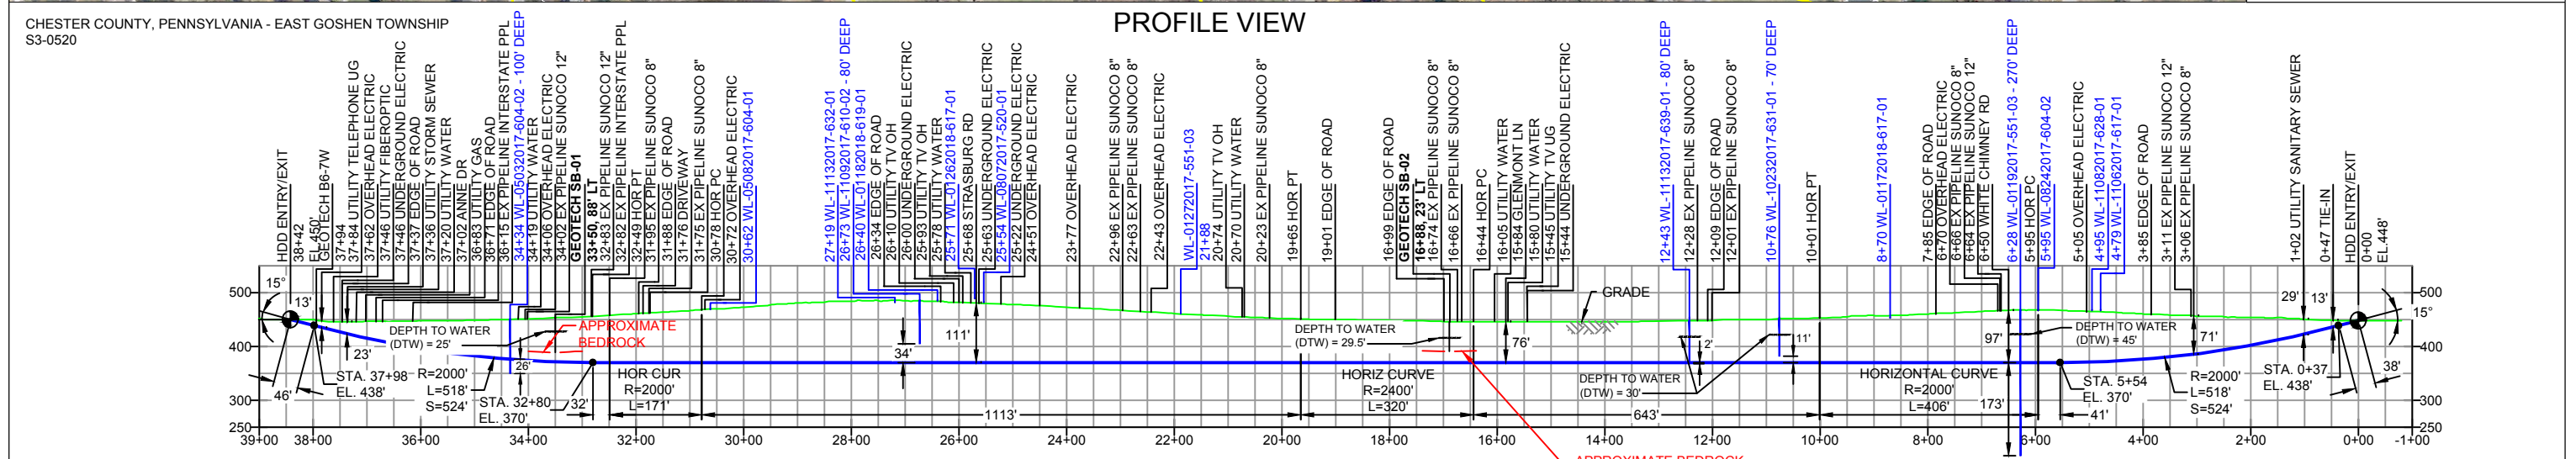
GEOTECH SB-01	GEOTECH SB-02
-NG EL. 453'	-NG EL. 446'
-GRAVEL (0' - 0.5')	-TOPSOIL (0' - 0.1')
-ML (0.5' - 7.0')	-ML (0.1' - 9.0')
	-SM (9.0' - 12.0')
-GROUNDWATER (25.0')	-GROUNDWATER (29.5')
-SM (7.0' - 53.0')	-SILT (USCS:MH) (12.0' - 36.5')
-WEATHERED GNEISS (53.0' - 64.0')	-SM (36.5' - 56.0')
-AUGER REFUSAL (64.0')	-AUGER REFUSAL (56.0')
-WHITE/GRAY GNEISS (64.0' - 70.0')	
COMPLETION DEPTH EL. 383'	COMPLETION DEPTH EL. 390'

As reported by Terracon, geotechnical bore B6-7E entered degraded and weathered gneiss at 40 ft of depth, continuing to 70 ft of depth upon which the bore was terminated. The materials above 40 ft of depth is reported by Terracon as Sandy Lean Clay. Gneiss is a type of rock; therefore the qualities of this gneiss were discussed as rock strength.
