STORMWATER INFILTRATION TEST REPORT

Kernsville Road Industrial

Lowhill Township, Lehigh County, Pennsylvania

GTA Job No: 31211548

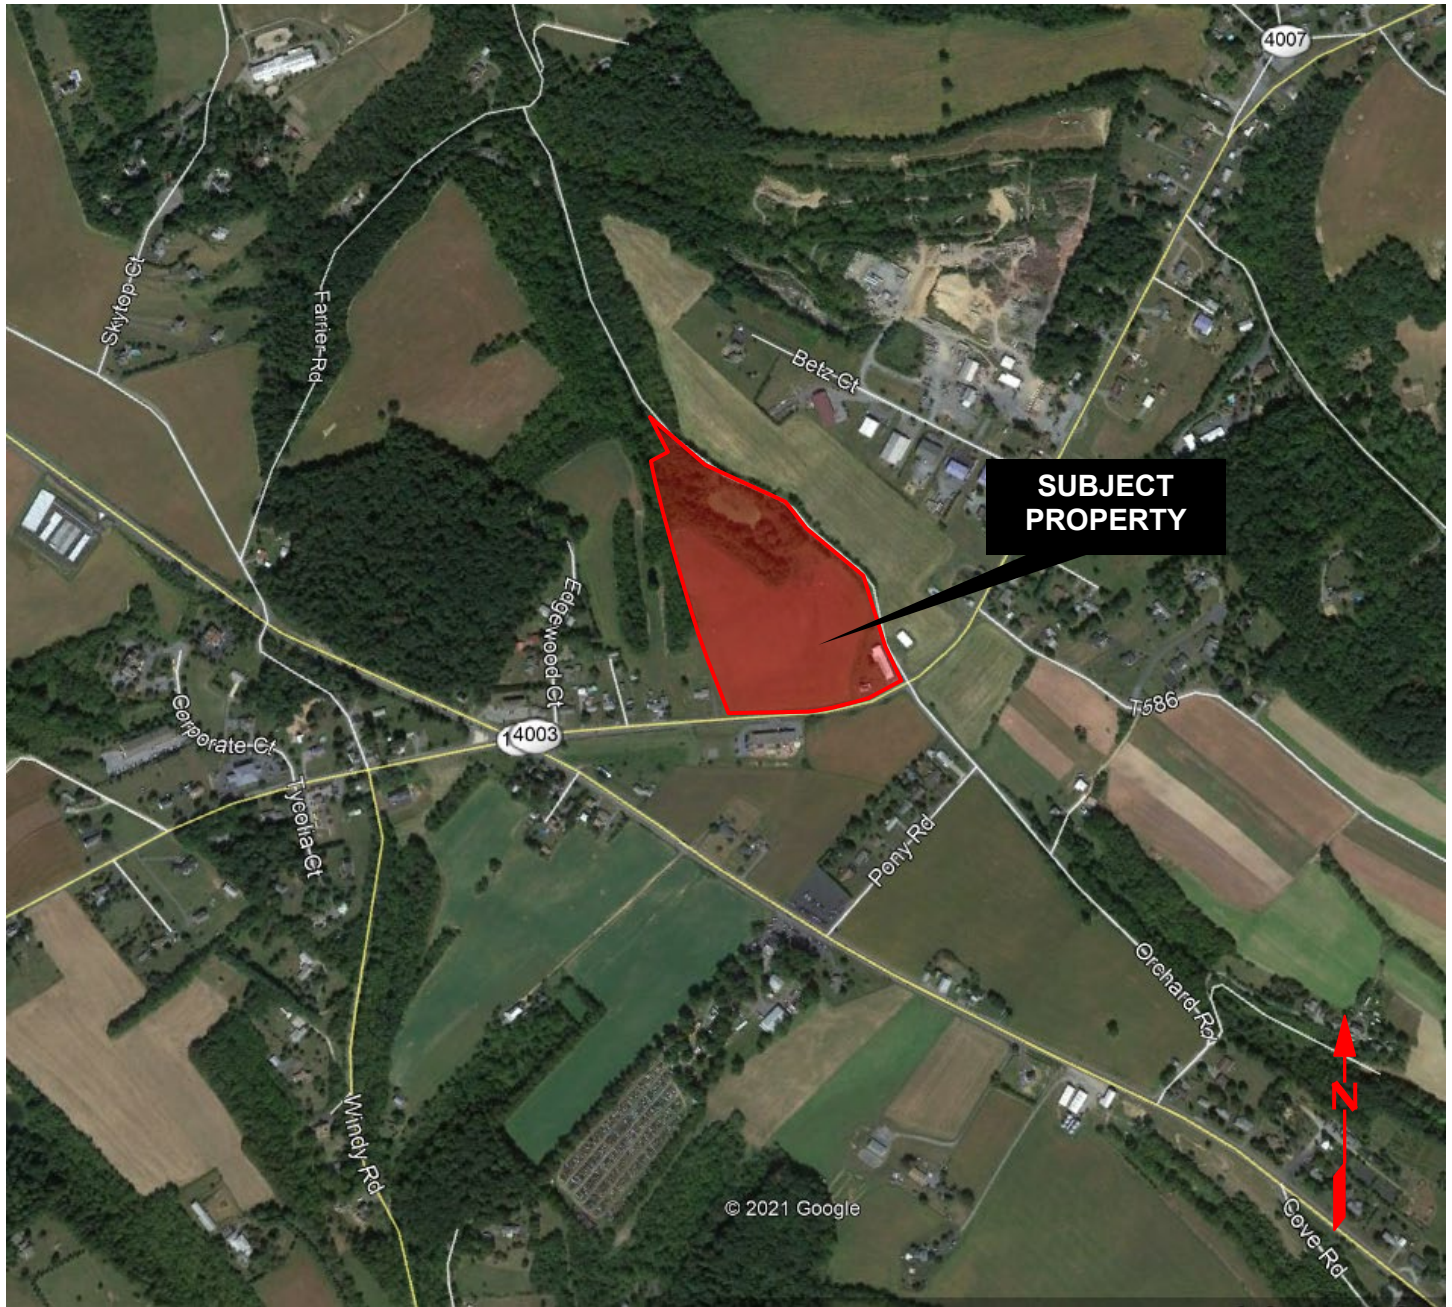
SCALE NTS	DATE AUG 2021	DRAWN BY CML	REVIEW BY MWD	JOB NO. 31211548	FIGURE NO. 1
--------------	------------------	-----------------	------------------	---------------------	-----------------

SITE LOCATION MAP
 7503 KERNSVILLE ROAD
 LEHIGH COUNTY, PENNSYLVANIA

The topography of the site is gently to steeply rolling, with the majority of the site draining to a pond (headwaters to Cherith Brook), located in the northeast corner of the site along Orchard Road. Ground surface elevations within the property range from approximately elevation (EL) 677 feet above mean sea level (ft. msl) along the topographical high ridge at the southern portion of the property, to a low of approximately EL 597 ft. msl at the northeastern corner of the property. Refer to the attached *Site Location Map* included as Figure 1 for additional information.

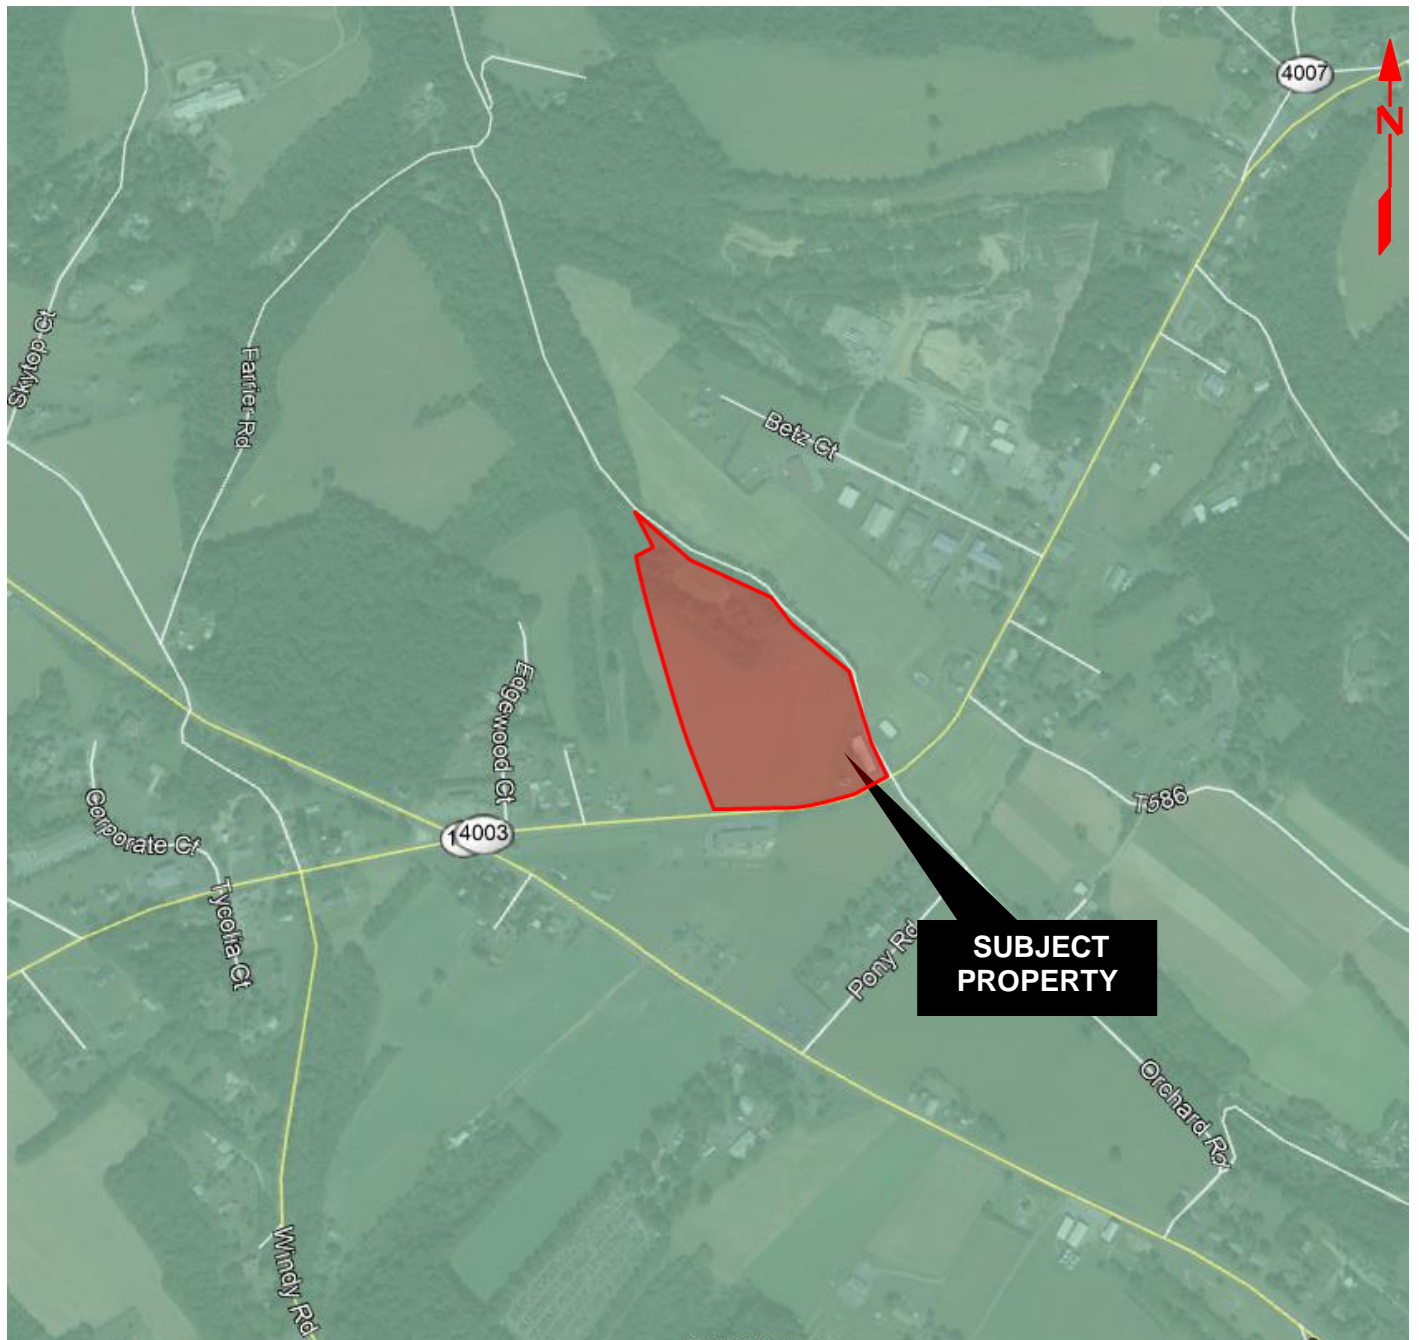
- 1) **Green Shading:** Consists of gray to dark-gray, buff-weathering shale of the Ordovician Age Martinsburg Formation
- 2) Base map obtained by Google Earth, 2021; Geological Units of Pennsylvania.
