PA DEP Small Drinking Water Systems Engineering Services Services Program (ESP) Case Study

Client Name: Hazel Hurst Water Company
Location: McKean County, Pennsylvania
Project Name: Distribution System Improvements

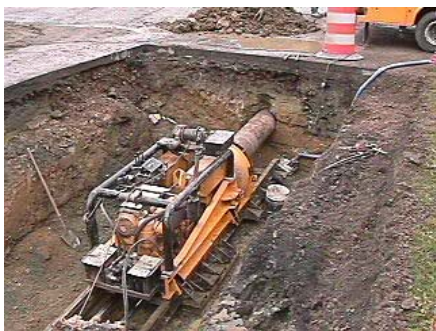
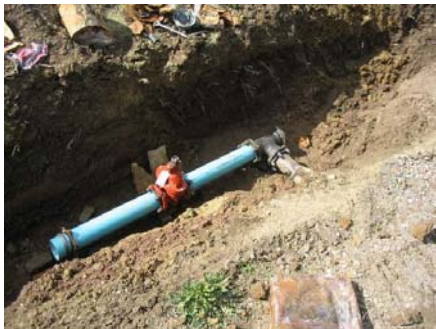
This second project completed the renewal of the distribution system by providing an upgrade and eliminating the conditions and deficiencies. The improvements included the installation of approximately 16,000 feet of PVC distribution pipe, system control and isolation valves, and appurtenances. The project involved four (4) bore and jack crossings of heavily traveled Historic Route 6, nine (9) new fire hydrants, and three (3) stream crossings. The installation of the fire hydrants at strategic locations provides fire protection throughout the entire Village which was not available prior to the improvements.
