**HORIZONTAL DIRECTIONAL DRILL ANALYSIS  
GOMBACH ROAD CROSSING  
PADEP SECTION 105 PERMIT NO.: E65-973  
PADEP SECTION 102 PERMIT NO.: PA-WM1-0111.0000-RD  
(SPLP HDD# S1B-0260)**

This reanalysis of a horizontal directional drill (HDD) installation of a 20-inch diameter pipeline crossing under Bushy Run Creek, Stream S202, and Gombach Road (west to east), in Penn Township, Westmoreland County, is in accordance with Stipulated Order (Order) issued under Environmental Hearing Board Docket No. 2017-009-L for HDDs listed on Exhibit 2 of the Order. This HDD is number 2 on the list of HDDs included on Exhibit 2. This HDD was not initiated before the issuance of the Order.

- Geologic and hydrogeologic characteristics in the area of HDD S1B-0260;
- Summaries of studies performed pertinent to reevaluation, including fracture trace analysis and geotechnical borings;
- A site conceptual model; and
- Reevaluation recommendations.

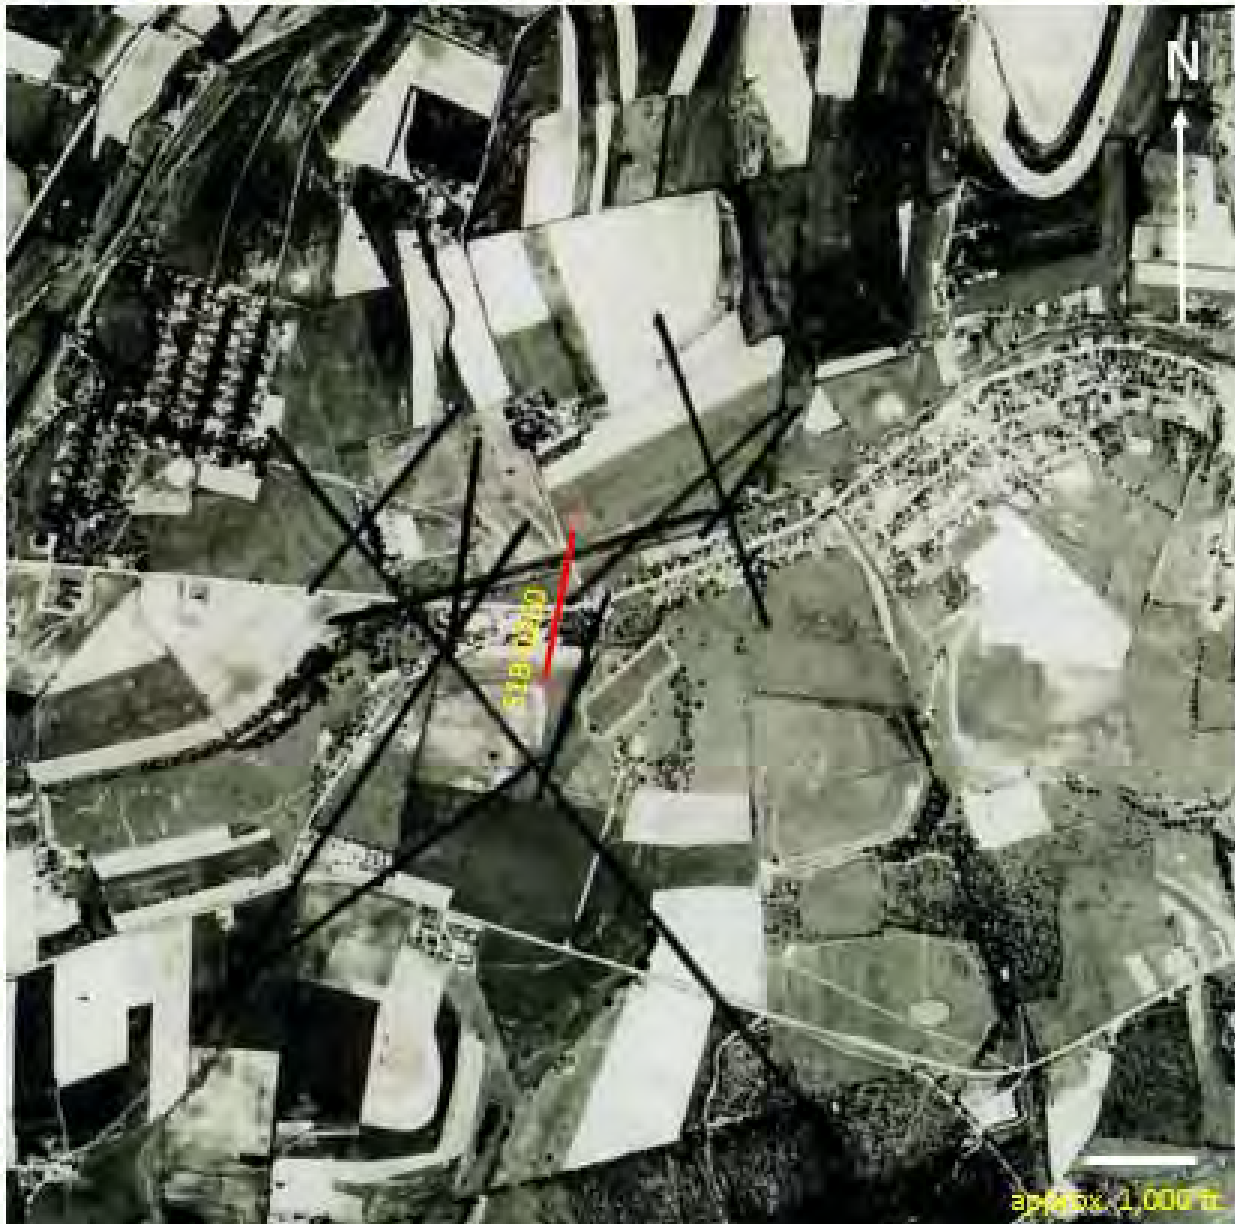
**Figure 4. Fracture Trace Map**

Fracture traces (one mile in length or less) and lineaments (greater than one mile in length) are the surficial expression on natural landscapes of vertical zones of bedrock fracture concentration. Fracture trace analysis is partly subjective; therefore, every mapped fracture trace does not necessarily represent a zone of bedrock fracture concentration. **Figure 4** shows a fracture trace map prepared for this reevaluation. This mapping was performed using aerial stereographic pairs flown in the spring of 1939. As such, much of the land surface appears undeveloped therefore; fracture traces are more easily seen. Several orientations are present in the set of fracture traces. One fracture trace is oriented ENE and crosses the northern end of both the HDD and FlexBor alignments.

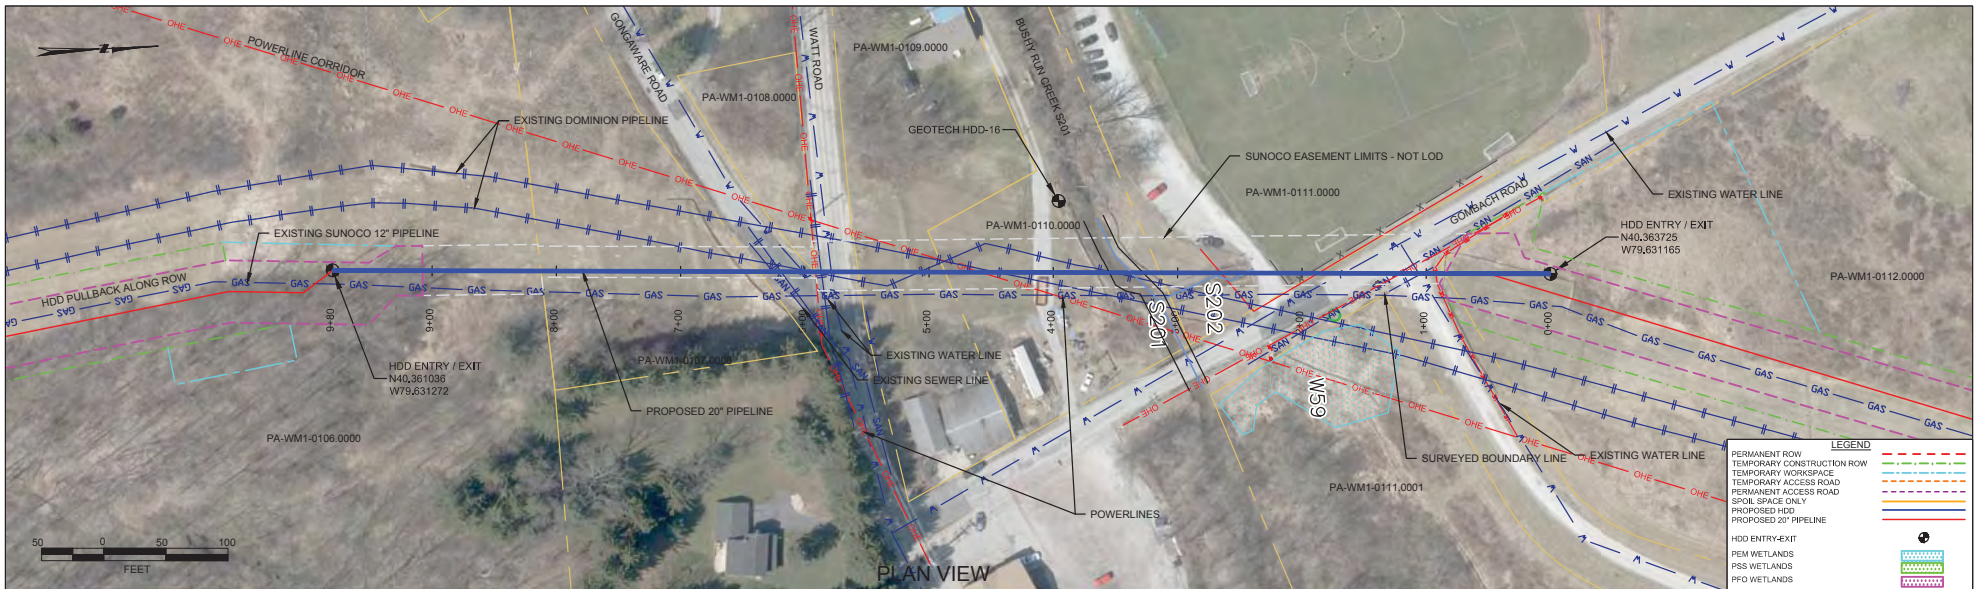
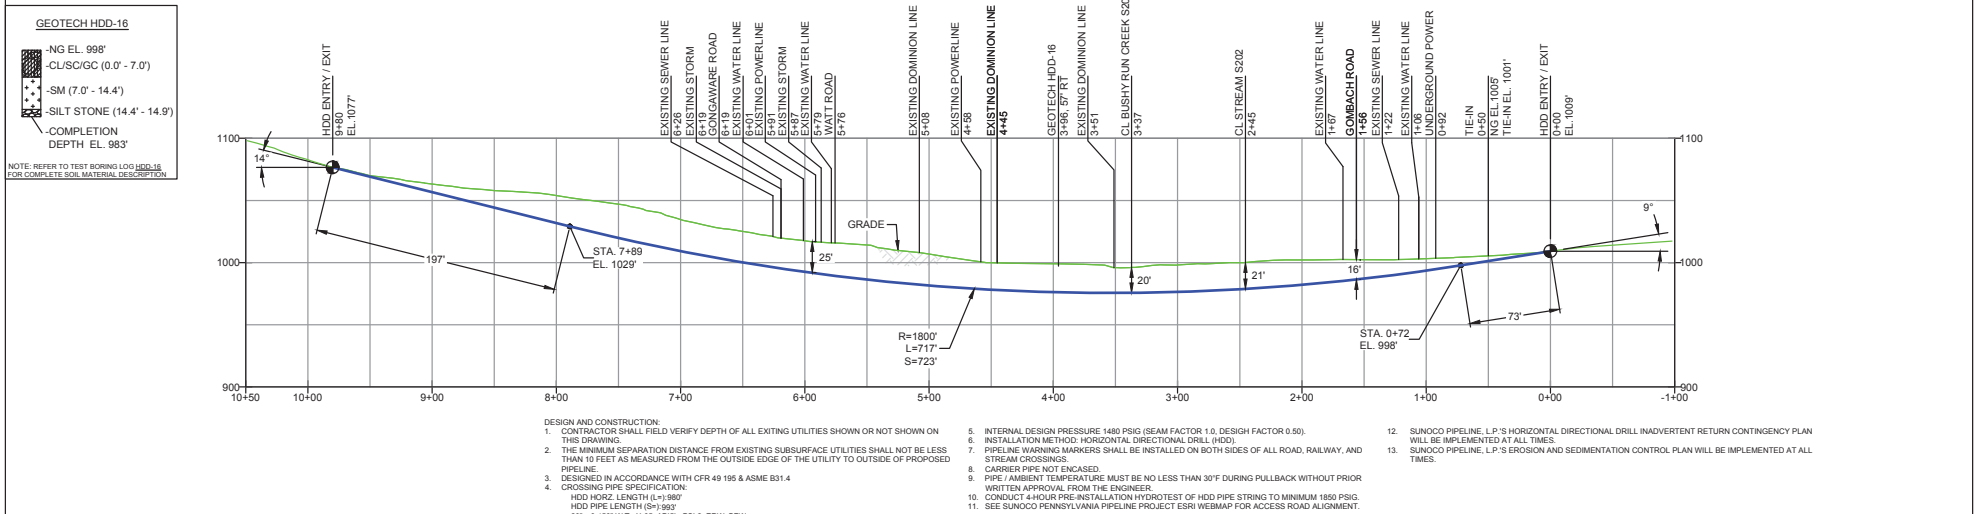
### **HDD and FlexBor Plan and Profiles**

WESTMORELAND COUNTY, PENNSYLVANIA - PENN TOWNSHIP  
S1B-0260

PLAN VIEW

PROFILE VIEW

A copy of the original HDD plan and profile is included as Figure 1 in Attachment 3.

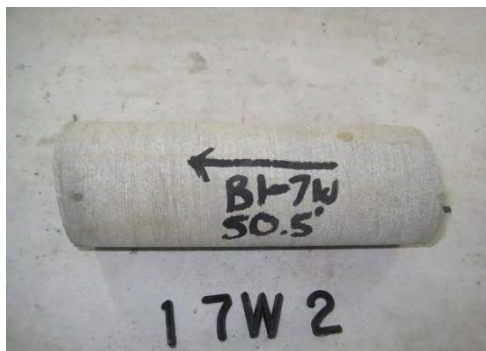
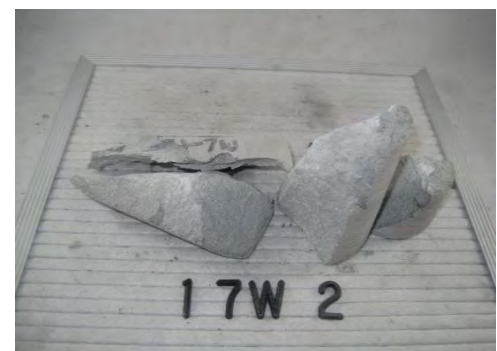
Maximum Axial Load at Failure: 49,480 lb  
 Compressive Strength: 16,233 psi  
 Compressive Strength: 111.92 Mpa  
 Unit Weight 160 pcf

Before the Test

After the Test

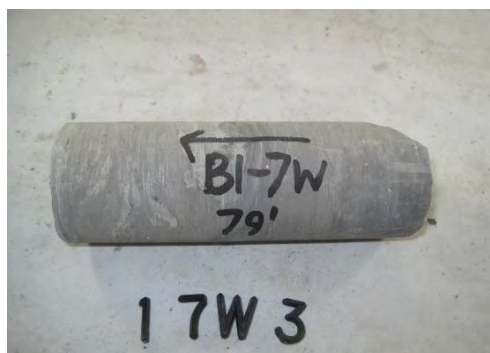
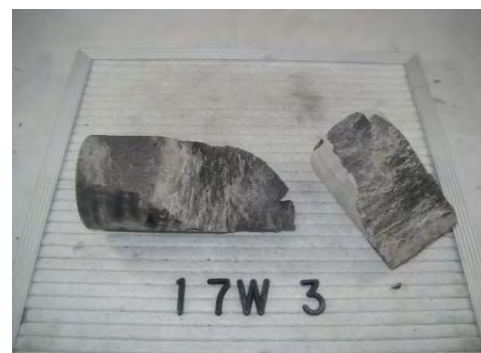
Maximum Axial Load at Failure: 21,220 lb  
 Compressive Strength: 6,962 psi  
 Compressive Strength: 48.00 Mpa  
 Unit Weight 166 pcf

Before the Test

After the Test

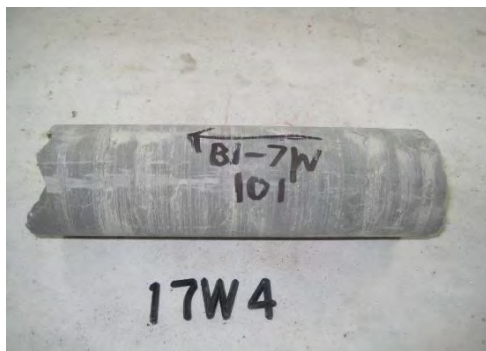
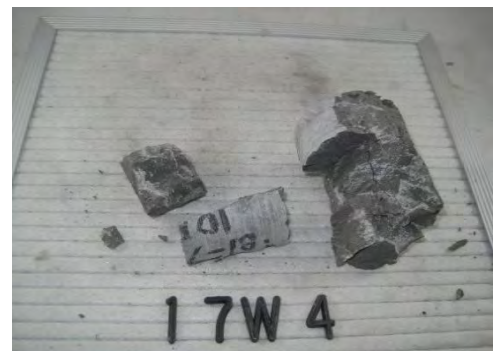
Maximum Axial Load at Failure: 19,690 lb  
 Compressive Strength: 6,460 psi  
 Compressive Strength: 44.54 Mpa  
 Unit Weight 164 pcf

Before the Test

After the Test

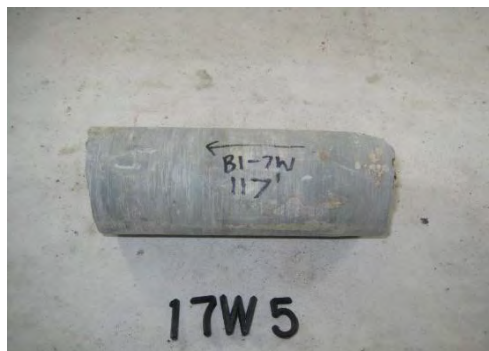
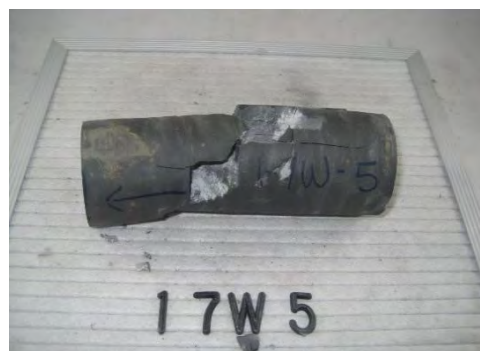
Maximum Axial Load at Failure: 22,930 lb  
 Compressive Strength: 7,523 psi  
 Compressive Strength: 51.87 Mpa  
 Unit Weight 171 pcf

Before the Test

After the Test

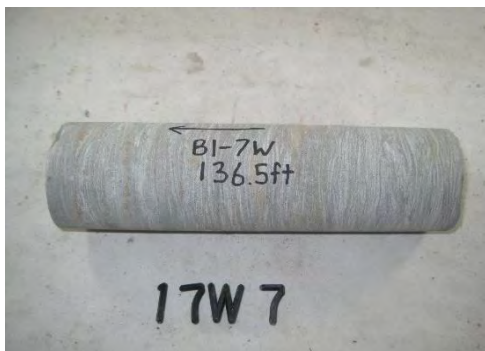
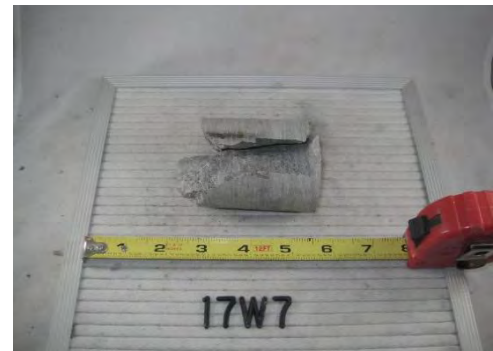
Maximum Axial Load at Failure: 31,800 lb  
 Compressive Strength: 10,328 psi  
 Compressive Strength: 71.21 Mpa  
 Unit Weight 169 pcf

Before the Test

After the Test

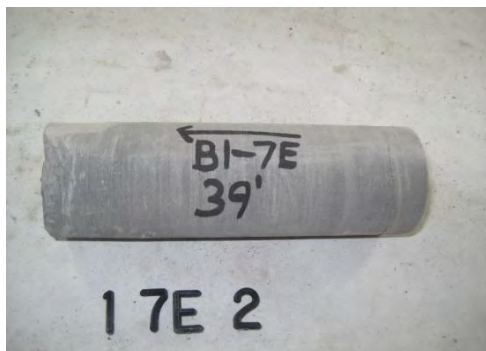
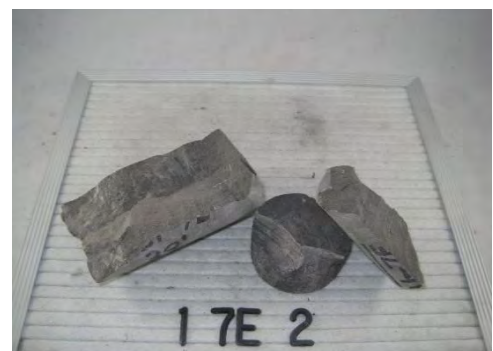
Maximum Axial Load at Failure: 25,580 lb  
 Compressive Strength: 8,478 psi  
 Compressive Strength: 58.45 Mpa  
 Unit Weight 165 pcf

Before the Test

After the Test

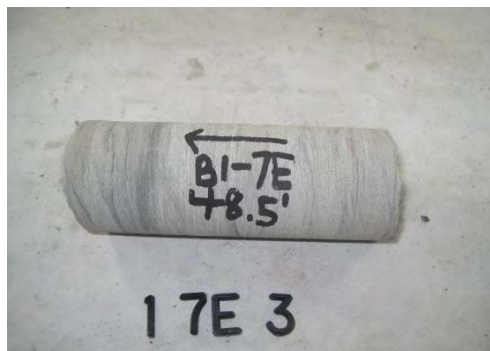
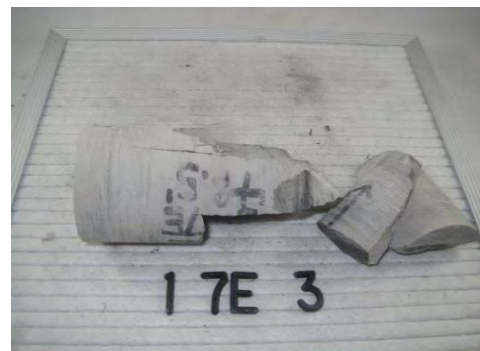
Maximum Axial Load at Failure: 34,470 lb  
 Compressive Strength: 11,309 psi  
 Compressive Strength: 77.97 Mpa  
 Unit Weight 163 pcf

Before the Test

After the Test

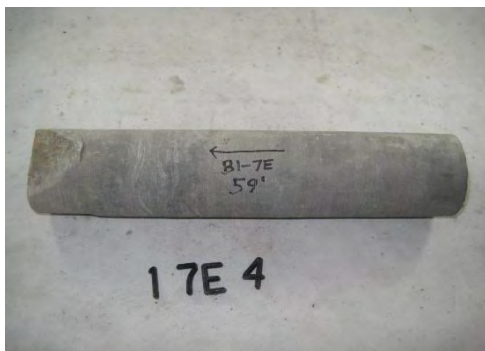
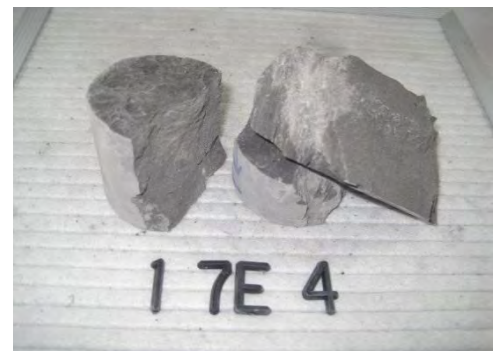
Maximum Axial Load at Failure: 29,250 lb  
 Compressive Strength: 9,694 psi  
 Compressive Strength: 66.84 Mpa  
 Unit Weight 165 pcf

Before the Test

After the Test

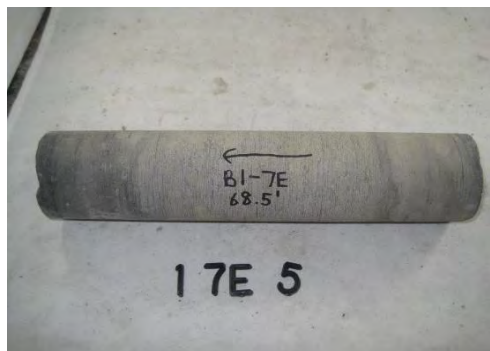
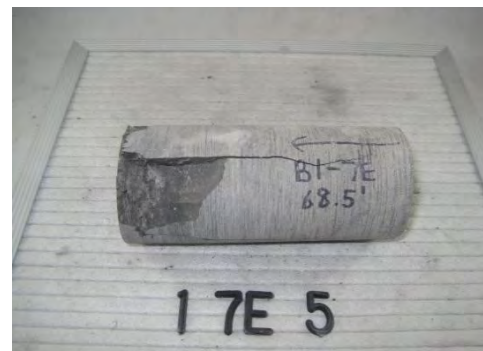
Maximum Axial Load at Failure: 31,330 lb  
 Compressive Strength: 10,175 psi  
 Compressive Strength: 70.15 Mpa  
 Unit Weight 169 pcf

Before the Test

After the Test

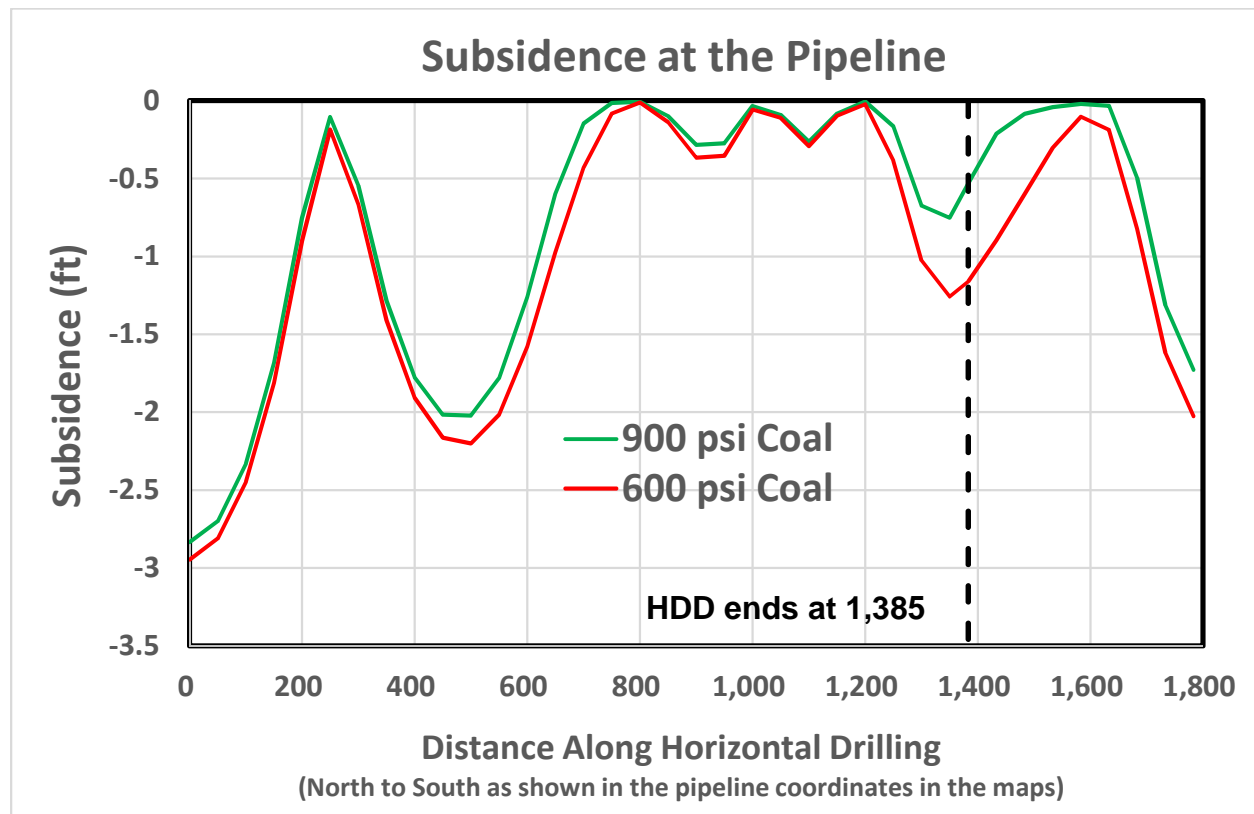
**Figure 4. Estimated Subsidence**

Modeling of the Claridge and Penn Manor #5 mines was conducted using a base coal strength of 900 pounds per square inch (psi) to simulate the strength of the coal at the time of mining. Subsequently, a coal strength of 600 psi was modeled to simulate the coal strength after the mine pillars degrade over time. The predicted subsidence with both coal strengths along the pipeline alignment is shown on Figure 4. The 900-psi coal subsidence plot indicates anticipated ground subsidence directly after mining. The 600-psi plot predicts the subsidence that may occur along the pipeline as the mine conditions degrade over time. It is unknown when or if the 600-psi conditions will ever occur. Mine subsidence at this site may have already occurred, may occur at some time in the future, or may never occur. Predicting the exact condition of the mine at this time, or at any precise time in the future, is not possible. Subsidence may also occur in different areas at different times so that the estimated subsidence in the model may not occur at the same time.

LaModel was chosen as the mining-induced stress analysis program to estimate strain on the strata at the location of the pipeline within the strata. This program is primarily designed to calculate the seam stress and displacement within an underground mine. The software uses boundary elements for calculating the stresses and displacements in coal mines or other thin tabular seams or veins. During active mining, it can be used to optimize pillar sizes and mine layout by minimizing pillar stress. Multi-seam mining stress can also be reviewed. This program can also reasonably calculate surface subsidence. A medium distance of 150 feet above the Claridge and Penn Manor #5 mines was chosen for detailed analysis of mine subsidence. In the LaModel program, the overburden is modeled as a continuum. Therefore, the program shows the subsidence directly over the mined areas and within the angle of draw. The magnitude of subsidence decreases as the distance from the mine increases and the subsidence spreads. The program does not model any dilation of the overburden.

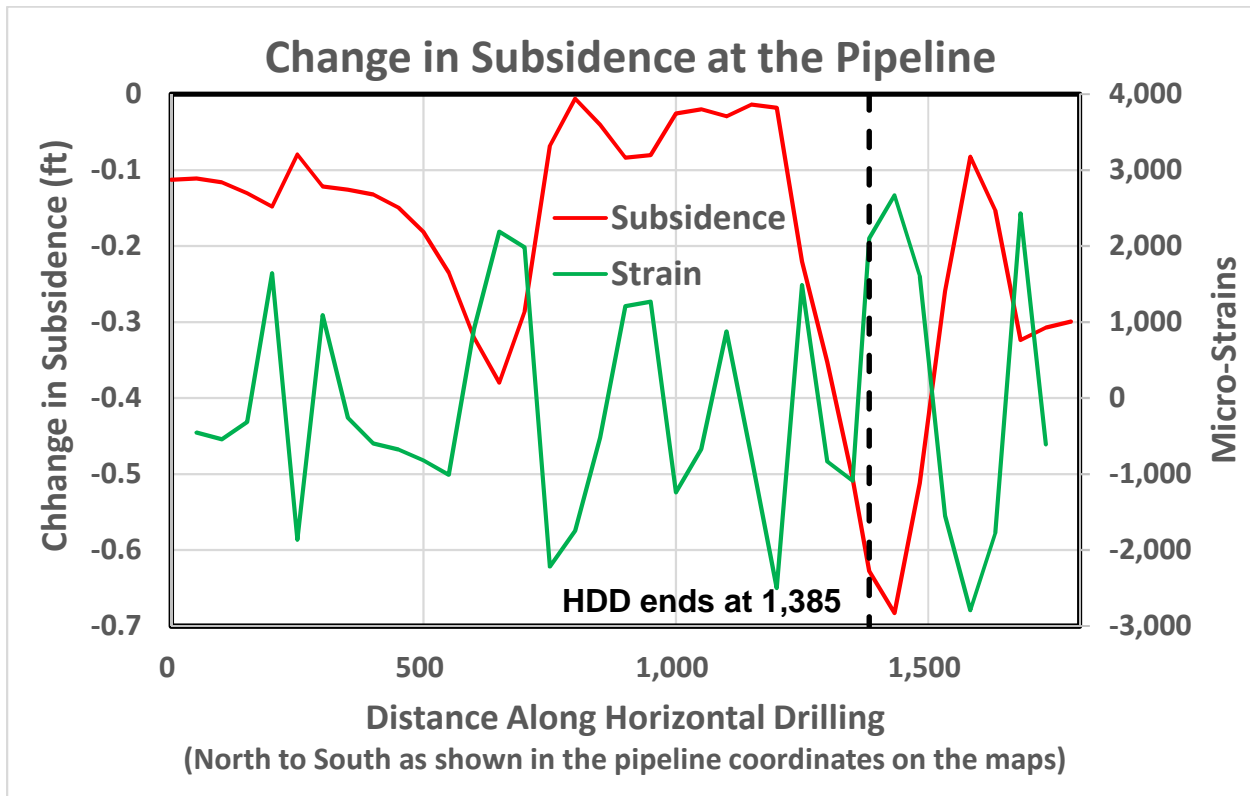
Figure 5. Change in Subsidence

The estimated maximum subsidence that the pipeline may experience in the future is the difference between the subsidence estimated using the original strength (900 psi) of coal and the subsidence estimated using degraded strength (600 psi) of coal. This differential subsidence is shown on Figure 5. There are two primary areas of potential future subsidence. One area is centered at Station 6+50 and occurs within a retreat mined area that was not completely caved based on our interpretation of the 3D seismic data. The increased subsidence at this location was estimated to be about 0.38 foot (4.6 inches). The second area of increased subsidence occurs just beyond where the HDDP exits to the surface. This area is again located in a retreat mined area that was interpreted as not being completely caved. The additional subsidence at this area is estimated to be about 0.68 foot (8.2 inches).

The strains within the strata associated with the estimated future subsidence should the pillars fail are shown on Figure 5. The maximum strain values range from 0.25% to -0.25% and fluctuate continuously along the pipeline length. The level of strain that the pipeline may experience is a function of the ground movement and a function of how tightly the pipeline is coupled to the ground movement. If the pipeline can slide within the HDDP, then areas of tensile or compressive strain can be reasonably canceled by adjacent areas of the opposite strain.

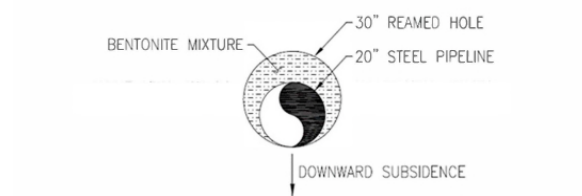
HDDP 20"

**Figure 6 – Borehole and Pipeline Cross Section**

The modeled strains are in the strata at the location of the pipeline alignment. The bored excavation for the HDDP will be larger than the pipe to be installed. As shown on Figure 6, the strain in the strata encompassing the hole, is not directly correlated to the strain imparted to the pipeline. The overbore (larger diameter of the hole compared to the pipe) leaves room for potential movement of the pipe within the strata. Transmission of the strain from the strata to the pipe associated with this project is being reviewed by pipeline engineers.

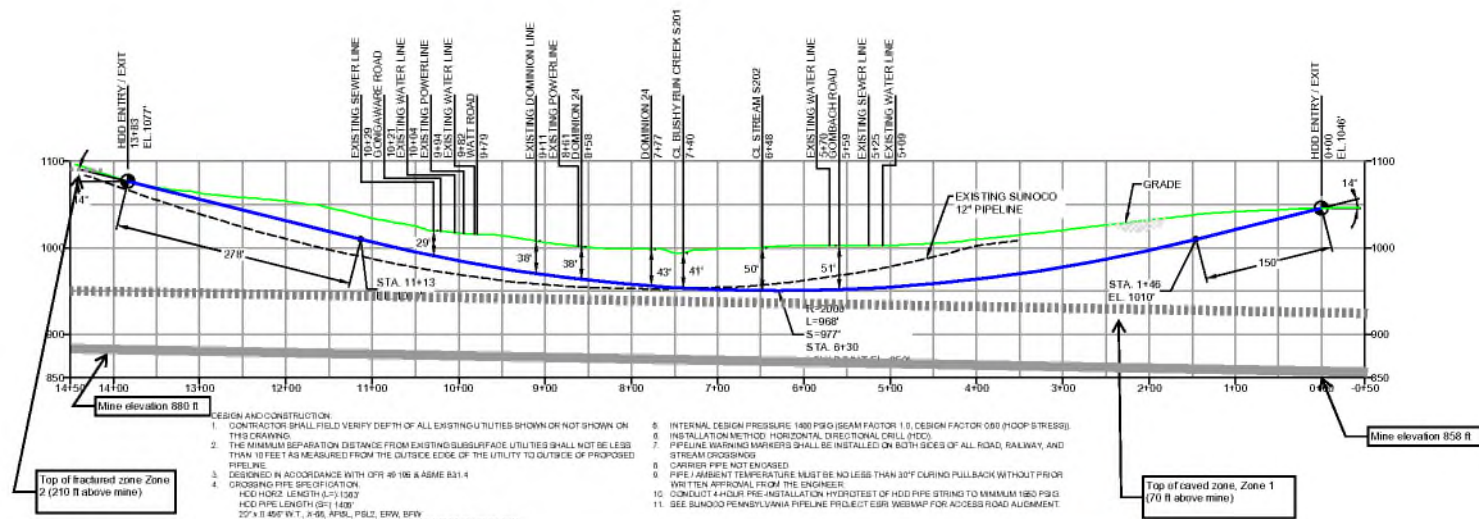
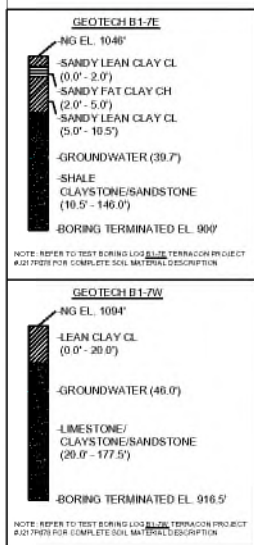
# PLAN VIEW

Figure 3 - HDD Plan and Profile

Figure 3 was prepared using the planned HDDP profile and adding the top of each fracture zone if subsidence would occur or has occurred. To be conservative, the top of each fracture zone was selected as the maximum value based on the Kendorski's research (Kendorski, 2006). The entire bore will be completed within the (fractured) zone. It is expected that the rock fracturing in this area may be severe due to the shallow depth of the coal and relatively thick coal extraction height. The presence of perched aquifers in the boring logs B1-7W and B1-7E may be an indication that at least some fractures have closed after mining was completed.

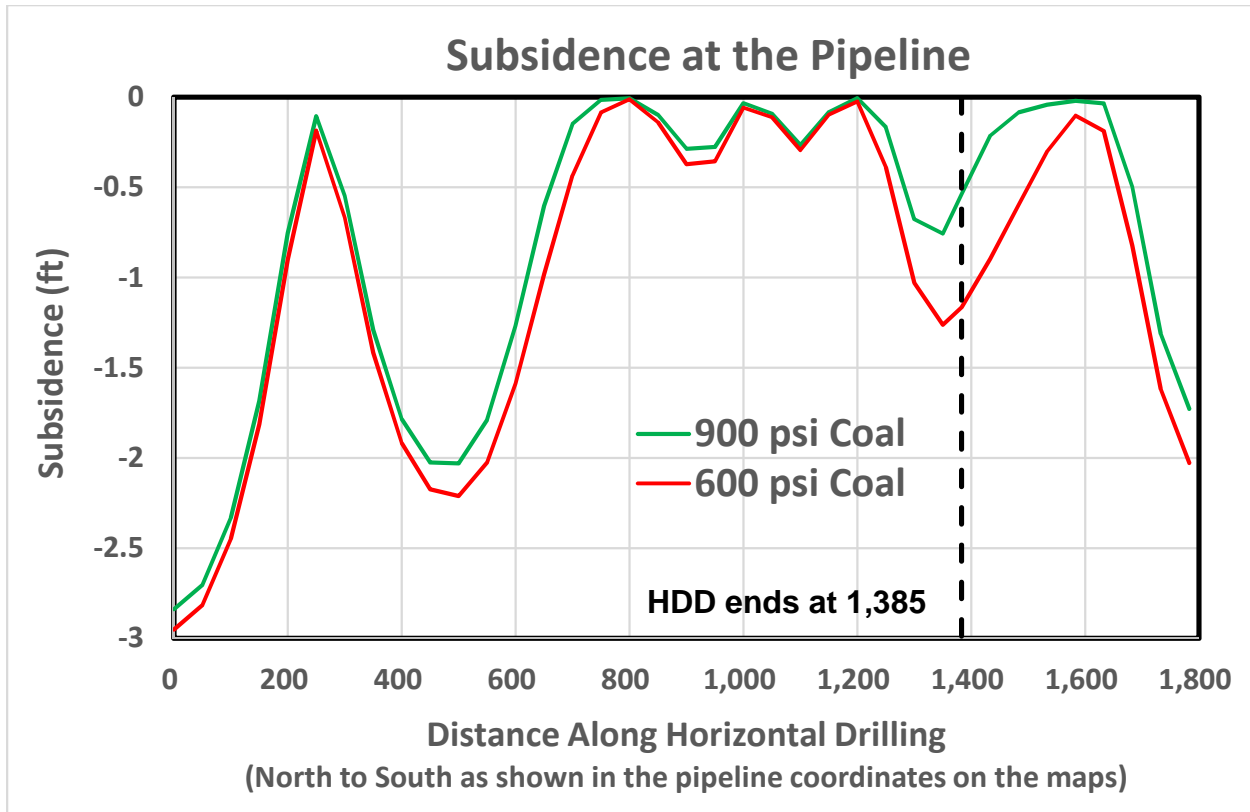
Figure 6. Subsidence prediction along the pipeline alignment at different coal strengths.

To examine the details of the previous subsidence along the pipeline alignment, the subsidence above the seam has been interpolated from the output shown in Figure 6 directly to the pipeline coordinates, as shown in Figure 6. In this plot, the subsidence under the pipeline as it crosses over the various gob and mainline pillar areas is clearly visible.

As previously stated, the model with 900 psi coal strength (as shown in Figures 3, 4, and 5) was intended to simulate the mine conditions immediately after mining. The subsidence shown in Figure 5 and the 900 psi coal line in Figure 6 has assumedly already occurred immediately after mining. To simulate the maximum potential subsidence that might occur over time due to degradation of the coal, roof and/or floor by oxidation, spalling, moisture, etc., a model with a coal strength of 600 psi (a 33% strength reduction) was run, analyzed and compared with the post-mining 900 psi model.

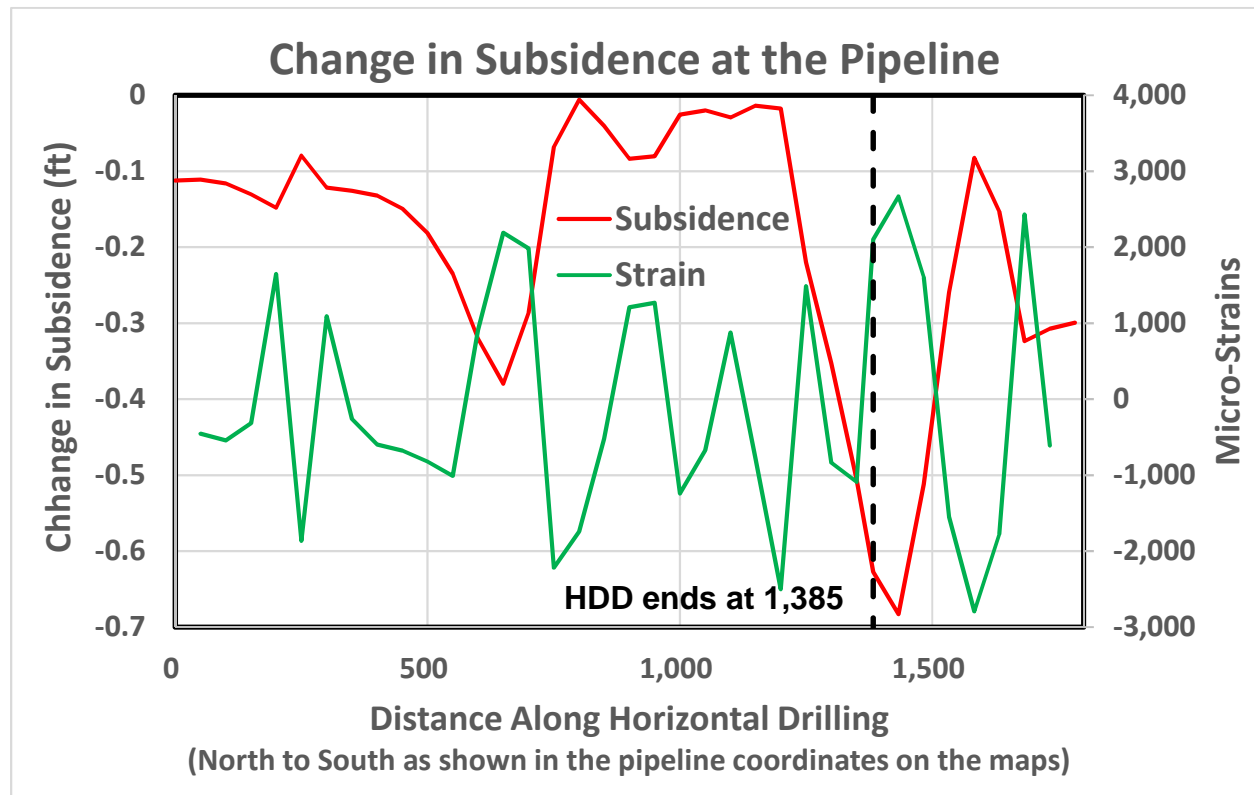
Figure 9. Predicted worst case subsidence and associated strains (tension is negative) .

In the first area in the north between pipeline stations 5+00 to 8+00, the failure of the thin rib pillars results in an additional 0.4 ft (5 in) of subsidence. Similarly, between pipeline stations 12+00 and 16+00 the retreat pillar failure results in an additional 0.7 ft (8.5 in) of subsidence (see Figures 8 and 9).

**Strains:** The strains associated with the predicted post-mining subsidence are also shown in Figure 9. The maximum strain values at the HDD location range from 0.0020 to 0.0025, or 0.20% to 0.25%, and fluctuate continuously along the pipeline length. (note: the HDD only runs from 0+00 to 13+85 in Figure 9)

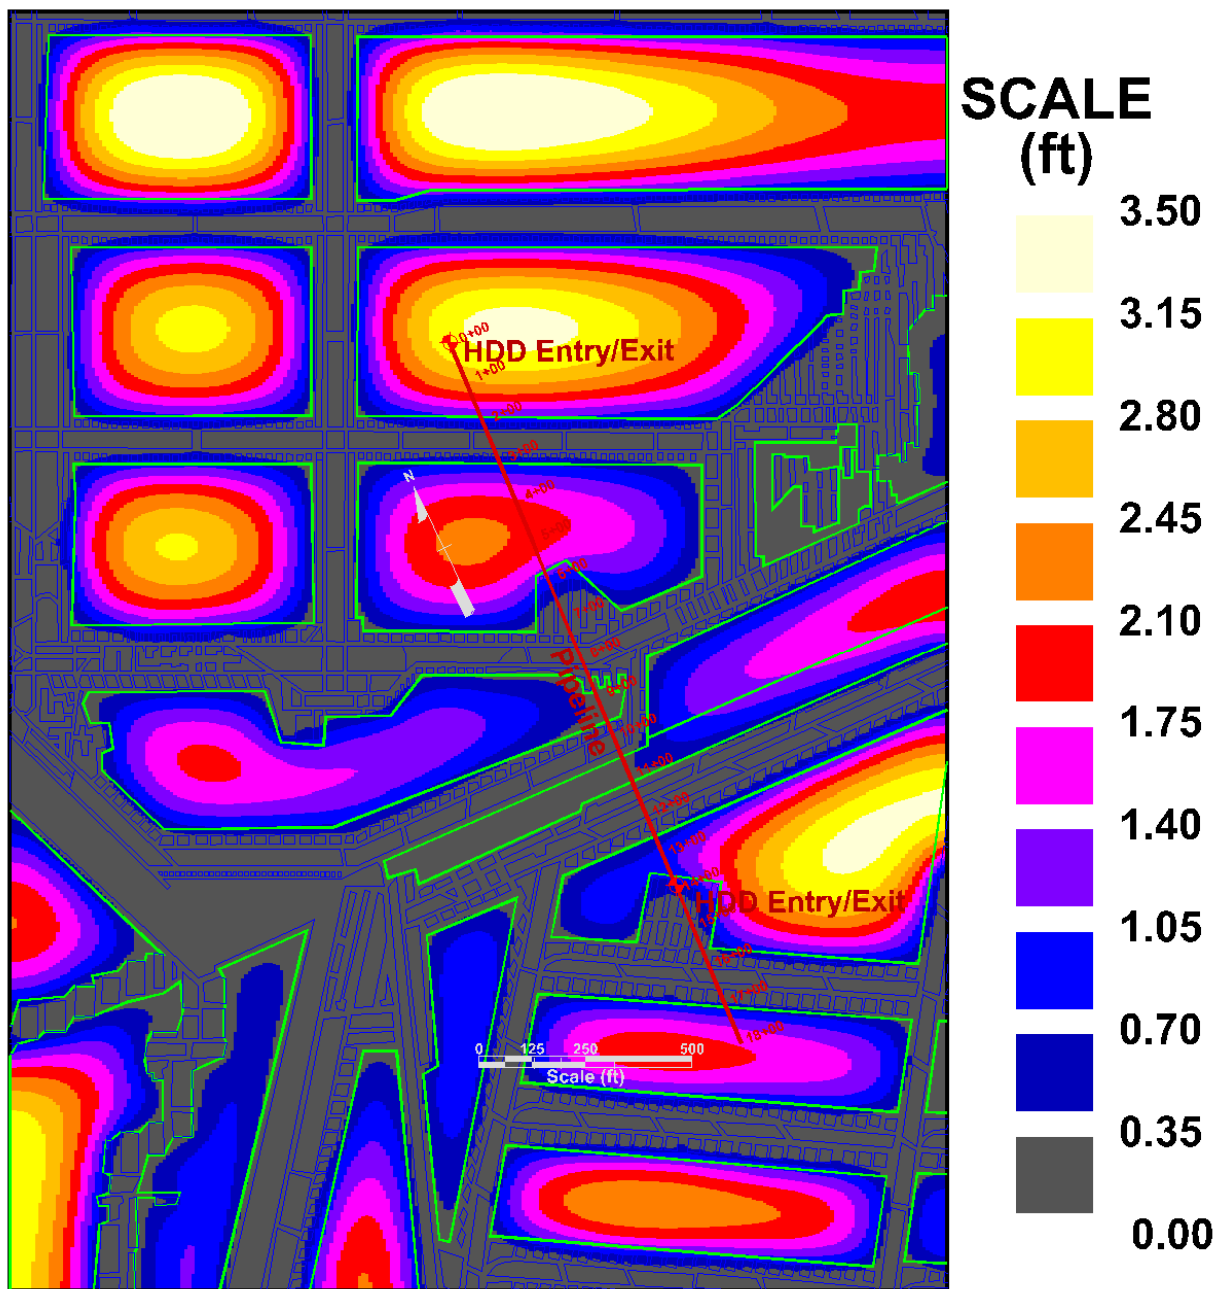
Figure 3. Seam convergence with 900 psi coal strength.

*Seam Convergence:* Initially, the model with the 900 psi coal strength intended to simulate the mine conditions immediately after mining was run and analyzed in order to gain an understanding of the post-mining conditions. The first model output to be examined was the seam convergence as shown in Figure 3. In this output, the overburden convergence over the various size and shaped gobs is clearly visible. In particular, the panels adjacent to the pipeline show 2 to 3+ ft of convergence.

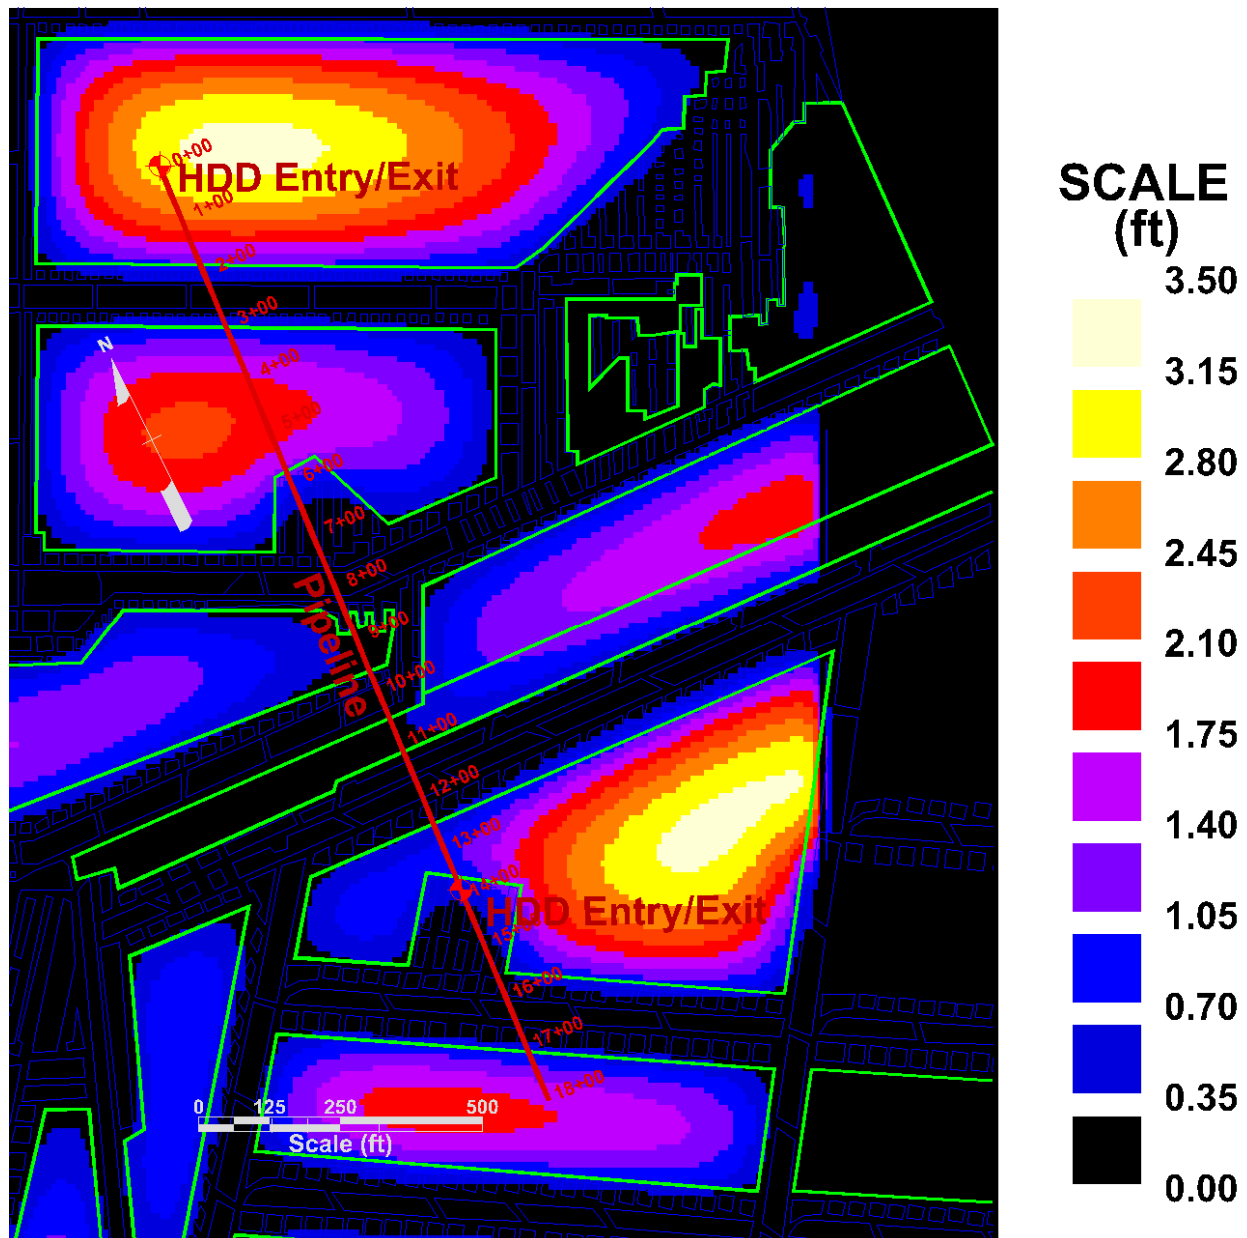
Figure 5. Subsidence at the pipeline for 900 psi coal strength.

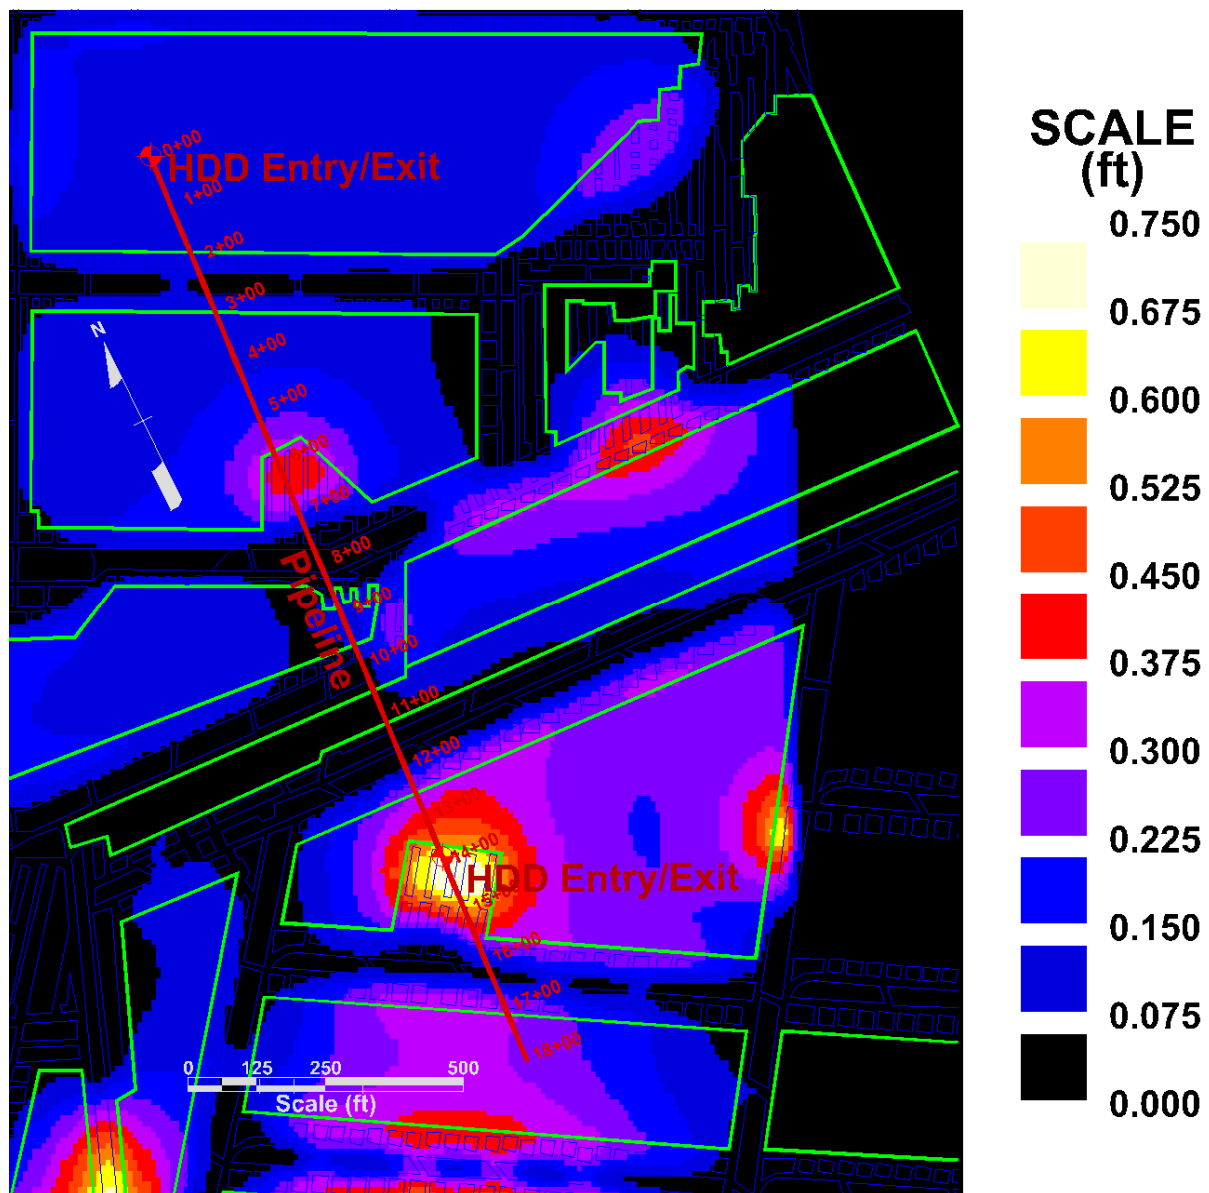
Figure 8. Increase in subsidence going from 900 psi coal to 600 psi coal.

**Additional Subsidence:** When the thin rib pillars in the uncaved areas fail, they cause convergence directly over the pillar. Also, the pillar failure puts additional loading and associate convergence on the adjacent gob areas. The ground reaction to the pillar failures then results in additional overburden subsidence as shown in Figures 8 and 9. With a reduction in coal strength to 600 psi, the areas of greatest increased subsidence are the areas of the uncaved retreat pillars.

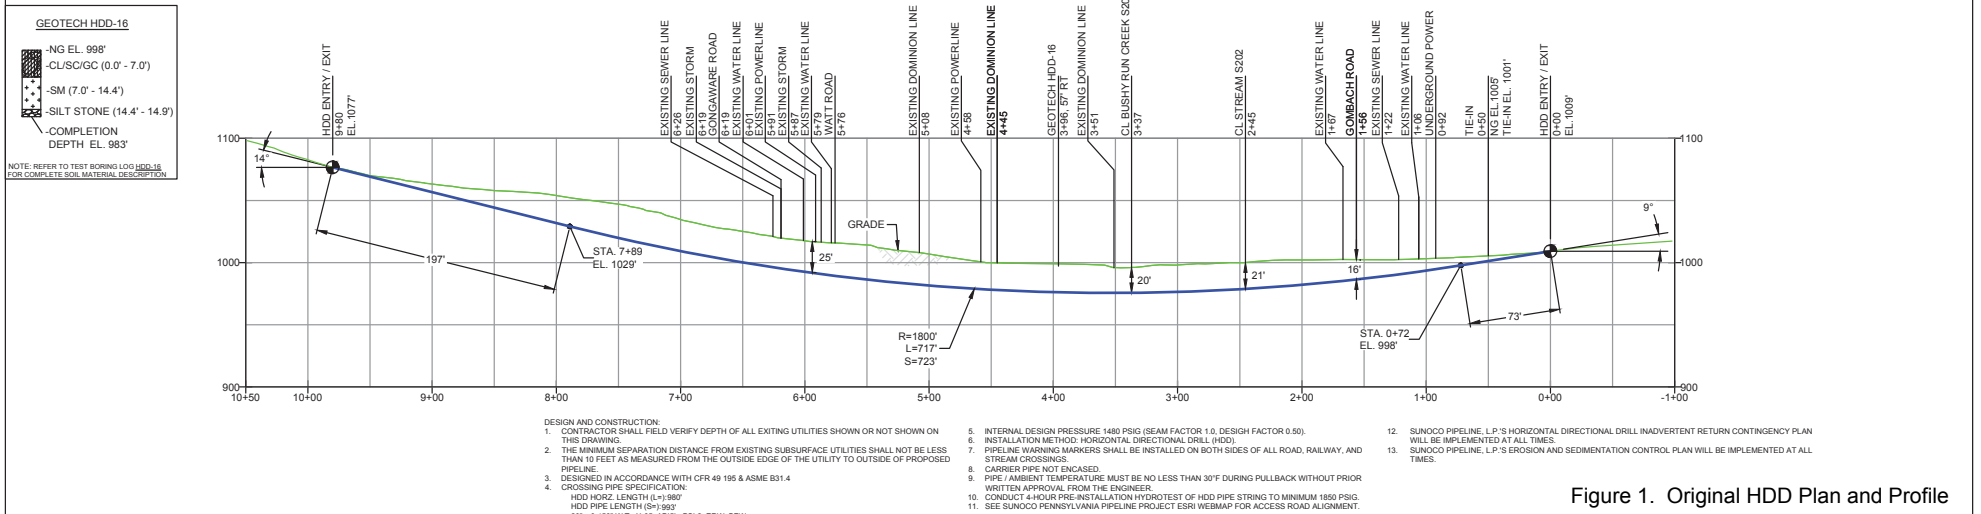
**PROFILE VIEW**

Figure 1. Original HDD Plan and Profile

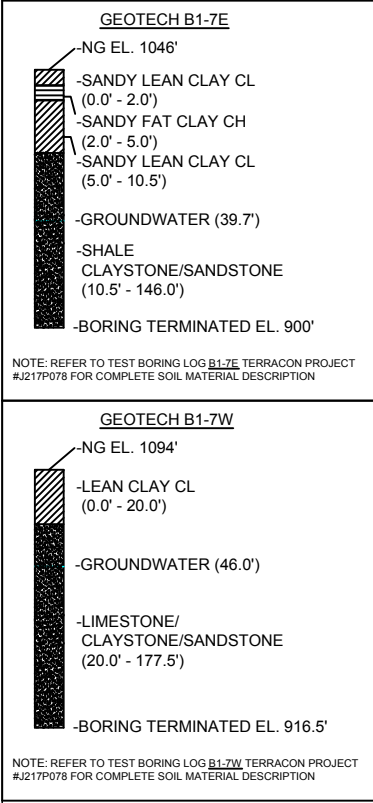
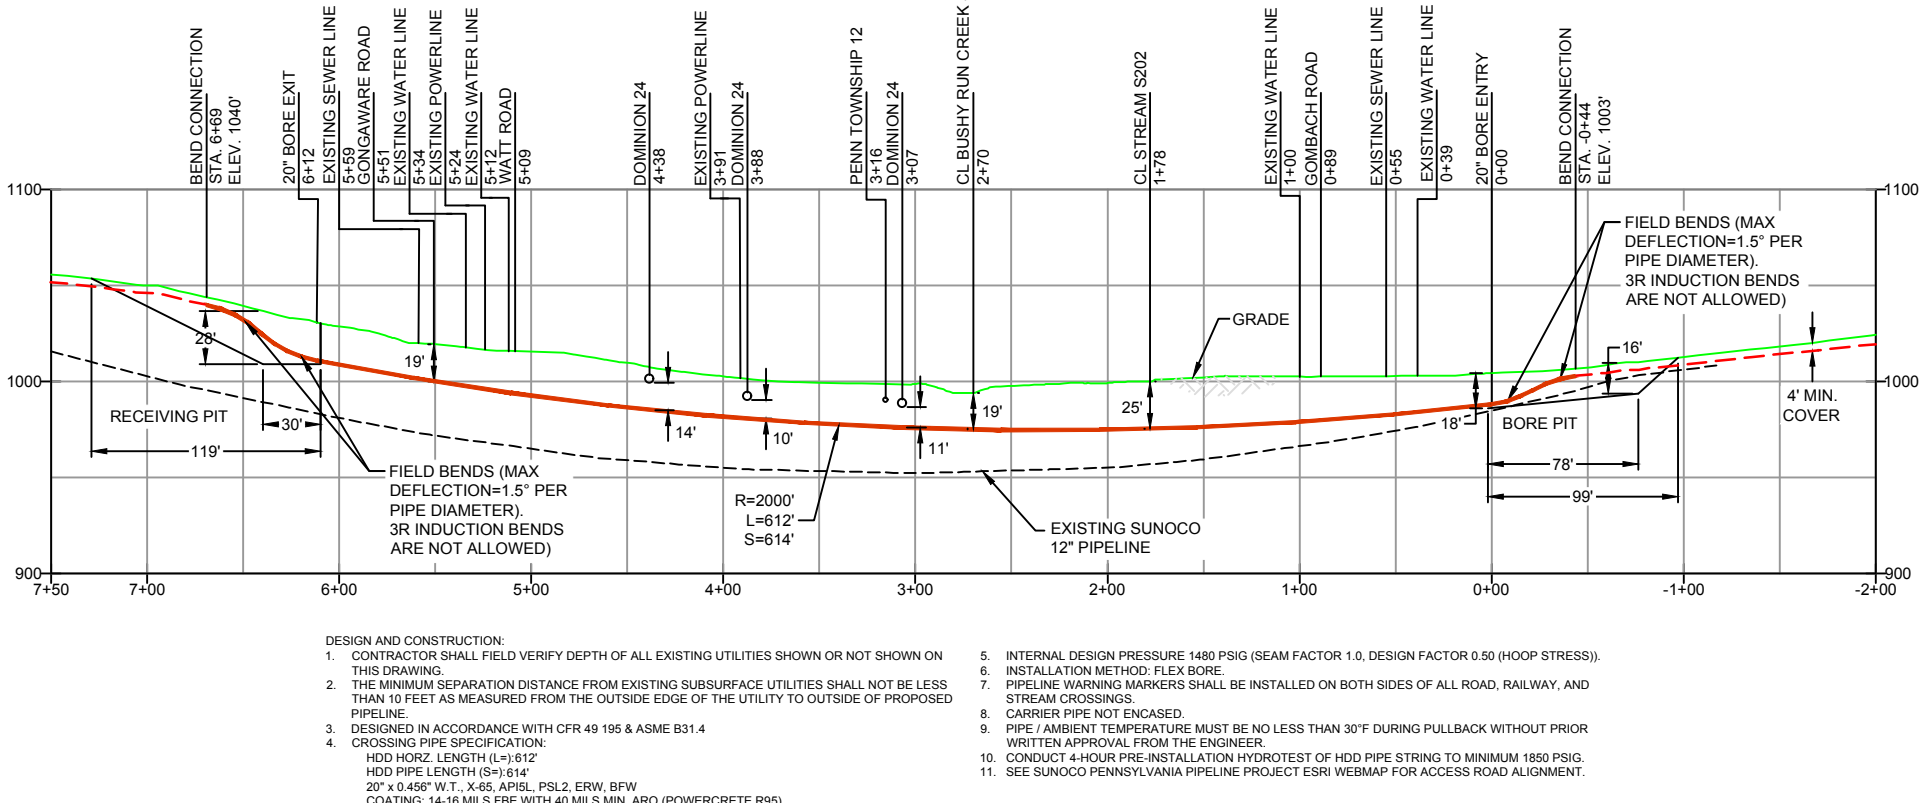
Figure 3.

PROFILE VIEW
