## **TRIP REPORT FAIRVIEW ROAD EFRD SITE – INFILTRATION TESTING**

**Table 1**  
**Summary of Infiltration Test Results**  
**Fairview Road ME2 EFRD**  
**Wallace Township, Chester County, PA**  
**Sunoco PPP**

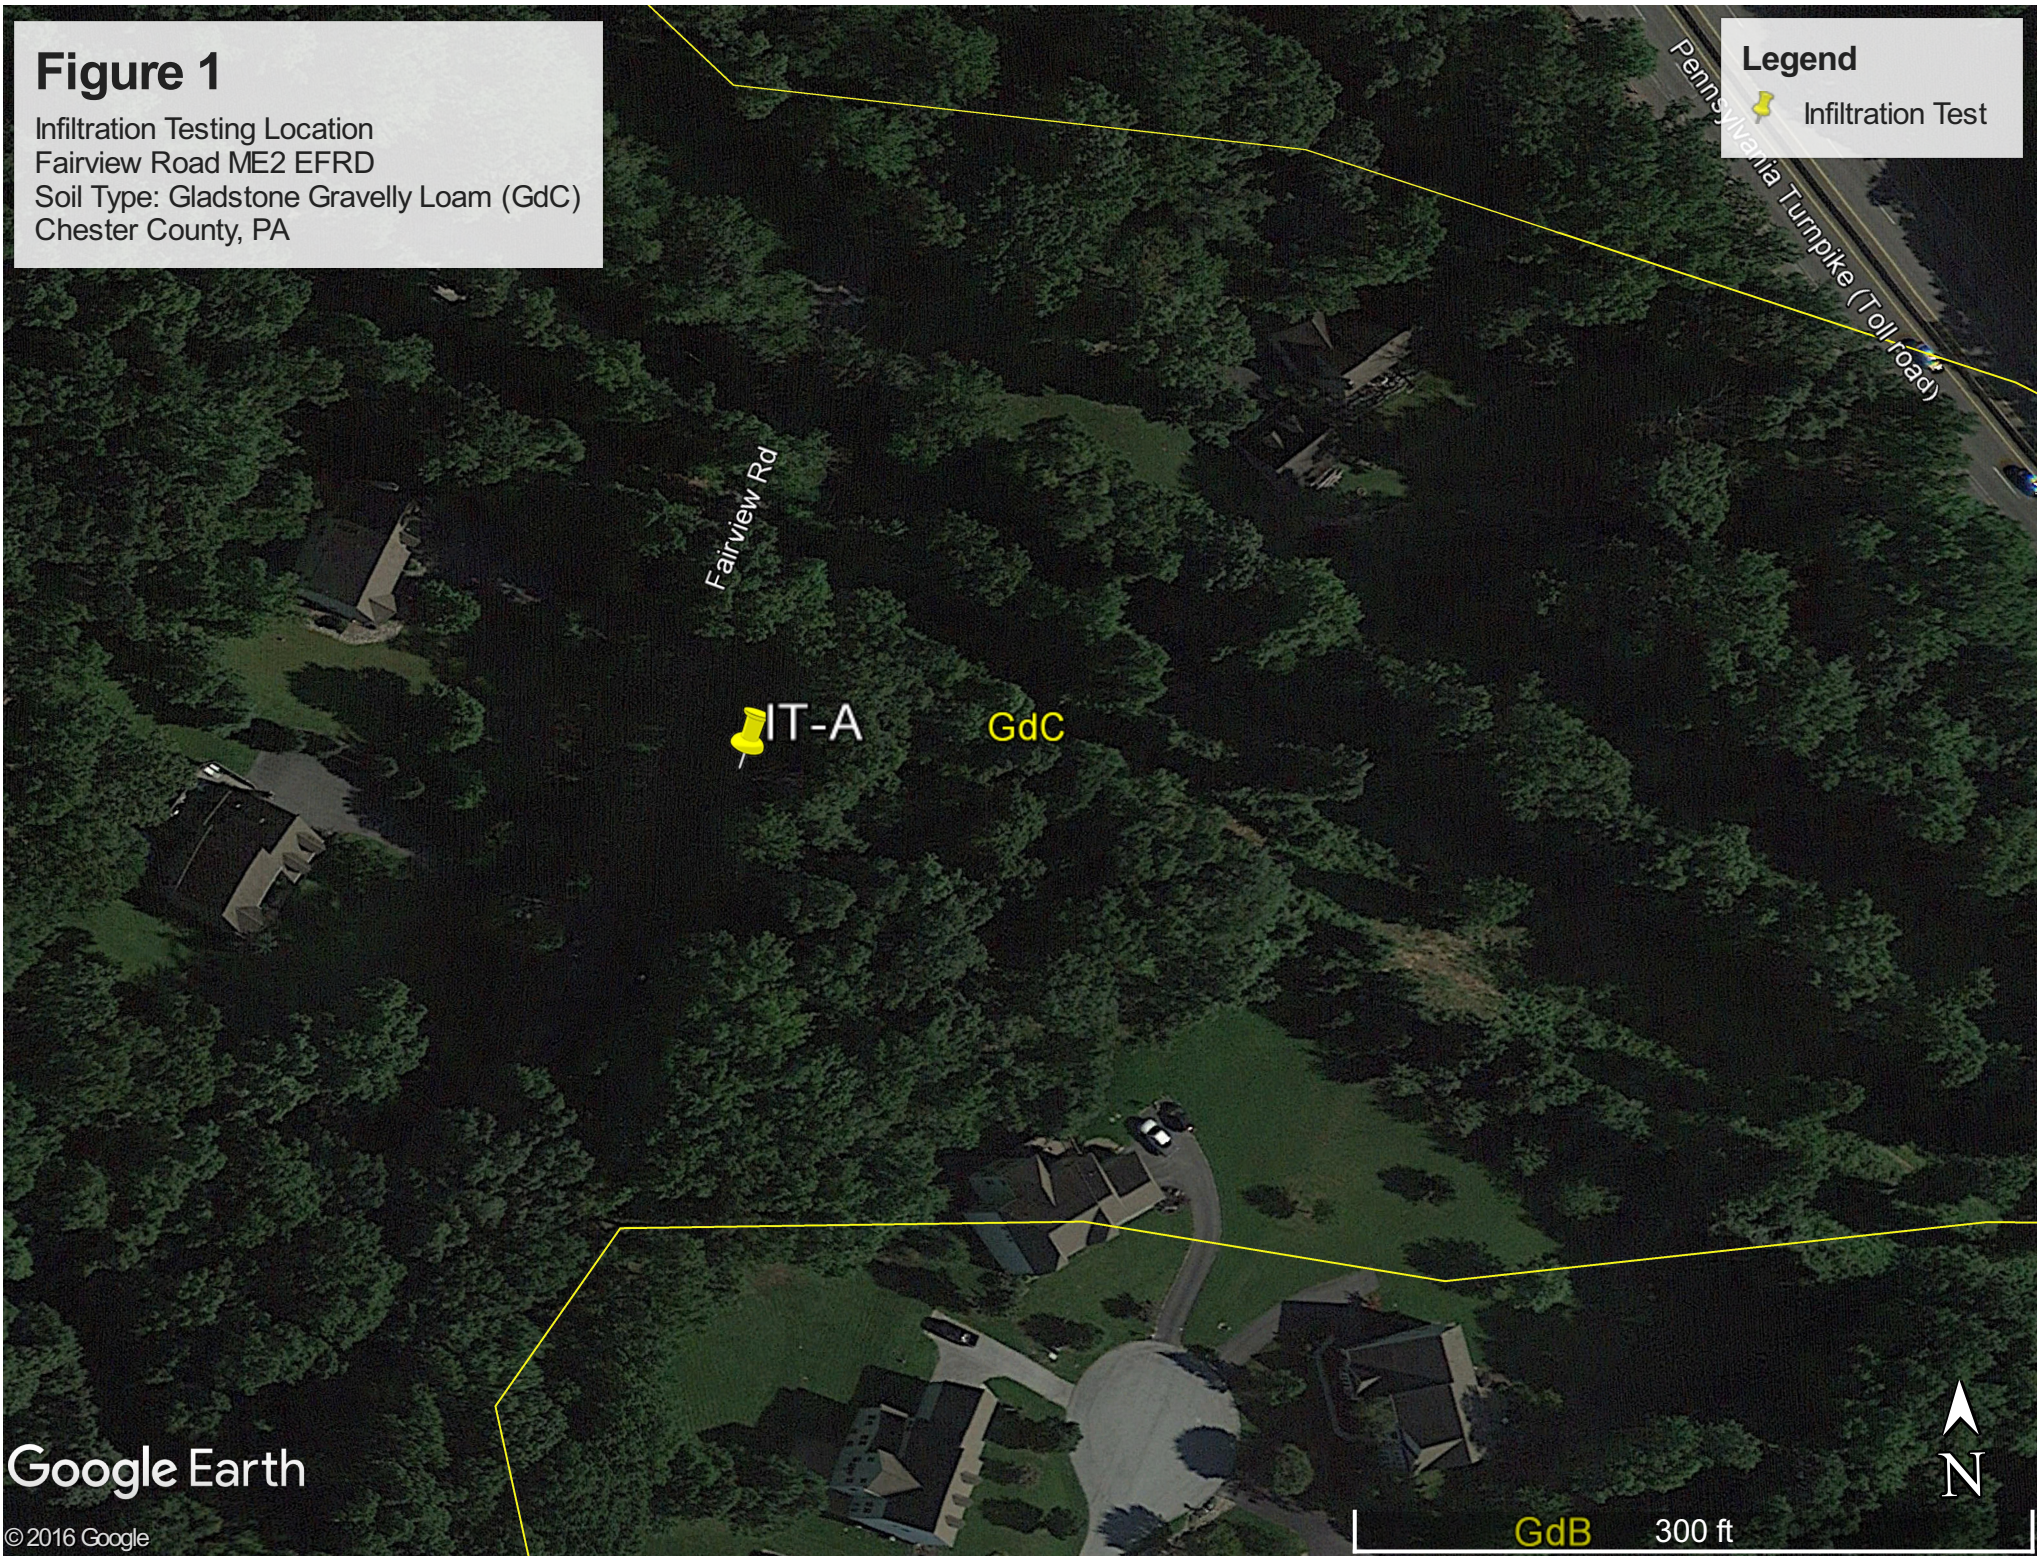
Infiltration Testing Location  
Fairview Road ME2 EFRD  
Soil Type: Gladstone Gravelly Loam (GdC)  
Chester County, PA

**Legend**  
📌 Infiltration Test

This Trip Report presents the field data and results of double-ring soil infiltration tests conducted to support the design of a stormwater management system at the Fairview Road EFRD site located in Wallace Township, Chester County, Pennsylvania as part of the Pennsylvania Pipeline Project (PPP) for Sunoco Pipeline, LP. One surface test (IT-A) was performed at the site. The test location is listed by coordinates (latitude and longitude) in Table 1 and shown on the attached figure.

The infiltration test was conducted by Greg Ritson of Rettew, Inc., on September 27, 2016. The test location was positioned in the field using a handheld, WAAS-enabled GPS unit. Table 1 provides the coordinates of the test location. The test was located in a wooded area, approximately 35 feet east of Fairview Road.
