TRIP REPORT EAST LINCOLN HIGHWAY VALVE SITE – INFILTRATION TESTING

1.0 PURPOSE

This Trip Report presents the field data and results of double-ring soil infiltration tests conducted to support the design of a stormwater management system at the East Lincoln Highway Valve site located in West Whiteland Township, Chester County, Pennsylvania as part of the Pennsylvania Pipeline Project (PPP) for Sunoco Pipeline, LP. One shallow test (IT-A) was performed at the site. The test location is listed by coordinates (latitude and longitude) in Table 1 and shown on the attached figure.

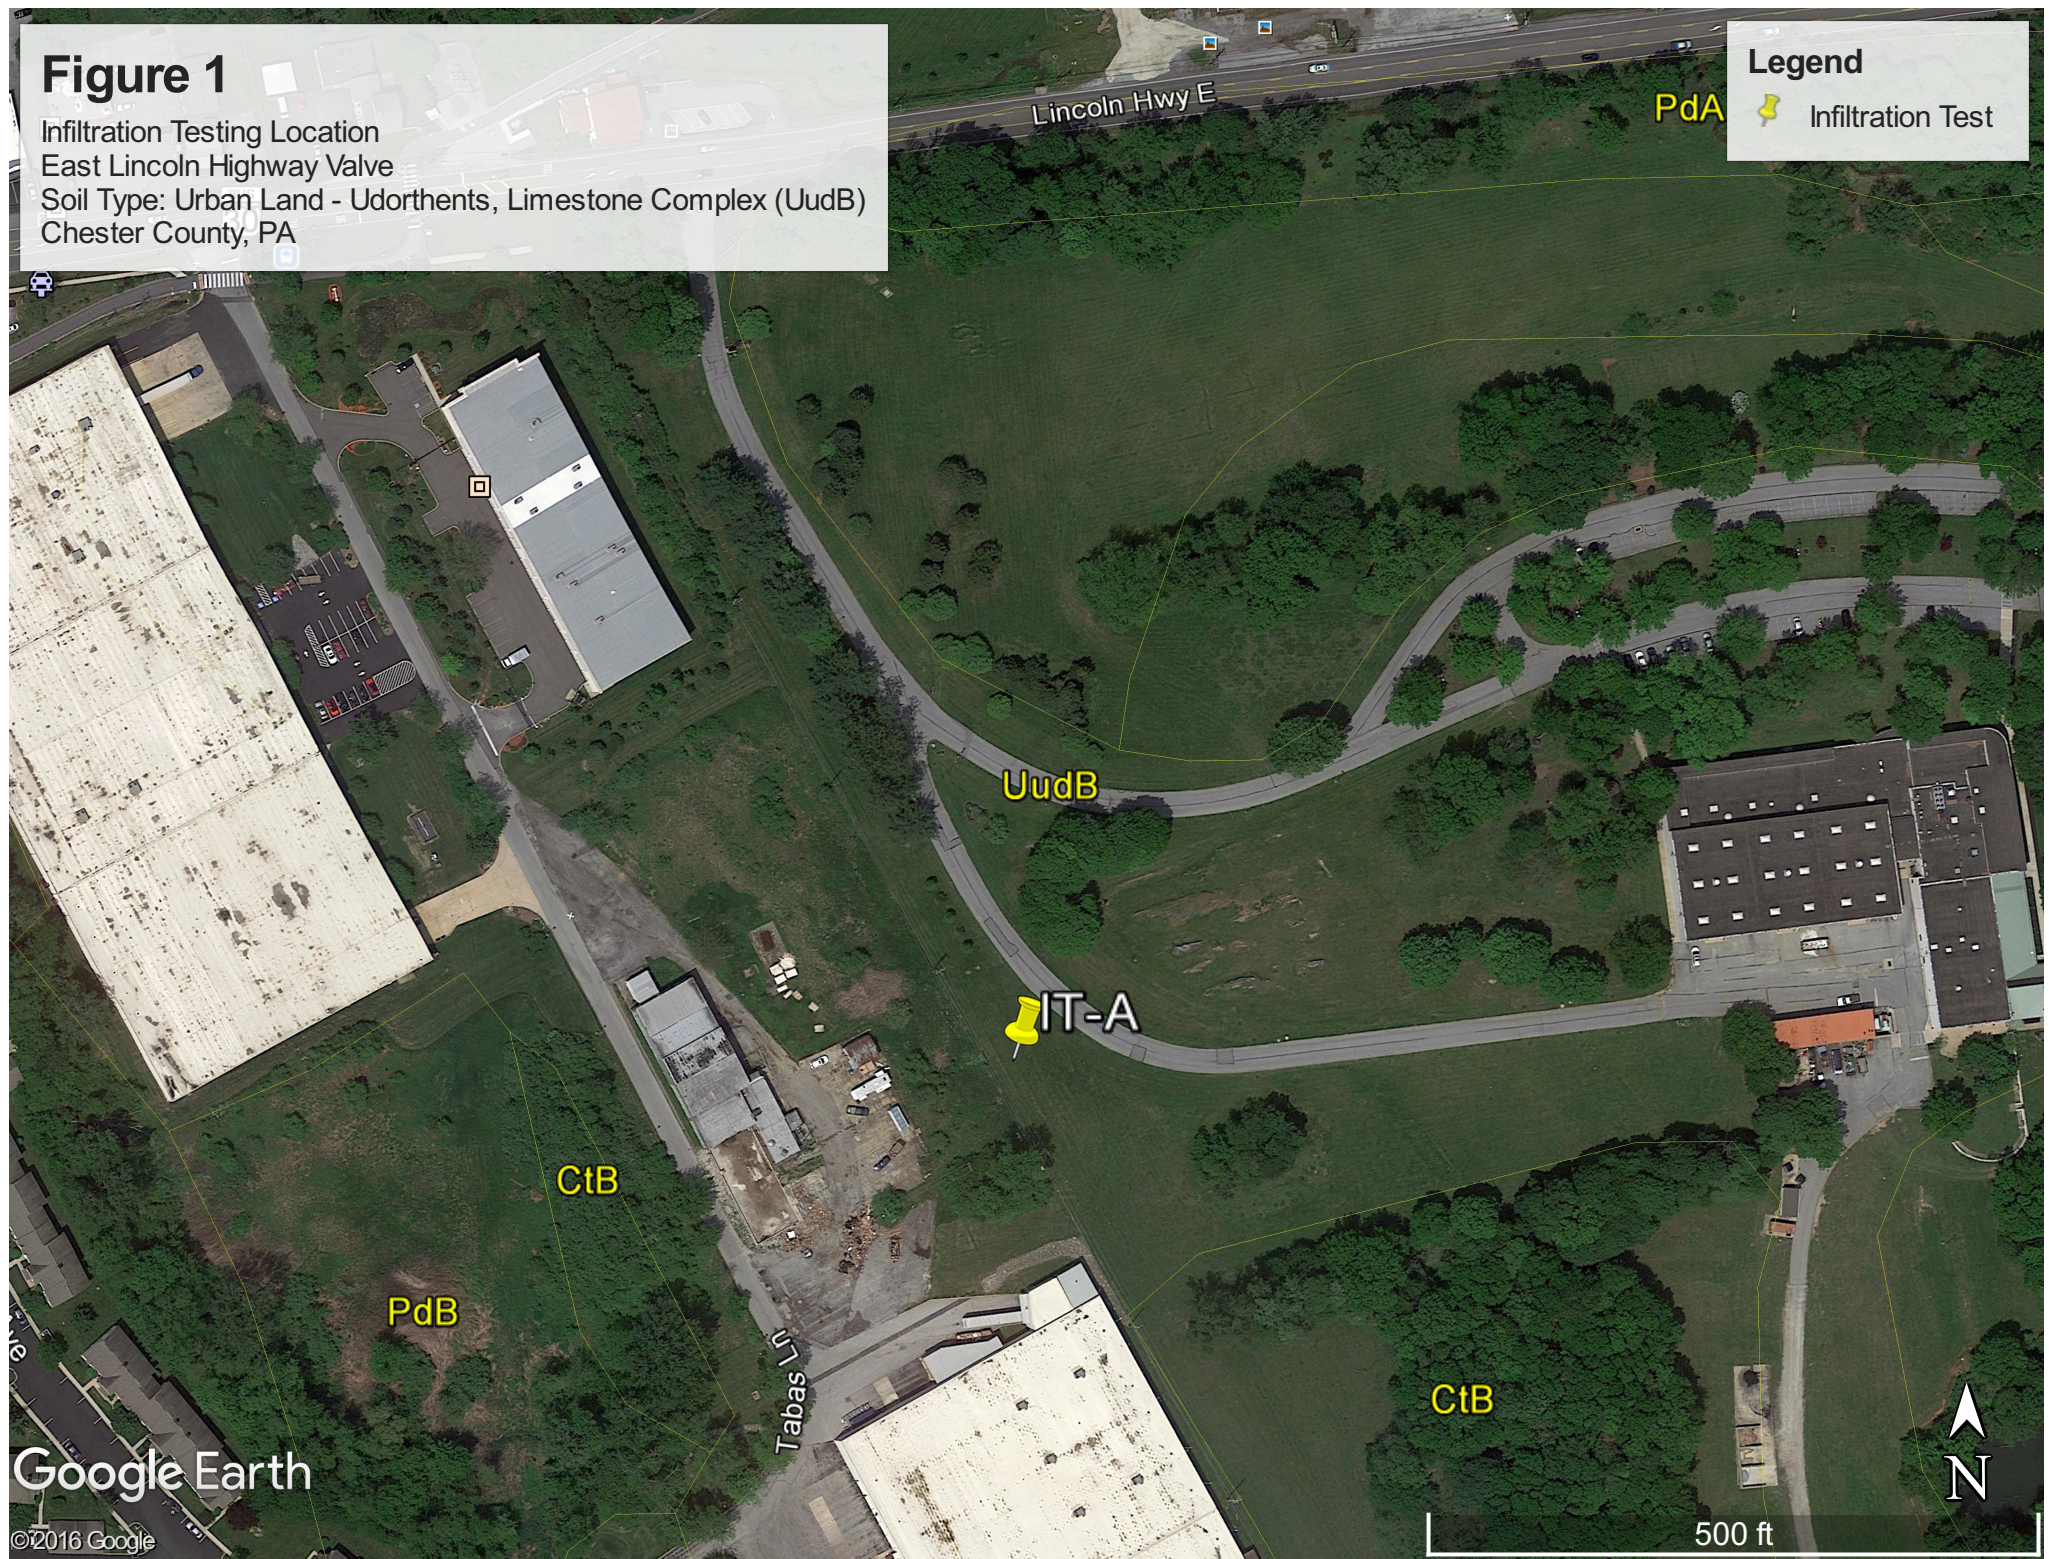
Infiltration Test

Infiltration Testing Location
East Lincoln Highway Valve
Soil Type: Urban Land - Udorthents, Limestone Complex (UudB)
Chester County, PA

The infiltration test was conducted by Jim Goerdt and Jim Coffman of Tetra Tech, Inc., on October 7, 2016. The test location was positioned in the field using a handheld, WAAS-enabled GPS unit. Table 1 provides the coordinates of the test location. IT-A was located on a flat grassy area, approximately 800 feet south of East Lincoln Highway.
