**Re: Hydrogeologic HDD Re-Evaluation Report
Snitz Creek/North Zinns Mill Road Crossing
16" Horizontal Directional Drill Location (S3-0101-16)
Permit No. E38-194
West Cornwall Township, Lebanon County**

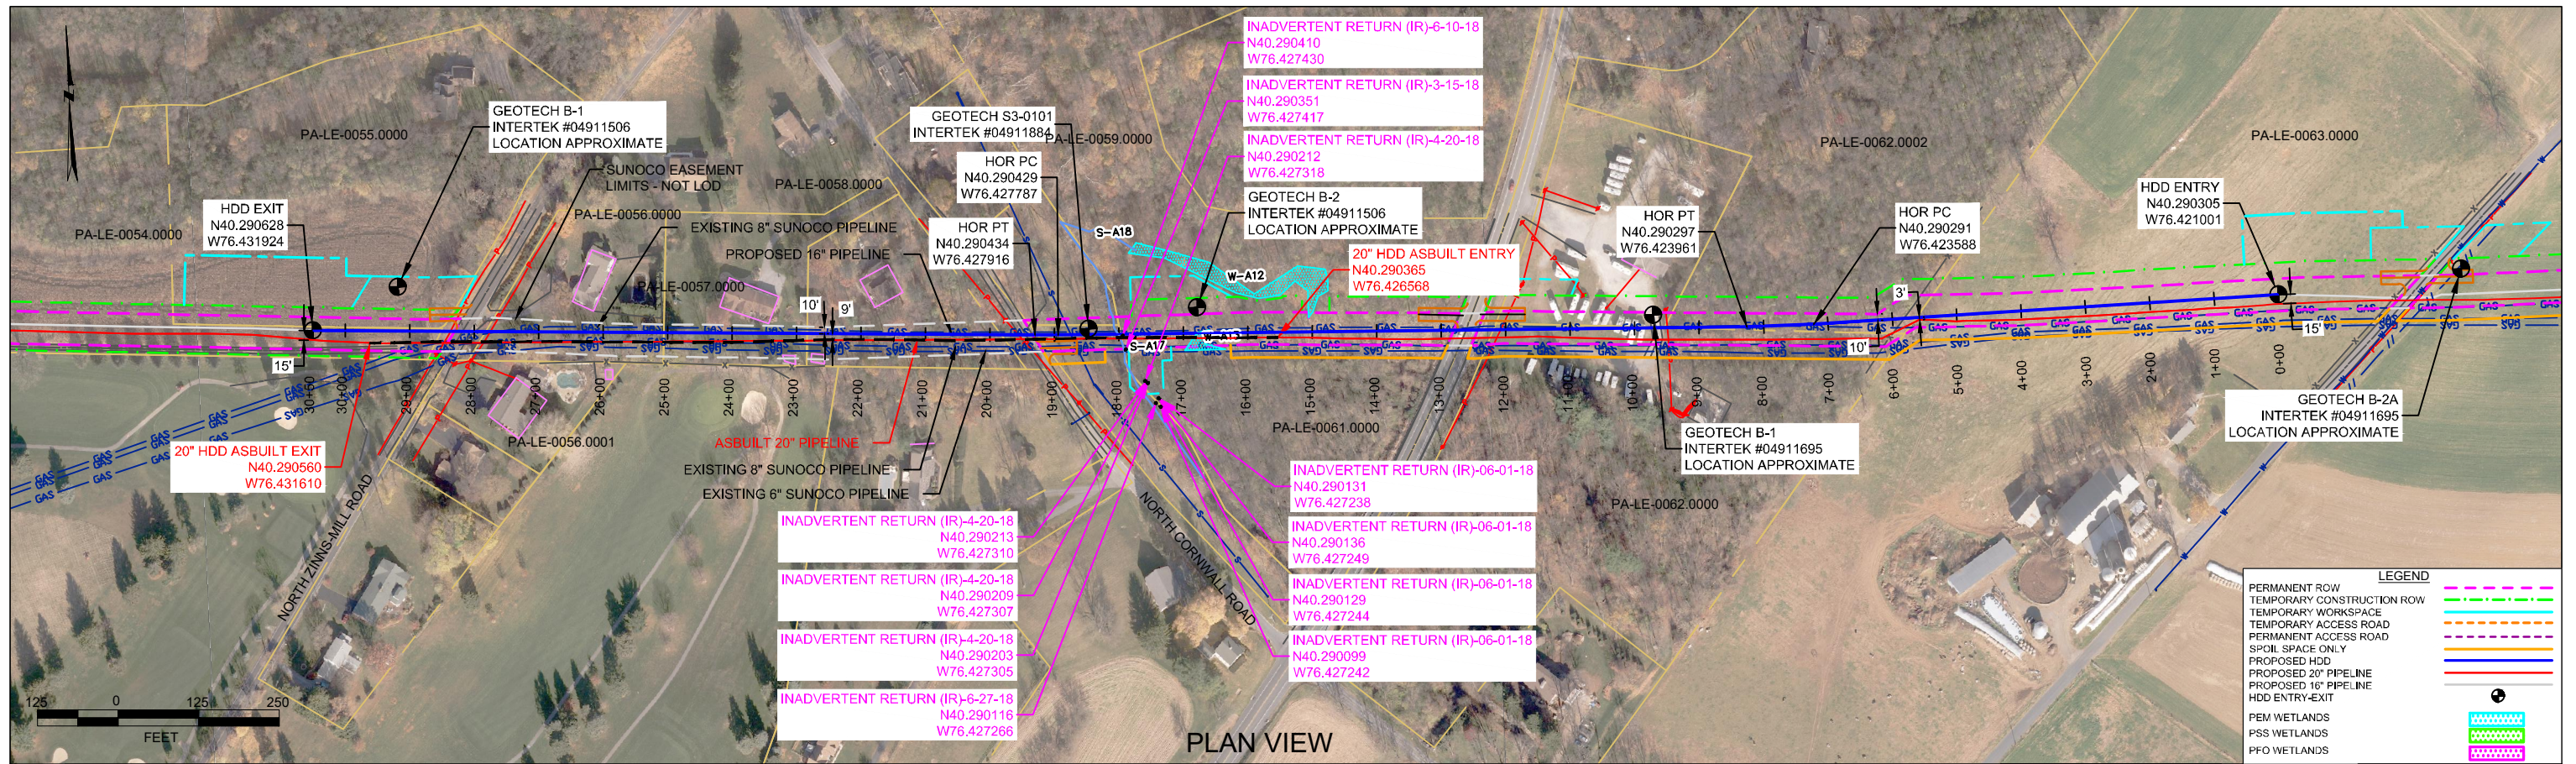
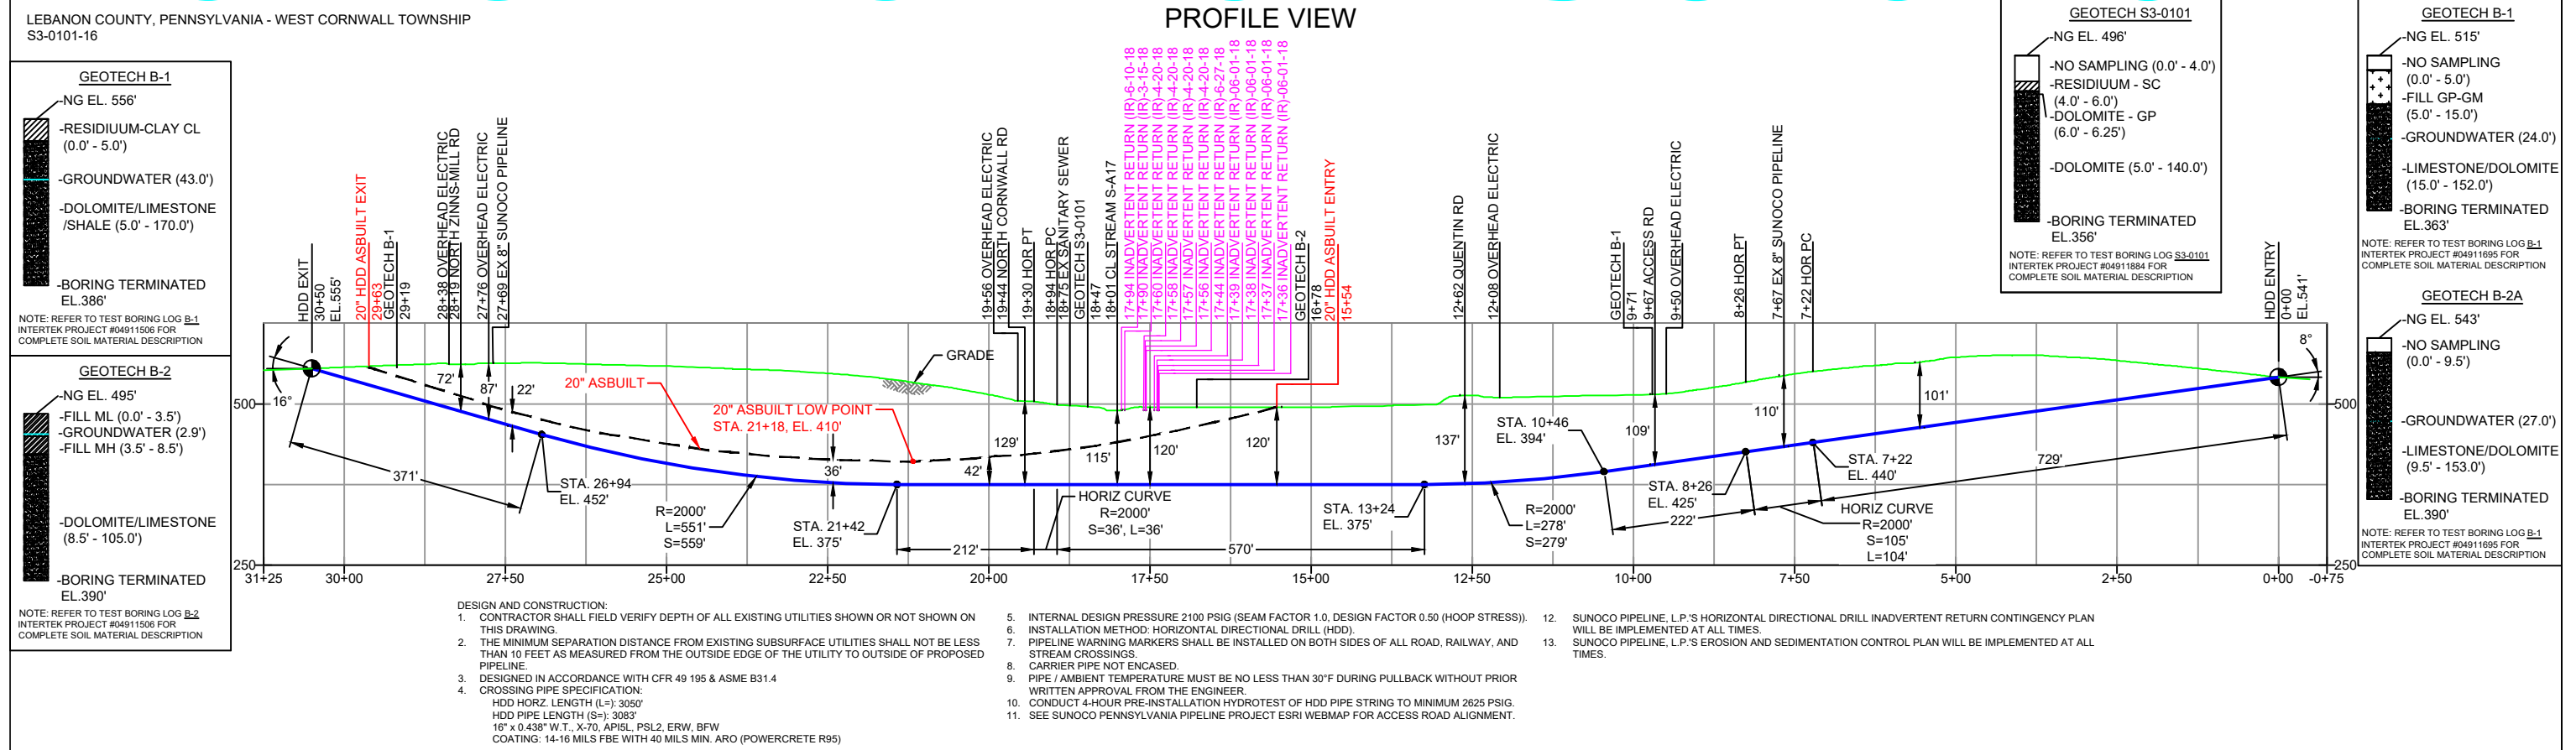
PLAN VIEW

PROFILE VIEW

- DESIGNED IN ACCORDANCE WITH CFR 49 195 & ASME B31.4
 - CROSSING PIPE SPECIFICATION:
HDD HORZ. LENGTH (L=): 3050'
HDD PIPE LENGTH (S=): 3083'
16" x 0.438" W.T., X-70, APISL, PSL2, ERW, BFW
COATING: 14-16 MILS FBE WITH 40 MILS MIN. ARO (POWERCRETE R95)

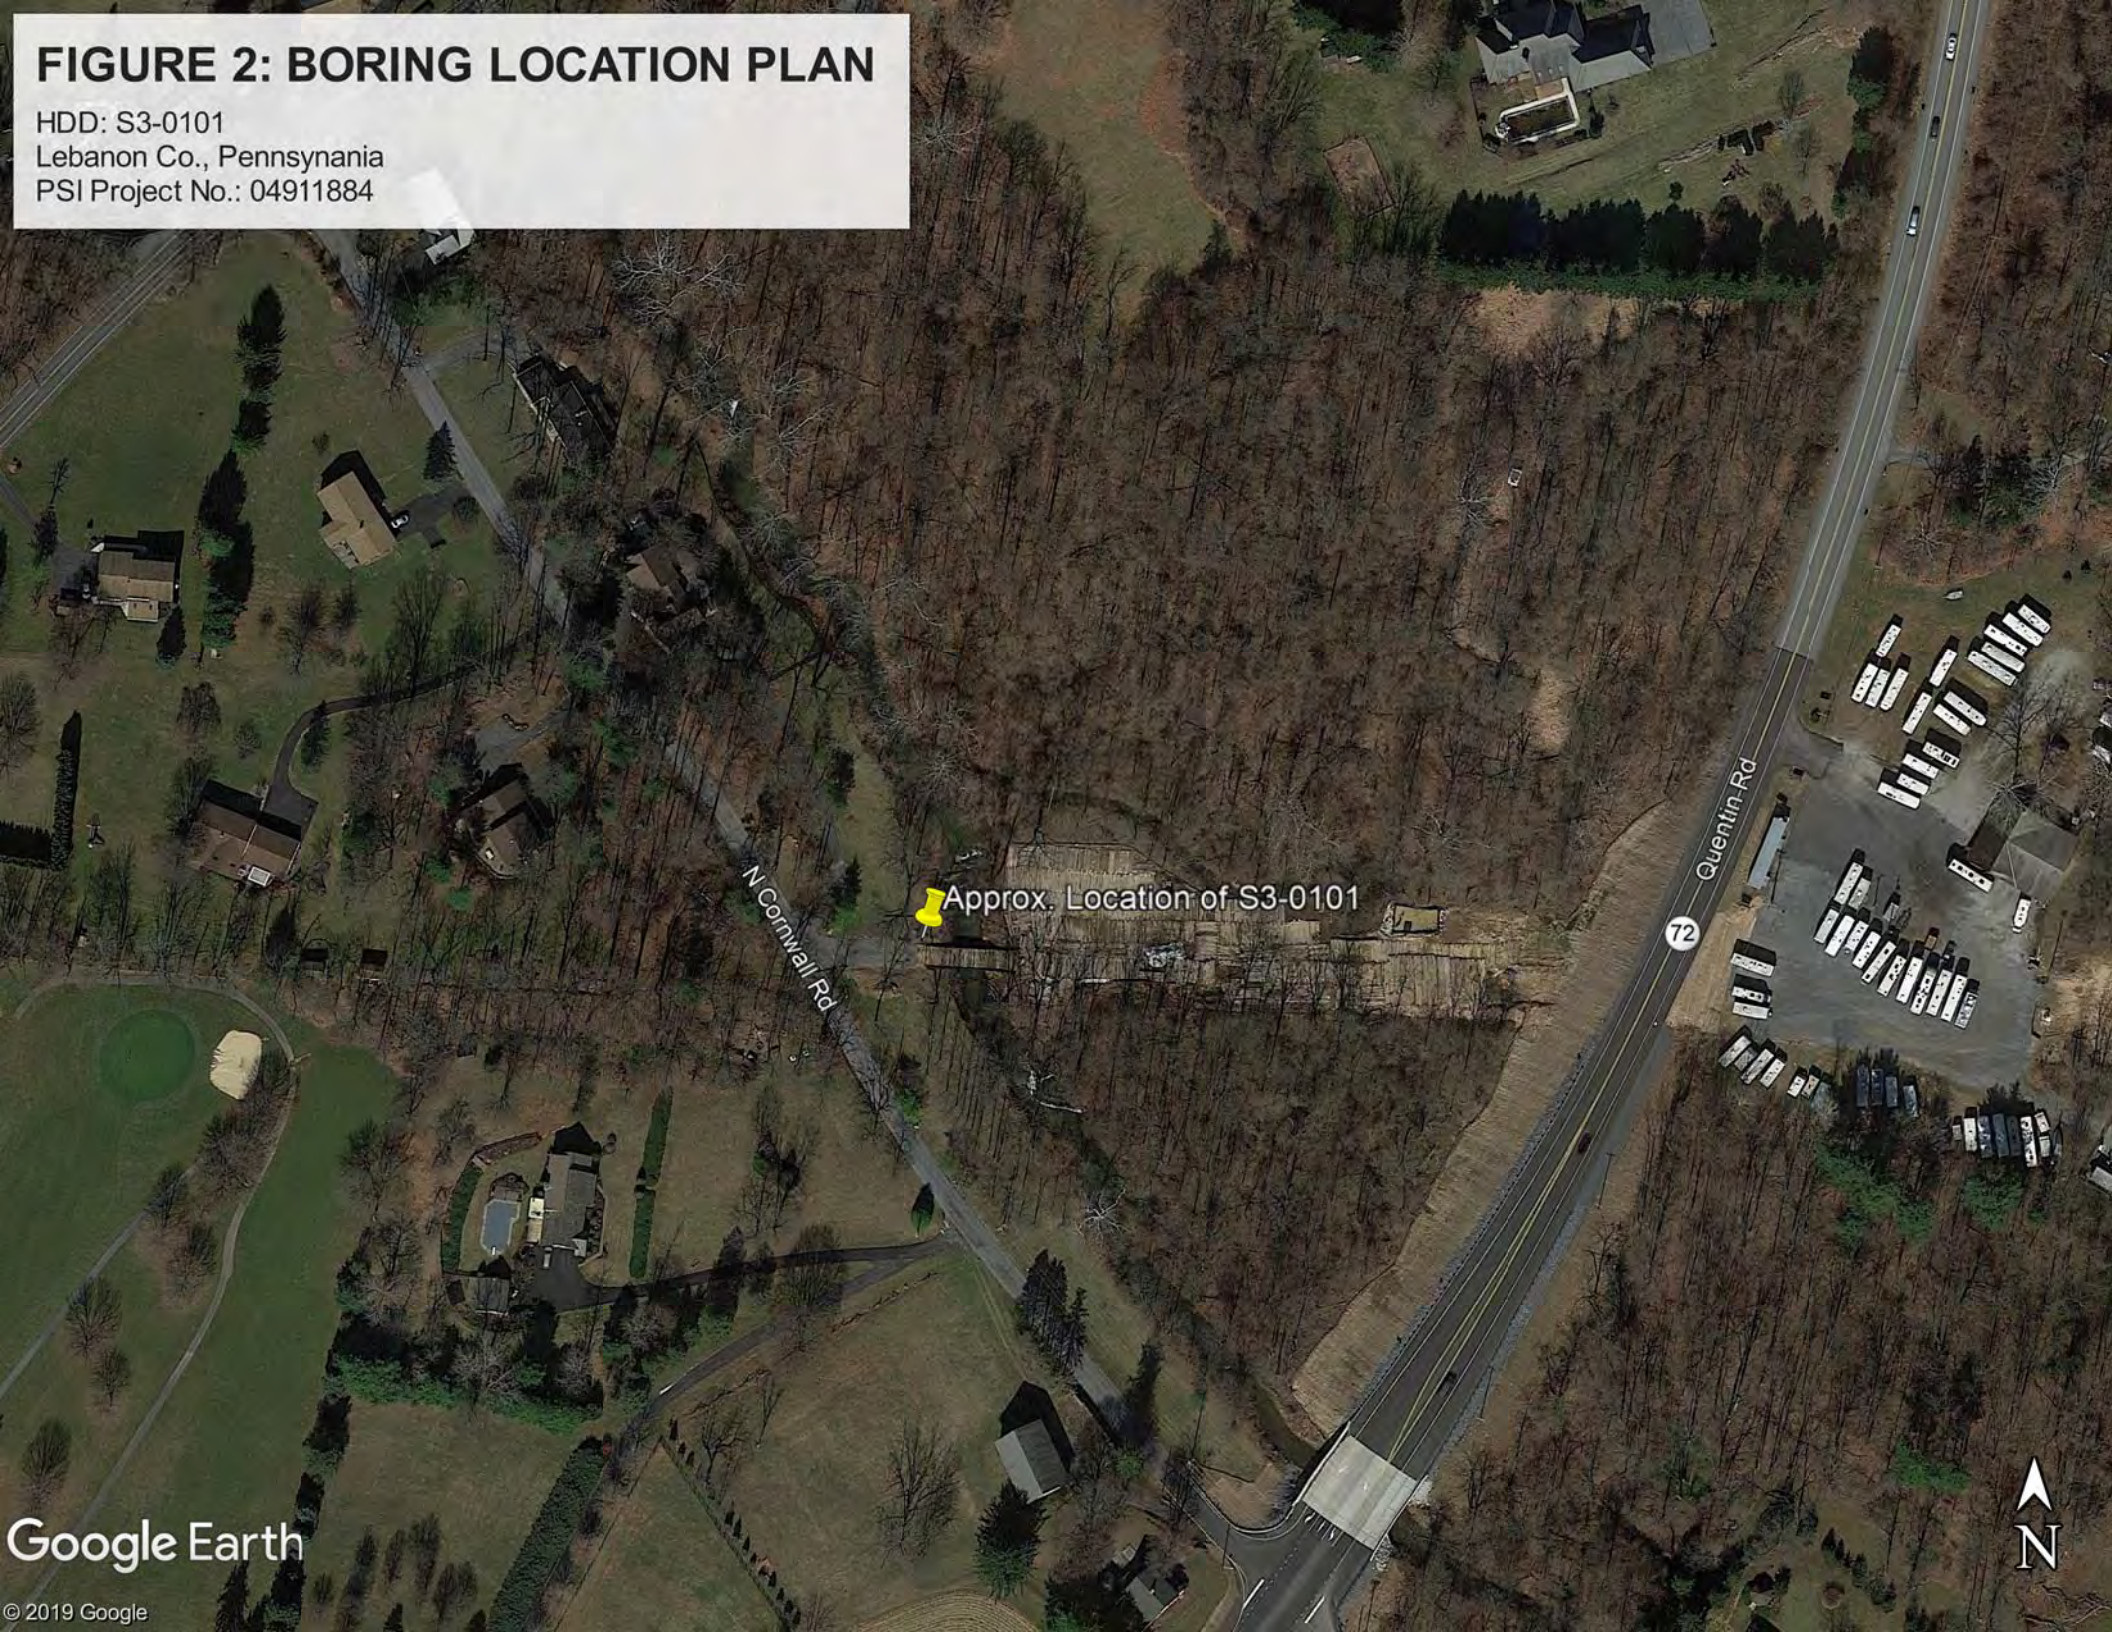
FIGURE 2: BORING LOCATION PLAN

HDD: S3-0101
Lebanon Co., Pennsylvania
PSI Project No.: 04911884

Attachment: Figure 1 – Site Vicinity Map
Figure 2 – Boring Location Plan
Figure 3 – Site Geology Map
Figure 4 – Karst Map
Boring Logs/Rock Core Photos/General Notes

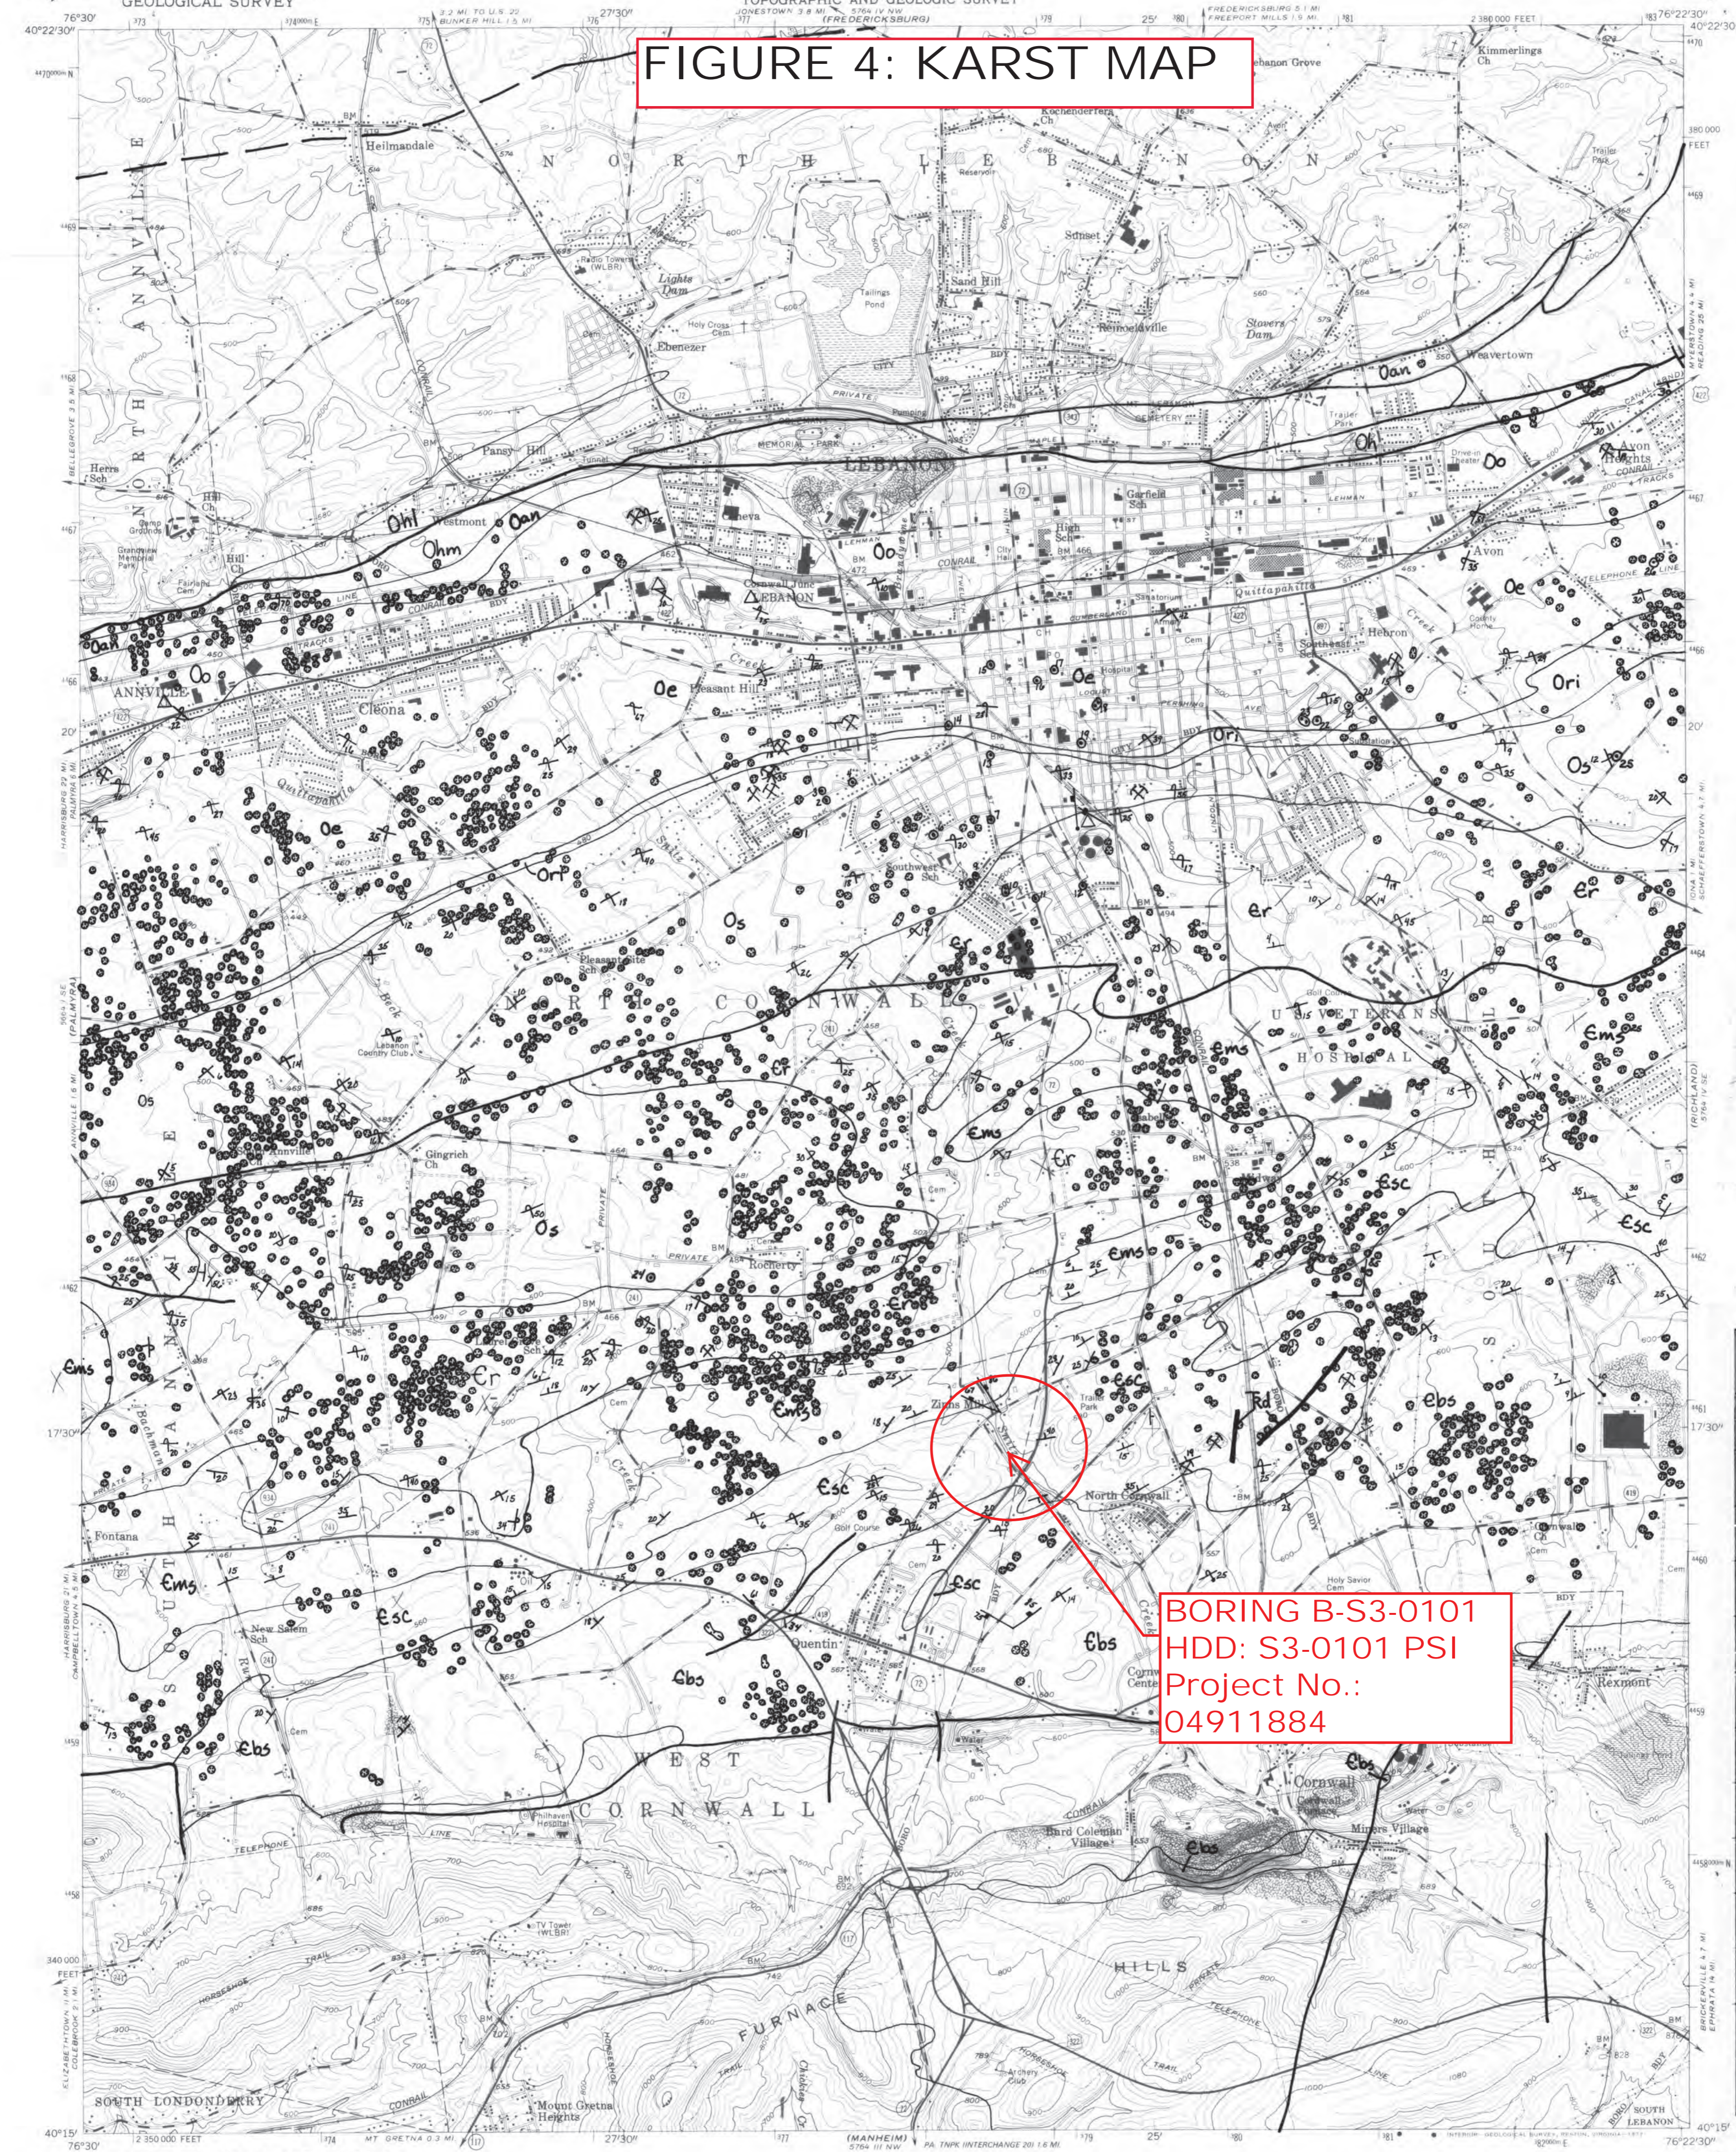
FIGURE 4: KARST MAP

**SINKHOLES AND KARST-RELATED FEATURES
OF LEBANON COUNTY, PENNSYLVANIA**

SYMBOLS	
	individual sinkhole
	or sinkhole group
	closed depressions interpreted from aerial photographs
	surface mine, iron
	surface mine limestone/dolomite
	surface mine type unknown
	cave entrance
	bedding orientation strike and dip
	approximate strike and dip
	overturned, bed strike and dip
	joint orientation strike and dip
	joint orientation strike and 90° dip
	fault contact
	formation contact

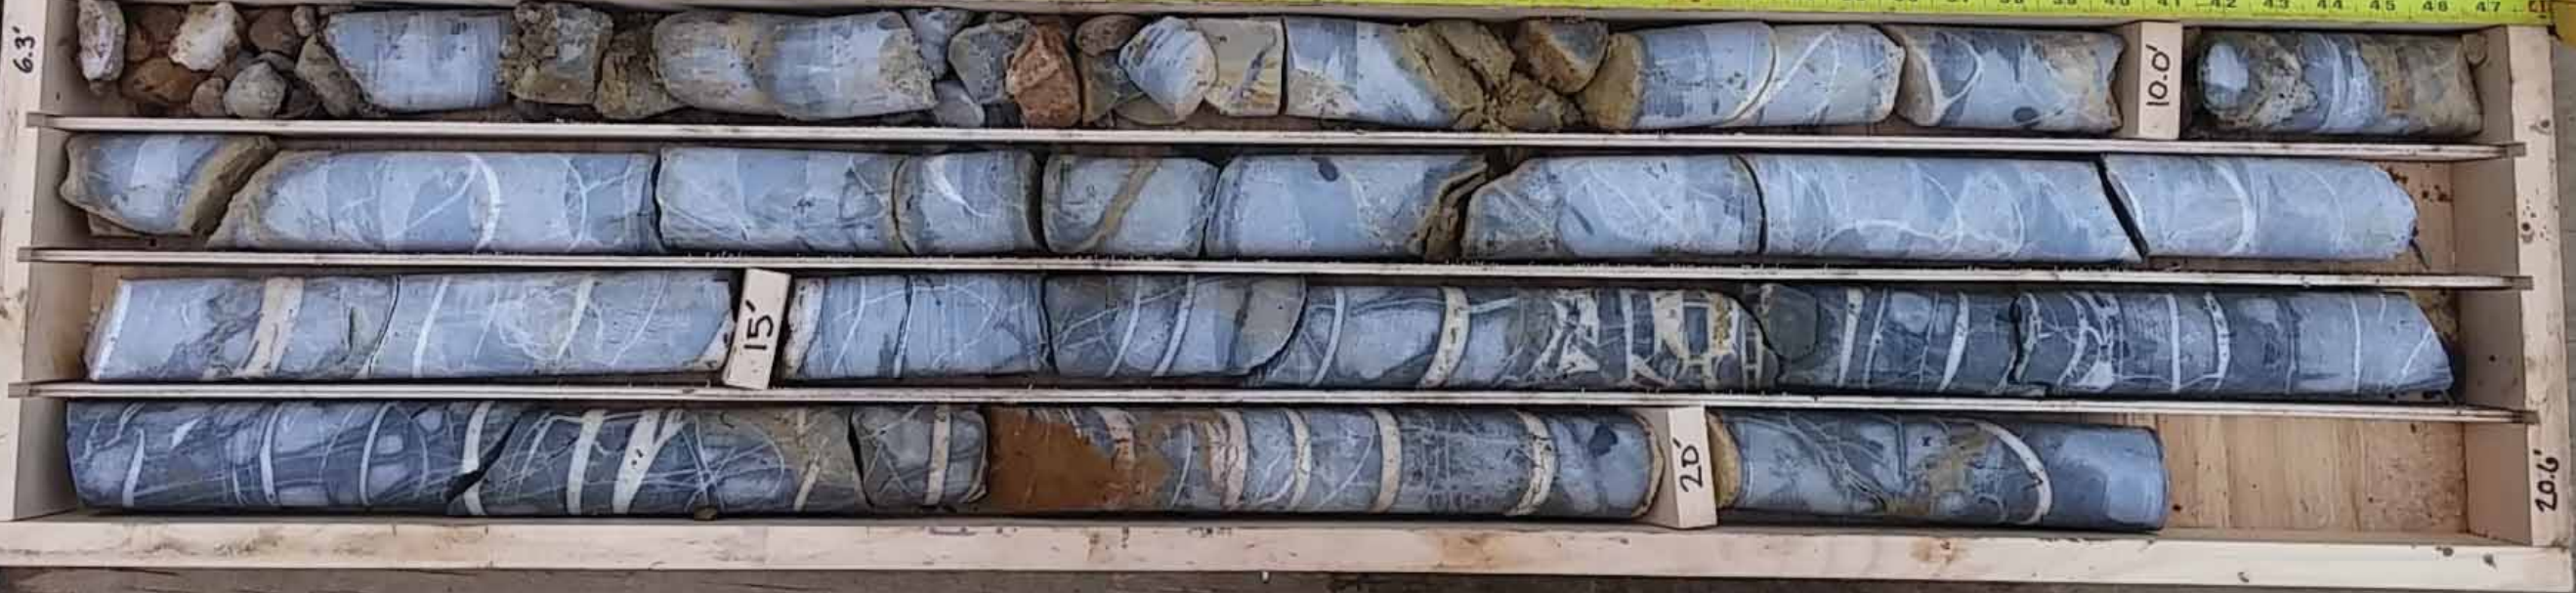
04911884
 N. ZINNS MILL RD
 1/24/2020 - 1/27/2020
 S3-0101 (6.3-20.6)
 Box 1

RUN	DEPTHS	LENGTH	REC.	RQD
1	6.3' - 10.0'	3.7'	39"	0"
2	10 - 15'	5.0'	60"	48.5"
3	15 - 20'	5.0'	60"	49.5"
4	20 - 25'	5.0'	60"	49.5"

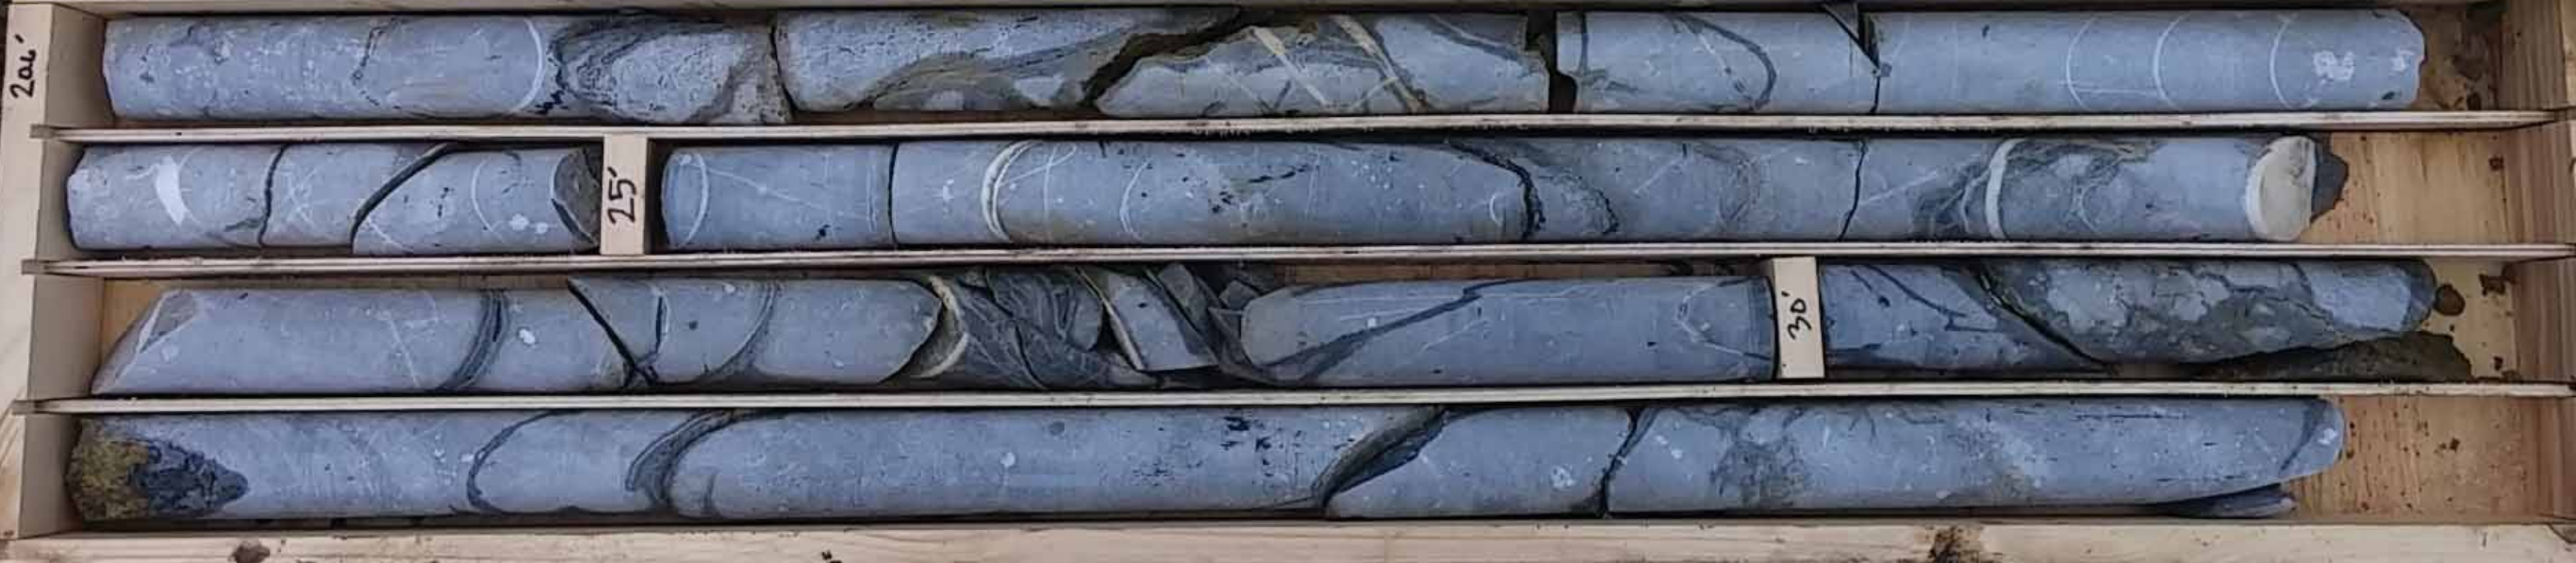
04911884
N. 2nd sec. 8.
1/27/20
S3-0101 (20.6-34.3')
Box 2

Run #	Depth	Length	Rec	Rad
5	25-30'	5.0'	60°	53°
6	30-35'	5.0'	60°	42.5°

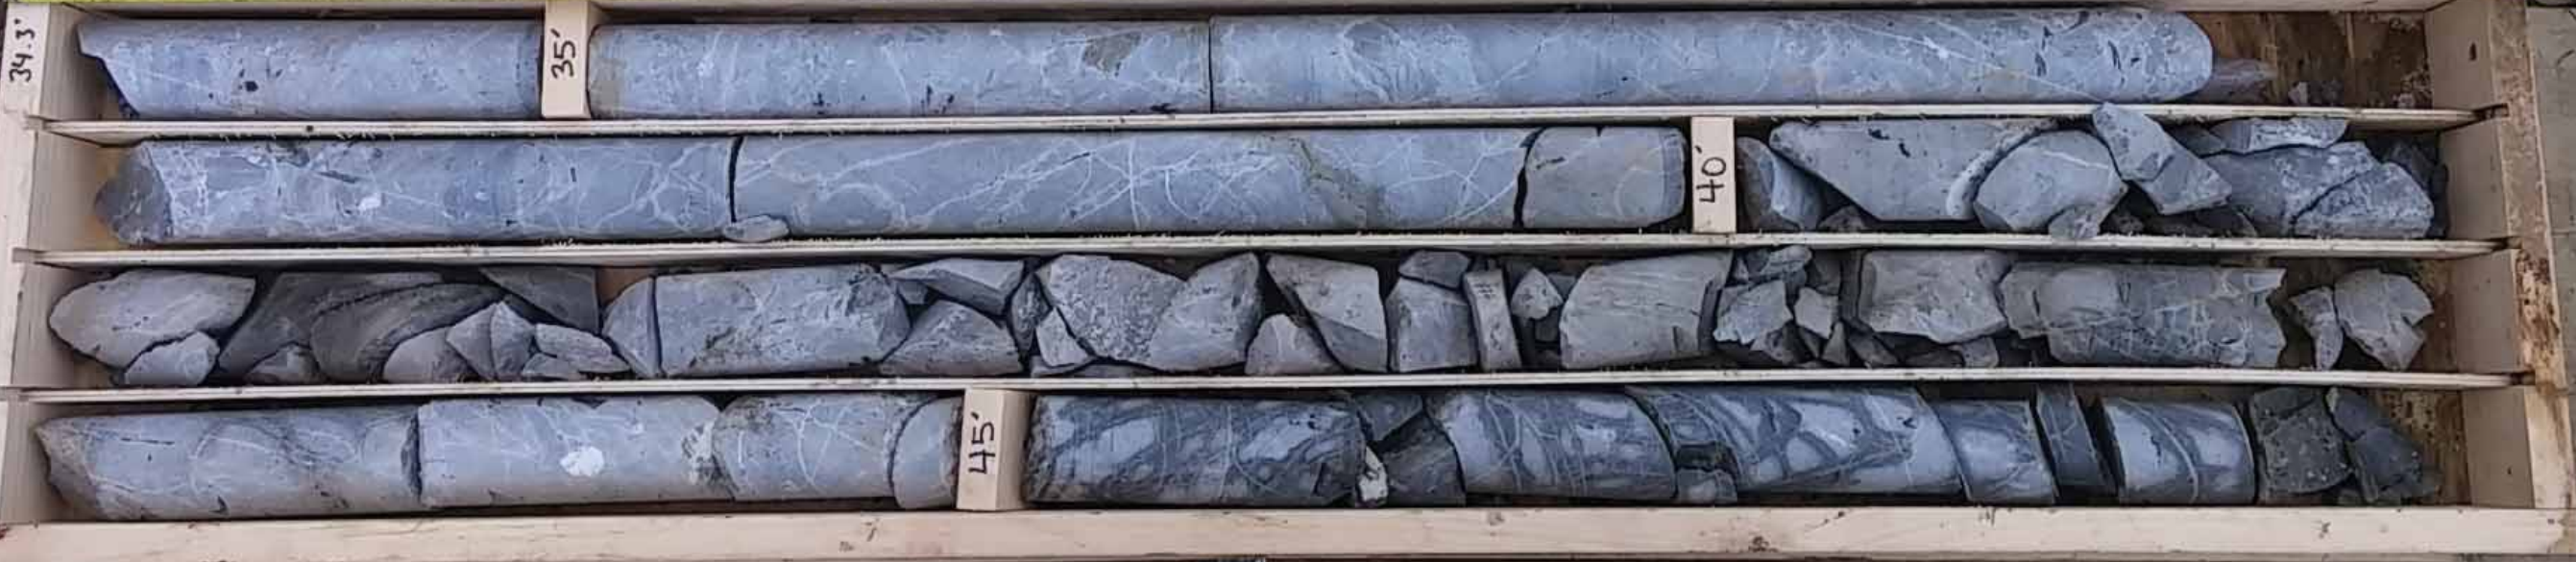
04911884
N. Zim Mill 22
1/27/20
33-0101(34.3-47.1')
Box 3

Run#	Depth	Length	Re	Rad
7	35-40'	5.0'	60"	60°
8	40-45'	5.0'	60"	16.5"
9	45-50'	5.0'	60"	39"

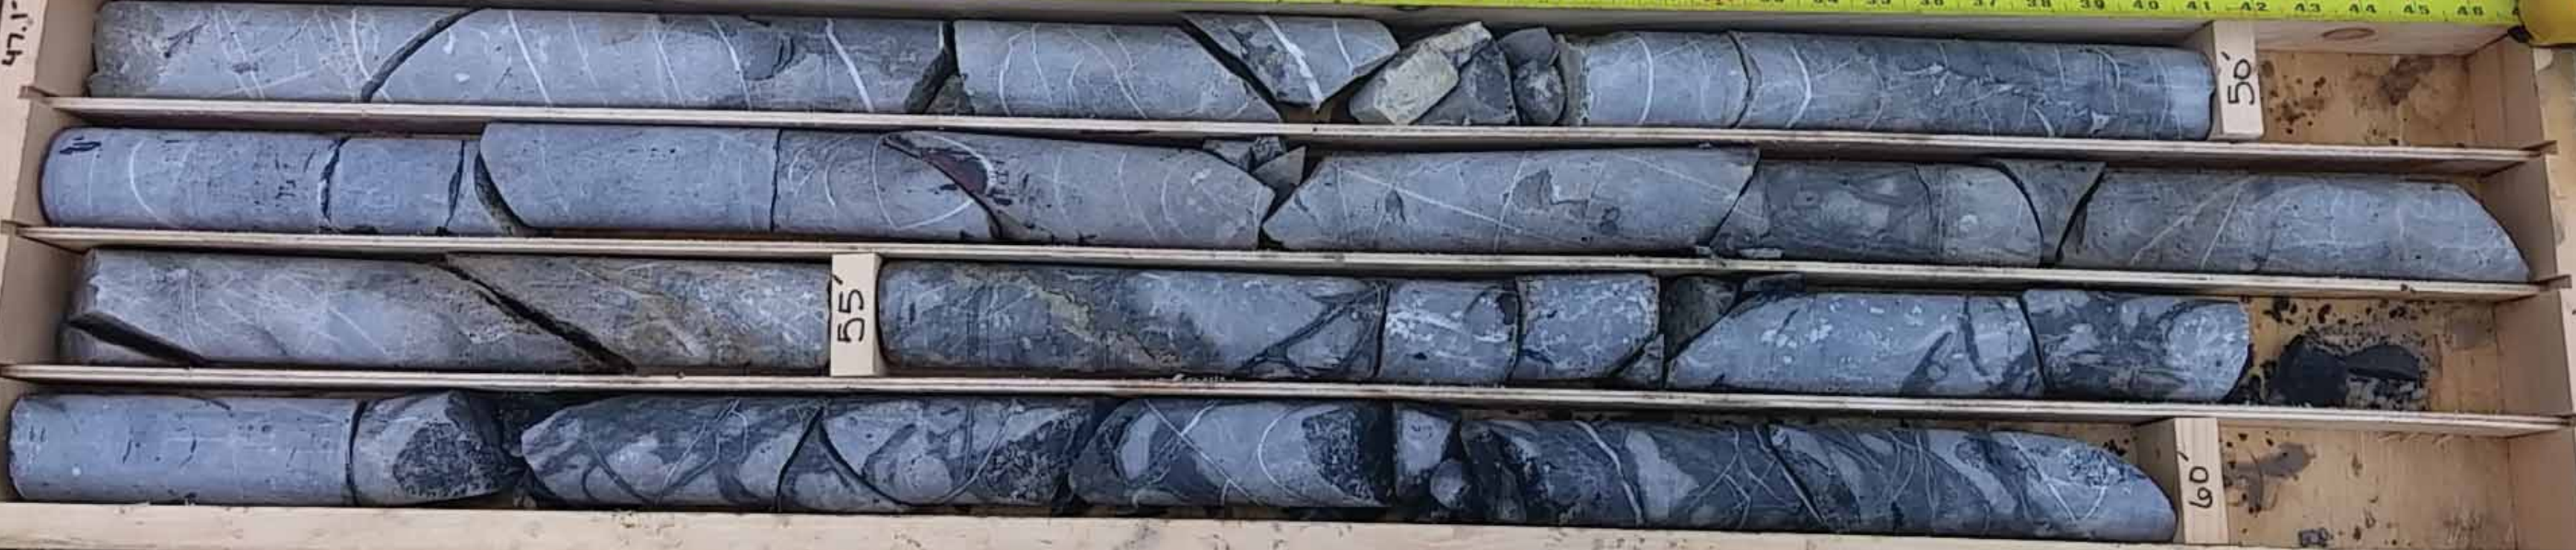
04911884
N. Zima Mill Rd.
1/27/20
53-0101(47.1-60')
Duv 4

Run #	Depth	Length	Rec	RQD
10	50-55'	5.0'	60°	43.5°
11	55-60'	5.0'	60°	41°

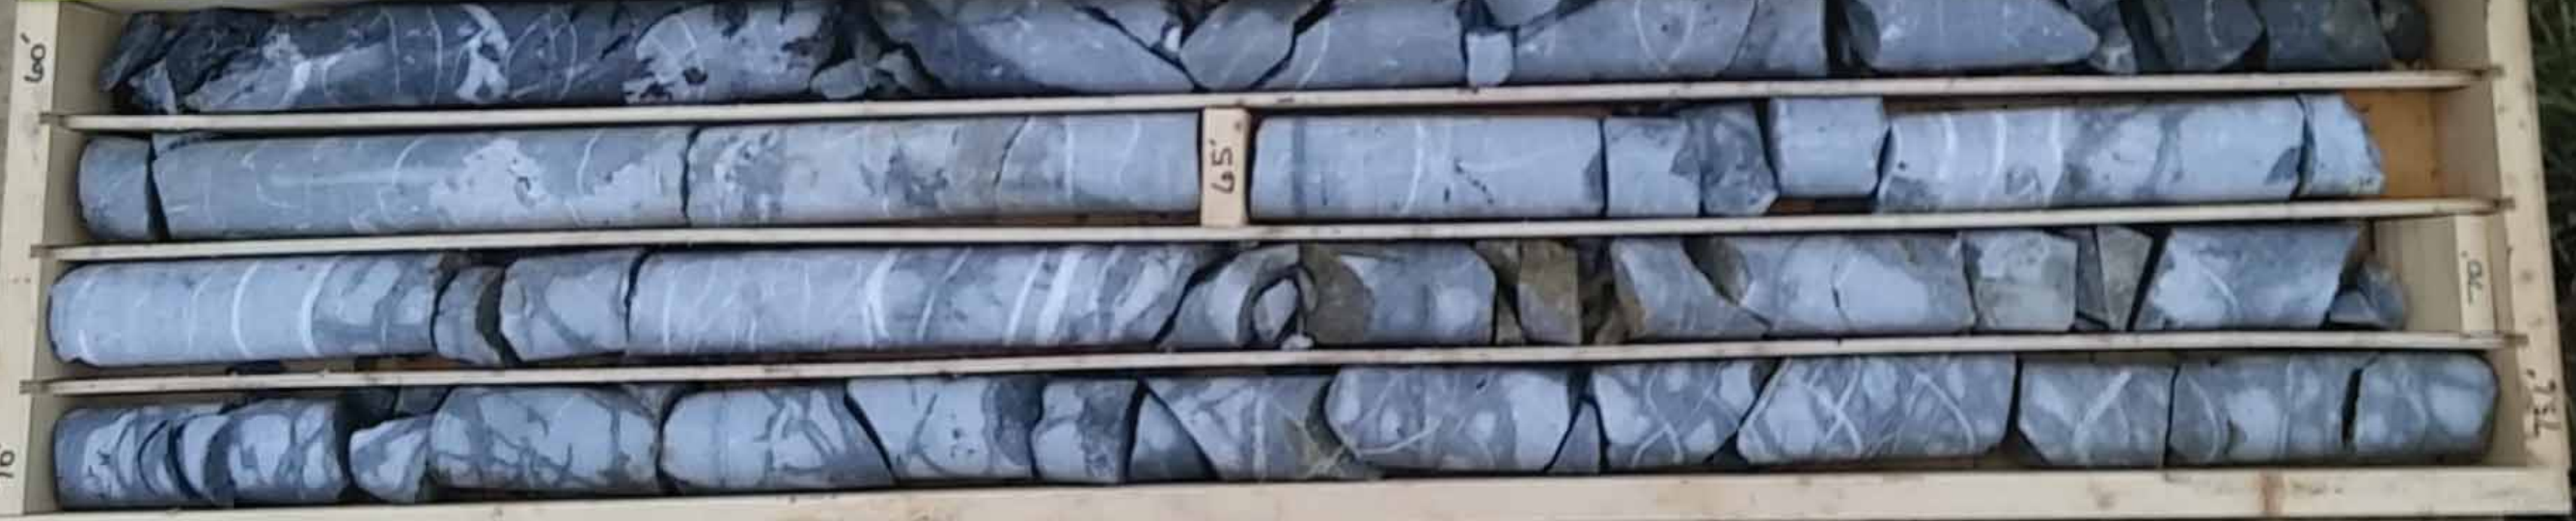
D44118EM
N. 2" pipe
1/28/20
53-Div (60-75)
Box 3

Ran	Depth	Length	Ran	RAD
12	60-65'	5.0'	60"	31.5"
13	65-70'	5.0'	60"	32"
14	70-75'	5.0'	60"	34.5"

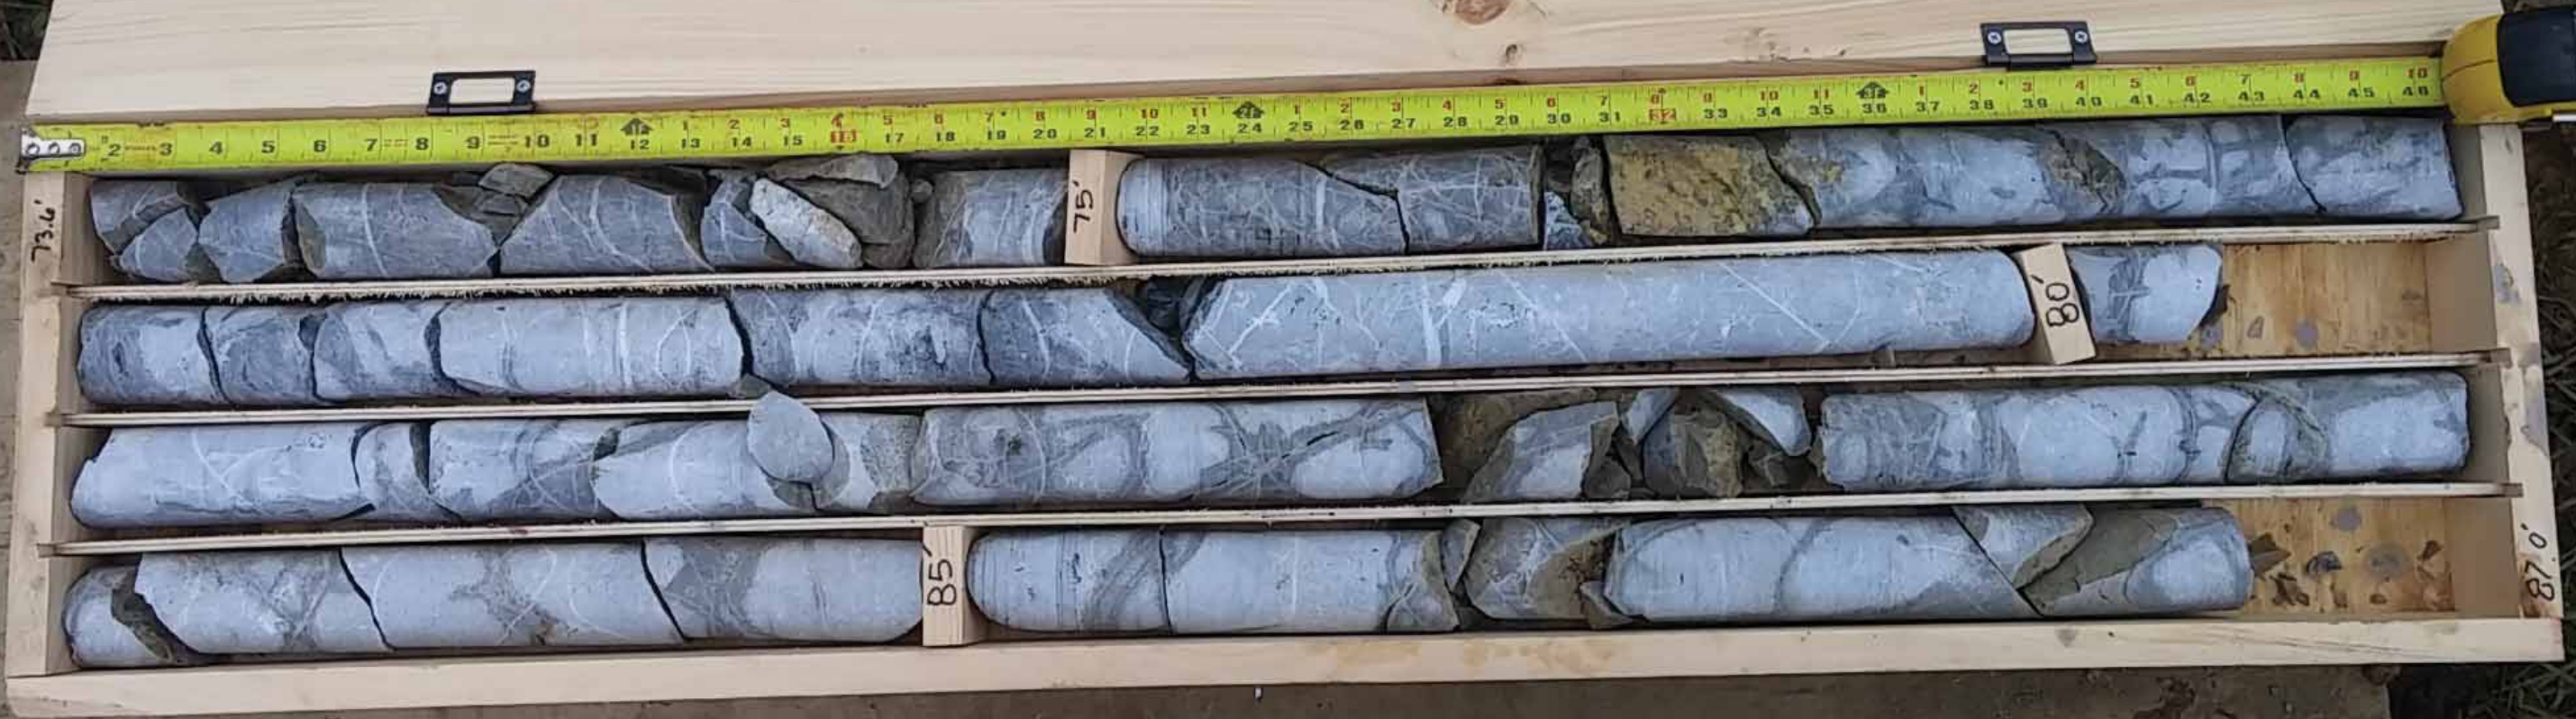
0491884
N. Zions Mill Rd.
1/28/20
53-0101 (73.6-87.0)
Box #6

Run #	Depth	Length	Reel	RAD
15	75-80'	5.0'	60"	35"
16	80-85'	5.0'	60"	33.5"
17	85-90'	5.0'	60"	28"

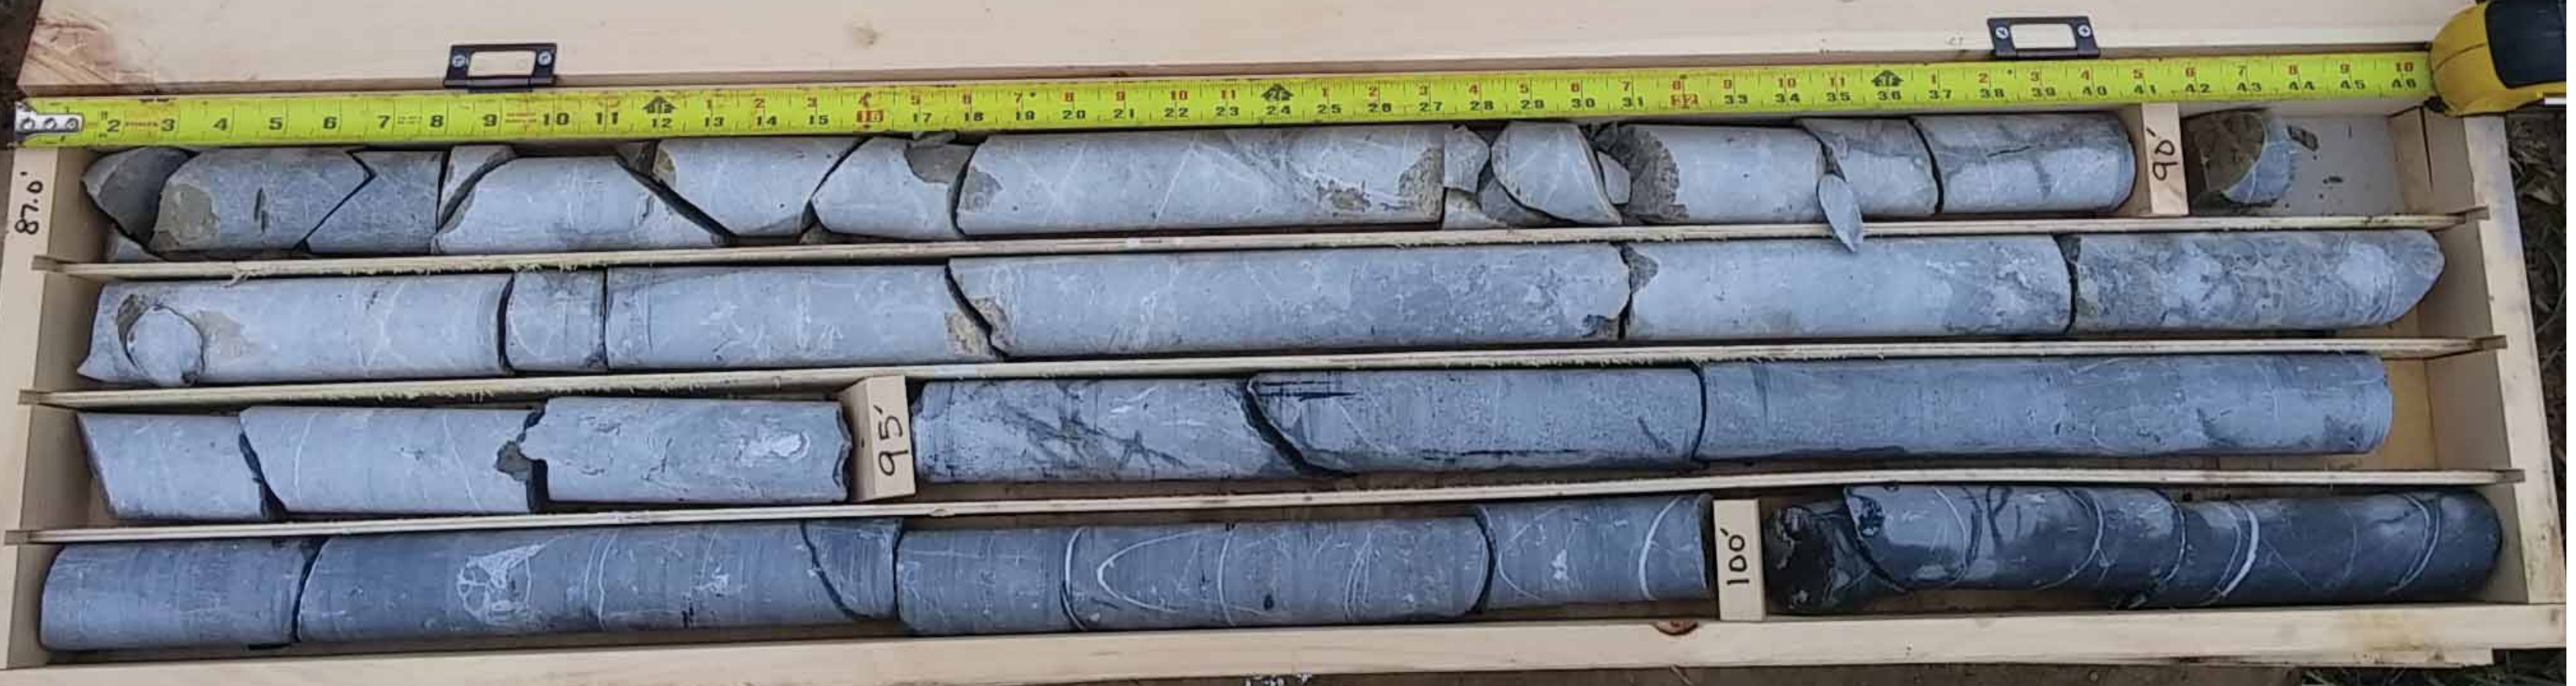
04911884
N. Zions Mill Rd.
1/28/20
S3-0101(87.0-101.1')
Box 7

Run #	Depth	Length	Rec	Rad
18	90-95'	5.0'	60°	53°
19	95-100'	5.0'	59.5°	59.5°
20	100-105'	5.0'	60°	58.5°
