**Re: Hydrogeologic HDD Re-Evaluation Report
Snitz Creek/North Zinns Mill Road Crossing
16" Horizontal Directional Drill Location (S3-0101-16)
Permit No. E38-194
West Cornwall Township, Lebanon County**

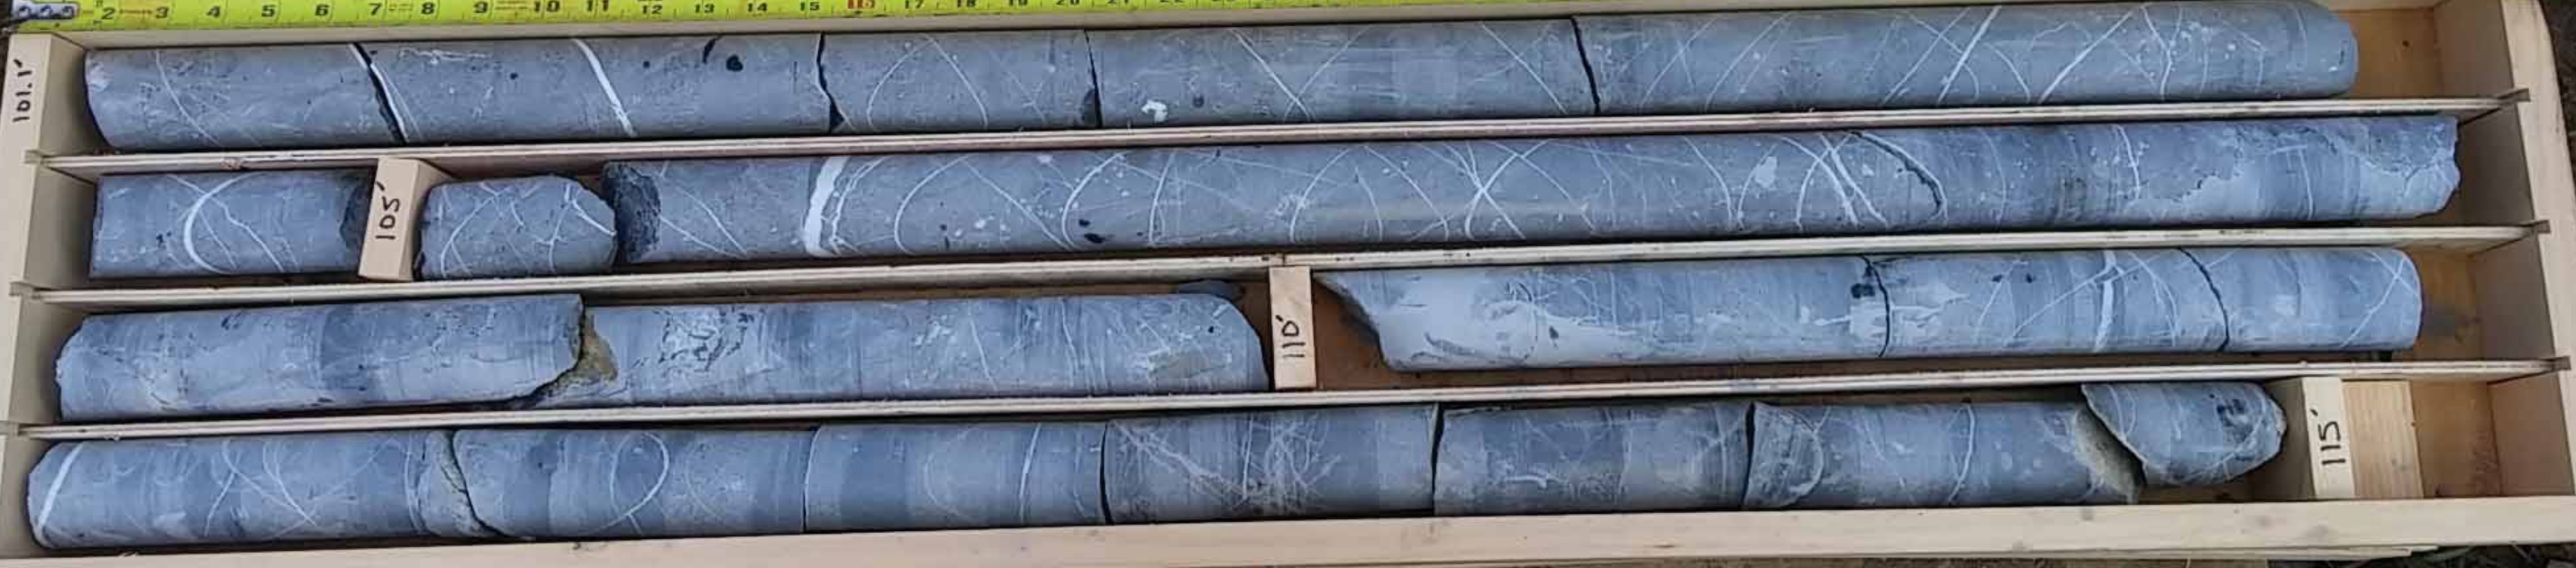
D4911884
N. Zinn Mill Rd.
1/28/20
53-0101(101.1-115)
Box 8

Run #	Depth	Length	Ree	RGD
21	105-110'	5.0'	60"	54.5"
22	110-115'	5.0'	60"	53"

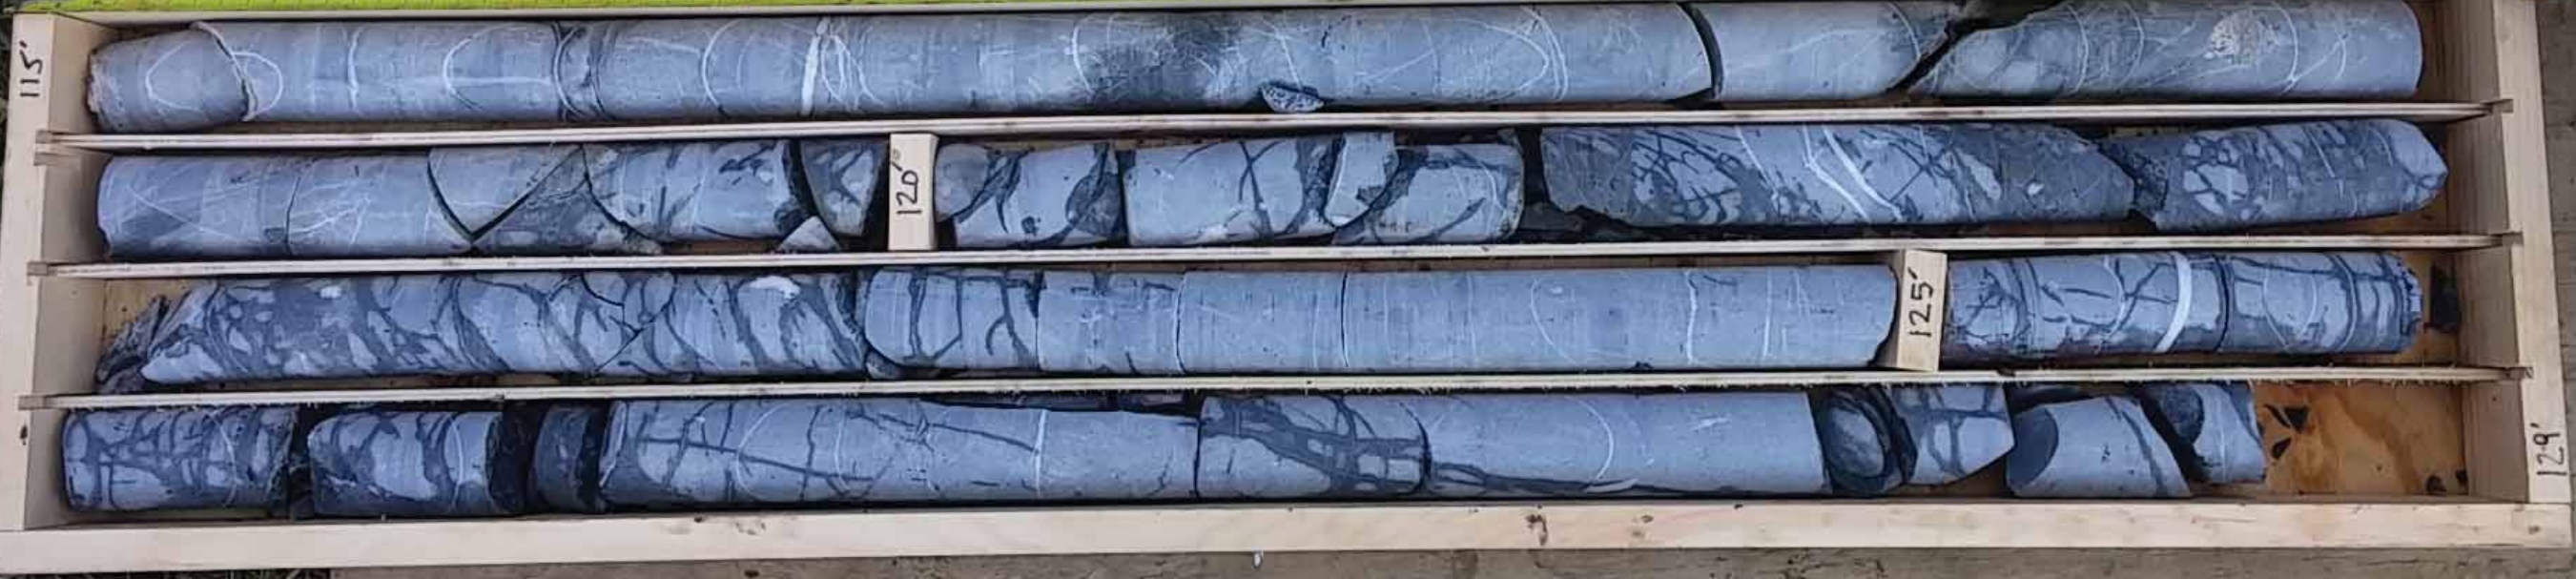
04911884
N. Zone Mill B.
1/29/20
S3-0101 (115-129.0')
Box 9

Run #	Depth	Length	Rec	Rad
23	115-120'	5.0'	59.5"	41"
24	120-125'	5.0'	60"	36.5"
25	125-130'	5.0'	60"	37"

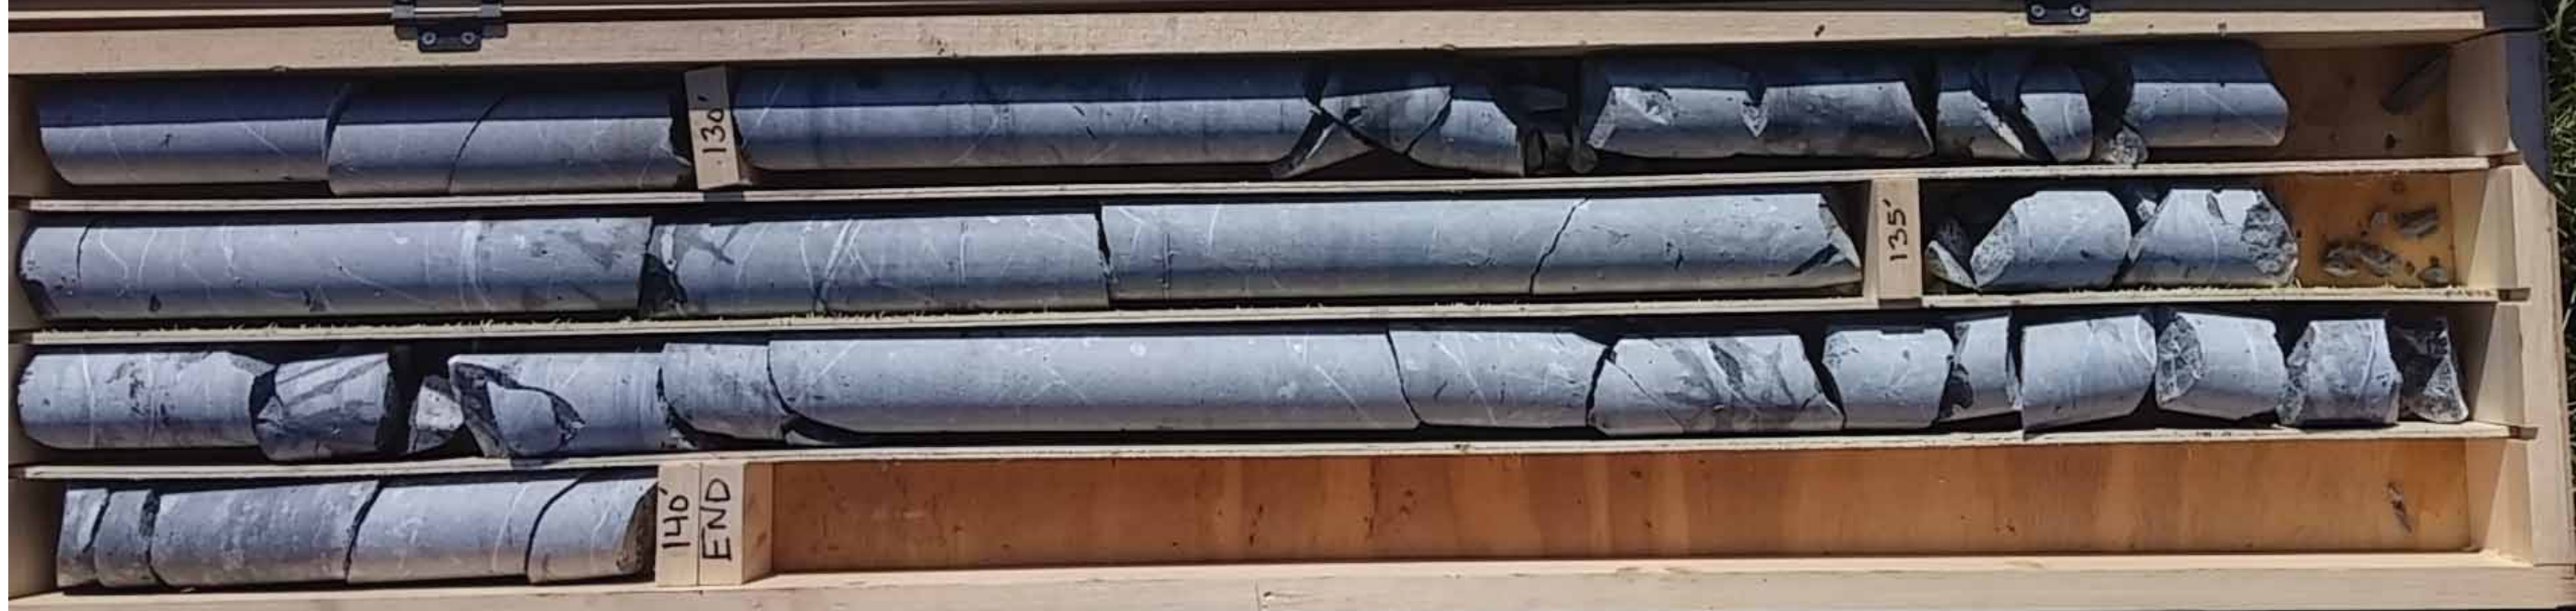
04911884
N. Zinn Mill Rd.
1/29/20
53-0101(129.0-140)
Box 10

Run #	Depth	Length	Acc.	R&D
26	130-135'	5.0'	60"	43.5"
27	135-140'	5.0'	60"	19"
