**SUBJECT: Hydrogeologic Investigation Report (HIR) Addendum  
Furlong Fault Groundwater Study  
New Hope Crushed Stone  
SMP No. 7974SM3  
Solebury Township, Bucks County, PA  
ERG Project No. 011012.009**

# Hydrogeologic Investigation Report Addendum

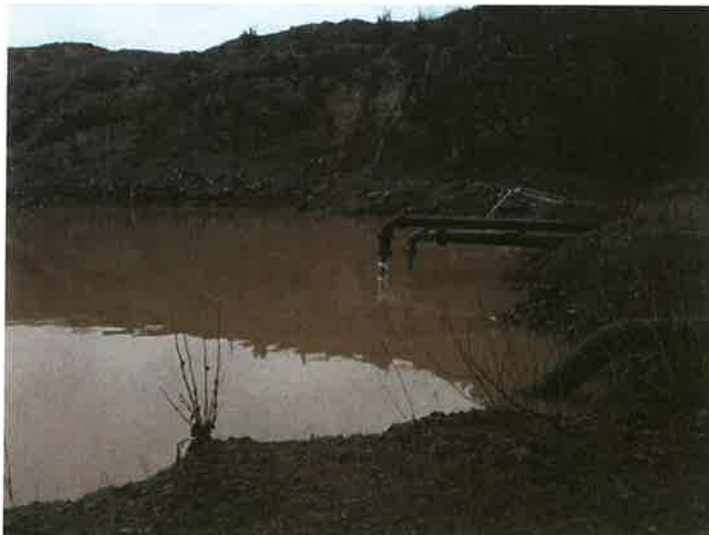
Fault zone swale (looking Northeast or "upstream")

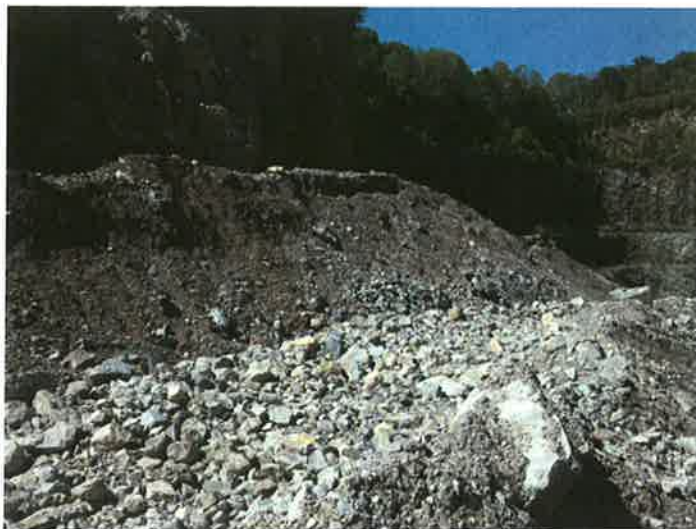
Fault Zone swale – filled with rock (looking southwest)

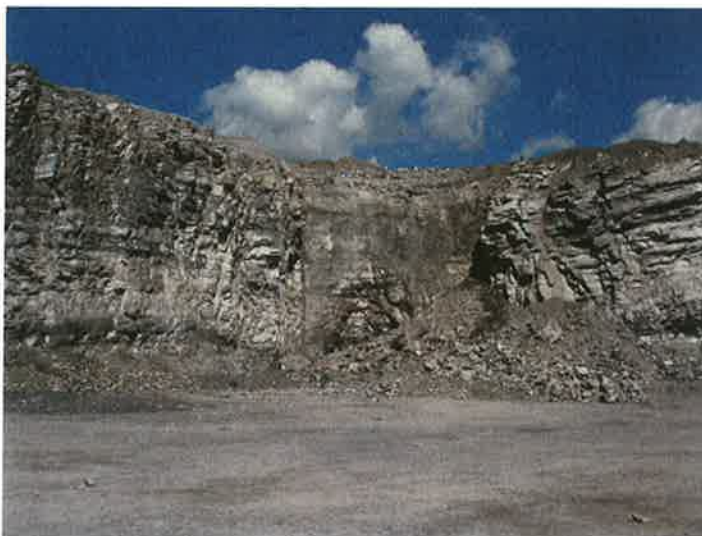
Seep (photo taken from pit floor, looking east)

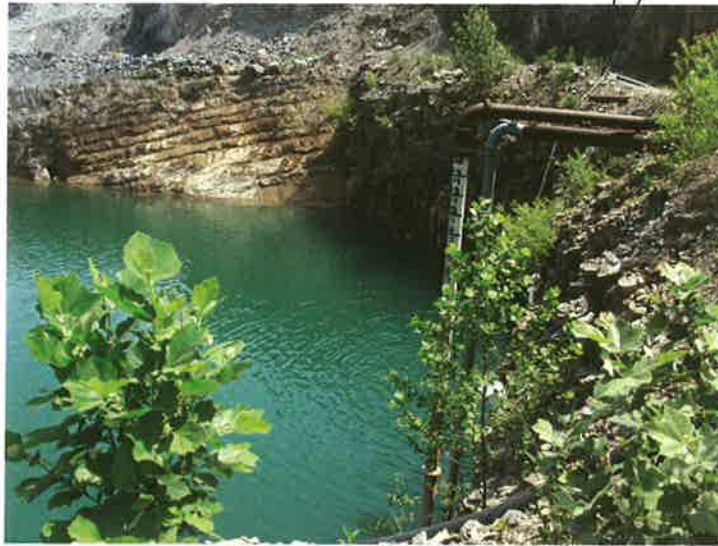
Transducer

Sump

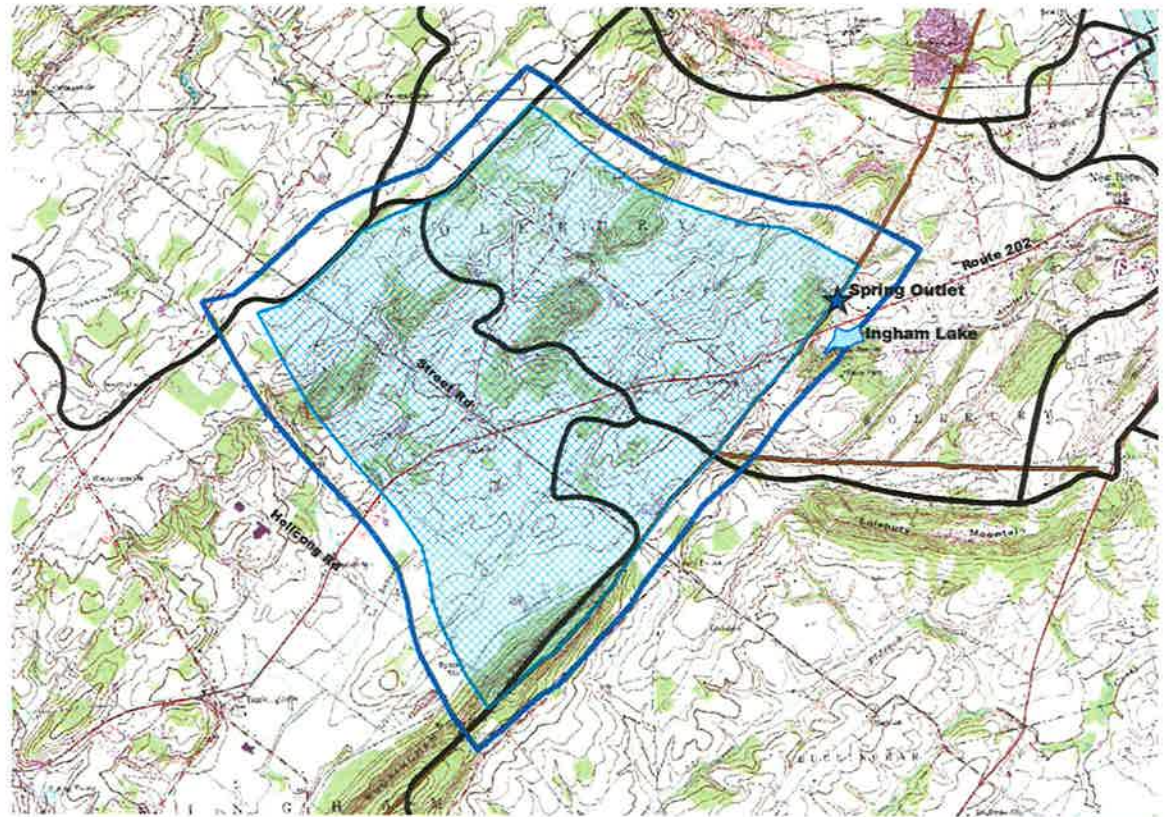
## Ingham Spring Contribution Area

- ◆ Goal is to identify primary and secondary areas for protection, based on seasonal and yearly fluctuations in contribution area
- ◆ For example:
  - Primary Protection Area (light blue hatched)
  - Secondary Protection Area (dark blue outline)
