INITIAL SERVICE LINE INVENTORY

SUFFICIENT EVIDENCE FOR NON-LEAD – TRAINING AID

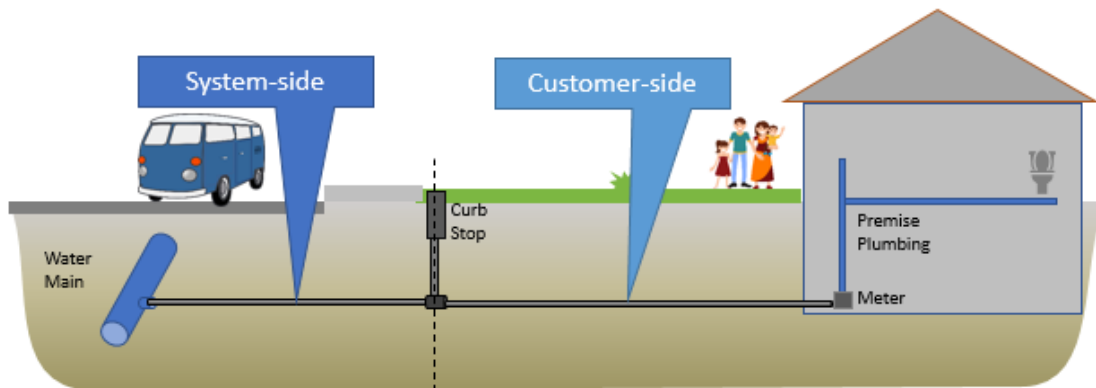
Note: For systems that own a portion of the service line, such as shown below, the pipe material for both the customer and system portions must be identified. The complete service line, which combines both portions, is assigned a category of non-lead, lead, galvanized requiring replacement, or unknown.

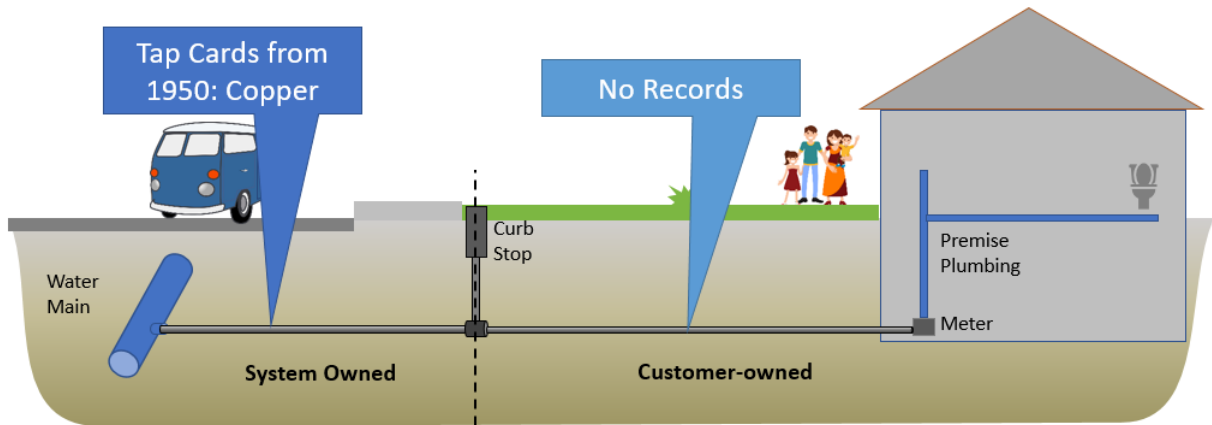
Example 2: Records for System-side only

System Side	Customer Side
System has:	Tap Cards from 1950 showing copper for an area of the system (e.g., neighborhood)	Nothing
Additional Actions Expected:	<p>Verify record since it is pre-'91.</p> <p>Choose one of the following:</p> <ul style="list-style-type: none"> a) 1-point excavation >18" from curb stop for each SL b) External pipe CCTV inside curb box for each SL c) Use statistical analysis and/or modeling: Field verify one point at a statistically representative percentage of the service lines for this area (e.g., neighborhood). Field verification can include a or b above. 	<p>Choose one of the following:</p> <ul style="list-style-type: none"> a) 1-point excavation >18" from curb stop and visual observation of the material entering the residence for each SL b) 2-point excavation at each SL c) Statistical Analysis: <i>Example</i>: <ul style="list-style-type: none"> o Visual observation inside home prior to meter at <i>every</i> connection combined with a 1-point excavation >18" from the curb stop at a statistically representative percentage of the service lines for this area (e.g., neighborhood).

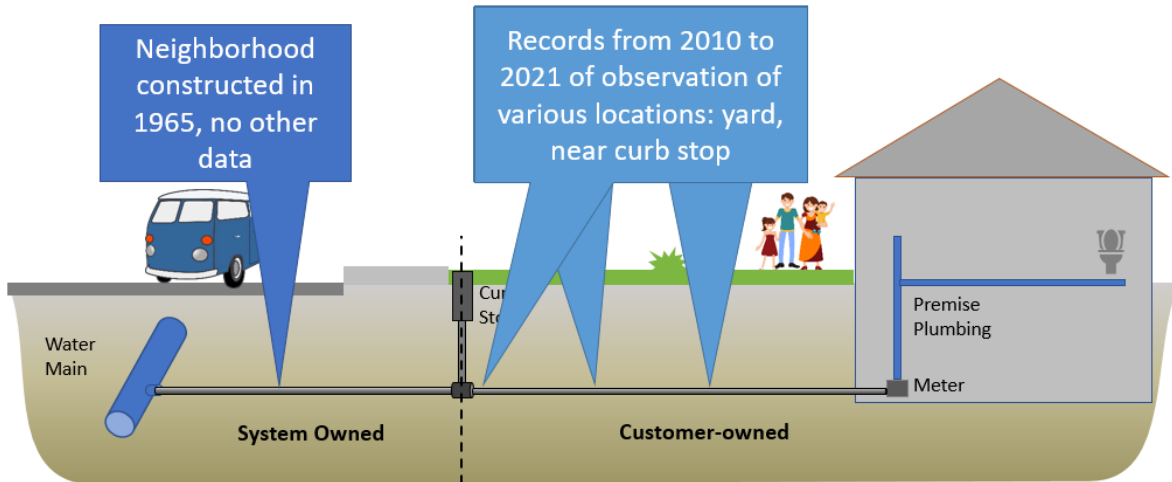
Example 5: Records of material observations during normal operations

System Side	Customer Side
System has:	Record that neighborhood was constructed in 1965, no other data	Records from 2010 through 2021 of water system staff observations of copper SL material from various locations on customer side (e.g. along line in-yard and near curb-stop, but not necessarily $\geq 18''$ from the curb stop). These observations were made during normal operations and are not considered new investigations as part of the service line inventory.
Additional Actions Expected:	Choose one of the following: <ul style="list-style-type: none"> a) 1-point excavation $>18''$ from curb stop at each SL b) Statistical Analysis - <i>Example</i>: <ul style="list-style-type: none"> o External pipe CCTV inside curb box at each SL combined with a 1-point excavation $>18''$ from the curb stop at a statistically representative percentage of the service lines for this neighborhood. 	Previous material observations along the customer side represent one point of verification and a second point is expected. Choose one of the following: <ul style="list-style-type: none"> a) Visual observation of the material entering the residence b) 1-point excavation at a location along the customer-side SL

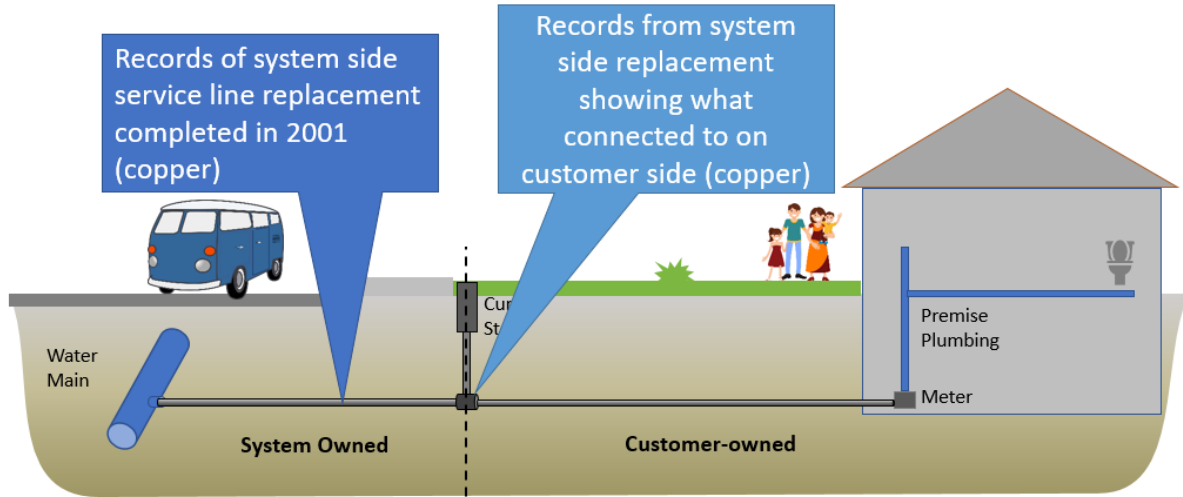
Example 12: System-side records showing connection to customer side

System Side	Customer Side
System has:	Records of system side service line replacement completed in 2001	Records from <i>system side</i> service line replacement (2001) showing what the line was connected to on customer side Building records show homes were built in the 1950s.
Additional Actions Expected:	None	Previous material observations at the curb stop represents one point and a second point is expected. Choose one of the following: <ul style="list-style-type: none"> a) Visual observation of the material entering the residence b) 1-point excavation at a location along the customer-side SL
