The Dents Run AML/AMD Ecosystem Restoration Project¹

Dean Baker, PE, Richard L. Beam, PG, Eric E. Cavazza, PE, and Thomas Malesky, PE

Pennsylvania Department of Environmental Protection

¹ –Paper presented at the 34th National Association of Abandoned Mine Lands Conference, Des Moines, Iowa, September 23-26, 2012

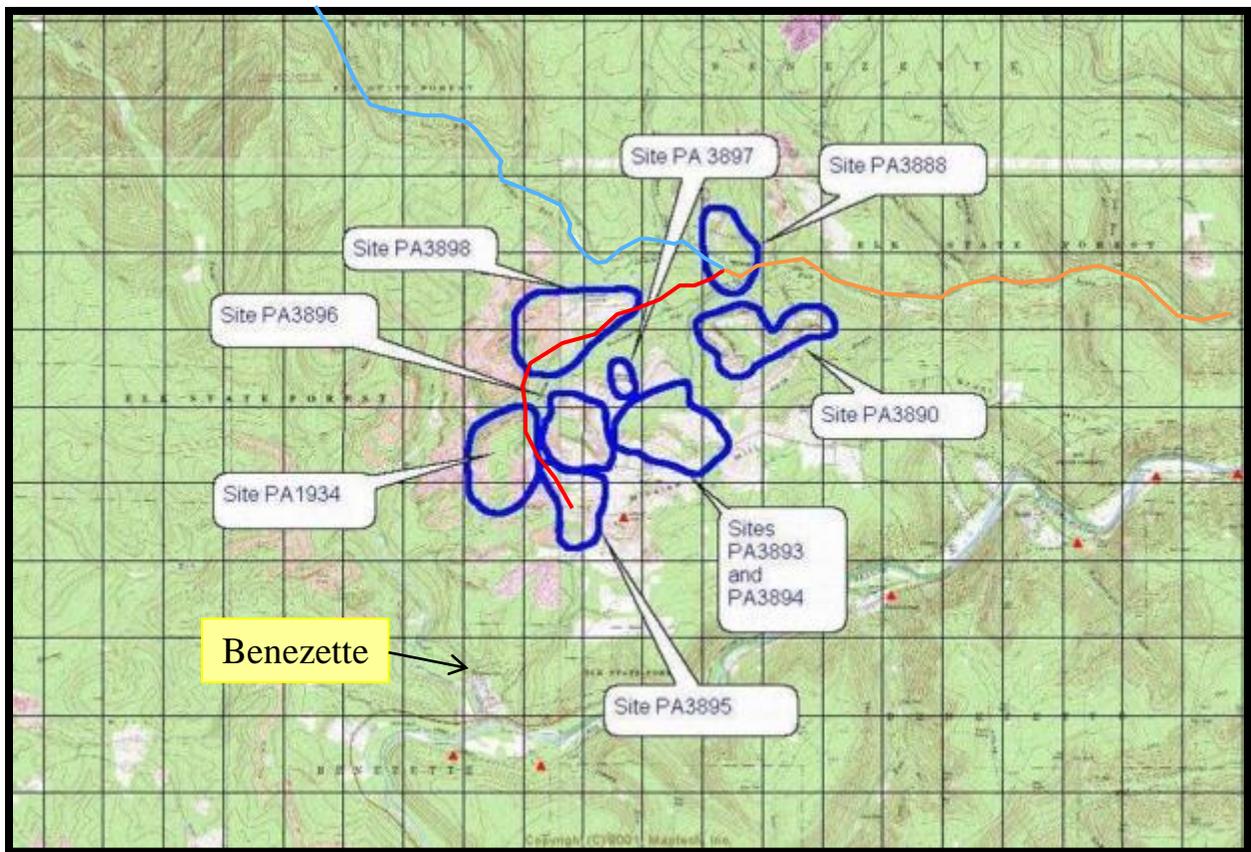
Figure 4 – AML inventory map showing problem areas included in the Dents Run Project

Figure 4, a portion of an AML Inventory Map for the project area, shows abandoned and unreclaimed mine features within various problem areas (identified by the letters “PA” followed by a four-digit number) located in the Dents Run Watershed. Figure 5 shows an unreclaimed, dangerous highwall located in PA 3898 in the upper Dents Run Watershed and Figure 6 shows a deep mine discharge from an abandoned underground mine located in PA 1934. These represent typical examples of the AML conditions that were present within the Dents Run Watershed.

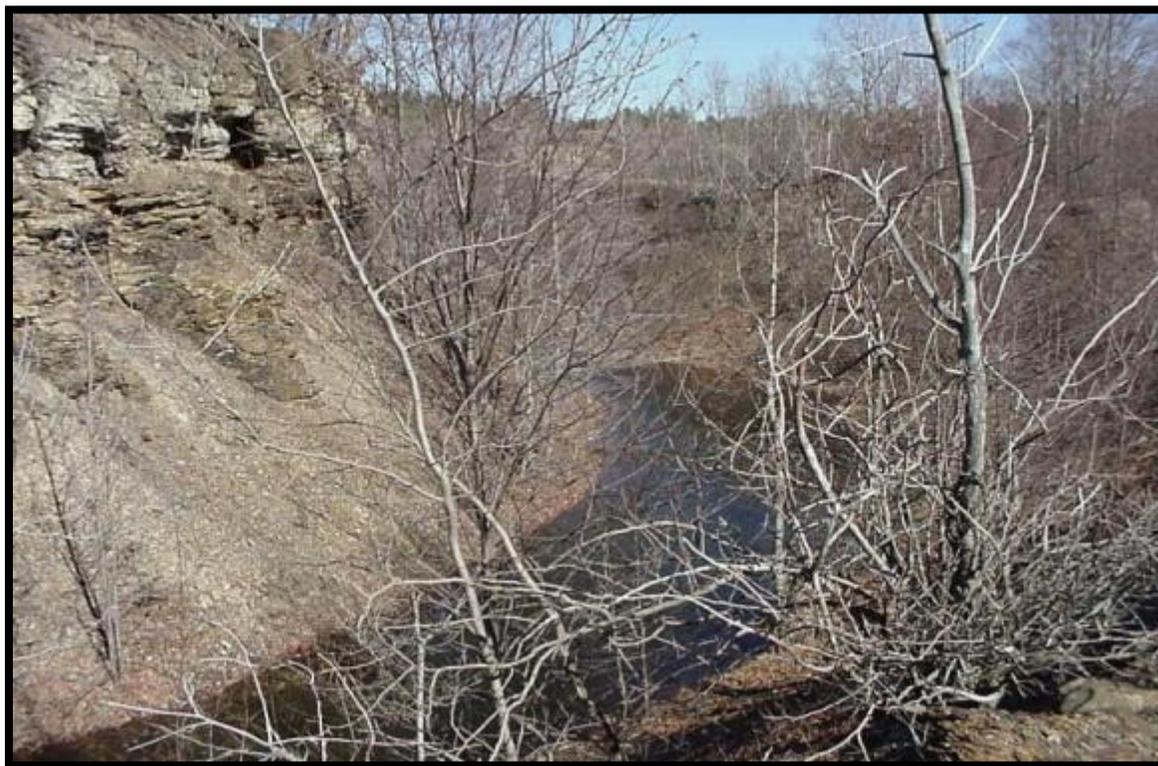
Figure 5 – Abandoned surface mine highwall and water-filled pit located in the Porcupine Hollow sub-basin of Dents Run

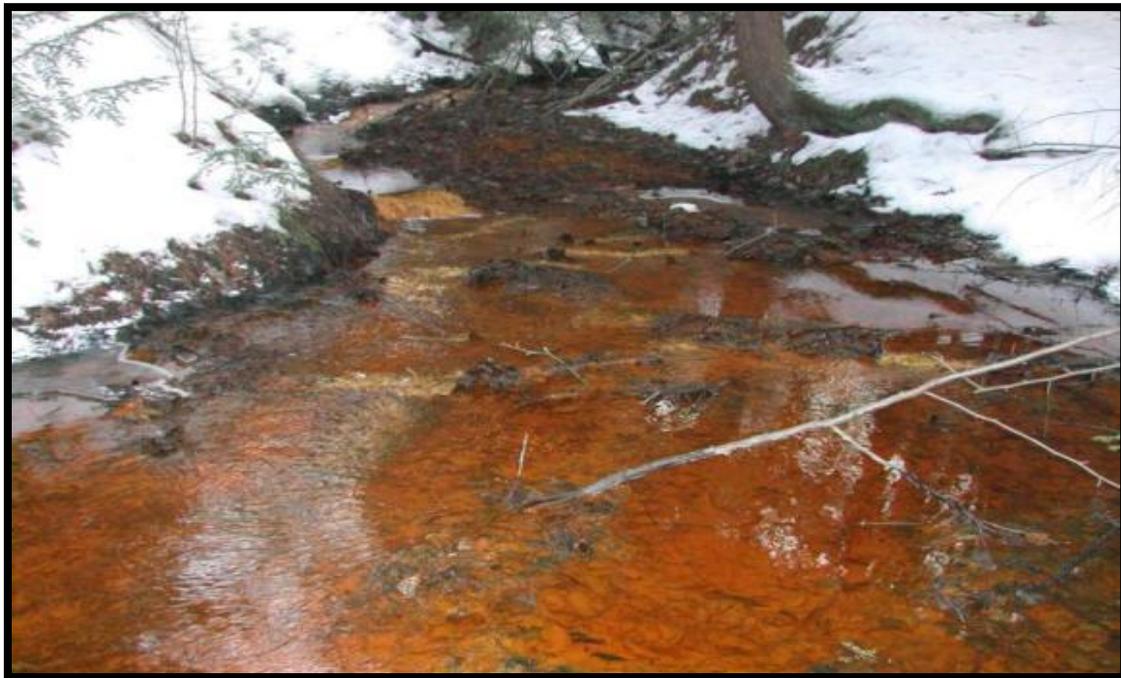
Figure 6 – Abandoned underground mine (Lower Kittanning Coal Seam) discharge located in the Porcupine Hollow sub-basin of Dents Run

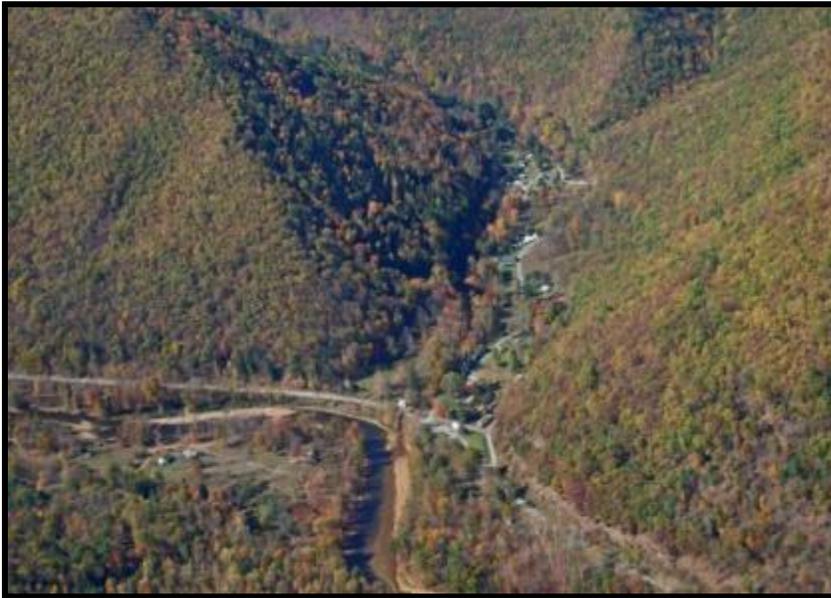
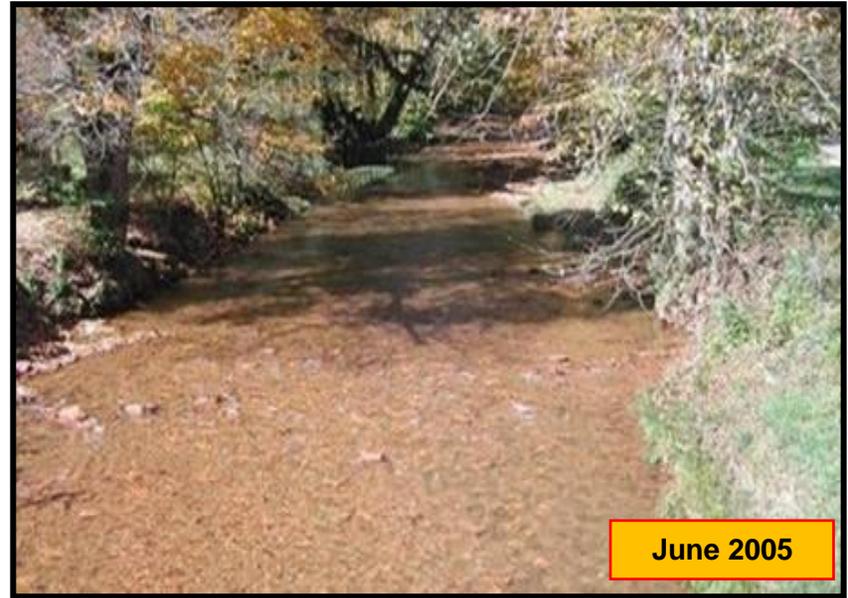
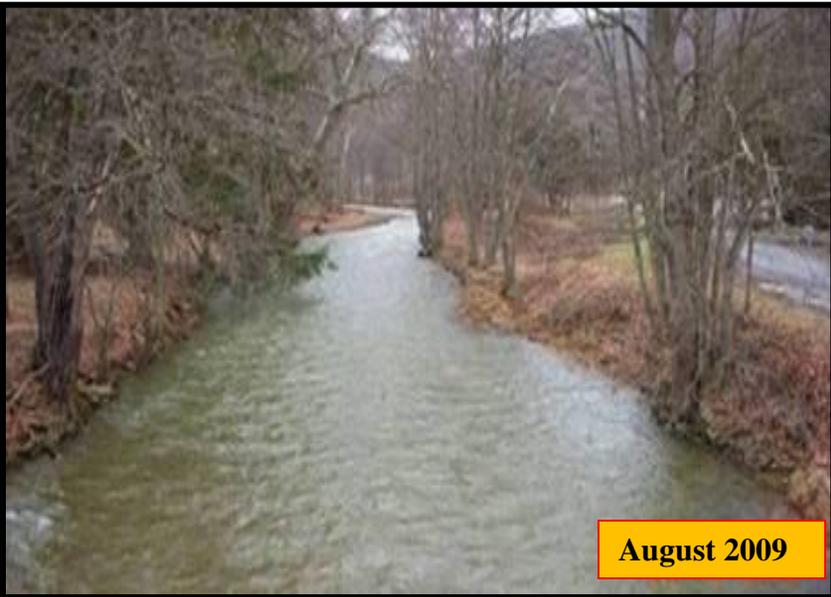
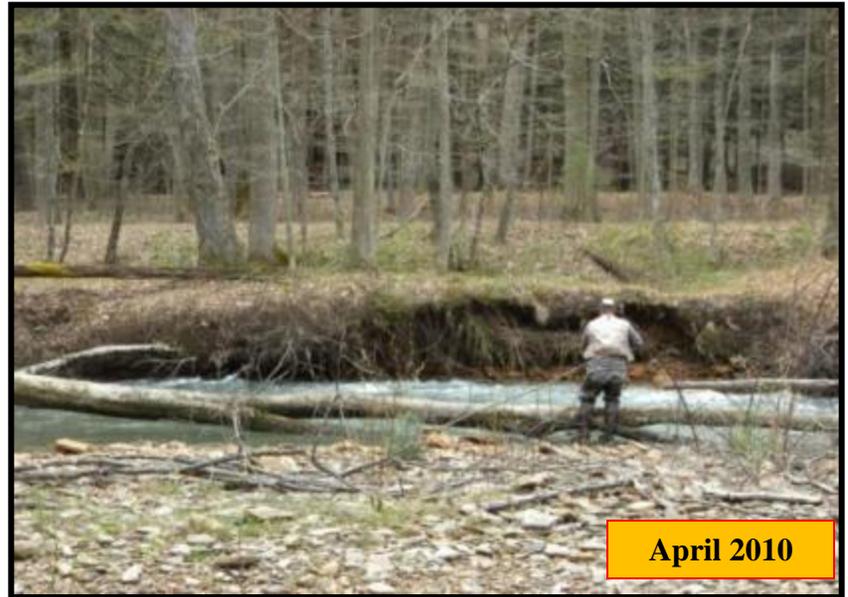
Figure 9 – Dents Run confluence with Bennett Branch 2005 (upper left), Dents Run mouth 2005 (upper right), Dents Run mouth 2009 (lower left), trout fisherman enjoying a restored section of Dents Run approximately 2 miles upstream of mouth (lower right)

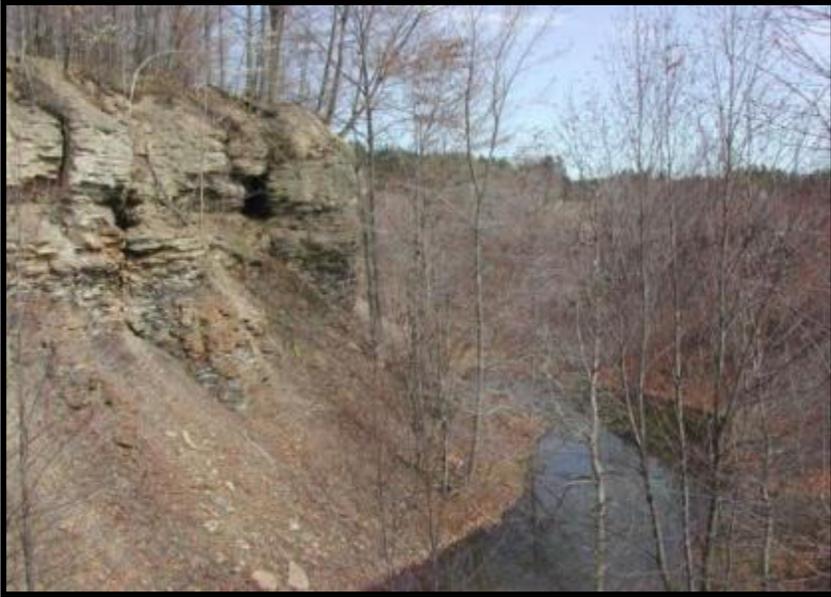
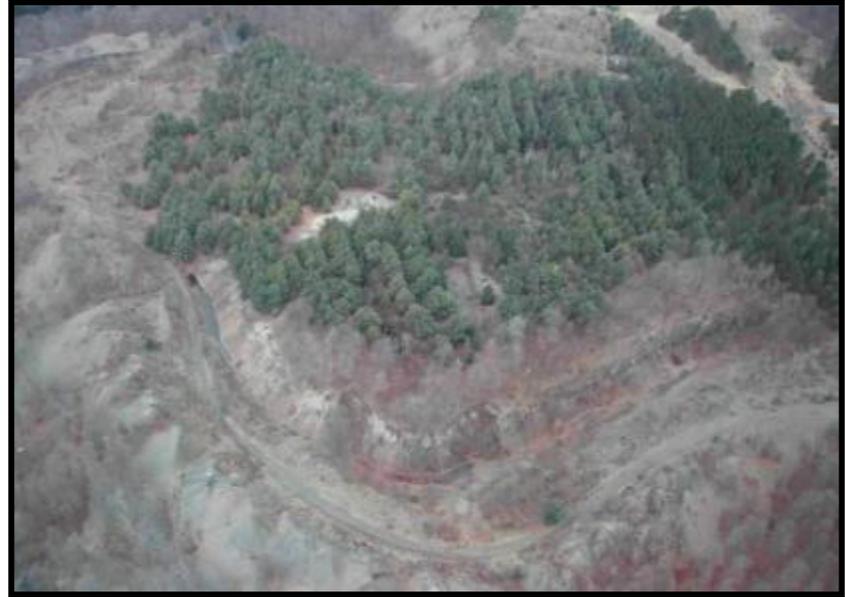
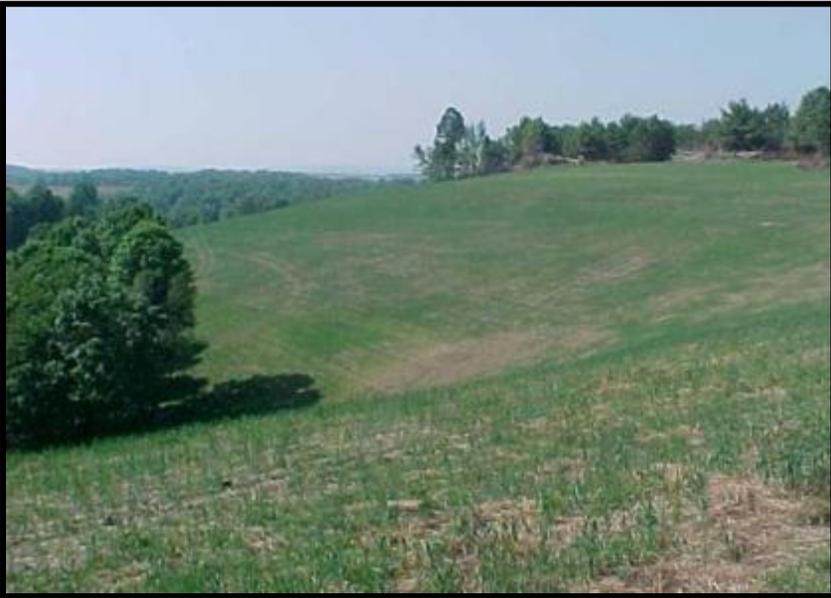
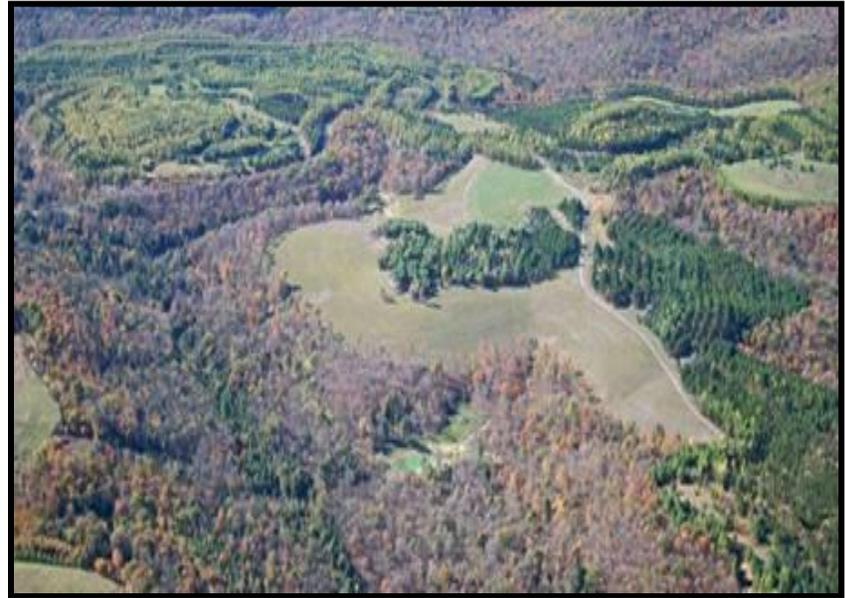
Figure 10 - PA 3898 prior to reclamation (upper left), dangerous highwall and highly acidic water impoundment (upper right), reclaimed site spring of 2007 (lower left) and aerial view of reclaimed site PA 3898 late summer of 2007 (lower right)

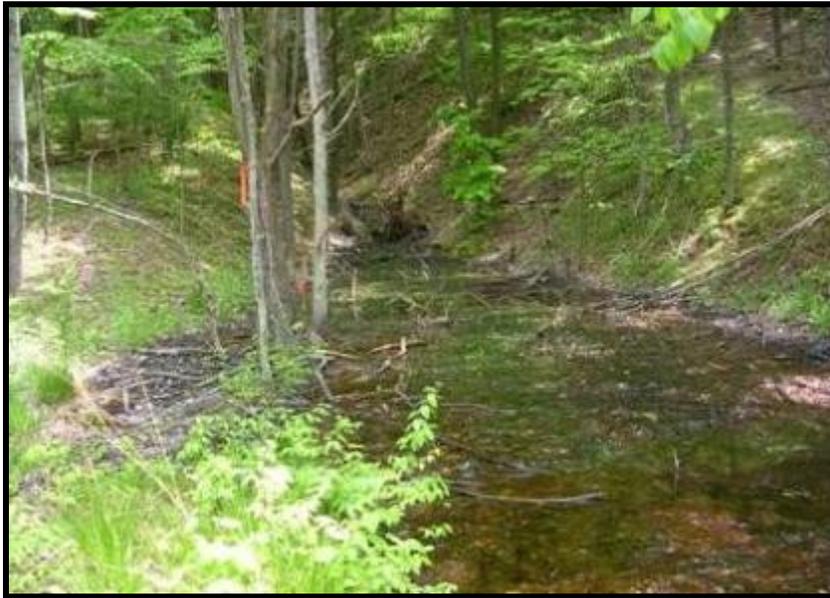
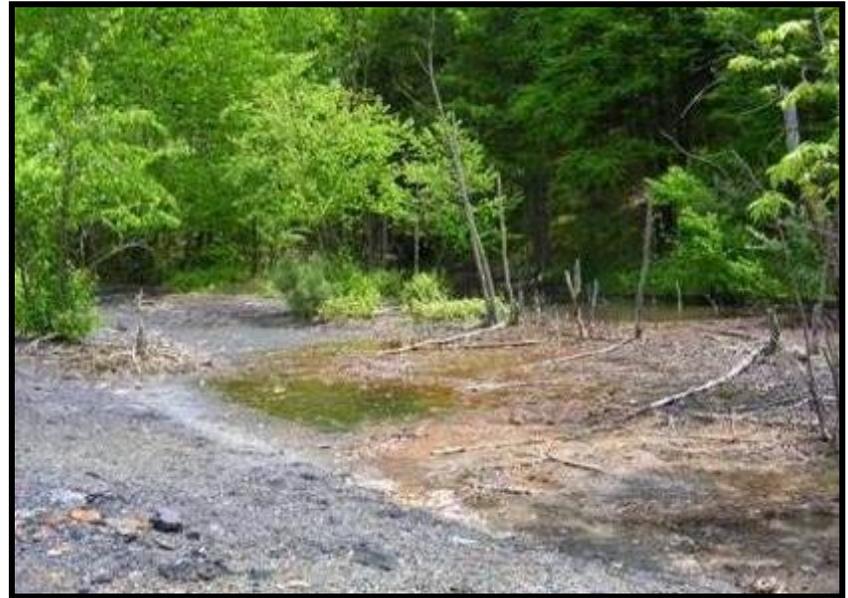
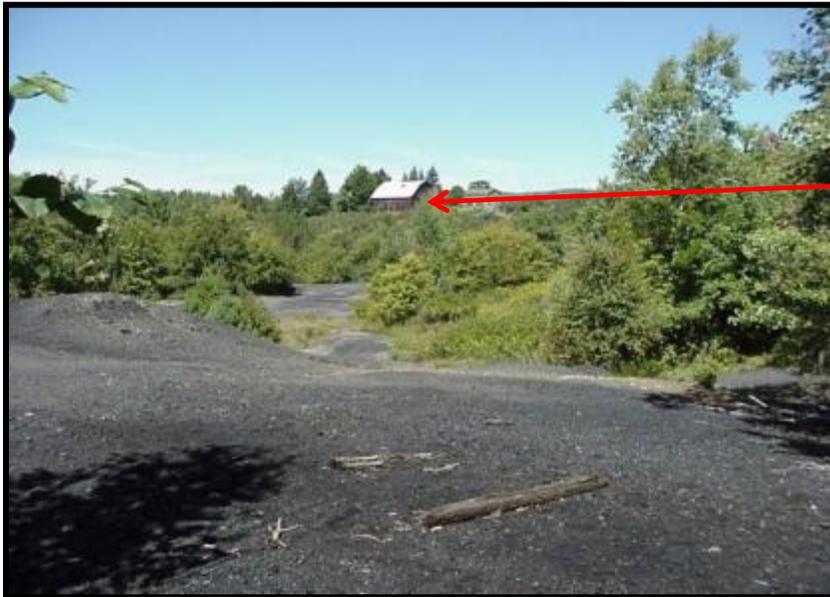
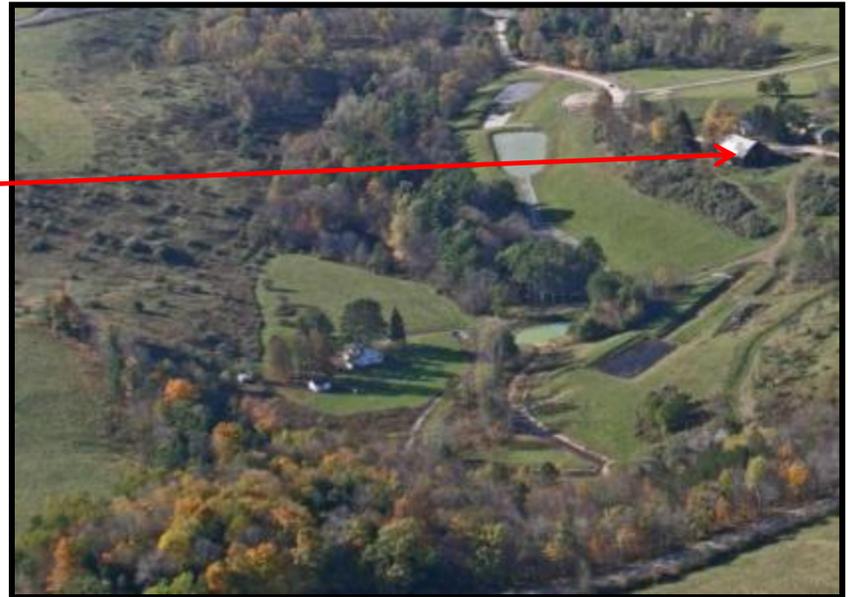
Figure 11 – Mine discharge near the headwaters of Porcupine Run PA 3895 (upper left), coal refuse in stream channel PA 3895 (upper right), mine spoil and coal refuse PA 3895 (lower left) and PA 3895 showing reclaimed area and passive treatment system (lower right)

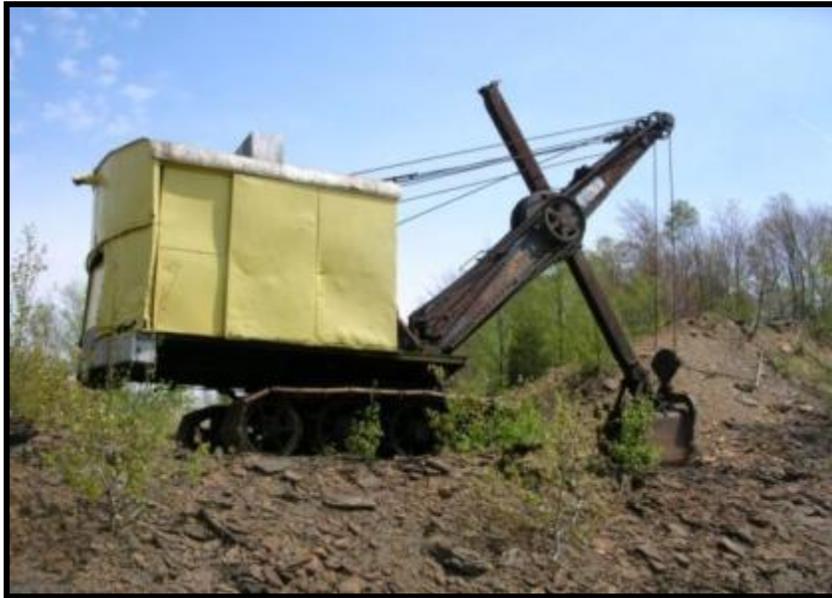
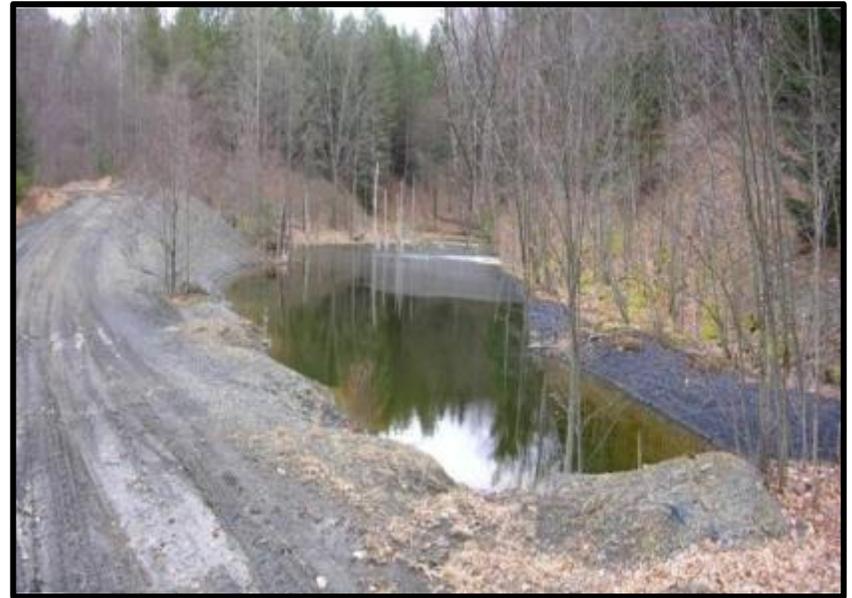
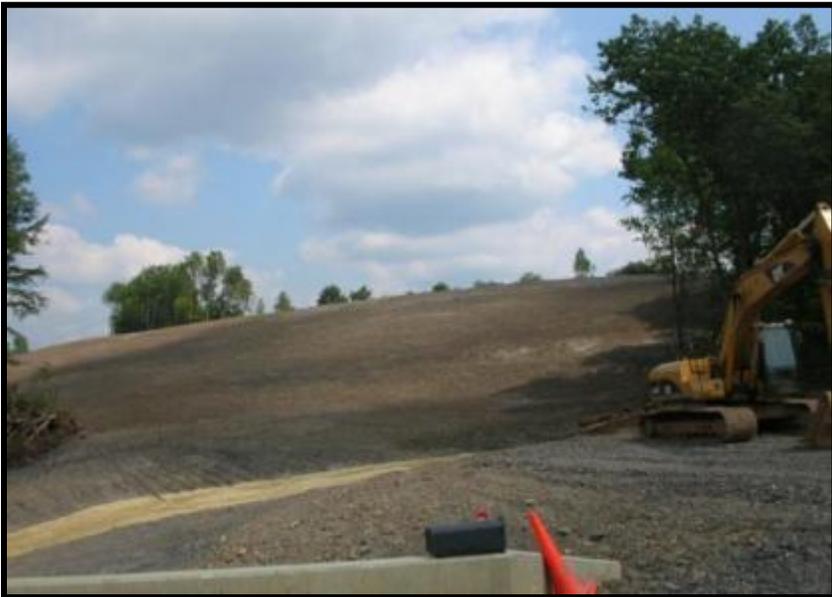
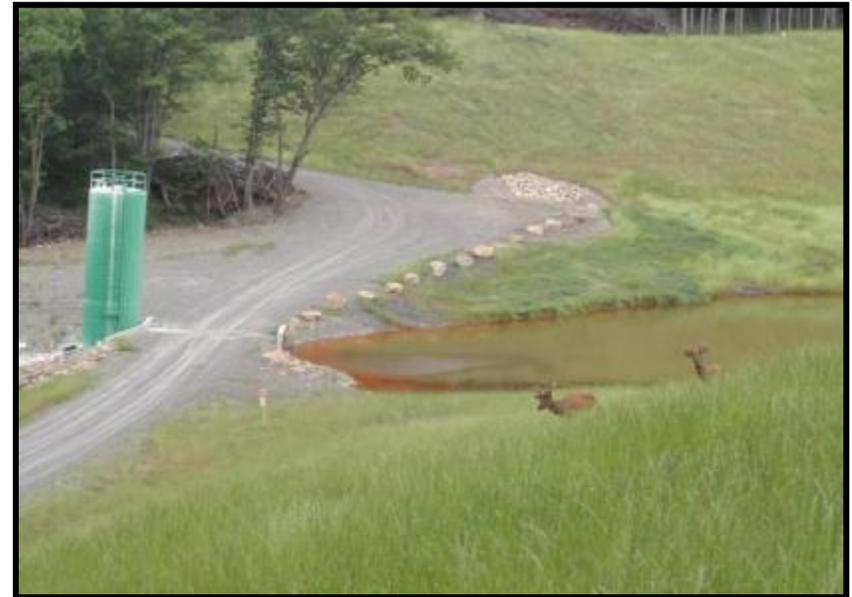
Figure 12 – 1920s era shovel on PA 3896/3897 (upper left), coal refuse and mine discharge area (upper right), site just prior to seeding in summer 2010 (lower left) and site in fall 2010 showing revegetation, white-tail deer and tipping bucket lime doser in operation (lower right)

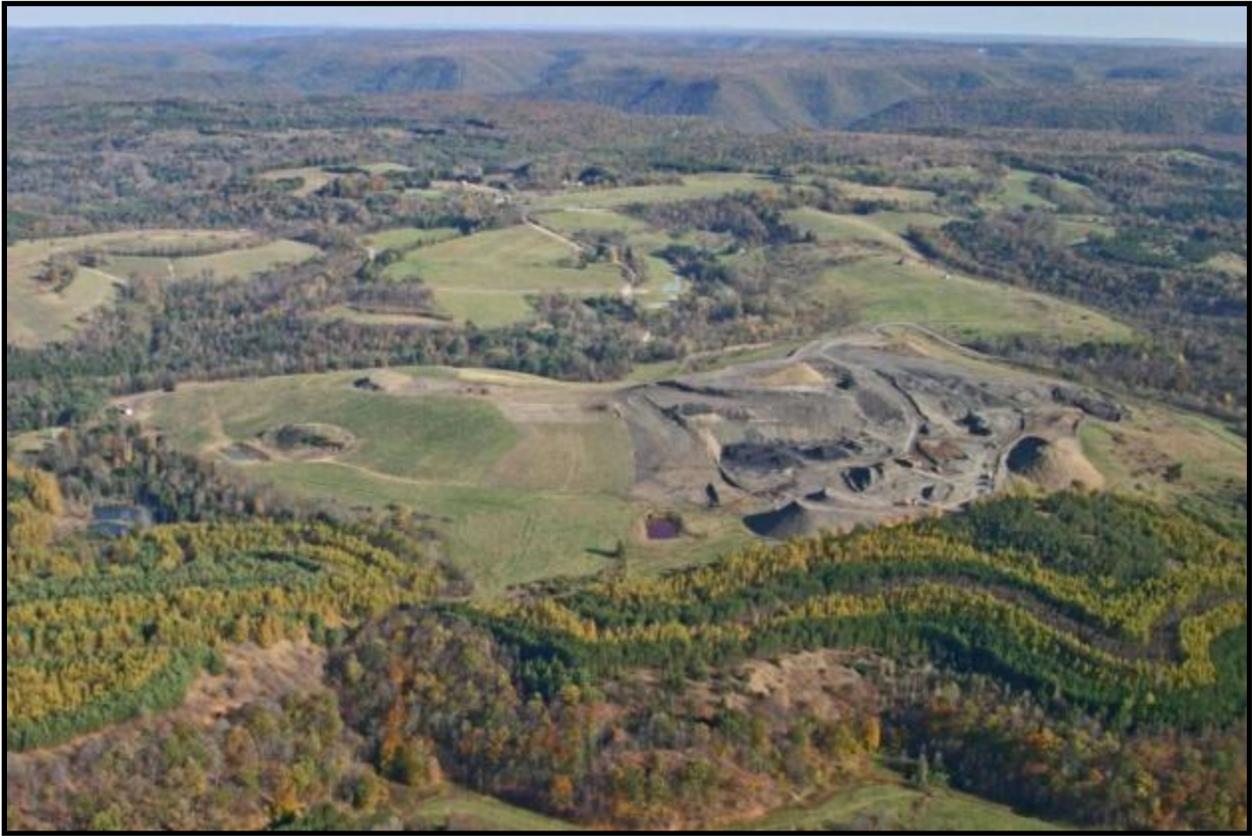
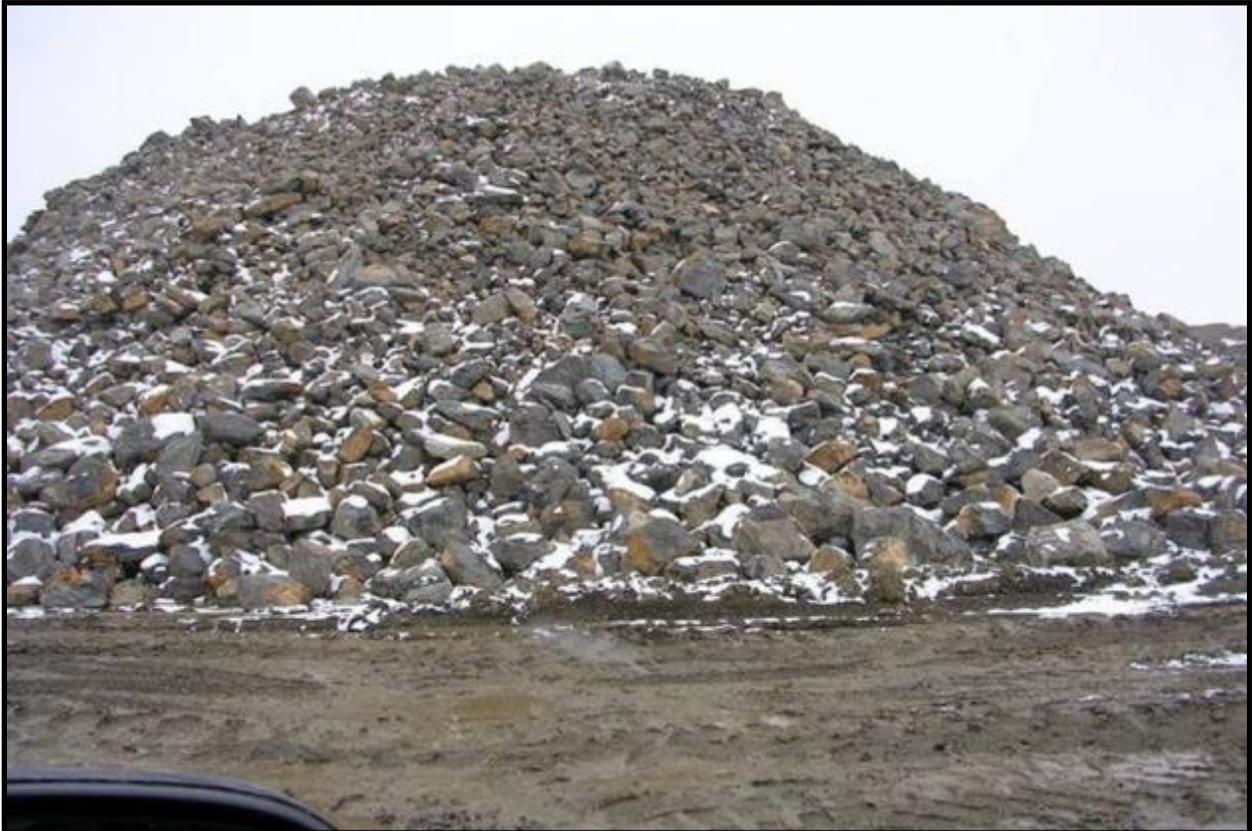
Figure 13 – Fall 2007 aerial view of remining operation on PA 1934 (above) and stockpile of limestone available for alkaline addition on PA 1934 site (below)

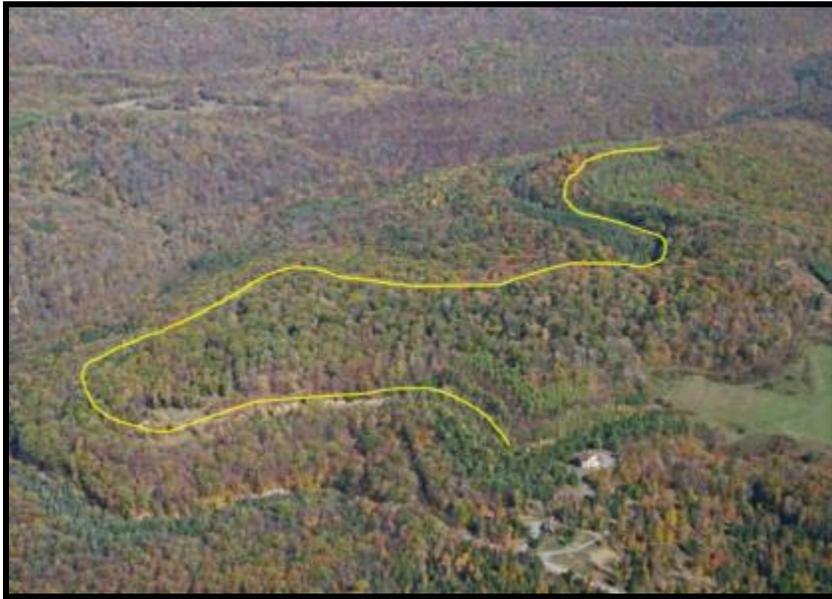
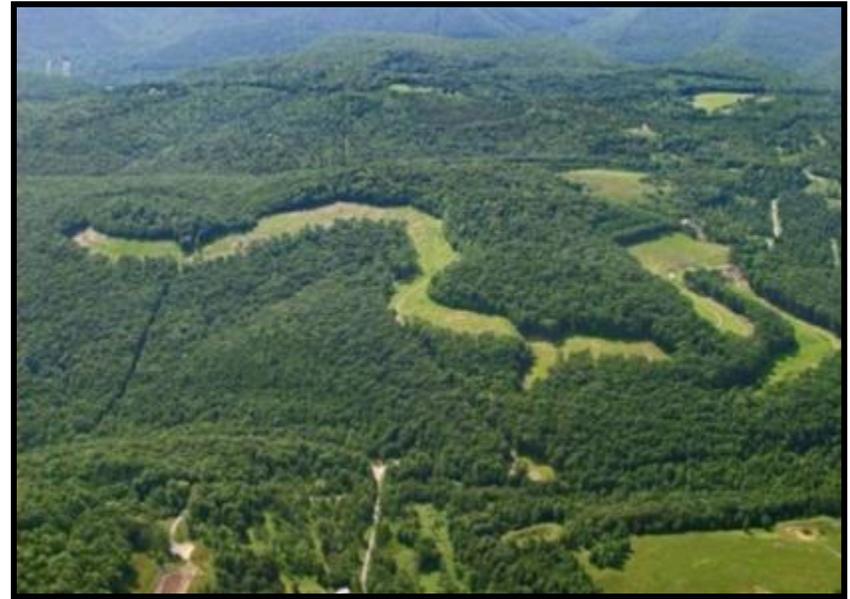
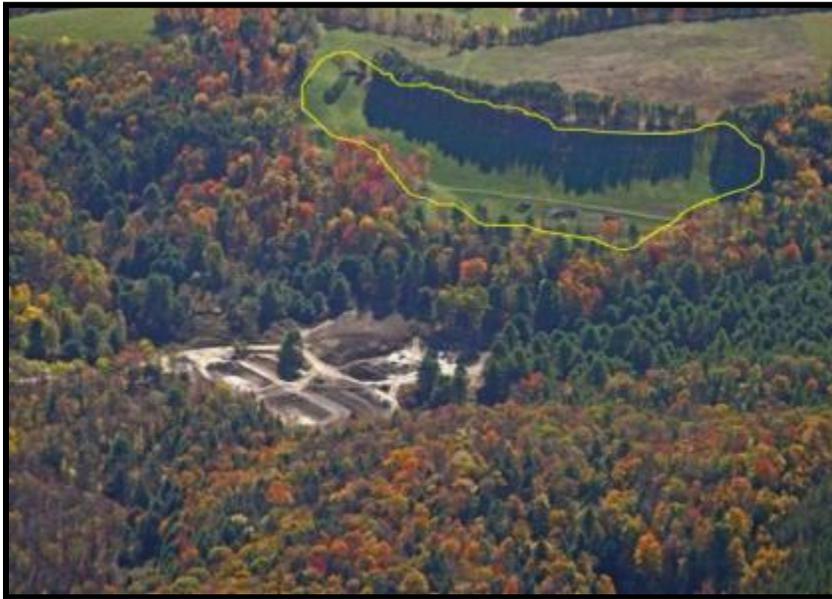
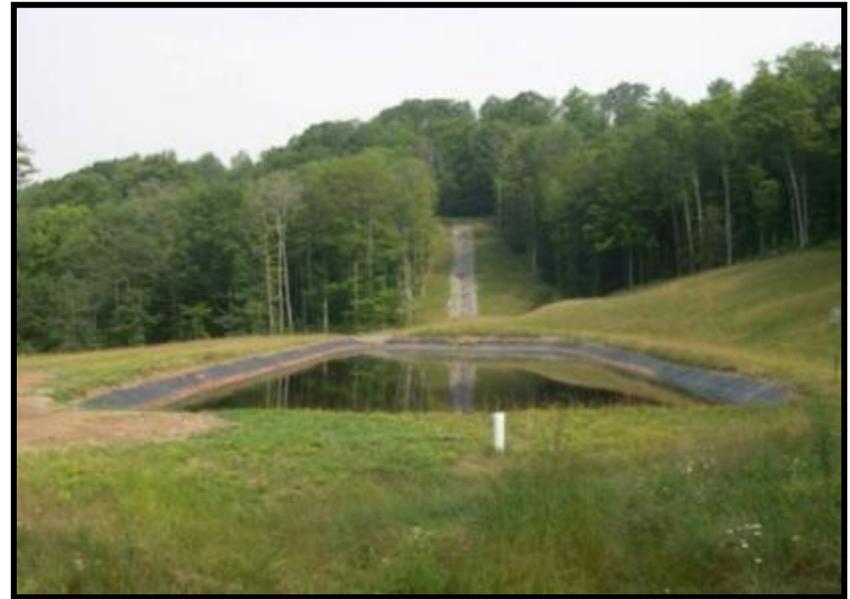
Figure 14 – Abandoned highwall on PA 3890 (upper left), aerial view of reclaimed PA 3890 site (upper right), U.S. COE highwall reclamation area and passive treatment system (under construction) on PA 3893 (lower left) and U.S. COE passive system on PA 3888 (lower right)

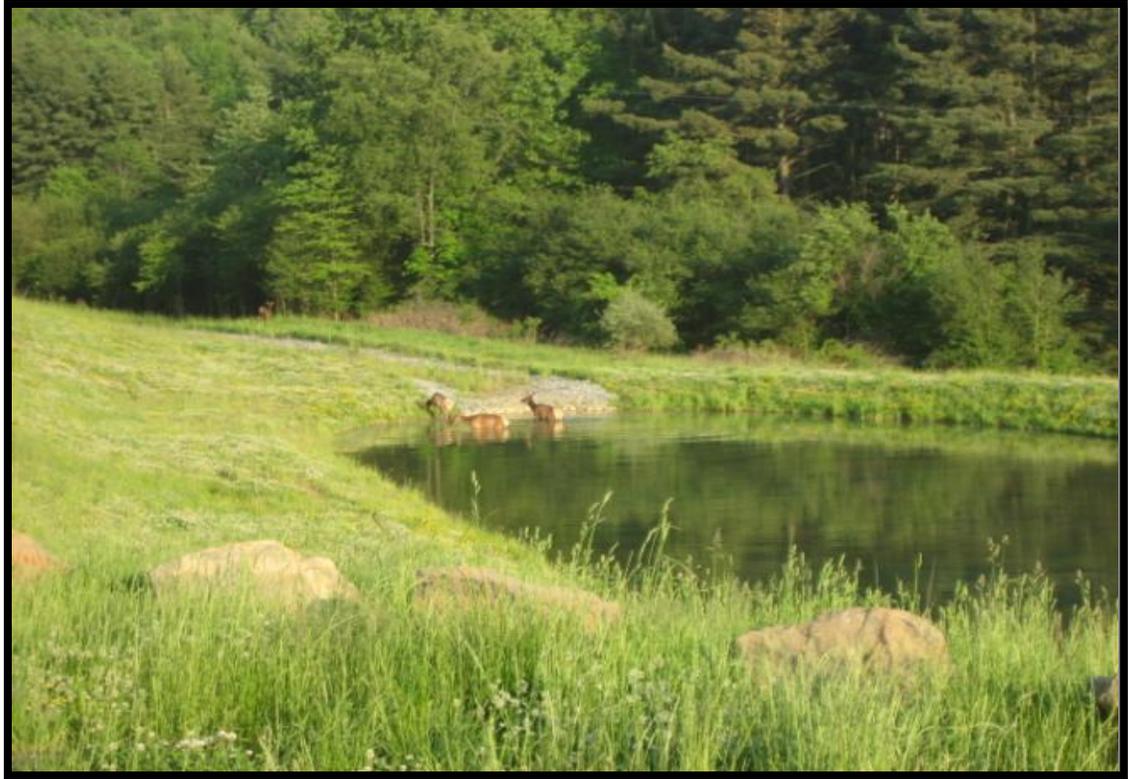
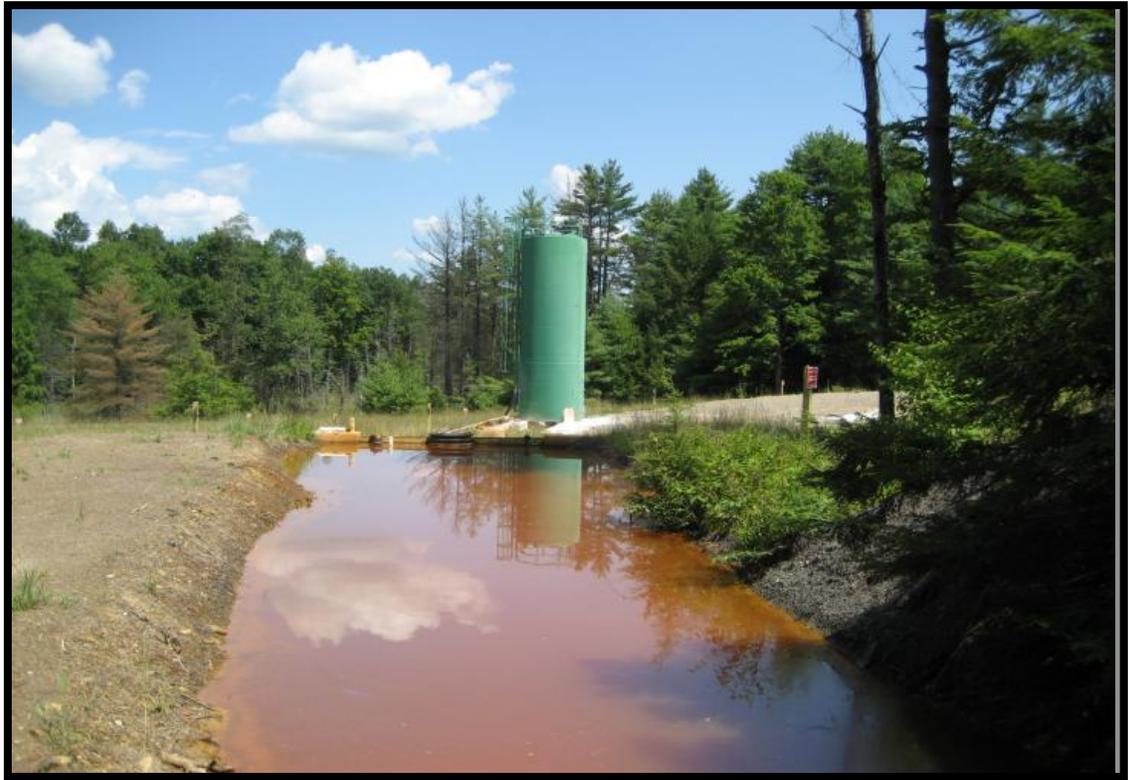
Figure 15 – Elk cooling off in COE passive treatment system PA 3888 (above), tipping bucket lime doser treating AMD Discharge No. 17 PA 1934 (below) photos from PGC website
